21 September 2012

## URGENT FIELD SAFETY NOTICE ALL HOSPIRA PLUM™ A+ FAMILY OF INFUSERS CONTINUOUS REBOOT - UPDATE

Product name:	Plum A+ Family of Infusers
List Number:	11005, 11006, 11971, 11973, 12348, 12391, 12618, 20677, 20678, 20679, 20791, 20792
EMEA FA ID:	EMEA.2011.010
Date:	21 September 2012

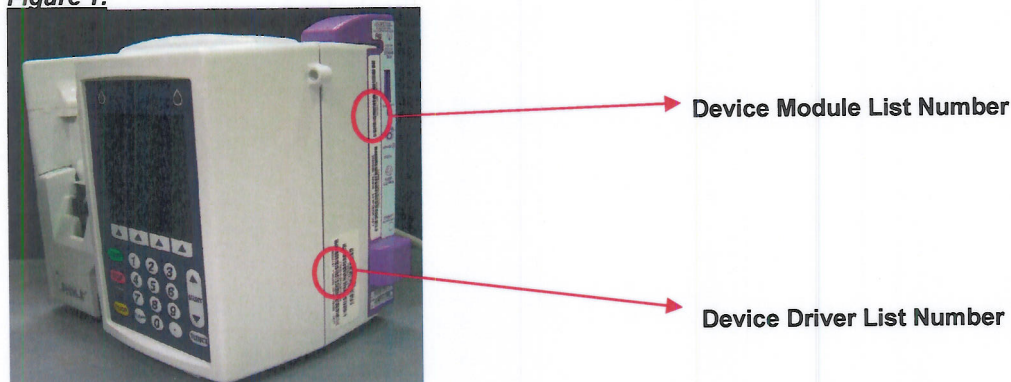
Figure 1.

- The Plum A+ single channel pump comprises a device driver and device module. Device modules with v13.0, v13.1, v13.2, v13.3, v13.40, and v13.5 software will require the software upgrade.
- The location of the Device Drive list number and Device Module list number is shown in *Figure 1. Single channel Plum A+ Pump - Location of Device Module and Device Driver List Numbers.*

If you have the following Device Module list numbers, regardless of Device Driver list number, you will be receiving a software upgrade:

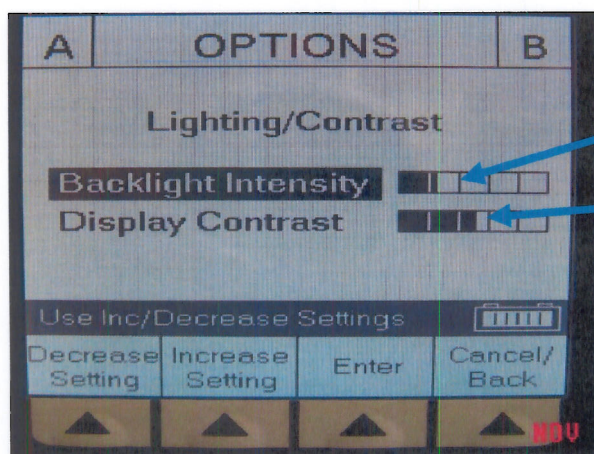
To prevent an occurrence of continuous recycling/rebooting during start-up, adjust the backlight intensity and contrast settings as described below:

1. Go to the Lighting/Contrast Screen under "Options"
2. Backlight Intensity: Set to one (1) increment past one (1) full bar from the left as shown in the picture below.
3. Display Contrast: Set to five (5) increments below three (3) full bars as shown in the picture below.
4. Press enter to save the settings. Correct LCD settings below:

**Backlight Intensity – One (1) increment above one (1) full bar.**

**Display Contrast – Five (5) increments below three (3) full bars.**
