January 28, 2013

Urgent Medical Device Field Safety Notice

ISOLINE defibrillation leads, model 2CR5, 2CR6 and 2CT6

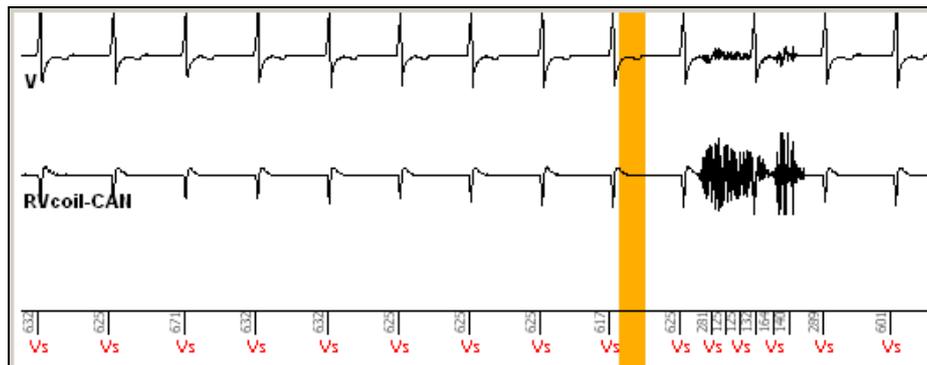
Ventricular oversensing caused by external signals (such as 50 Hz Electro Magnetic Interferences):

Such episodes are not related to lead malfunction. If such an episode is recurrent, avoidance of the source of interference is recommended.

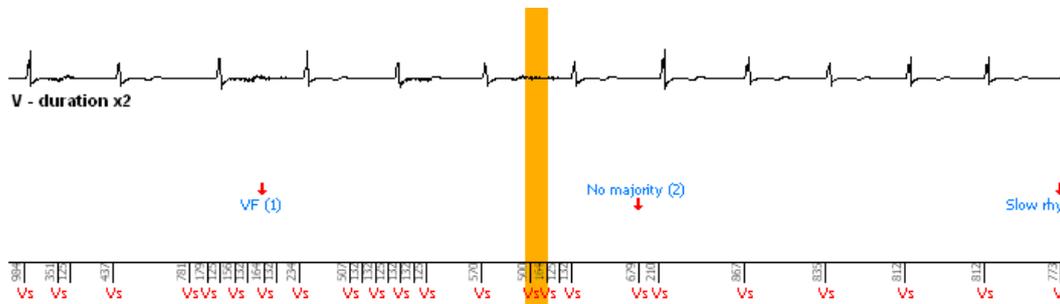
Ventricular oversensing caused by myopotentials:

Such episodes are not related to lead malfunction. If such an episode is recurrent, sensitivity should be adjusted.

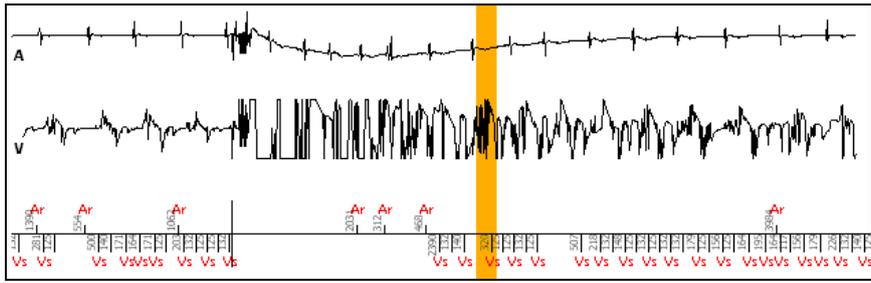
Ventricular oversensing caused by lead issue:

- In case of evidence of a lead issue (as shown in the appendix), physicians should consider replacing the lead, while weighing the risks and benefits of extracting the
