**Report on the accident to  
Airbus A-320-231, G-MEDA  
On approach to Addis Abeba Airport,  
Ethiopia  
31 March 2003**

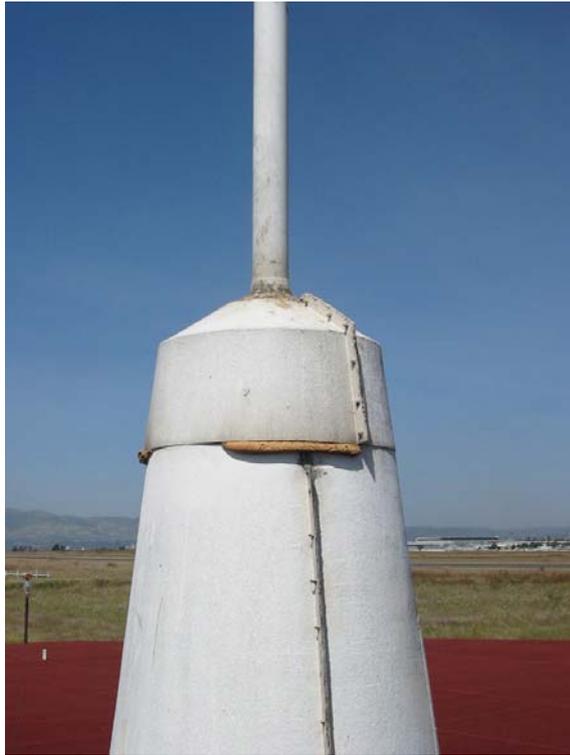
**Figure 9**

ADS VOR antenna radome on top of the ground plane

Physical inspection of the ADS VOR ground station, in the days after the incident involving G-MEDA, revealed water ingress in the capacitors used to couple the signal generators to the antennas. It was reported that the impedance matching capacitor of the NE/SW variable signal was full of water; the affected area was cleaned and dried. A transistor in the control unit was also found to be faulty and was replaced. Changing the characteristics of one of these capacitors will affect the power output and/or phase of the varying signal used to drive the corresponding antenna pair. Figure 10 illustrates the effects of changing the power and phase of the NE/SW antenna signal. The errors generated by these types of faults are not uniform. For some bearing ranges, large changes in actual bearing will result in relatively small changes in the bearing sensed at the aircraft.

The sealant used on the antenna assembly had been supplied by a contracting firm and was established to have been of an incorrect type; the sealant was replaced. Technicians used a hand-held receiver to test the signal strength, identification and navigation guidance of the ADS VOR. This test indicated normal operation; however, since the test was not conducted from a surveyed position the accuracy of the ADS VOR could not be determined. A serviceability report was requested from an aircraft in flight, which confirmed that the ADS VOR was operating.

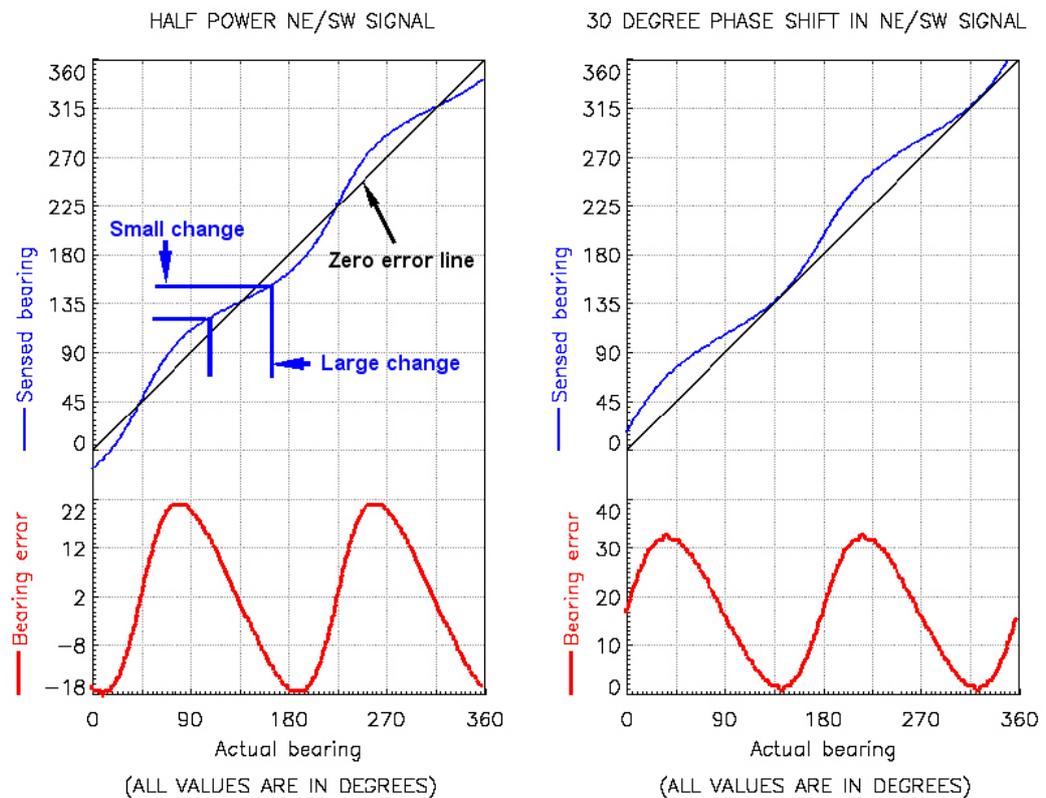
**Figure 10**  
Simplistic models of VOR behaviour with altered signal power and phase for the NE/SW VOR signal

The day after the incident, with the aircraft outbound from the ADS VOR on a heading of  $092^\circ$ , the crew observed a  $22^\circ$  error. With the aircraft inbound on a heading of  $249^\circ$ , a VOR error of  $30^\circ$  was observed. The crew made these observations when in good visual contact with the runway and the surrounding terrain. These errors were reported to ATC.

No single simplistic model of VOR error matched all the observed ADS VOR deviations, however, observations were made at different times and it is likely that the effect of the water ingression on the radiated ADS VOR signal varied over time.

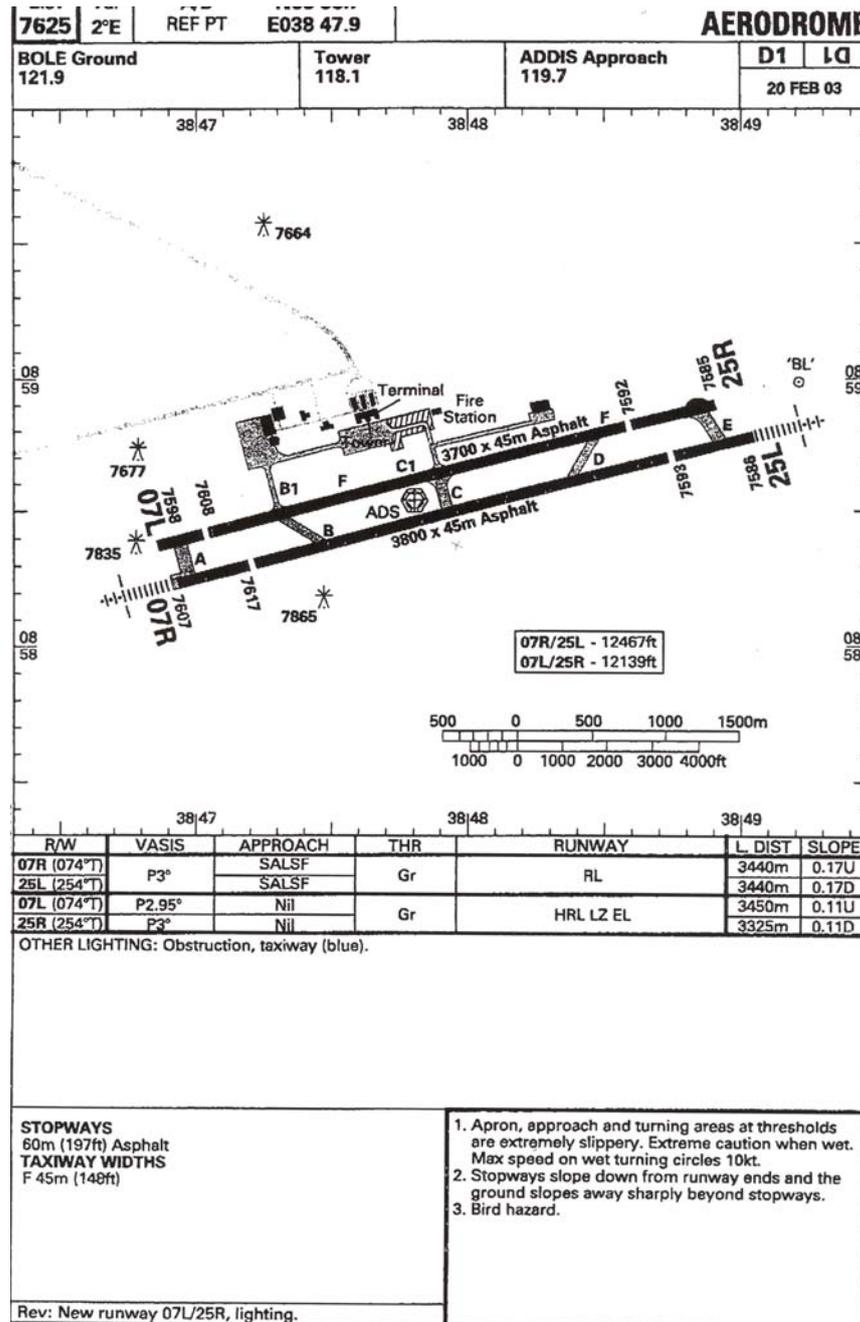
**Figure 12**  
Addis Abeba aerodrome chart D1

A copy of the airfield (D1) chart is reproduced at Figures 12. The position of the ADS VOR relative to the runways is depicted incorrectly on chart D1; the ADS VOR was in fact located to the south of both runways.

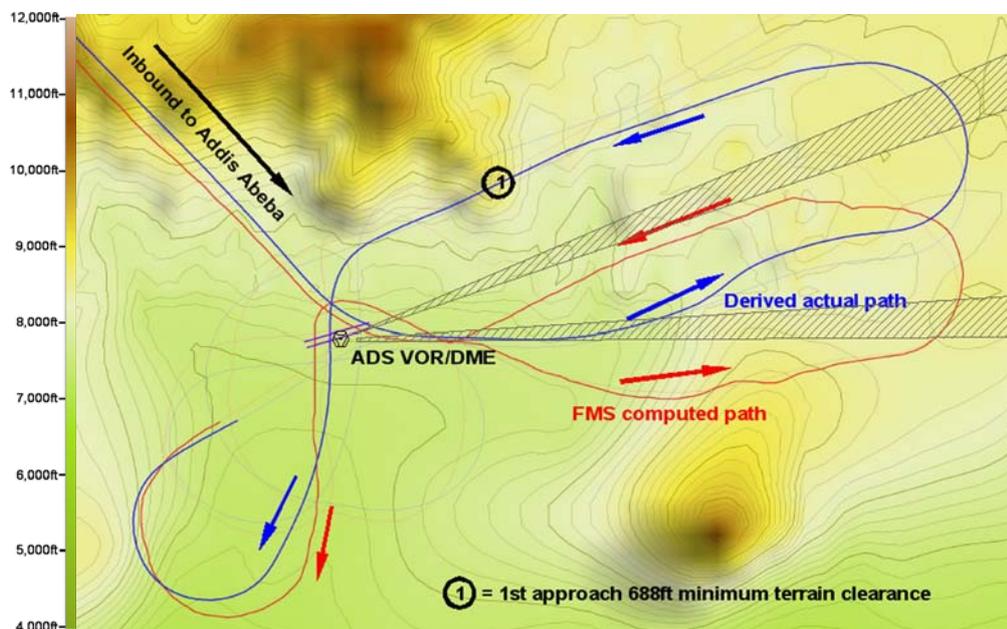
**Figure 13**

The go-around was initiated at 2323 hrs with the lowest recorded terrain clearance of 688 ft. The relationship between the FMS and actual flight paths fluctuated to a lesser extent during the go around.

First ADS VOR/DME procedural approach and go-around showing the FMS computed path and derived actual path (Hatched area = procedural ADS VOR bearings)

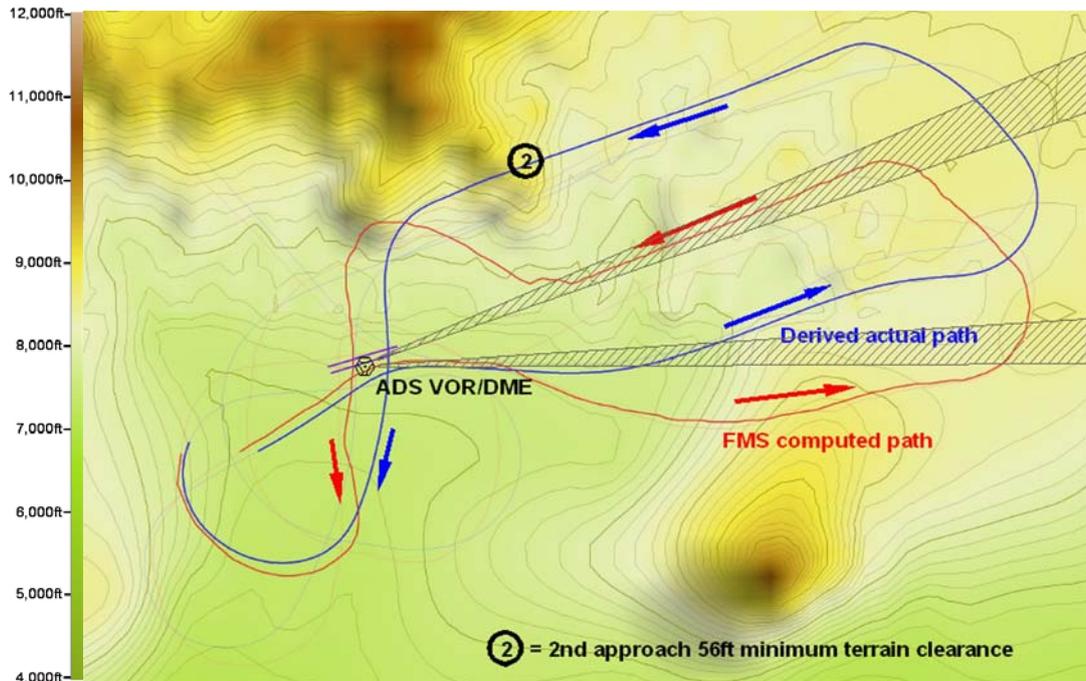
**Figure 14**

The second approach had similar lateral position characteristics as depicted in Figure 14. The aircraft completed the turn onto the inbound track and commenced the descent. The aircraft was then configured with the gear down and full flap. The rate of descent varied between 700 and 950 fpm, the indicated airspeed was maintained at about 135 kt, and the heading drifted from 240°M to 245°M. The autopilot was engaged throughout the second approach.

Second ADS VOR/DME procedural approach and go-around showing the FMS computed path and derived actual path (Hatched area = procedural ADS VOR bearings)

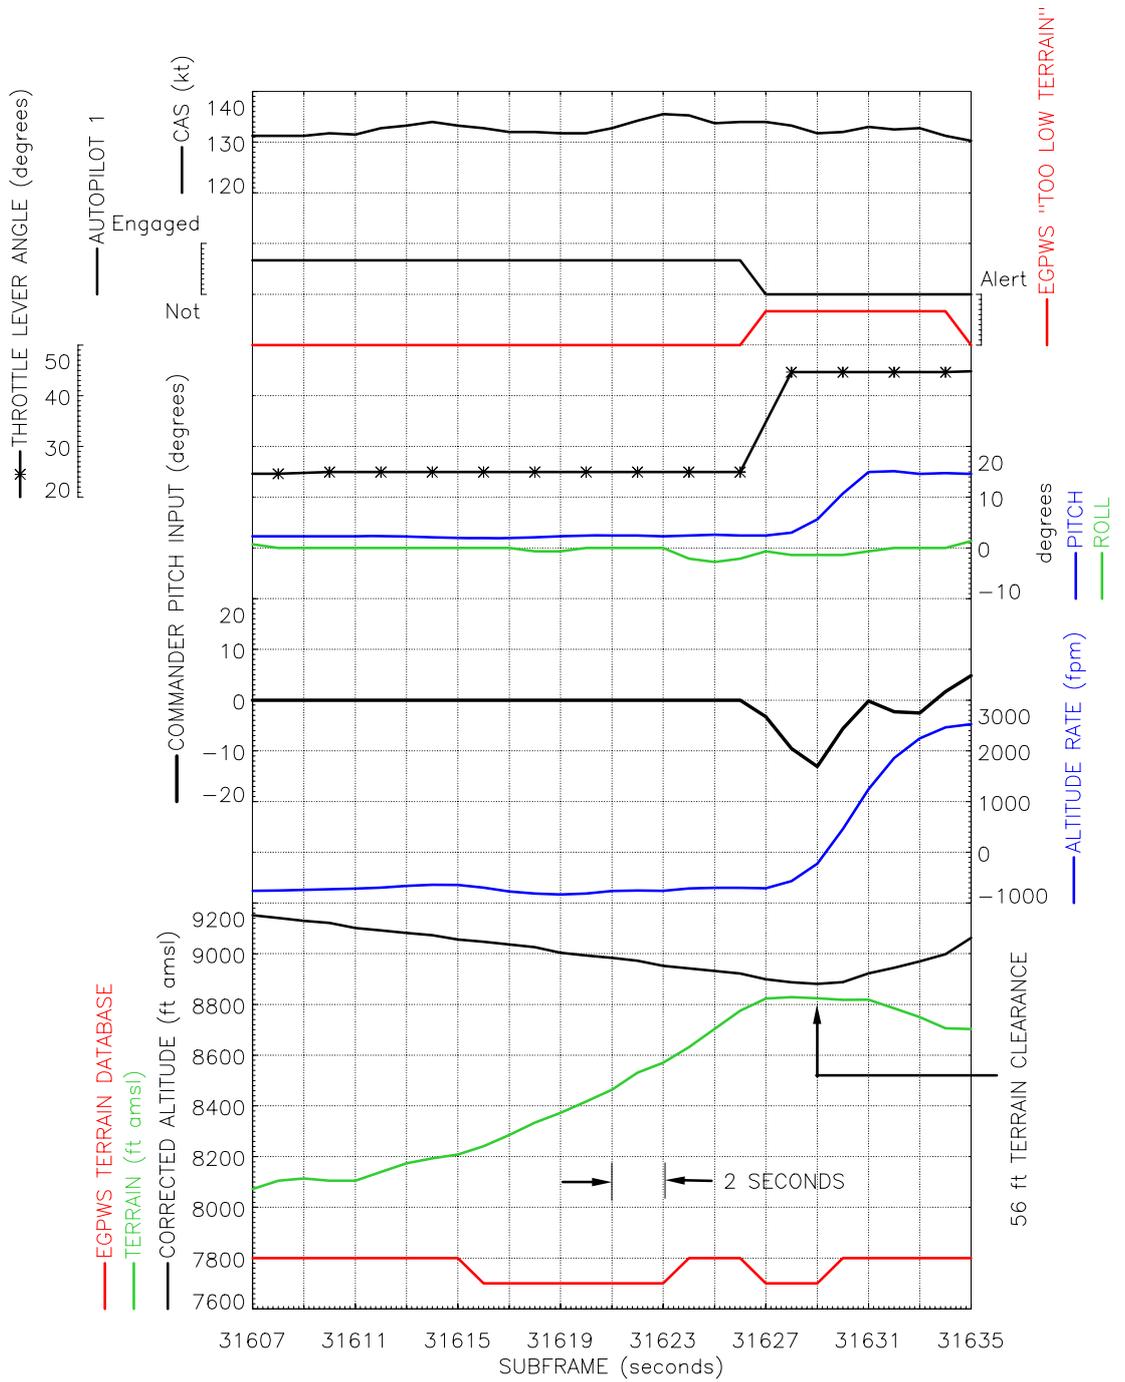
**Figure 15**  
EGPWS alert on the second approach

The EGPWS also recorded the expected terrain elevation from its database for the given FMS aircraft position. This is also shown in Figure 15. When the aircraft

was closest to the ground, the difference between the EGPWS database expected terrain elevation and the measured terrain elevation was more than 1,000 ft.

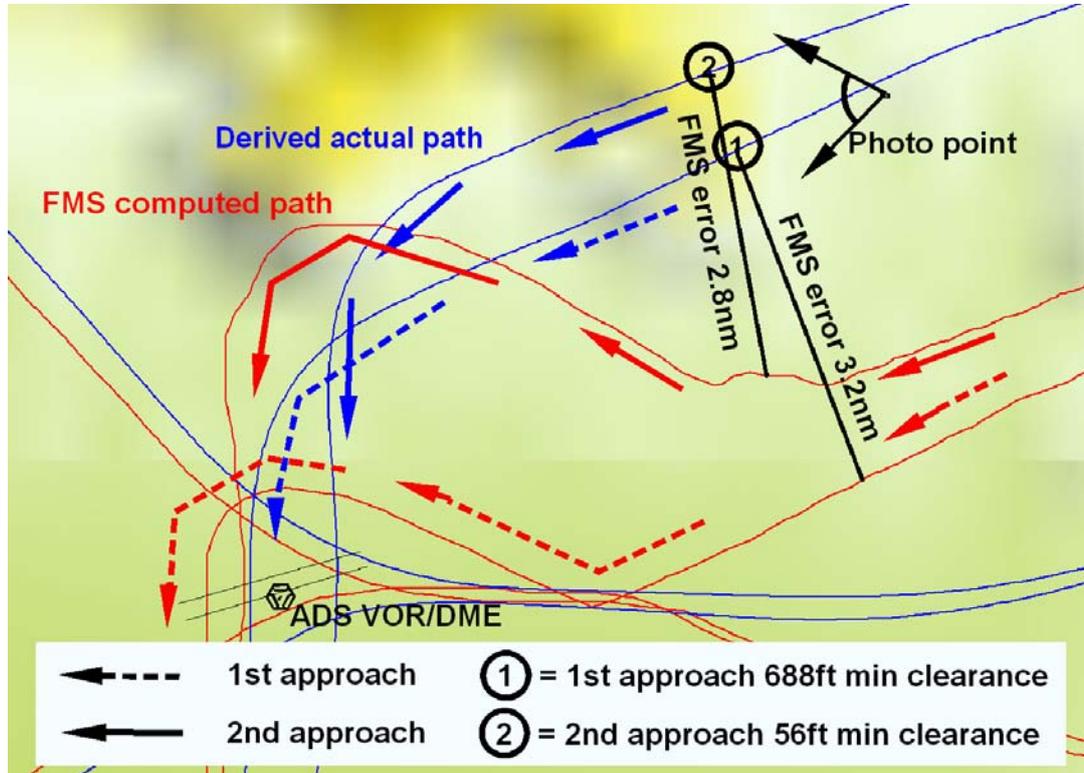
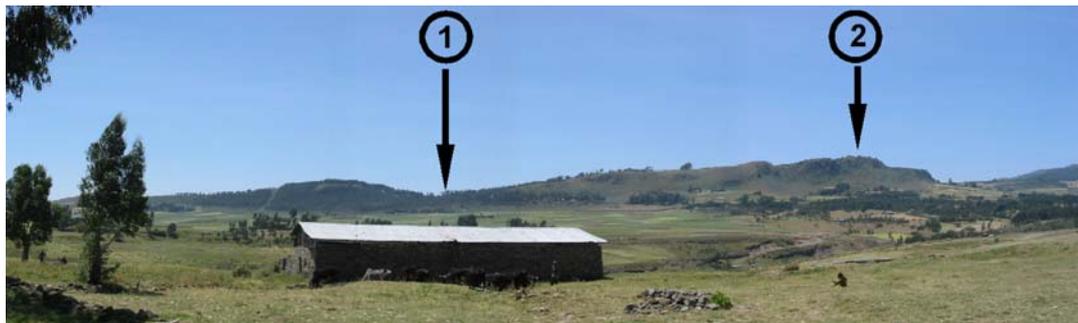
**Figure 16**

Figure 16a shows a comparison of the sections of both approaches where the terrain clearance was at a minimum. The data shows that the FMS was approximately 3 nm in error on each approach, with the aircraft over much higher terrain than the FMS position would indicate. The picture at Figure 16b shows the physical locations of the points of closest approach to terrain during each approach.

b) Picture showing the points of closest approach to terrain during the 1<sup>st</sup> and 2<sup>nd</sup> approaches.

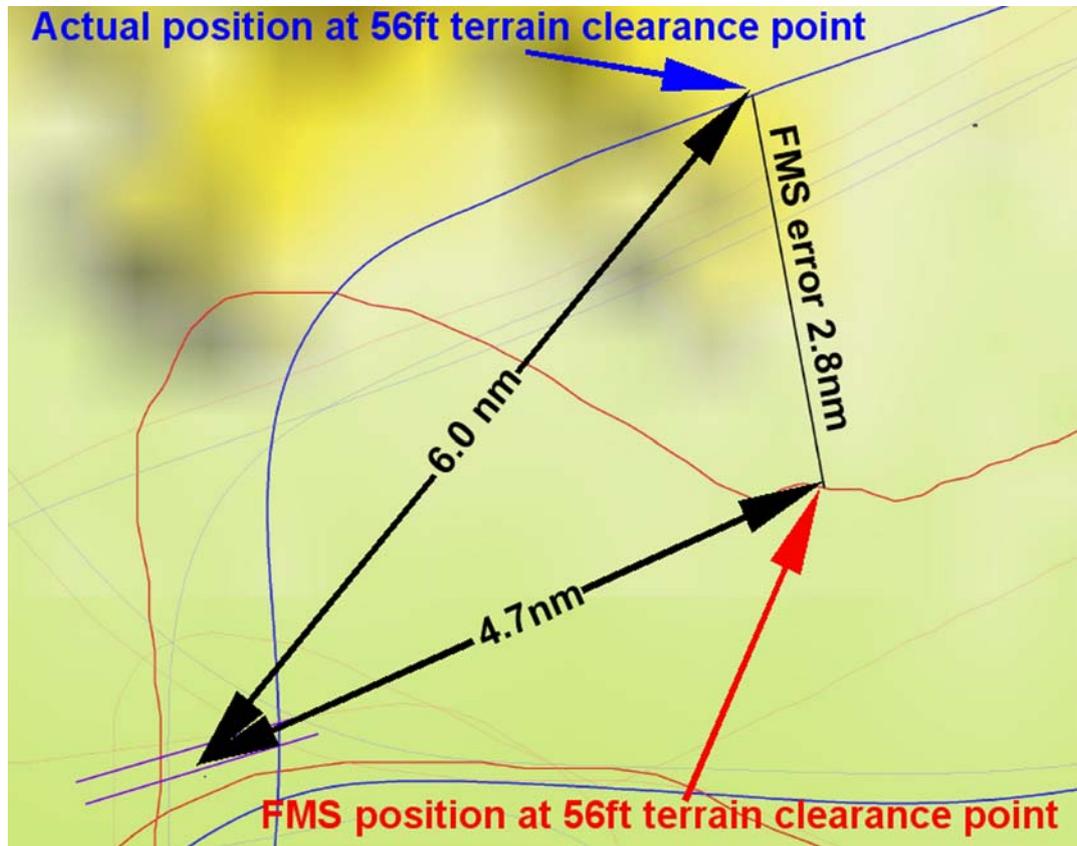
**Figure 18**

The TCF allowed clearance height is a function of distance to runway, therefore the effect of the FMS error on the TCF function should be reviewed. The effect on TCF distance is shown in Figure 18 below.

Effect of the FMS error on the distance to runway centre calculation of the TCF function, at the point of minimum terrain clearance

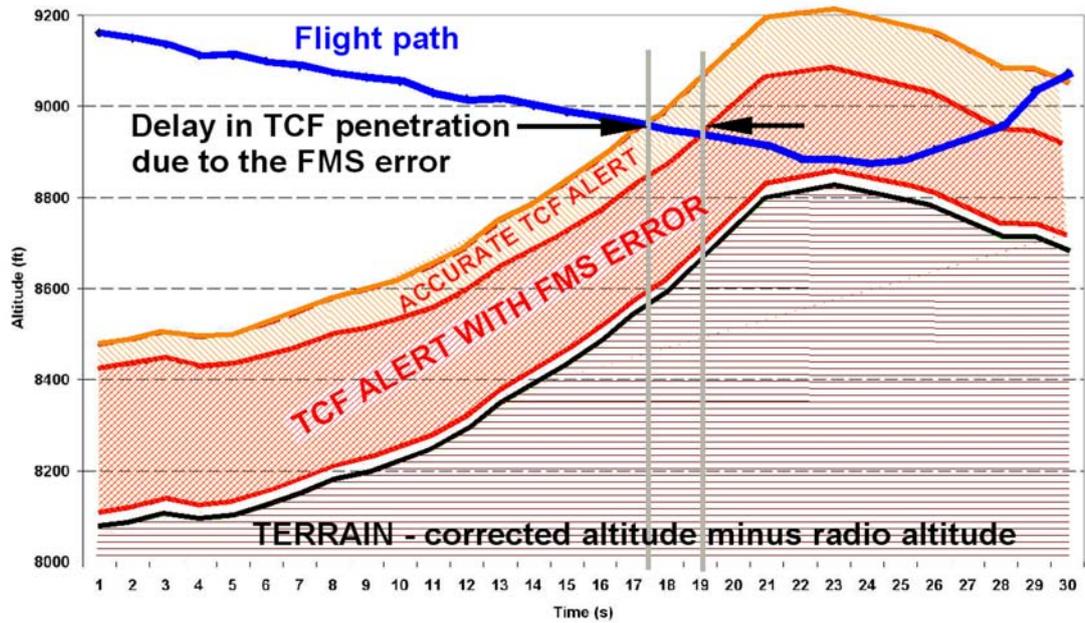
**Figure 19**  
TCF alert envelope with and without the FMS error

Applying these distances along with a simplistic model of the aircraft's flight path gives a less sensitive TCF alert envelope with the FMC error than if the navigation had been accurate. This is illustrated in Figure 19.

The FMS error effectively only delayed the alert by approximately 1.5 seconds. In this case, using the latest, tightest TCF envelopes would not have significantly increased the time to alert.

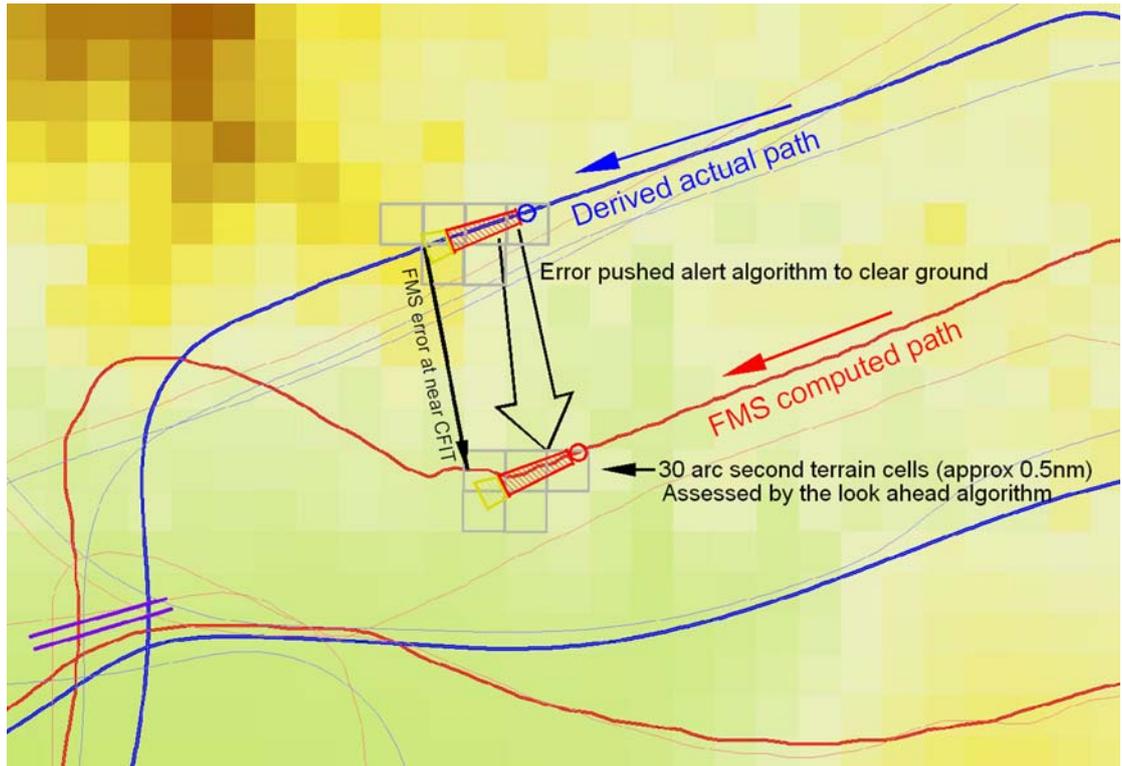
**Figure 20**

In this case the cross track navigation error was about 2.8nm so the alert algorithm 'passed' by the side of the hazard. Figure 20 illustrates this using terrain data that is not from the EGPWS but is of a resolution that is representative of typical terrain cell sizes used by the EGPWS in terminal areas. The representation of blocks of interest to the look ahead alert algorithms are only an illustration of the nature of the interaction of the terrain data with the algorithms are not definitive indications of actual terrain cells used in the terrain database.

FLTA - Honeywell alert envelopes in relation to the navigation error

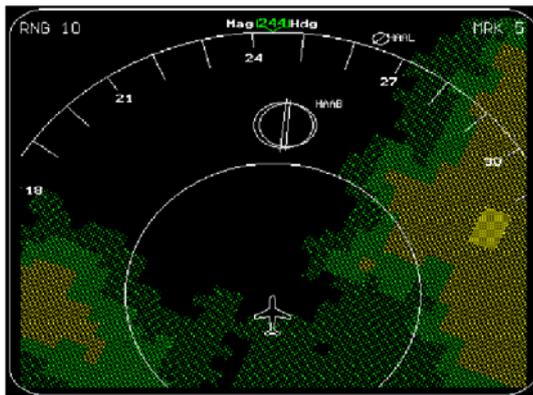
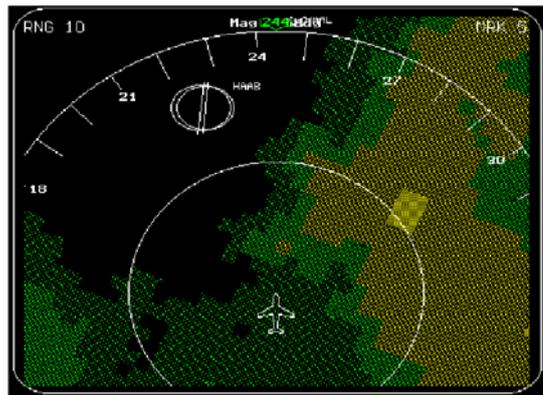
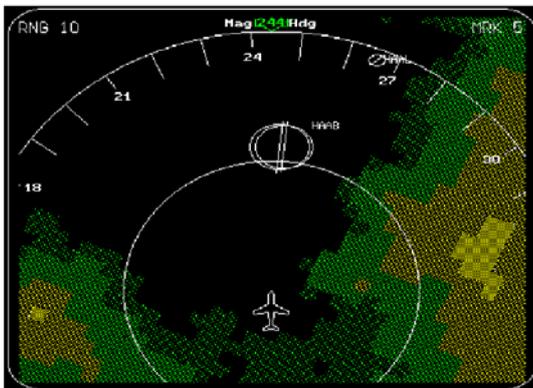
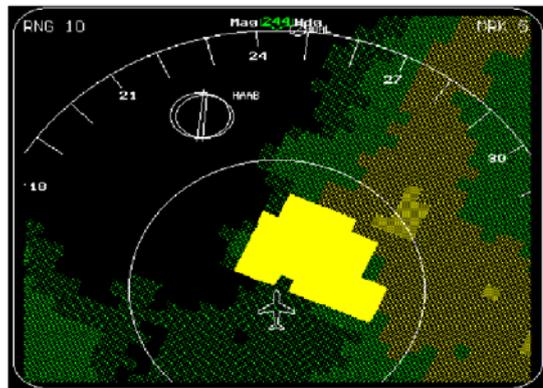
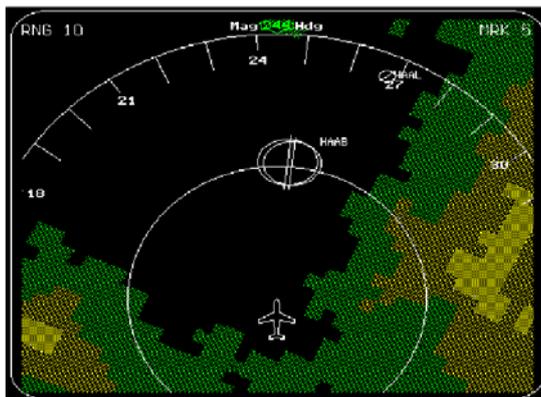
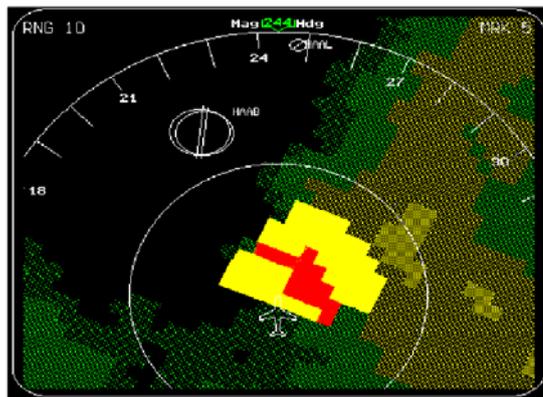
**Figure 21**

If the terrain display and the navigation display systems had used independent sources of navigation data then the display would have either given correct terrain depiction and incorrect runway depiction or vice versa. Either way, it would have been a possible cue to the crew that things were not right.
