INCIDENT

Aircraft Type and Registration:	Cessna 550 Citation, G-FCDB	
No & Type of Engines:	2 Pratt & Whitney Canada PW530A turboprops	
Year of Manufacture:	2001	
Date & Time (UTC):	25 November 2004 at 0700 hrs	
Location:	Teesside Airport, Darlington, Co Durham	
Type of Flight:	Public Transport (Passenger)	
Persons on Board:	Crew - 2	Passengers - 1
Injuries:	Crew - None	Passengers - None
Nature of Damage:	None.	
Commander's Licence:	Airline Transport Pilot's Licence	
Commander's Age:	52 years	
Commander's Flying Experience:	7,500 hours (of which 4,000 were on type) Last 90 days - 102 hours Last 28 days - 32 hours	
Information Source:	Air Accident Report Form submitted by the pilot, flight data recorder and reports from the airport operator and aircraft engineering facility

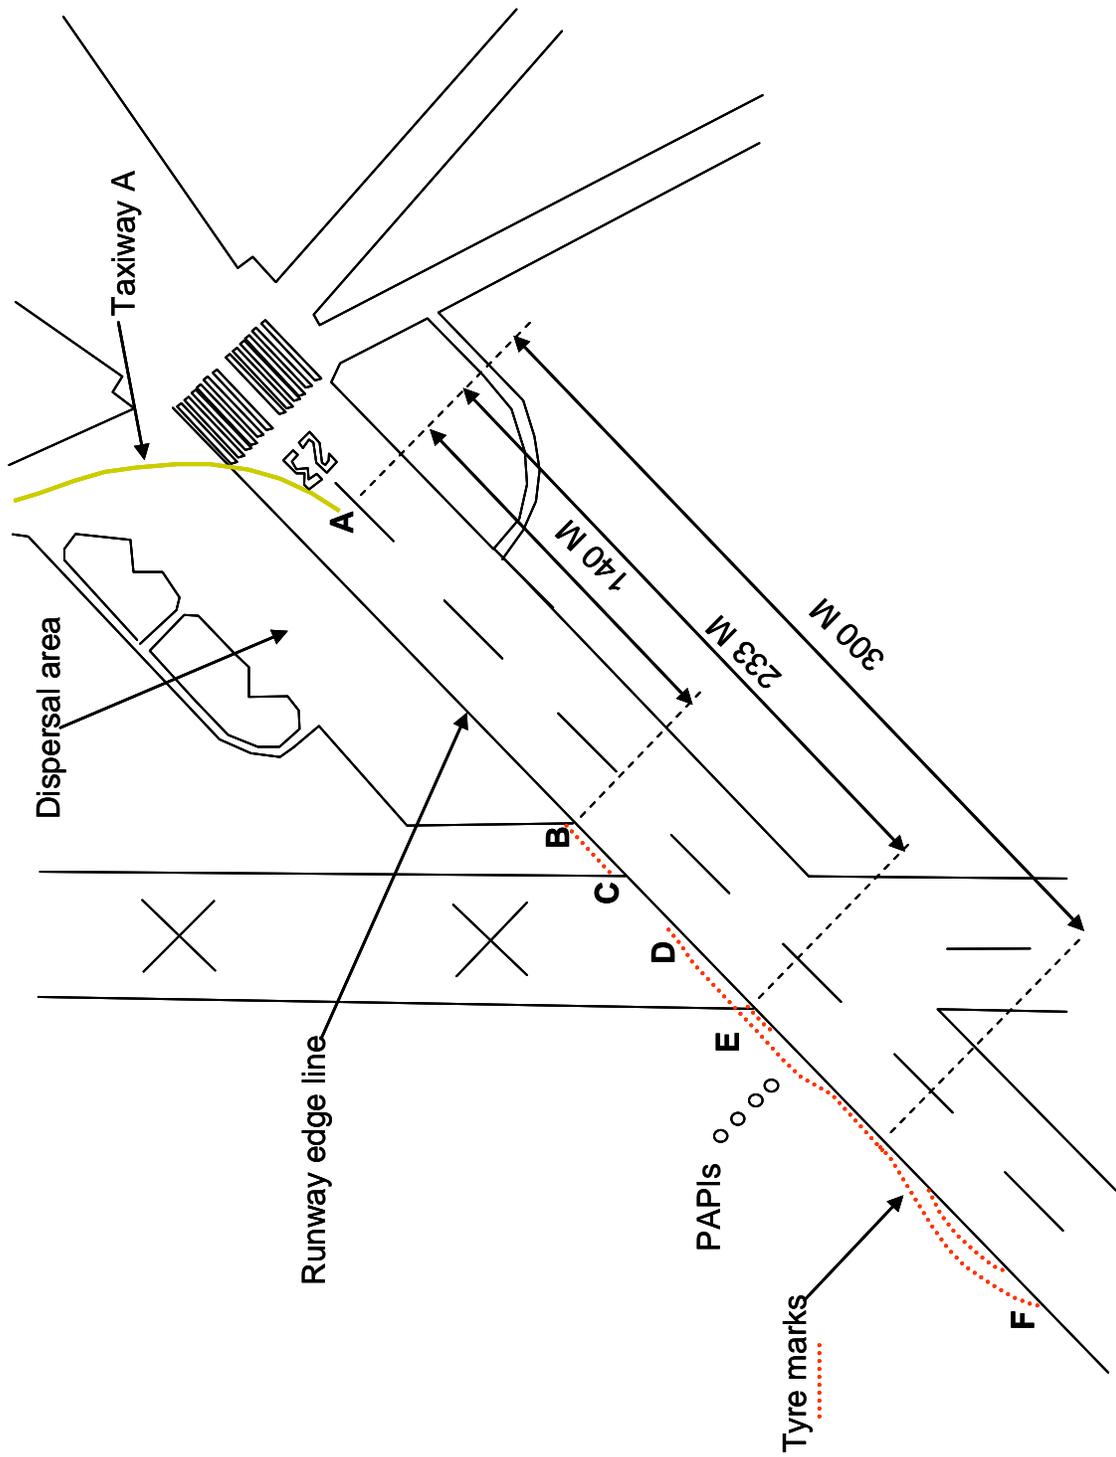
Figure 1

An examination of the site was conducted by the airport operator. The results of the examination are shown diagrammatically at Figure 1. The diagram also shows the centreline of Taxiway Alpha entering the runway, and a notional point A indicating the start of take-off roll for an aircraft following this yellow line.

Tyre marks were seen entering the grassed area at point B, which measured 140 metres from point A. The point where the tyre marks entered the grass was 26.2 metres from the runway centreline, and continued for 23.3 meters, approximately parallel with the runway, until the track entered the crossing runway at point C. A further tyre mark started on the crossing runway at point D, 28 metres from point C, and continued for a further 37.2 metres to the edge of the disused runway at point E. As the tyre mark crossed the disused runway, it was deviating to the right slightly. As the tyre mark entered the grass at point E, a further tyre mark is seen entering the grass, but closer to the runway. Both tracks then deviate to the left and the tyre track closer to the runway re-enters it 10 metres further along. The main tyre track then parallels the runway edge before deviating to the right once again at which point the second track re-appears. Both tracks then show a gradual turn to the left and re-enter the runway at F, a distance of 134 metres from point E where the tracks entered the grass for the second time.

The available flight data and ground witness marks indicate that the aircraft was lined up for takeoff on the runway edge line instead of the runway centre-line. The commander's report that the runway did not have centre-line lighting, when in fact it does, also supports this conclusion. The investigation therefore looked at how the crew may have made this error and what may have caused both pilots to interpret the subsequent events in the way they did.

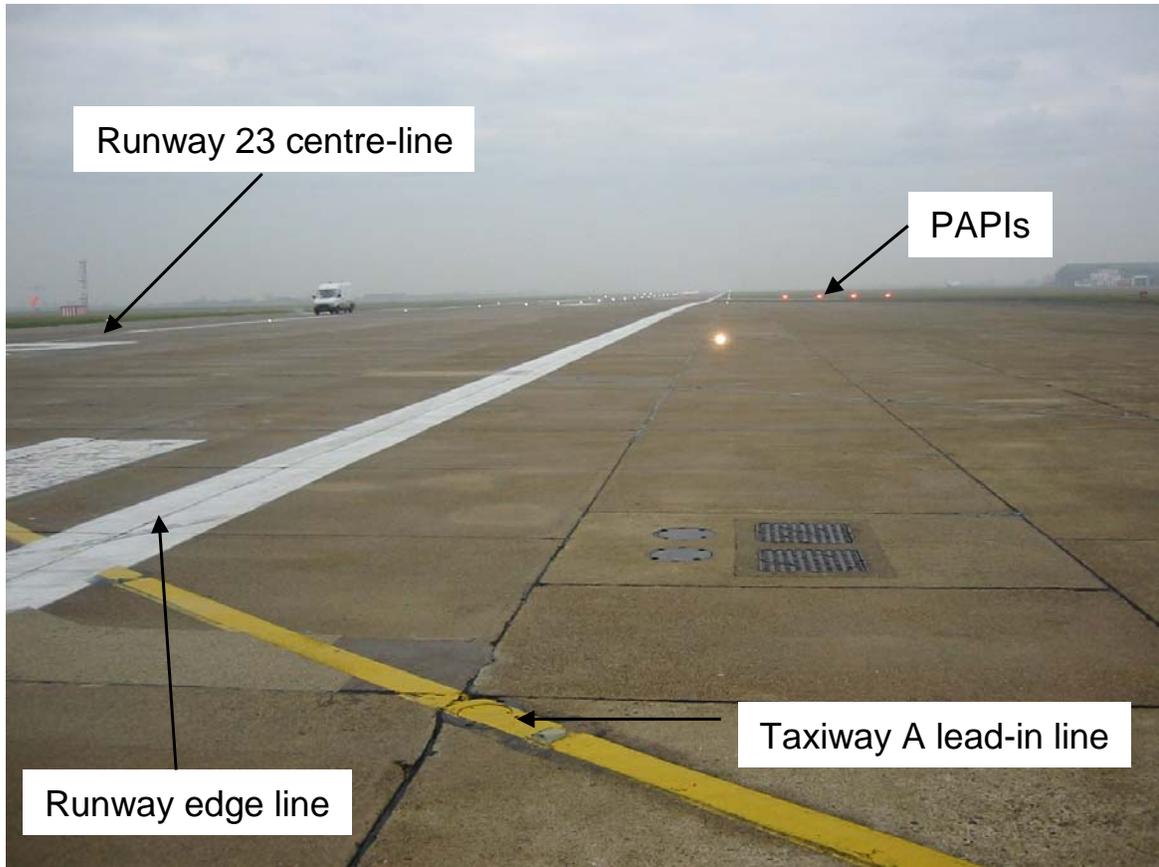
metre outside the line for that part of it which crosses the dispersal area. Apart from the white runway edge line, there are no ground markings on the Runway 23 dispersal area. The associated dispersal area for Runway 05 is marked by white crosses to indicate that it is not to be used for take off. Figure 2 shows the view along Runway 23 from a point adjacent to taxiway Alpha as it enters the runway.

Measures had been taken by the airport operator to reduce the likelihood of a crew lining up on the edge line. These included the requirement stated in the UK AIP that crews follow the taxiway marking and lights until established on the centre-line lights, the provision of blue taxiway edge reflectors when approaching the runway and the red reflectors placed about one metre outside the edge line as it crosses the dispersal area. However, unlike Runway 05, there were no ground markings to indicate that the dispersal area was not part of the runway. The view had been taken that the position of the PAPI lights was such as to alert a crew of an incorrect line up. However, this visual cue may not be available in poor visibilities when the error may be likely to occur. Nor did

Runway 23 threshold area

The ground markings at Teesside Airport are the subject of a current refurbishment programme. In the light of this incident and as part of that process, the airport operator has scheduled a review of the ground markings for Runway 23 which will take place early in 2005. Additionally, an upgrade to the airfield ground lighting system is scheduled for mid-2005.
