ACCIDENT

Aircraft Type and Registration:	Boeing 777-236ER, G-YMMM	
No & Type of Engines:	2 Rolls-Royce RB211 Trent 895-17 turbofan engines	
Year of Manufacture:	2001	
Date & Time (UTC):	17 January 2008 at 1242 hrs	
Location:	Runway 27L, London Heathrow Airport	
Type of Flight:	Commercial Air Transport (Passenger)	
Persons on Board:	Crew - 16	Passengers - 136
Injuries:	Crew - 4 (Minor)	Passengers - 1 (Serious) 8 (Minor)
Nature of Damage:	Aircraft damaged beyond economic repair	
Commander's Licence:	Airline Transport Pilot's Licence	
Commander's Age:	43 years	
Commander's Flying Experience:	12,700 hours (of which 8,500 hours were on type) Last 90 days - 85 hours Last 28 days - 52 hours	
Information Source:	Inspector's Investigation

The investigation

This report is an update on the progress of the investigation into the accident to G-YMMM on 17 January 2008, and should be read in conjunction with the initial Interim Report issued on 4 September 2008. That report includes a detailed history of the accident flight, a technical description of the fuel system in the

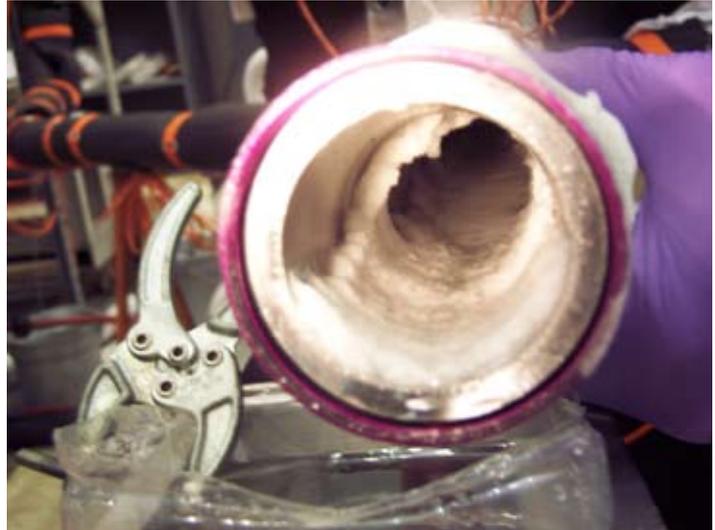
Figure 1

Ice in the flexible hose located at the rear of the strut

- When the fuel temperature was cooled from -12°C (10°F) to -33°C (-27°F), over a 7 hour period, at a similar rate to the accident flight, the amount of ice found in the fuel pipes was consistent with the findings after the 3 hour run at a fuel temperature of -12°C (10°F).
- The ice was soft and easy to move and there appeared to be no difference in the properties of the ice that accumulated at any of the cold test temperatures. However, in the test when the fuel temperature was cooled from -12°C (10°F) to -33°C (-27°F), the surface of the ice took on a 'pebbly' appearance.
- Examination of the melted ice showed that it consisted of a mixture of water and fuel. The quantity of water in the ice deposited along the inside of the fuel pipes in the strut area was greater than the amount found necessary, in previous tests, to restrict the FOHE.

- On two occasions approximately 90 ml of water was recovered from the ice that had accumulated in pipes in the strut area. On another occasion approximately 170 ml of water was recovered from this area; however, the possibility that this sample had been contaminated after the test could not be excluded.
