AAIB Bulletin S2/2014

SPECIAL

ACCIDENT

Aircraft Type and Registration:	Eurocopter EC135 T2+, G-SPAO	
No & Type of Engines:	2 Turbomeca Arrius 2B2 turboshaft engines	
Year of Manufacture:	2007 (Serial No: 0546)	
Location:	Glasgow City Centre, Scotland	
Date & Time (UTC):	29 November 2013 at 2222 hrs	
Type of Flight:	Commercial Air Transport	
Persons on Board:	Crew - 1	Passengers - 2
Injuries:	Crew - 1 (Fatal)	Passengers - 2 (Fatal) Other - 7 (Fatal) 11 (Serious)
Nature of Damage:	Helicopter destroyed	
Commander's Licence:	Commercial Pilot's Licence	
Commander's Age:	51 years	
Commander's Flying Experience	5,592 hours (of which 646 ¹ were on type) Last 90 days - 38 hours Last 28 days - 19 ² hours	
Information Source:	AAIB Field Investigation

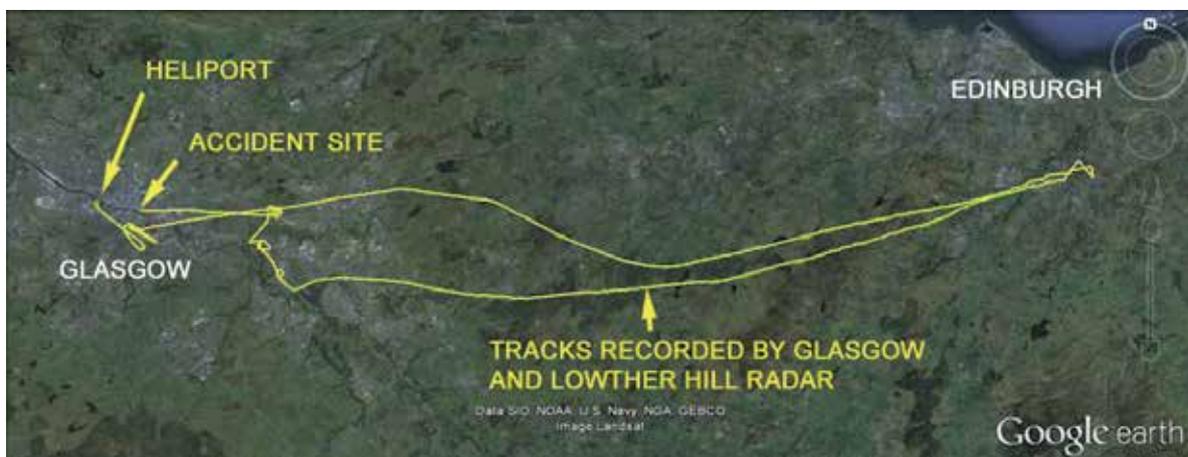
Figure 1

and Bargeddie, North Lanarkshire, where it carried out non-urgent tasks, orbiting in each location for less than five minutes (see Figure 1). At 2218 hrs, the pilot requested clearance from ATC to re-enter the Glasgow Control Zone, to return to GCH. This was approved. No further radio transmissions were received from the pilot.

The helicopter's track, as recorded by radar

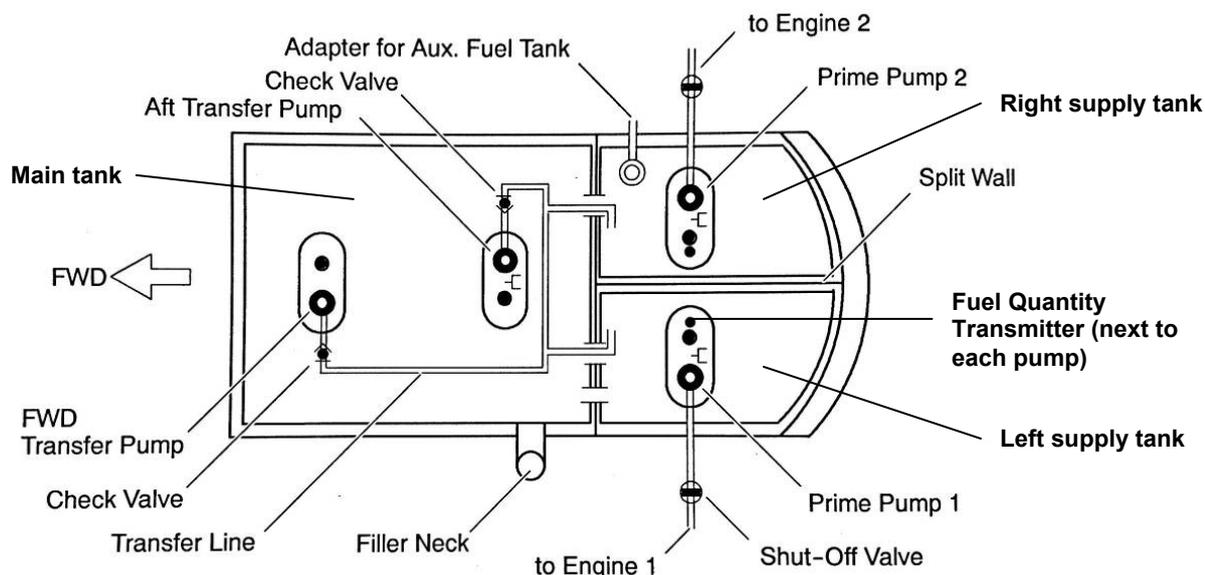
Figure 2
Fuel Tank Group Schematic

The helicopter's fuel tank group was drained and the contents were measured immediately after it was extracted from the building. It was found that the main fuel tank contained 76 kg of fuel, whilst the No 1 supply tank (left) contained 0.4 kg of fuel and the No 2 supply tank (right) was empty. It has also been confirmed, by examination and measurement of the internal design features, that this was the fuel disposition at the time of the accident. That is; fuel had not moved within the tank group whilst the helicopter was at rest in the building. Also, there was no evidence that fuel leaked from the helicopter before or during the impact with the building.

Since the helicopter's recovery to the AAIB facility, a very close examination of the fuel system has continued. It has been determined that the fuel tank group suffered sudden elastic compression during the impact, whilst retaining its basic shape. The compression was sufficiently severe to collapse all four internal fuel quantity transmitters, as they are designed to do, and the tank group bladders remained fuel-tight. Examination of all internal pipe work and transfer passages has not revealed any pre- or post-impact failure and all paths still permit uninterrupted fuel flow. It has been established that unrestricted flow was also available from each supply tank to the corresponding engine fuel control unit, through the relevant fuel shut-off valves which were found set to the OPEN position.
