History of the flight

Fuel suction filters and Modification NB/M/350

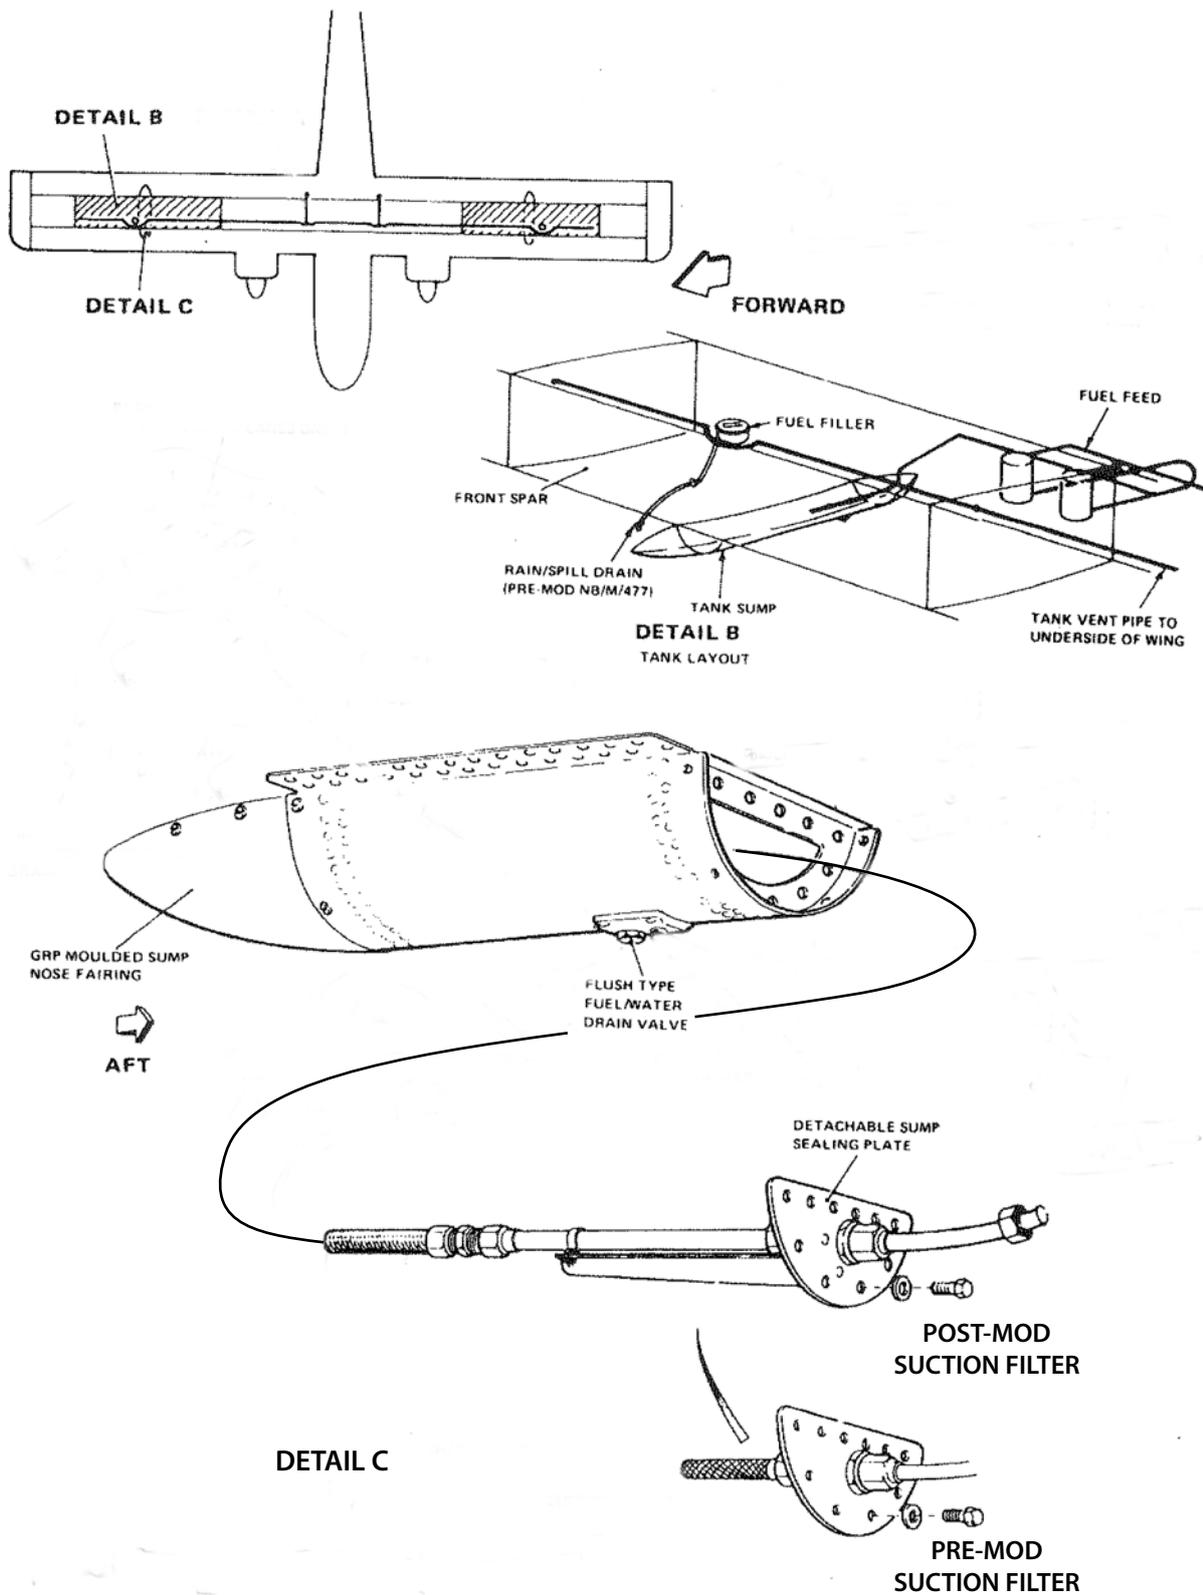
Figure 1 shows the aircraft fuel tank installation and the detail of a modification to the fuel suction filter assembly.

This modification, Mod NB/M/350, mounted the suction filter 8.5 in forward of the sealing plate, on the end of a tube, and raised the filter from 1.05 in to 2.25 in above the bottom of the sump. The modification, issued in 1968, was intended to provide increased protection from water contamination of the fuel. Water, if present, collects at the bottom of the sump and tends to move aft during takeoff and climb. The modified filter is more likely to remain above the water level, as represented in Figure 2.

The modification was not routinely installed on new build aircraft until aircraft Construction Number 091. The investigation has not established how many of the earlier aircraft had been modified. The fuel tank sumps of VP-MON (Construction Number was 082) had not been modified.

It is recommended that the European Aviation Safety Agency takes action to require that Britten-Norman Islander aircraft are equipped with fuel suction filter assemblies which minimise the likelihood of any water present in the fuel tank sumps being fed to the engines.

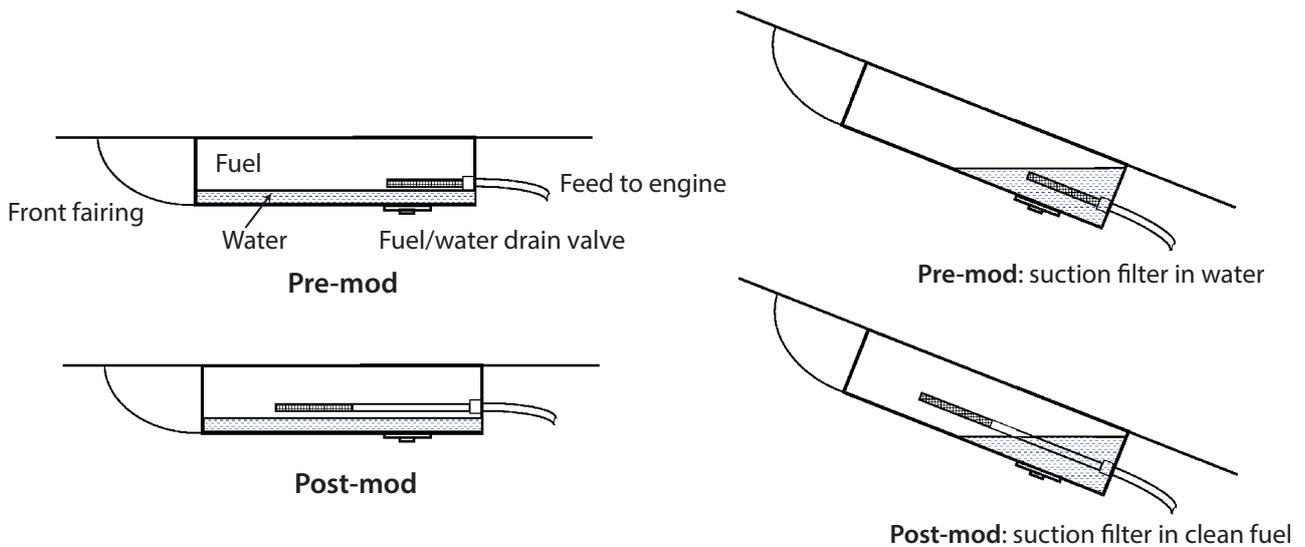
Figure 2

Both N589SA and VP-MON had the same pre-modification fuel suction filters, which drew fuel from the rear of the fuel sump. The modified design appears to offer improved tolerance to water in the fuel tank sump.
