**ACCIDENT**

<b>Aircraft Type and Registration:</b>	CZAW Sportcruiser, G-MELL	
<b>No &amp; Type of Engines:</b>	1 Rotax 912ULS piston engine	
<b>Year of Manufacture:</b>	2010 (Serial no: LAA 338-14866)	
<b>Date &amp; Time (UTC):</b>	17 May 2014 at 1230 hrs	
<b>Location:</b>	3 miles south-east of Westcott, Hertfordshire	
<b>Type of Flight:</b>	Private	
<b>Persons on Board:</b>	Crew - 1	Passengers - None
<b>Injuries:</b>	Crew - 1 (Minor)	Passengers - N/A
<b>Nature of Damage:</b>	Damage to canopy, tailplane, elevator and flaps	
<b>Commander's Licence:</b>	Private Pilot's Licence	
<b>Commander's Age:</b>	63 years	
<b>Commander's Flying Experience:</b>	517 hours (of which 156 were on type) Last 90 days - 9 hours Last 28 days - 5 hours	
<b>Information Source:</b>	Aircraft Accident Report Form submitted by the pilot and further enquiries by the AAIB and Light Aircraft Association

**Synopsis**

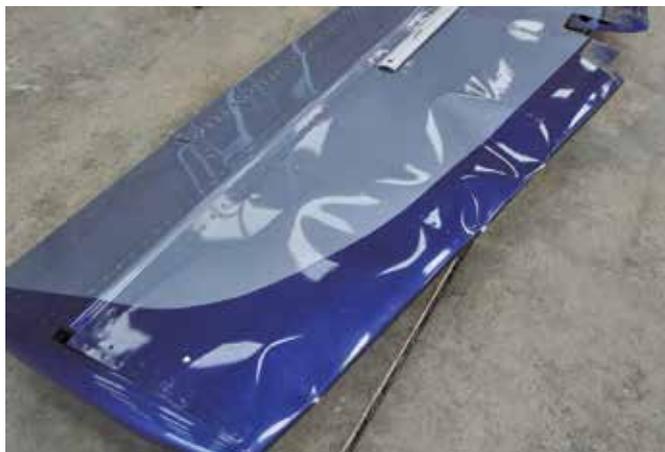
**Figure 1**

He was given directions to join directly downwind for Runway 26; the wind was less than 5 kt and virtually straight down the runway. A normal approach and landing followed and the pilot was able to taxi to his normal parking spot, disembark and inspect the damage to the aircraft. He found, in addition to the broken canopy, that the tailplane was severely buckled with ruptures on both sides and with consequent damage to the elevator. It was evident that the tailplane had been very close to complete failure (Figure 1).

Right side tailplane from G-MELL, showing severe buckling damage. Left side similar.  
(Photo courtesy LAA)

The most likely scenario, and the one being explored by the LAA, is that a sharp vertical gust of wind (perhaps the result of the aircraft's speed being abnormally high at low level) overstressed the tailplane and the 'g' spike caused the unsecured fire extinguisher to rise out of its stowage and the pilot's head to strike the canopy.

On 12 June 2014, the LAA issued Airworthiness Information Leaflet LAA MOD/338/018 Issue 1 to all existing and potential owners of homebuilt Sportcruisers. This reduced the  $V_{NE}$  of the aircraft from 138 kt to 120 kt. They followed it up on 13 June with Airworthiness Alert LAA/AWA/14/09 which gave a brief summary of the incident, highlighting the potential dangers posed by the unsecured fire extinguisher.

The LAA has initiated a design and certification review of the Sportcruiser tailplane structure with a view to eventually relaxing the  $V_{NE}$  restriction, which is seen as a temporary mitigation measure.
