## ACCIDENT

<b>Aircraft Type and Registration:</b>	Pegasus Quik, G-CCWR	
<b>No &amp; Type of Engines:</b>	1 Rotax 912ULS piston engine	
<b>Year of Manufacture:</b>	2004 (Serial no: 8053)	
<b>Date &amp; Time (UTC):</b>	18 April 2014 at 0843 hrs	
<b>Location:</b>	Farway Common Airfield, near Honiton, Devon	
<b>Type of Flight:</b>	Private	
<b>Persons on Board:</b>	Crew - 1	Passengers - 1
<b>Injuries:</b>	Crew - 1 (Fatal)	Passengers - 1 (Serious)
<b>Nature of Damage:</b>	Destroyed	
<b>Commander's Licence:</b>	National Private Pilot's Licence	
<b>Commander's Age:</b>	50 years	
<b>Commander's Flying Experience:</b>	162 hours (of which 100 were on type) Last 90 days - 2 hours Last 28 days - 2 hours	
<b>Information Source:</b>	AAIB Field Investigation

## Synopsis

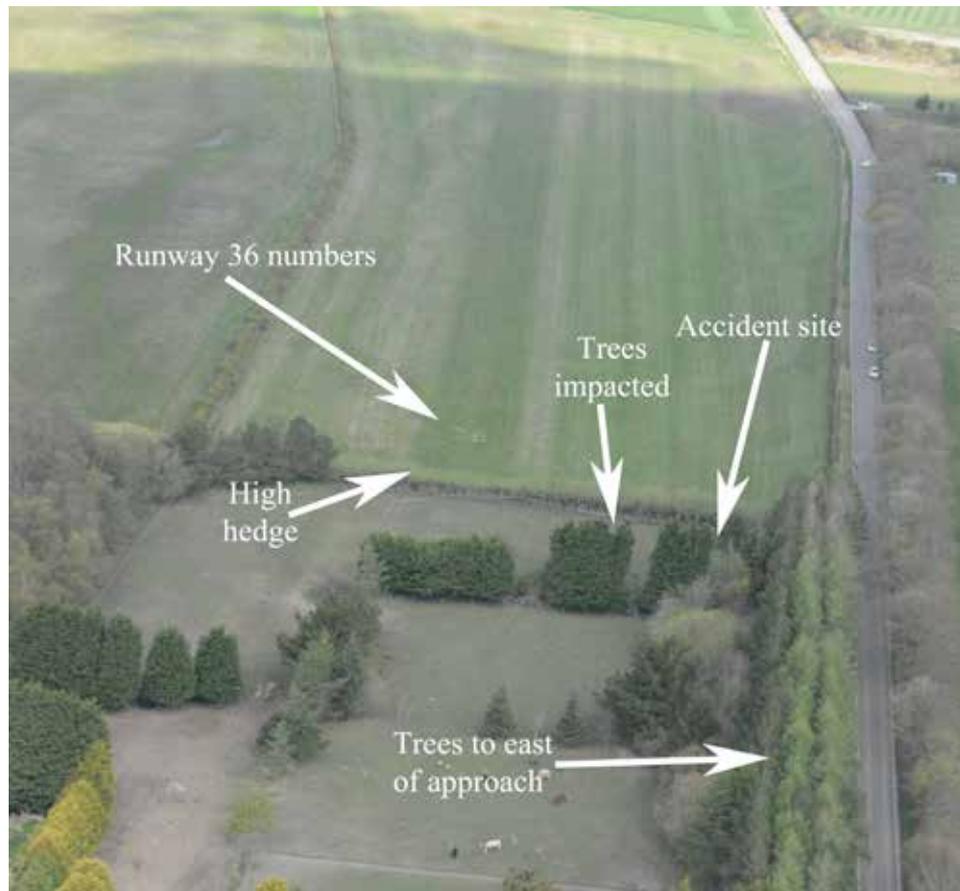
**Figure 1**

Along the southern boundary of the field there was a hedge approximately 2.5 m (8 ft) high which was depicted in the Pooleys Flight Guide for pilots as a '*High Hedge Bank*'. This can be seen in Figure 1, along with a line of trees perpendicular to the approach path that were approximately 50 m further south. The trees on the extended centreline of the runway, were approximately 10 m (33 ft) high but the adjacent trees, immediately to the east of the approach path, measured around 15 m (50 ft) high. G-CCWR impacted two of these trees,

as indicated on Figure 1. Parallel to the approach track there were lines of taller trees along both sides of a road which ran south from the eastern airfield perimeter.

View of the approach to Runway 36  
(photograph courtesy of the National Police Air Service, taken on 18 April 2014)

After this accident, the owner of Farway Common Airfield changed the airfield's website to add a cautionary note about turbulence and windshear from the trees close to the Runway 36 approach. He said he would request that the hazards be mentioned in commercially produced airfield guides. The Pooleys Flight Guide was subsequently amended in July 2014.

has annotated the website photograph with a note about the height of the trees on the approach to Runway 36 and added a cautionary note about turbulence. He has also stated that he will brief pilots about the hazards associated with Runway 36 when they phone him to request prior permission to visit Farway Common.

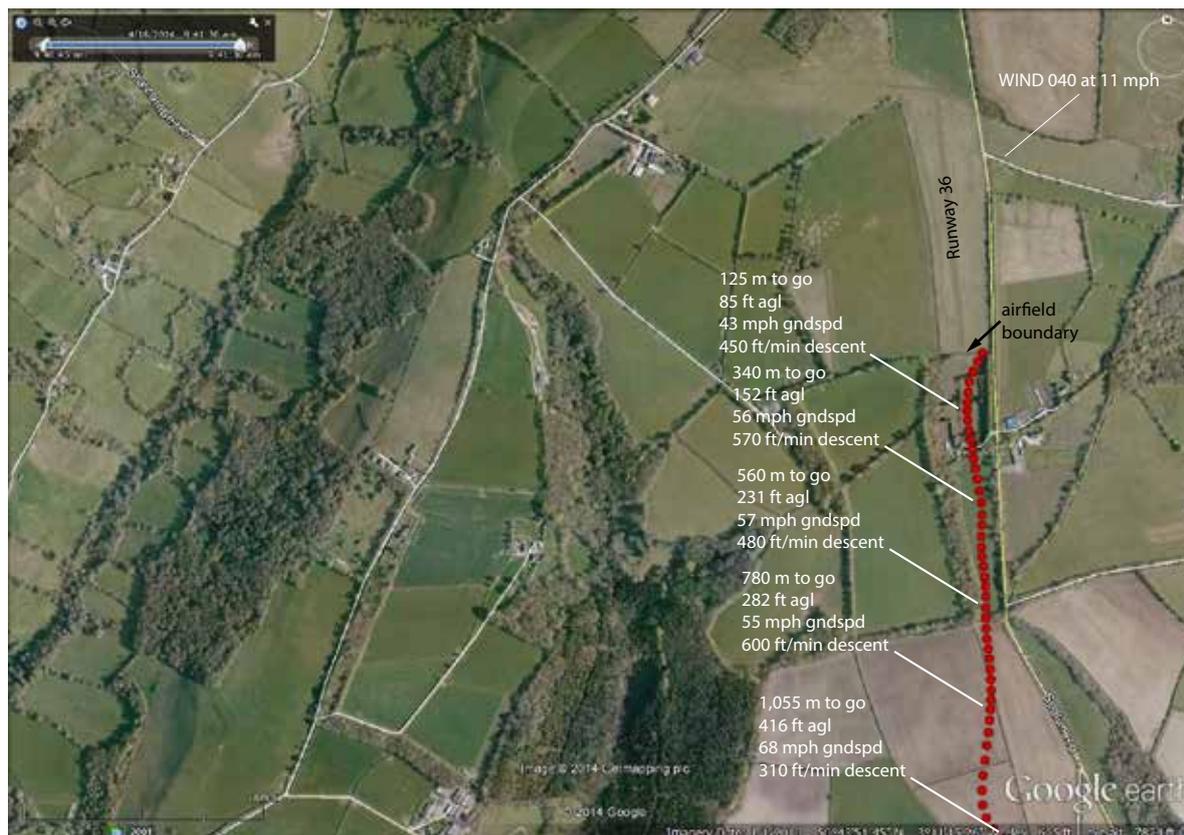
**Figure 2**

The data indicated that G-CCWR approached Farway Common from the east and turned directly toward the airfield on a north westerly track with about 2 nm to go. The aircraft overflew the numbers of Runway 36 at about 550 ft aal, turned downwind at about 500 ft aal, and turned final at about 400 ft aal and 70 mph groundspeed. The ground track of the aircraft on final approach is illustrated at Figure 2 with the associated GPS data at Figure 3.

Ground track of G-CCWR on finals to Runway 36  
(distance-to-go and height figures are relative to the airfield boundary for Runway 36)

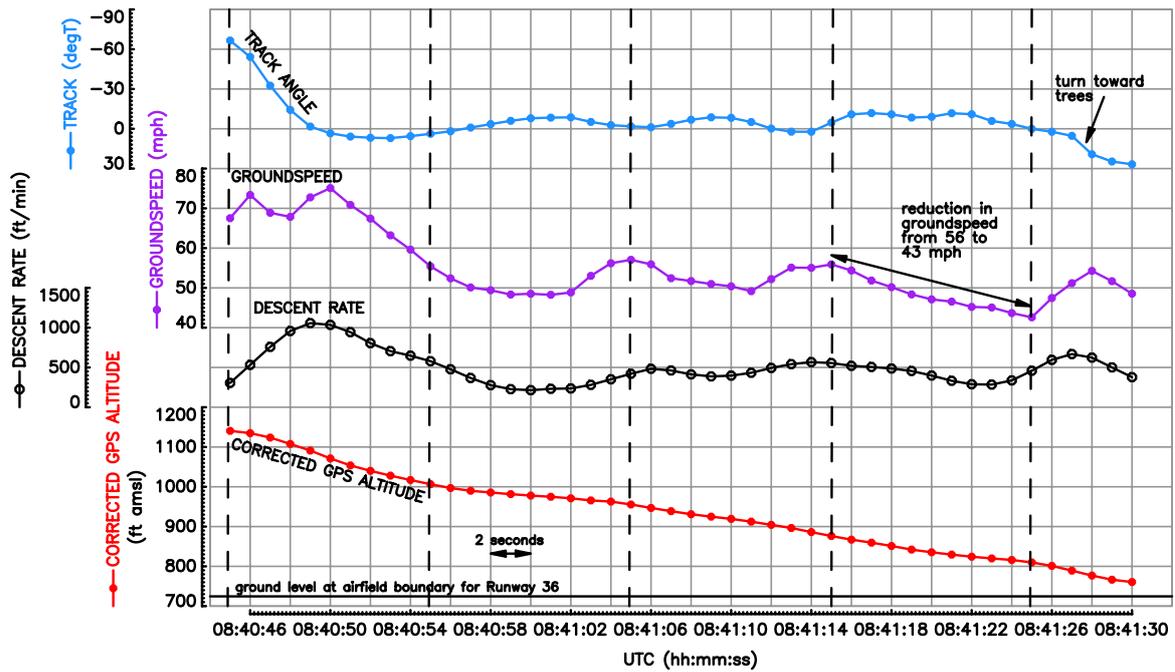
Figure 3 shows that during the latter part of the approach the groundspeed reduced steadily over a 10-second period until it reached a minimum of 43 mph about 3 seconds before the aircraft struck the trees. The wind speed was about 11 mph from 040° with gusts up to 16 mph suggesting that the airspeed at this point could have been between 51 mph and 55 mph. However, in the shadow of the trees the wind speed could have been lower and consequently the airspeed could have been lower than 51 mph. The groundspeed then increased briefly to 54 mph as the aircraft turned and descended into the trees.

GPS derived data of G-CCWR on final approach to Runway 36 (with points highlighted in Figure 2 identified by dashed lines)

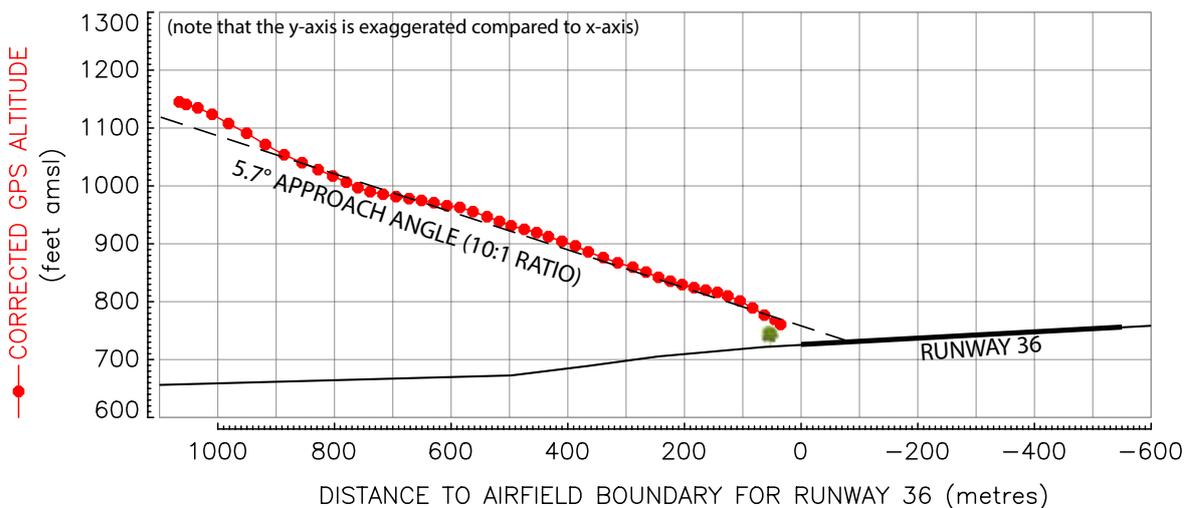
The altitude data of G-CCWR on final approach to Runway 36 is also presented in Figure 4 against distance to go to the airfield boundary to Runway 36. This indicates that G-CCWR was being flown with an approach angle of close to 6° after turning onto final approach (note that a 5.7° approach angle equates to a 10:1 slope ratio). It was calculated that an

Vertical profile of G-CCWR on final approach to Runway 36 and a dashed line for reference depicting a 5.7° approach angle (10:1 ratio) to clear the 33 ft high trees (50 m before the airfield boundary) by 10 ft

aircraft on such an approach angle for Runway 36 would have to aim at a point around 80 m beyond the airfield boundary if it was to achieve 10 ft clearance above the 33 ft trees positioned 50 m before the boundary. For comparison, an aircraft on a steeper approach angle of  $9.5^\circ$  (6:1 ratio) would need to aim at a point about 30 m beyond the airfield boundary to achieve a similar clearance, while an aircraft on a shallower  $3^\circ$  (19:1 ratio) approach angle would have to aim at a point about 200 m beyond the boundary. The recorded data indicated that G-CCWR was being aimed at a point far enough along the runway to clear the 33 ft trees.

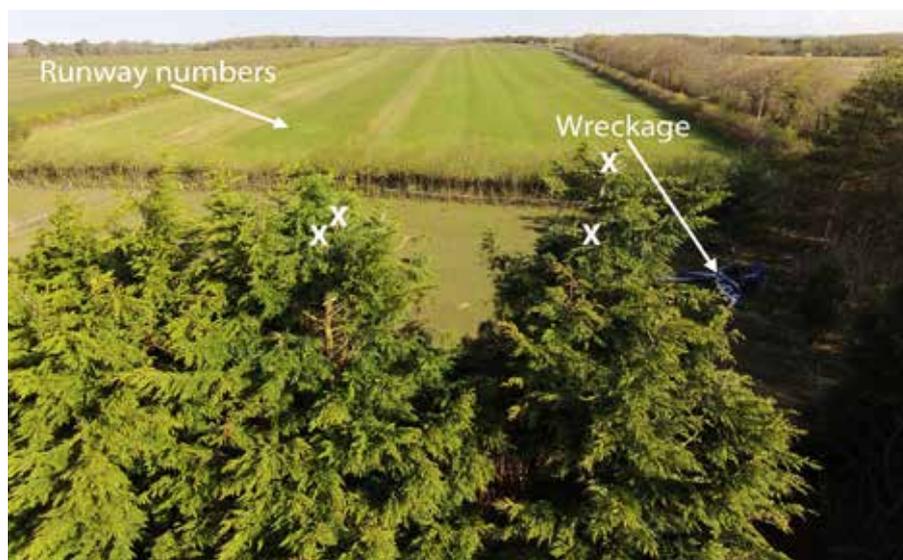
**Figure 6**

Examination of the accident site revealed that the aircraft had struck the tops of two trees 15 m high (Figure 6), and then descended steeply. It hit the ground in a steep left bank and then bounced about 7 m before coming to rest. Figure 7 shows the trike on its left side and the wing upside down. The left main landing gear leg had failed in compression and the left wing structure had crumpled in the impact. Two of the propeller blades had separated at the root and the remaining attached blade had suffered tip damage. One of the detached blades was found next to the main wreckage; the other blade was not found. Two pieces of propeller blade tip, identified as being from the two detached blades, were recovered from the opposite (southern) side of the trees. A piece of plastic cable end shroud was found midway between the trees and the main wreckage.

Accident site – the white Xs highlight some of the tree strike marks

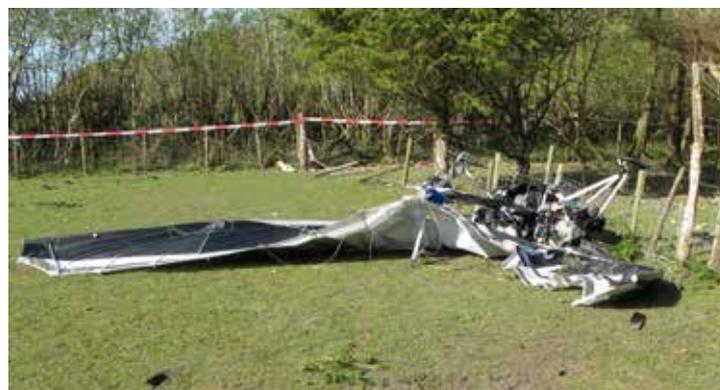
**Figure 7**

Main wreckage (wing upside down)
