SERIOUS INCIDENT

Aircraft Type and Registration:	Airbus A320-214, G-EZWM
No & Type of Engines:	2 CFM56-5B4/3 turbofan engines
Year of Manufacture:	2013 (Serial no: 5739)
Date & Time (UTC):	28 August 2014 at 0537 hrs
Location:	In climb over Oxfordshire
Type of Flight:	Commercial Air Transport (Passenger)
Persons on Board:	Crew - 6 Passengers - 157
Injuries:	Crew - None Passengers - None
Nature of Damage:	Static inverter overheated
Commander's Licence:	Airline Transport Pilot's Licence
Commander's Age:	52 years
Commander's Flying Experience:	13,976 hours (of which 5,641 were on type) Last 90 days - 183 hours Last 28 days - 35 hours
Information Source:	Aircraft Accident Report Form submitted by the pilot and subsequent enquiries by the AAIB

Synopsis

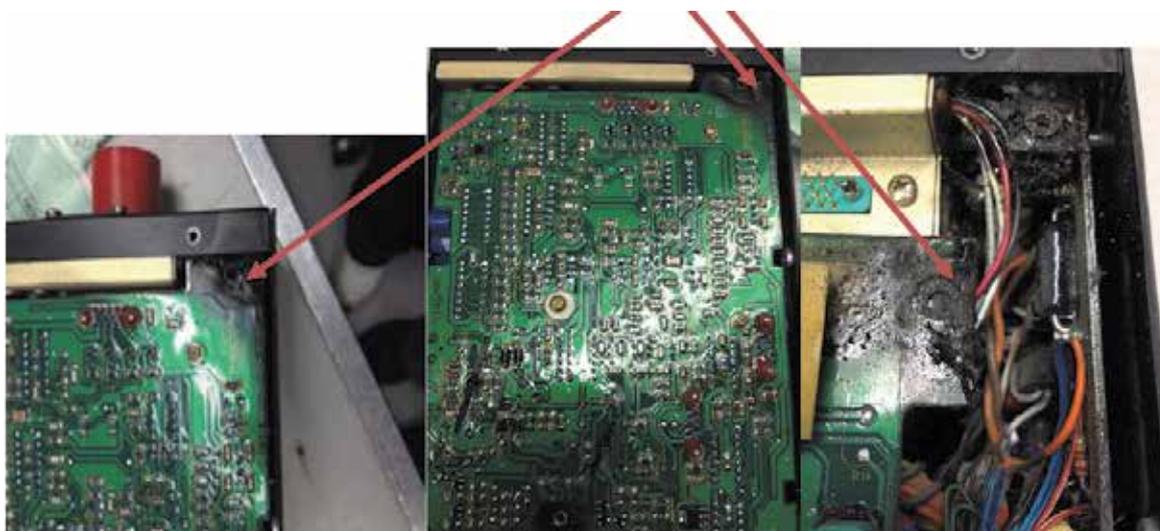
Figure 1

Further investigation by technicians found that a static inverter, part number 1-002-0102-1830/2A350-1AS-1830, located in the avionics bay, had signs of severe overheating (Figure 1). It was replaced and, after further testing, the aircraft returned to service. The function of the inverter is to supply 115VAC and 60 Hz power to a utility socket in the cockpit so that domestic equipment, such as computer laptops and tablets, can be plugged in. It does not form part of the racked avionics but is a stand-alone unit mounted below the co-pilot's footwell floor to the right of the centre console. The floor is not sealed to prevent fumes from the avionics bay entering the cockpit. The inverter was standard equipment on aircraft manufactured after serial number 2700.

Burn marks on the PCB of the static inverter

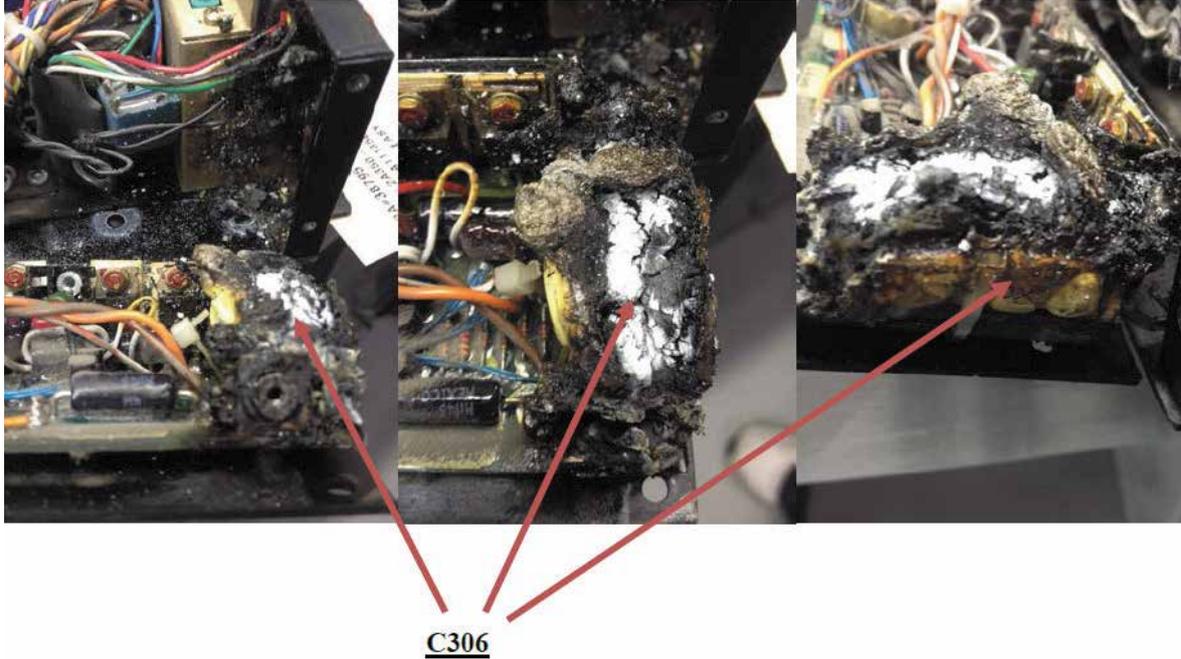
The inverter was returned to its manufacturer for examination. They reported that the damage centred on a capacitor, C306, which had been destroyed by overheating (Figure 2). The damage precluded establishing the precise reason for its failure, although tests on

another unit indicated that the capacitor was operating well within its allowable working temperatures. The manufacturer also examined the reliability and failure rates of the inverter and they were found to be acceptable. They consider this failure was an isolated incident but advise that they will monitor the reliability of the static invertors.

Figure 2
Overheated capacitor C306
