**ACCIDENT**

<b>Aircraft Type and Registration:</b>	Extra EA 300, G-SIII	
<b>No &amp; Type of Engines:</b>	1 Lycoming AEIO-540-L1B5 piston engine	
<b>Year of Manufacture:</b>	1994 (Serial no: 58)	
<b>Date &amp; Time (UTC):</b>	10 October 2014 at 1430 hrs	
<b>Location:</b>	White Waltham Airfield, Berkshire	
<b>Type of Flight:</b>	Private	
<b>Persons on Board:</b>	Crew - 1	Passengers - None
<b>Injuries:</b>	Crew - None	Passengers - N/A
<b>Nature of Damage:</b>	Damage to propeller, spinner, shock-loaded engine, lower cowling and left spat	
<b>Commander's Licence:</b>	Private Pilot's Licence	
<b>Commander's Age:</b>	55 years	
<b>Commander's Flying Experience:</b>	812 hours (of which 56 were on type) Last 90 days - 9 hours Last 28 days - 9 hours	
<b>Information Source:</b>	Aircraft Accident Report Form submitted by the pilot

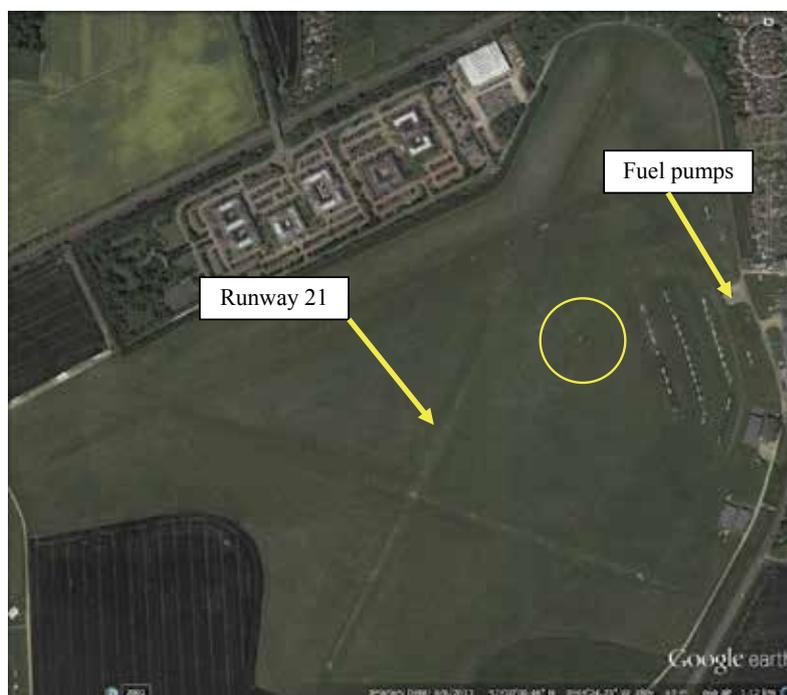
**Figure 1**

The pilot, who is a long-standing member of the flying club at White Waltham, had landed on Runway 21 and intended to taxi to the fuel pumps to refuel (Figure 1). Because forward visibility when taxiing is limited on the Extra 300, the pilot adopted a weaving path to clear himself from other aircraft and to follow some existing tyre tracks. Unfortunately, he did not see a small, low bowser containing Jet A1 fuel which the aircraft struck nose-first, causing damage to both. The pilot admitted that he had known perfectly well that the bowser, which

Aerial view of White Waltham Airfield, showing location of bowser containing Jet A1 fuel (circled)

is almost always parked in that location to service helicopters, would be there but on this occasion he had not picked it up visually. He was of the opinion that conflict was more probable with aircraft landing on Runway 21, since the bowser is located along the path that such aircraft would be likely to use when taxiing to the fuel pumps.
