ACCIDENT

Aircraft Type and Registration:	Socata TB10 Tobago, G-POPI	
No & Type of Engines:	1 Lycoming O-360-A1AD piston engine	
Year of Manufacture:	1982 (Serial no: 315)	
Date & Time (UTC):	17 June 2014 at 1600 hrs	
Location:	Field east of Guernsey Airport	
Type of Flight:	Private	
Persons on Board:	Crew - 1	Passengers - 1
Injuries:	Crew - 1 (Minor)	Passengers - 1 (Serious)
Nature of Damage:	Aircraft destroyed	
Commander's Licence:	Private Pilot's Licence	
Commander's Age:	59 years	
Commander's Flying Experience:	817 hours (of which 751 were on type) Last 90 days - 20 hours Last 28 days - 4 hours	
Information Source:	Aircraft Accident Report Form submitted by the pilot and additional enquiries by the AAIB

Synopsis

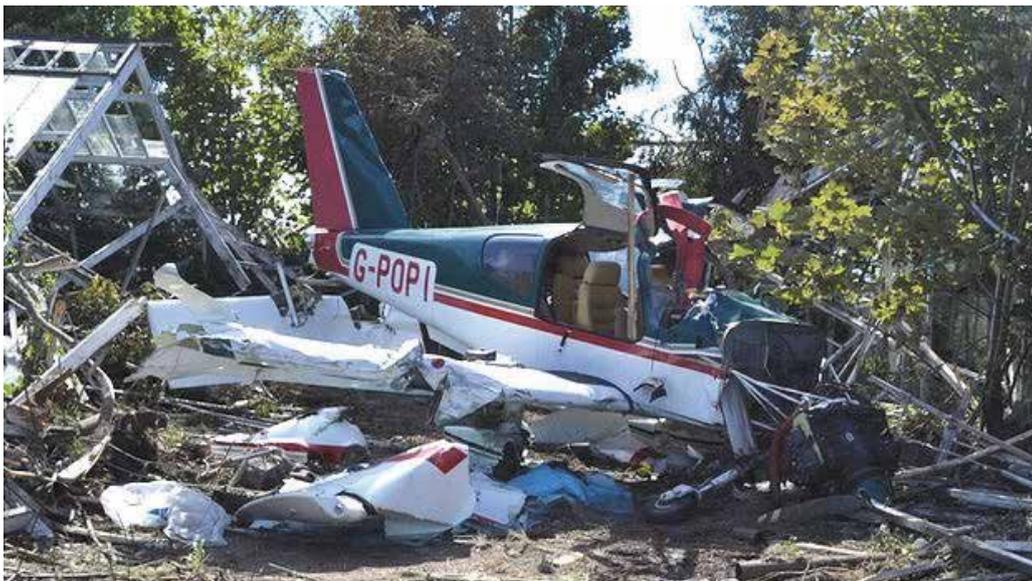
Figure 1

The pilot sustained an injury above his right eye and enquired after his passenger, who said her back was injured. The aircraft was suspended above ground in a nose-down and slightly left-wing-low attitude inside a disused and heavily overgrown commercial greenhouse. The pilot was concerned about fuel leaking from the ruptured wing tanks and told his passenger that they must exit the aircraft immediately. They did so through the pilot's door and exited the greenhouse and thick foliage with the assistance of others on the ground who had come to assist. They were then taken to hospital.

G-POPI after being laid on the ground and foliage cleared to assist recovery.
Note remains of the disused greenhouse to the left

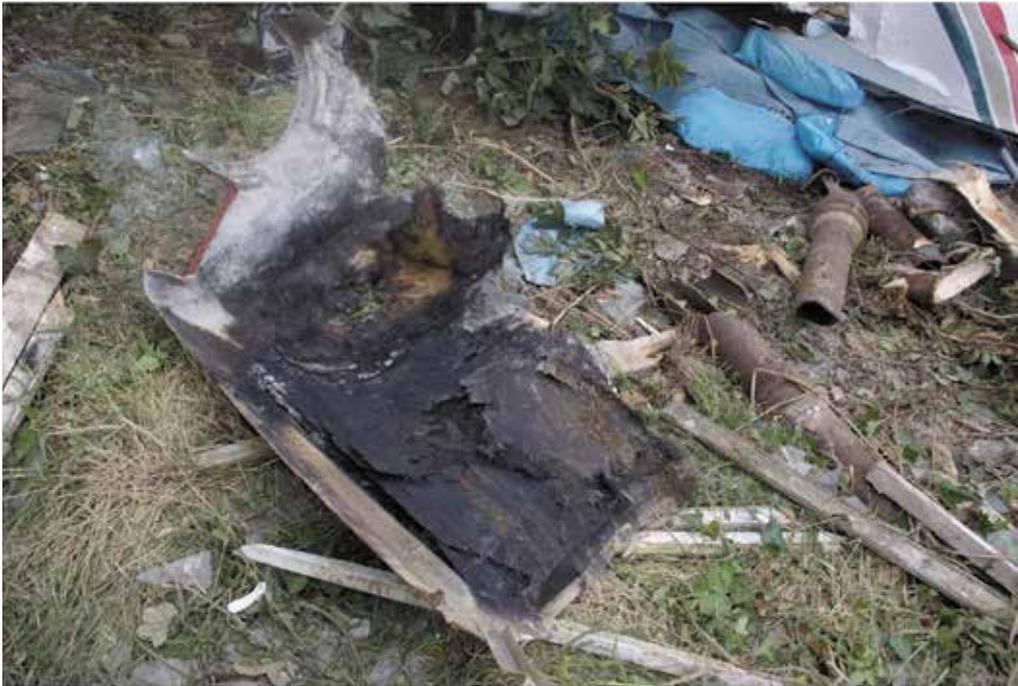
Figure 2

A local maintenance organisation examined the aircraft and prepared a report, which was made available to the AAIB. It identified an area of severe burning on the lower left side of the glass-fibre engine cowling (Figure 2) and scorching of the metal forward fuselage structure. The left side of the engine firewall was also scorched and, whilst the firewall itself had remained intact, a seal around the nosewheel steering linkage where it passed through it had been badly heat-affected and had probably allowed the smoke to enter the cabin.

Lower left side of engine cowling showing burning of glass-fibre construction

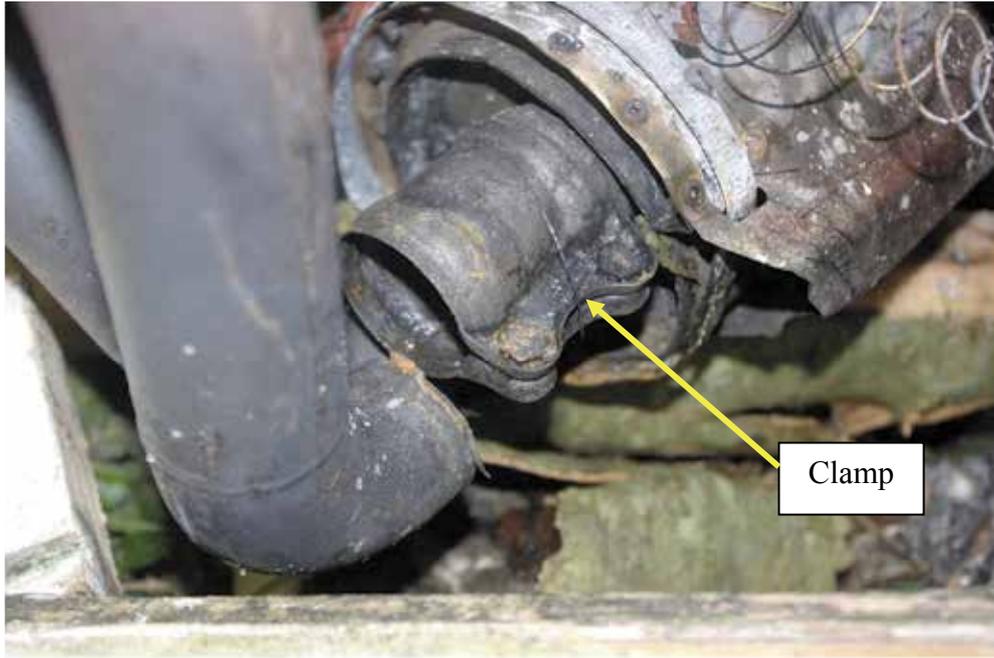
Figure 3

The No 4 engine cylinder exhaust downpipe had fractured at the clamp where it joins the exhaust muffler (Figure 3). Since the other end of the pipe allows movement should this occur, the end of the pipe was free to move away from its normal position and allowed hot exhaust gasses to flow unrestricted into the cowling.

The exhaust system and muffler are visually inspected every 50 flying hours or 6 months according to the Light Aircraft Maintenance Programme (LAMP). The condition of the fracture suggests that it had started as a crack which developed over a considerable period of time, but its location, effectively inside the clamp, would render it very difficult to see without dismantling the joint.

Fracture of No 4 cylinder exhaust downpipe where it attaches to exhaust muffler
