## ACCIDENT

<b>Aircraft Type and Registration:</b>	Kolb Twinstar MKIII (Modified), G-MYPC	
<b>No &amp; Type of Engines:</b>	1 Rotax 582 piston engine	
<b>Year of Manufacture:</b>	1994 (Serial no: PFA 205-12437)	
<b>Date &amp; Time (UTC):</b>	21 August 2014 at 1850 hrs	
<b>Location:</b>	Field near Shifnal Airfield, Shropshire	
<b>Type of Flight:</b>	Private	
<b>Persons on Board:</b>	Crew - 1	Passengers - None
<b>Injuries:</b>	Crew - None	Passengers - N/A
<b>Nature of Damage:</b>	Damage to fuselage pod and boom, wings, landing gear and propeller	
<b>Commander's Licence:</b>	National Private Pilot's Licence	
<b>Commander's Age:</b>	32 years	
<b>Commander's Flying Experience:</b>	64 hours (of which 5 were on type) Last 90 days - 4 hours Last 28 days - 0 hours	
<b>Information Source:</b>	Aircraft Accident Report Form submitted by the pilot

## Synopsis

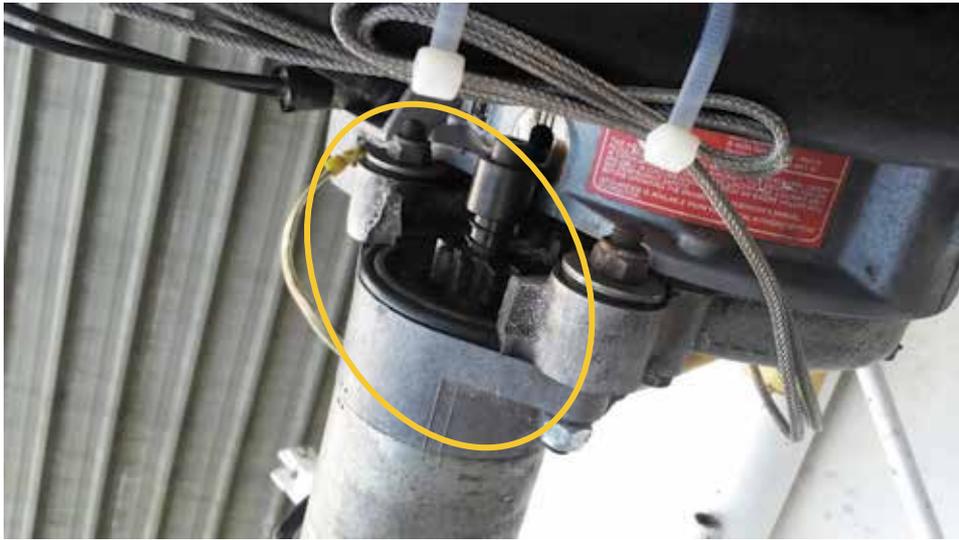
**Figure 1**

In addition to the extensive damage to the airframe, the pilot later observed that two of the three propeller blades had been damaged – one was missing a few millimetres of its tip and the other blade had started to delaminate at the tip. He believes that if either damage had pre-existed the landing, then that might explain the vibration. In addition, he noticed that the starter motor mounting flange had a piece missing (Figure 1). Again, he was uncertain whether this piece may have been liberated in flight and struck the propeller, or occurred as a result of the accident.

Starter motor mounting flange showing missing section
