## ACCIDENT

<b>Aircraft Type and Registration:</b>	Piper PA-28-181 Cherokee Archer II, G-BSIM	
<b>No &amp; Type of Engines:</b>	1 Lycoming O-360-A4M piston engine	
<b>Year of Manufacture:</b>	1986 (Serial no: 28-8690017)	
<b>Date &amp; Time (UTC):</b>	28 October 2014 at 1545 hrs	
<b>Location:</b>	Near RAF Henlow, Bedfordshire	
<b>Type of Flight:</b>	Private	
<b>Persons on Board:</b>	Crew - 1	Passengers - None
<b>Injuries:</b>	Crew - None	Passengers - N/A
<b>Nature of Damage:</b>	Damage to left landing gear, left wing and fuselage	
<b>Commander's Licence:</b>	Private Pilot's Licence	
<b>Commander's Age:</b>	50 years	
<b>Commander's Flying Experience:</b>	188 hours (of which 71 were on type) Last 90 days - 4 hours Last 28 days - 1 hour	
<b>Information Source:</b>	Aircraft Accident Report Form submitted by the pilot and recorded weather information

## Synopsis

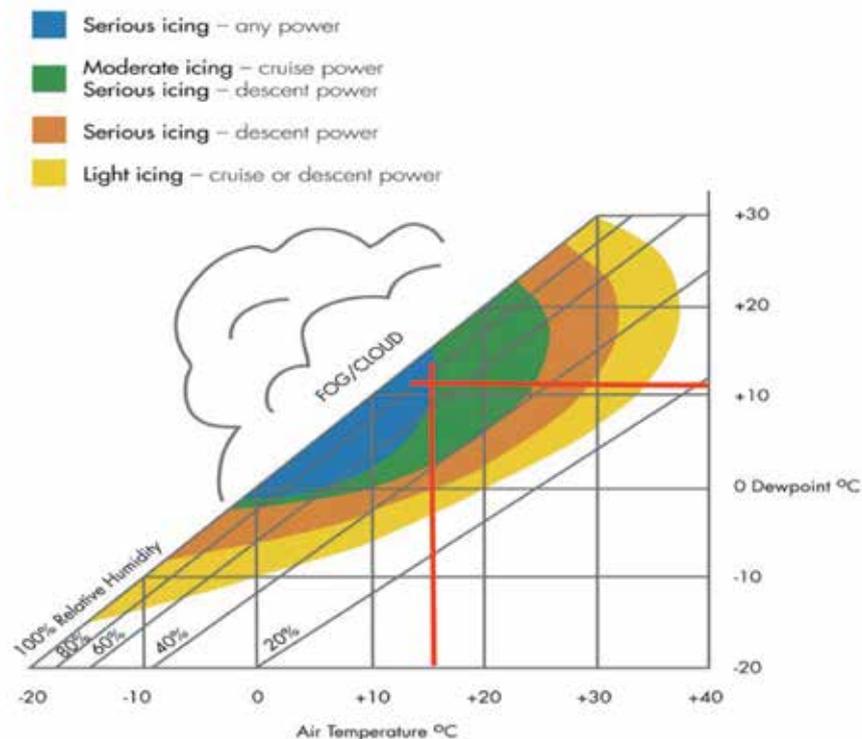
**Figure 1**

The pilot, who was uninjured, reported that the loss of engine power was due to carburettor icing. The meteorological report for Luton Airport (8.5 nm south) at 1520 hrs gave a temperature of 16°C and a dew point of 11°C. Over the next two hours, these values changed to 14°C and 13° C respectively. Figure 1 shows a graph widely used to predict the likelihood of induction system icing. Using the conditions reported at Luton Airport, the aircraft can be seen to have been at risk of moderate icing at cruise power and serious icing at descent power. A more refined version of the graph (not shown here) identifies a risk of serious icing at both cruise and descent power settings for carburettor equipped engines, such as that fitted to G-BSIM.

Graph predicting risk of induction system icing; actual values of temperature and dewpoint shown by red lines
