Rail Accident Investigation Branch

Rail Accident Report

Unauthorised entry of a train onto a single line at Greenford 20 March 2014

Report 29/2014
December 2014

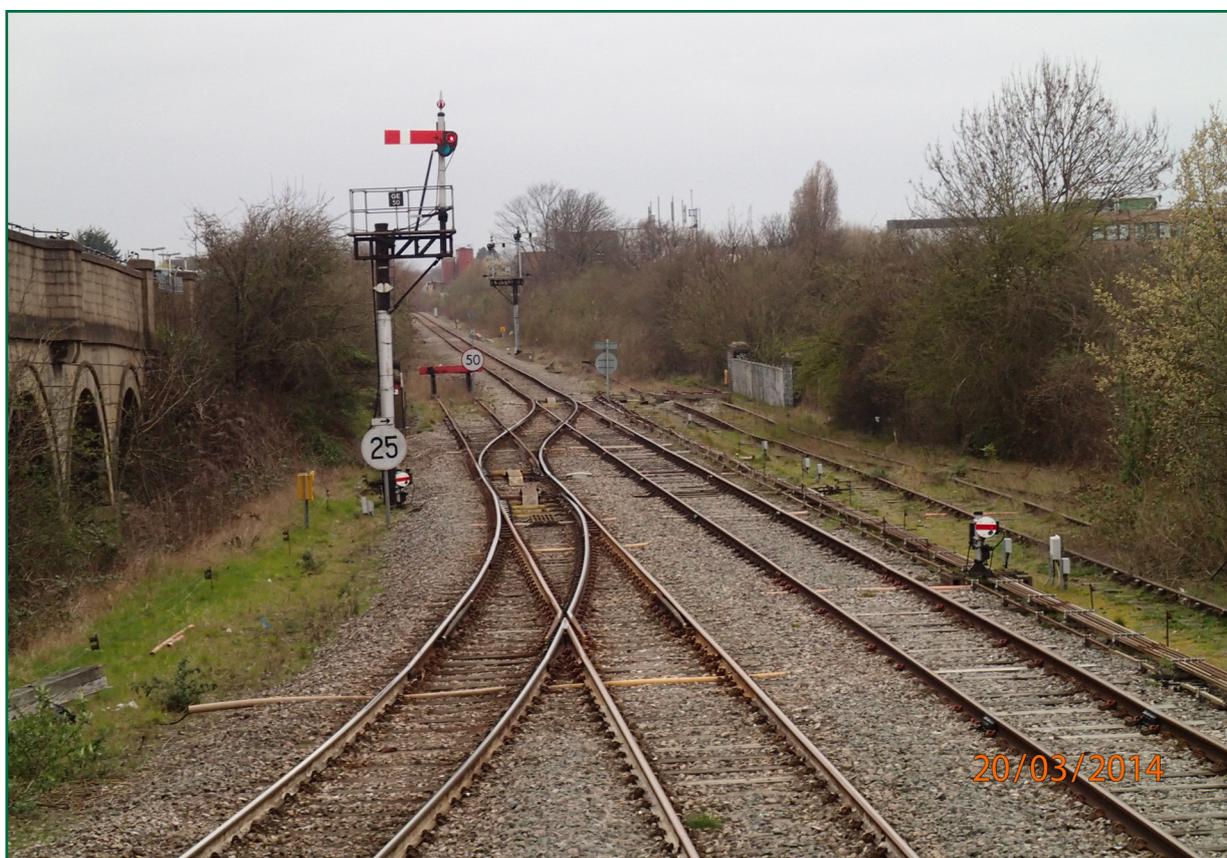
- 25 The signaller knew that signal GE55 was fitted with TPWS. He stated that he expected this equipment to stop the train before it reached signal GE50, which he could clearly see at danger in front of him (figure 3). However, the train did not stop, and continued onto the single line.

Figure 3: Greenford signaller's view of signal GE50 and the single line towards Northolt Junction (South Ruislip)

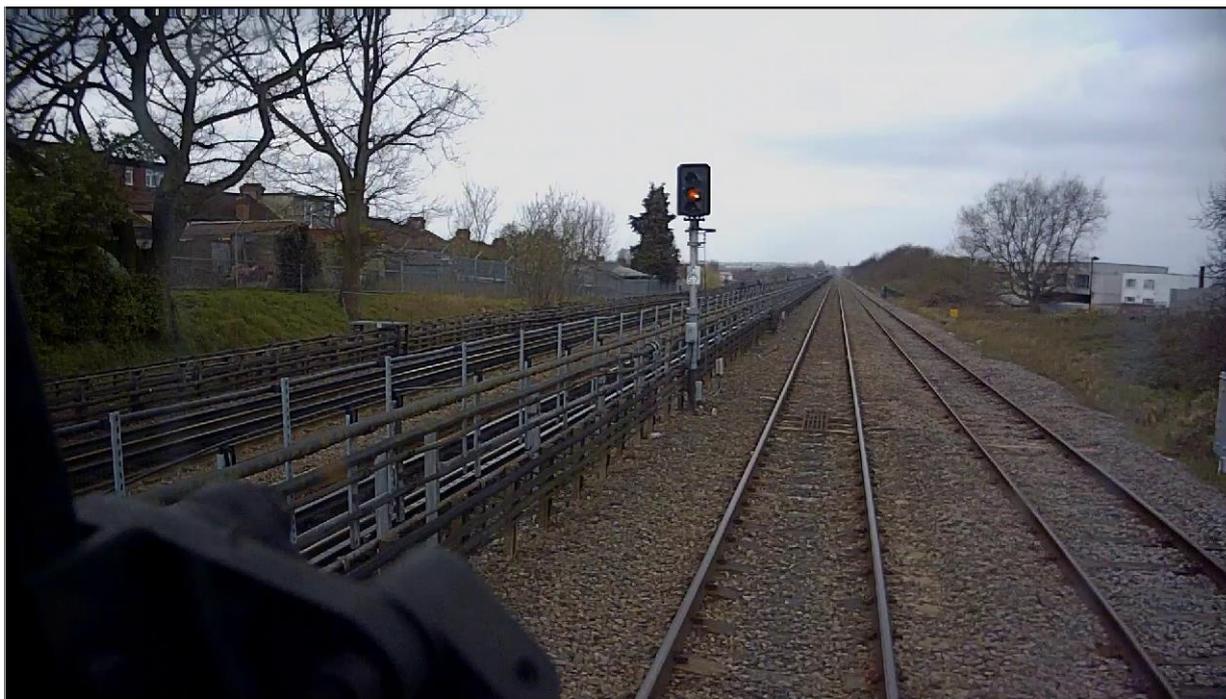
Figure 5: signal GE57 showing yellow (caution). The signal was incorrectly plated G57 at the time of the incident, but this has since been corrected.

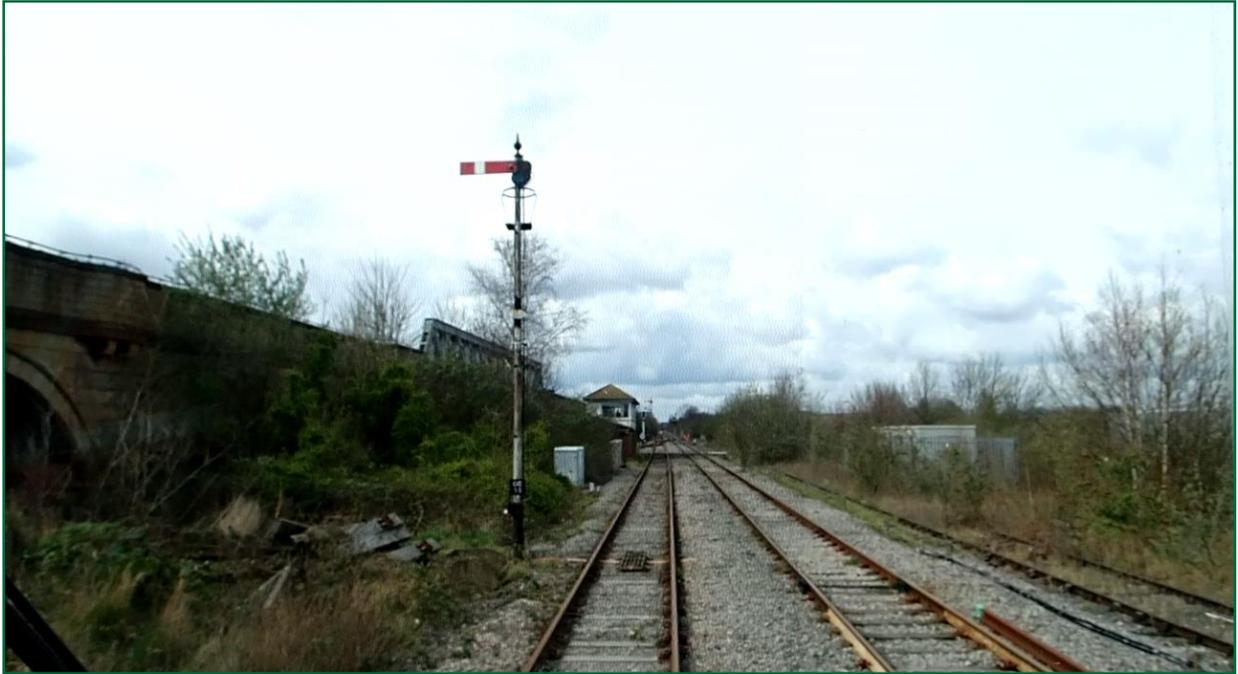
33 The route to Greenford South Junction and Ealing diverges to the left. The next signal is GE55, visible in the distance in figure 6 and in the foreground of figure 7, which is 72 yards (66 metres) from the signal box. This signal protects the junction with the line from Ealing, which converges from the left beyond the signal box, about 130 yards (119 metres) beyond signal GE55.

Figure 7: Signal GE55, with Greenford signal box and signal GE50 in the distance

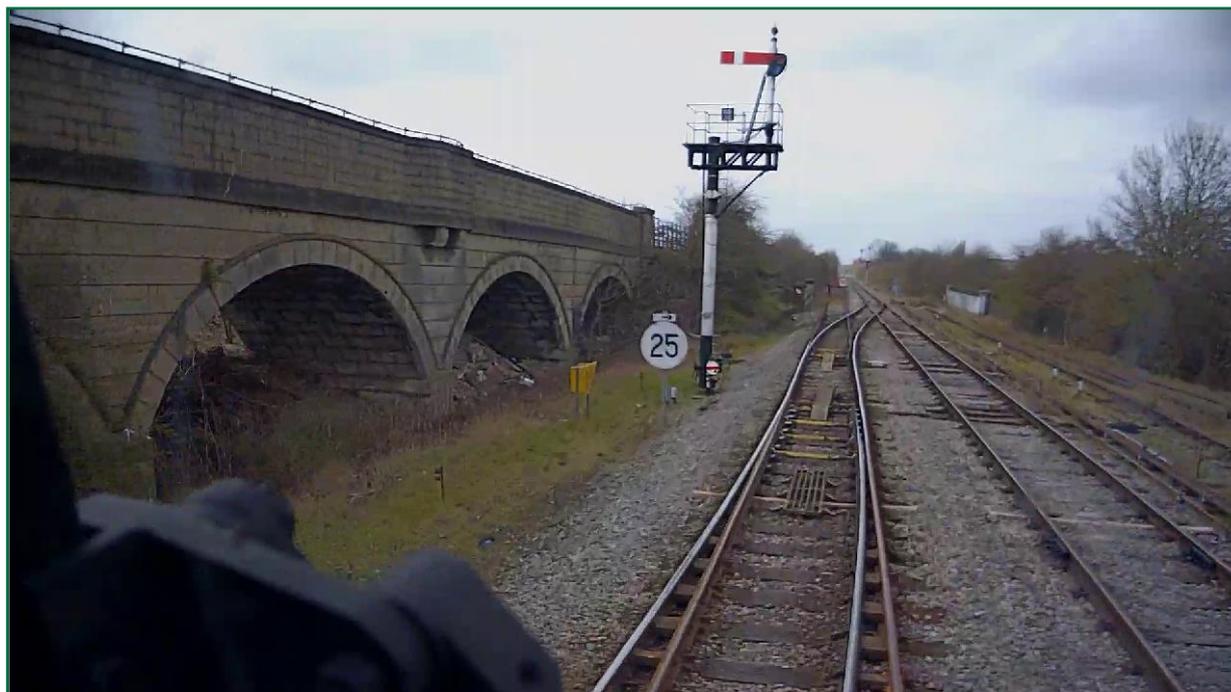
- 34 After passing the signal box, signal GE 50, 70 yards (64 metres) from the box, controls entry to the single line (figures 3 and 8). The signal is jointly controlled by Greenford signal box and Marylebone signalling centre (where it is known as ME65), and to allow a train onto the single line, the signallers at Greenford and Marylebone must co-operate to clear this signal, thus confirming that the single line is clear and that there is no train approaching it from the opposite direction. The entrance to the single line is also protected by trap points, which divert trains into a dead-end if they are not set for the single line (figures 3 and 8). The interlocking requires the trap points to be set for the dead-end before a train can enter the single line from the Northolt Junction end, so that if a train were to pass signal GE50 at danger in those circumstances, it would be diverted and derailed, but a head-on collision would be avoided. However, when two trains are following each other in the same direction towards Northolt Junction, there is no requirement for the trap points to be set for the dead-end. If the signaller had set the trap points for the dead-end before train 2M30 approached on the 20 March 2014, and the driver had not noticed this, the train would have been derailed after passing signal GE50 at danger.

Figure 8: signal GE50 and the start of the single line, showing the trap points.

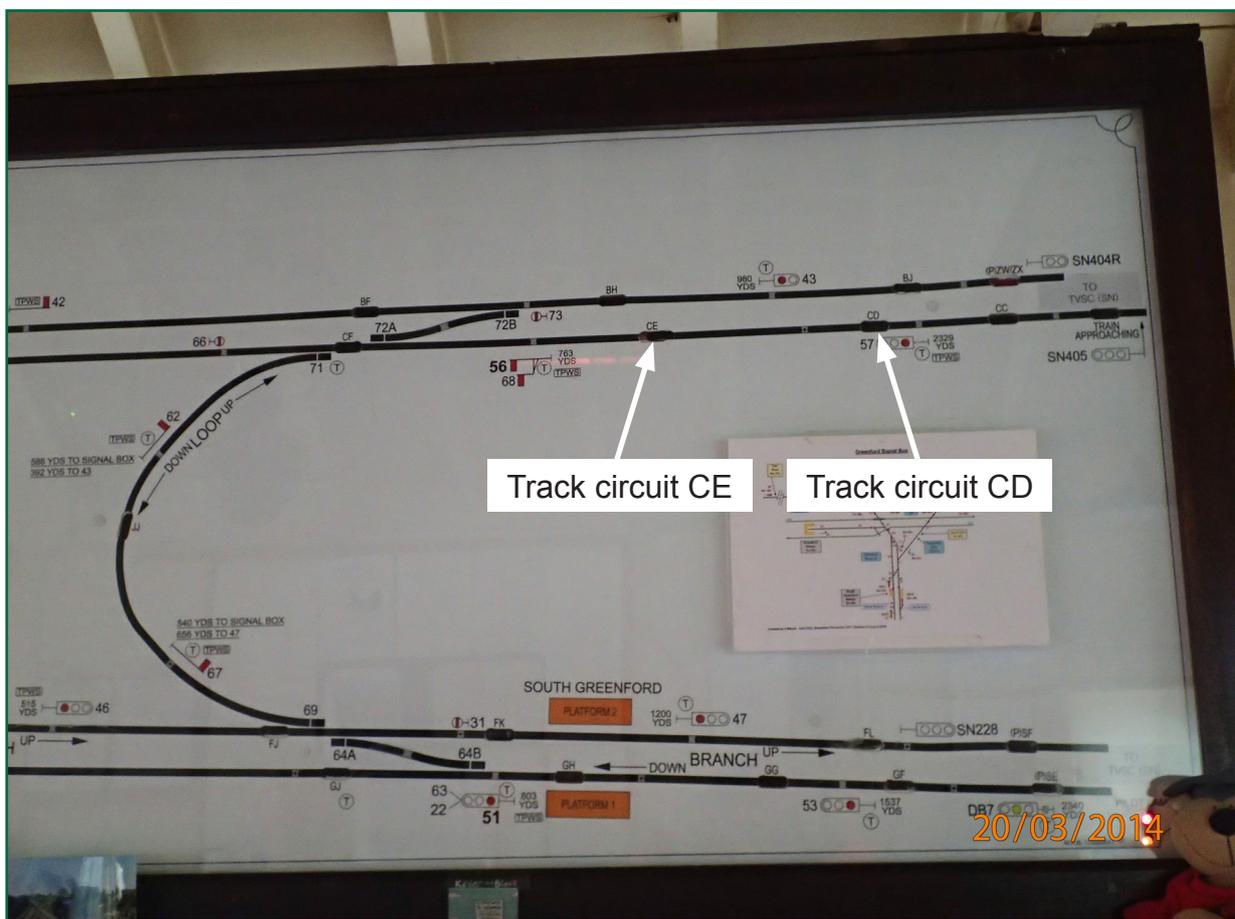
- 55 The information that the signaller at Greenford has about the position of trains approaching on the down main line is limited. The train's position relative to signal GE56 cannot be established by looking from the signal box, because the signal is 763 yards (698 metres) away, and at the time of the incident it was concealed from the signal box by vegetation (the tree which is visible behind the signal in figure 6). The signaller must rely on the indications on the illuminated diagram in the signal box (visible above the lever frame in figure 4), which show which track circuit the train is occupying (figure 9).

Figure 9: Signal box diagram at Greenford (part), showing down main line approach

- 56 There are two track circuits indicated between signals GE56 and GE57: CD and CE. The two signals are 1566 yards (1432 metres) apart. Track circuit CD extends for 422 yards (386 metres) beyond signal GE57, and track circuit CE covers the remaining 1144 yards (1046 metres).

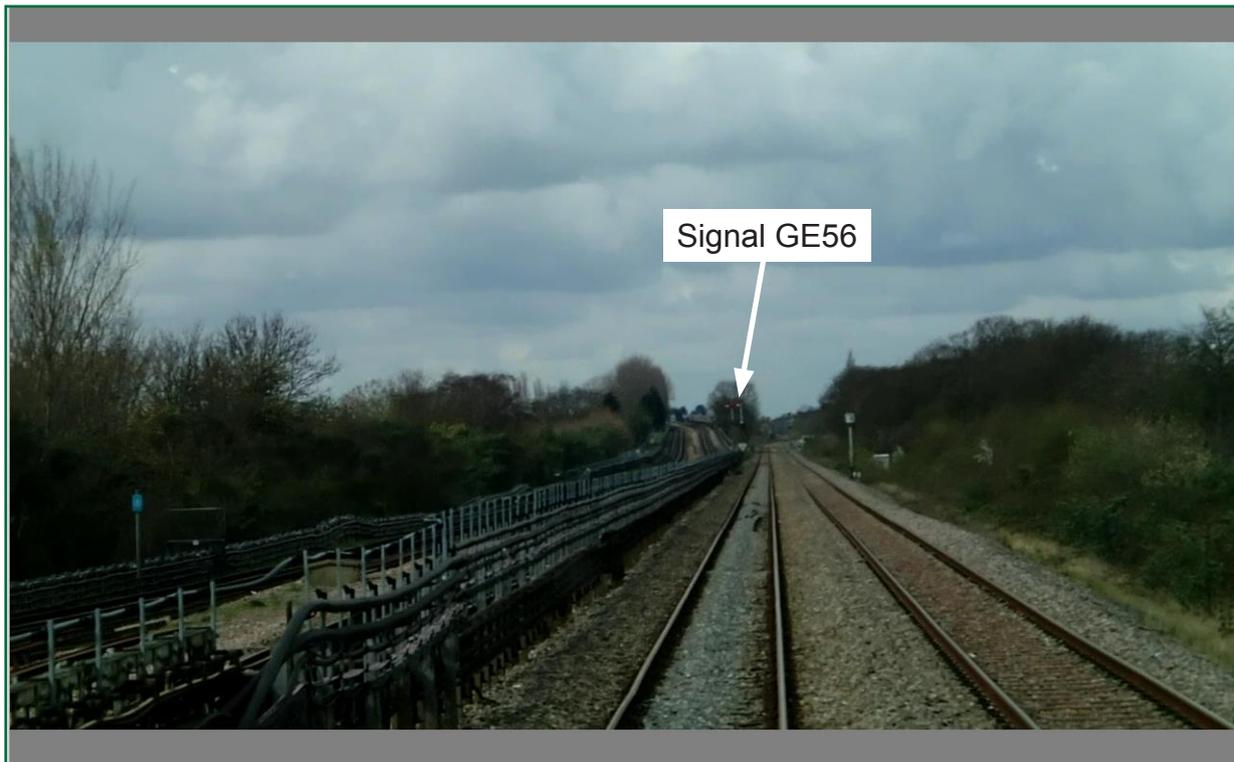
Figure 10: View of signal GE56 at clear, from 650 yards (594 metres) away

62 If the signaller had in fact operated the signals in the same way on 20 March, and only waited for 30 seconds before clearing signal GE56, the driver of 2M30 may not have realised that the clearance of signal GE56 had been delayed, if he had first noticed its position only after it was cleared, when the train was about 650 yards (594 metres) from it. This may have created the belief in his mind that the rest of the Greenford signals would also be clear for his train.

- 132 Network Rail has adjusted the timer on the approach release for signal GE57 to its designed value of 43 seconds, and cut back the vegetation which obscured the view of signal GE56 from the signal box (although this was not likely to have been directly linked to the causes of this incident) (paragraph 125a).

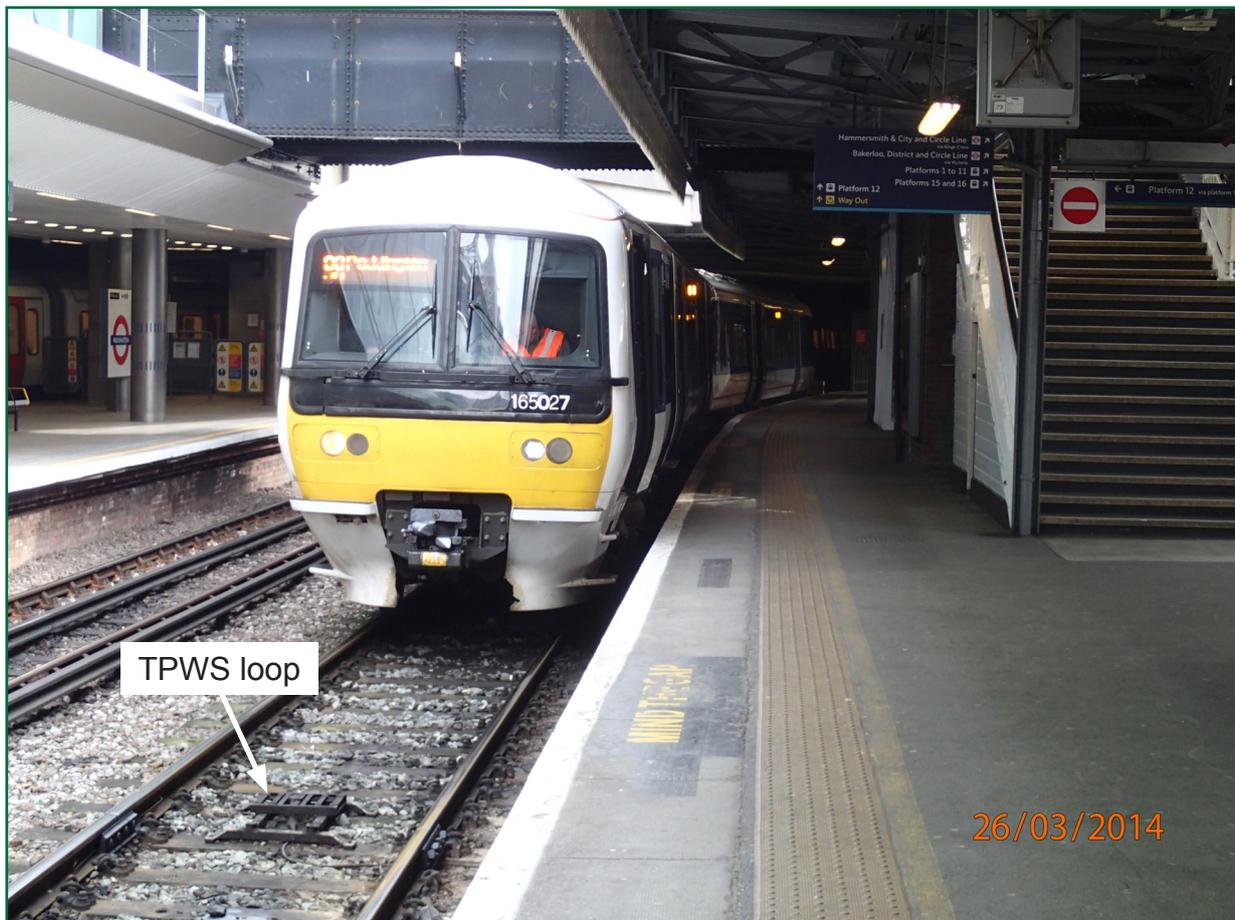
- 78 If a two-coach class 165 train (which is 46 metres long) is stopped two metres away from the stop block in platform 14 at Paddington, the rear of the train will be clear of the trigger loop for the TPWS associated with the stop block (figure 11).

Figure 11: Two-car class 165 drawn up the stop block in platform 14 at Paddington, showing TPWS trigger loop clear of west end cab

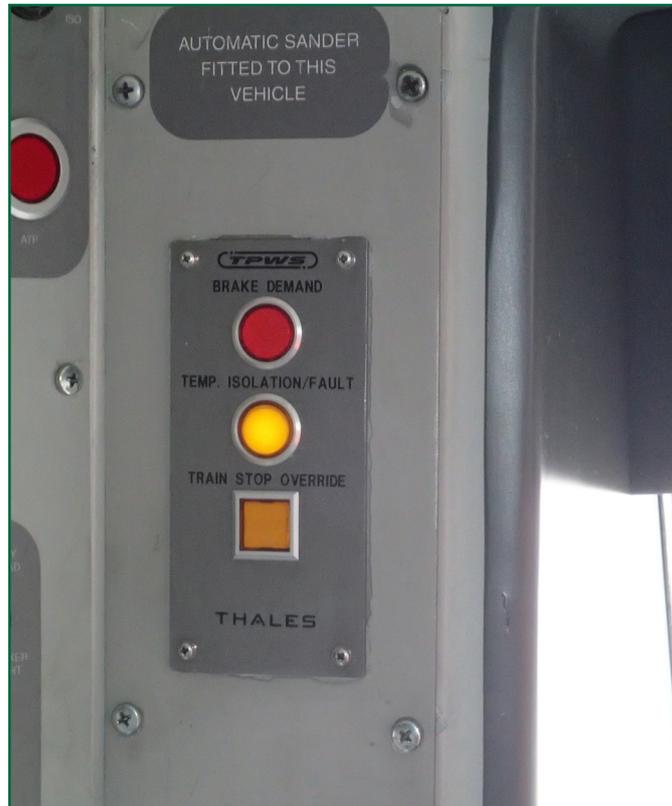
- Off *TPWS state is normal*
- Flashing *A fault has been detected in the train TPWS equipment*
- On (steady) *The train TPWS equipment has been temporarily isolated.*

Figure 12: TPWS control panel in unit 165026

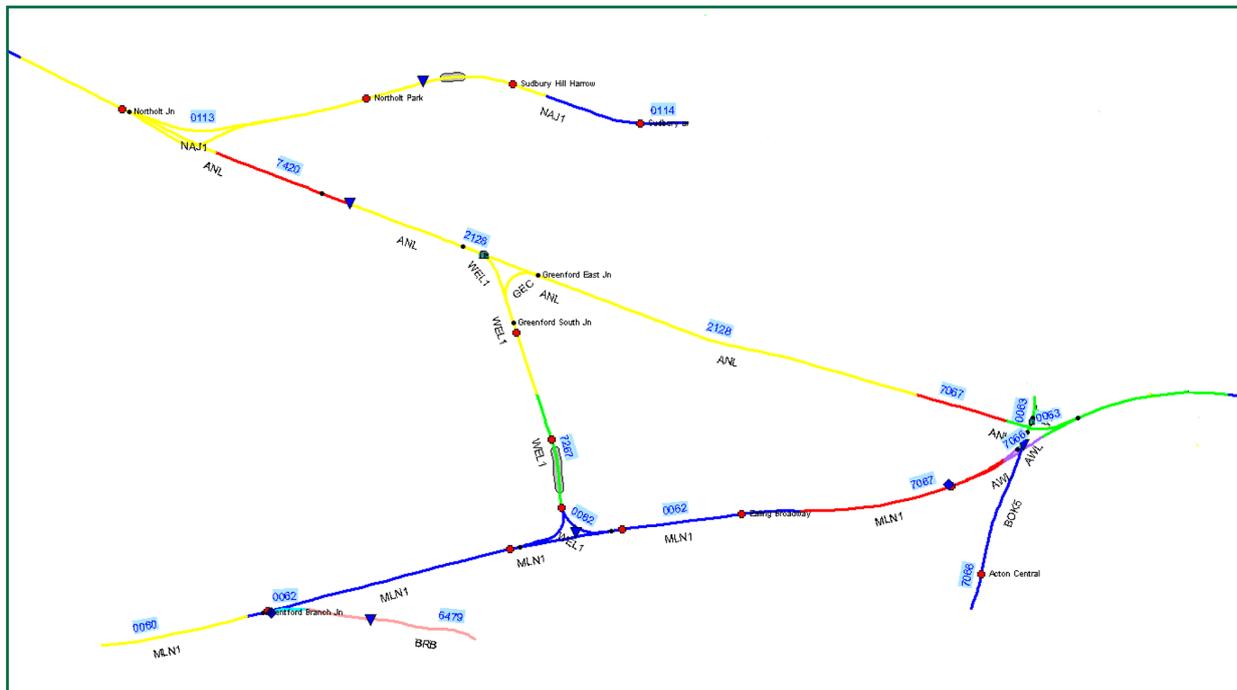
- 6 Greenford is the nominated signallers' terminal for cell 2128 only (figure 13). The coverage of cell 2128 corresponds closely to the control area of Greenford signal box: it extends approximately from North Acton to Northolt (mile post 4 to milepost 8¾) on the main line, and as far as Castle Bar Park (milepost 7½) on the Ealing branch.

Figure 13: Greenford area, showing GSM-R cell coverage boundaries (courtesy of Network Rail)

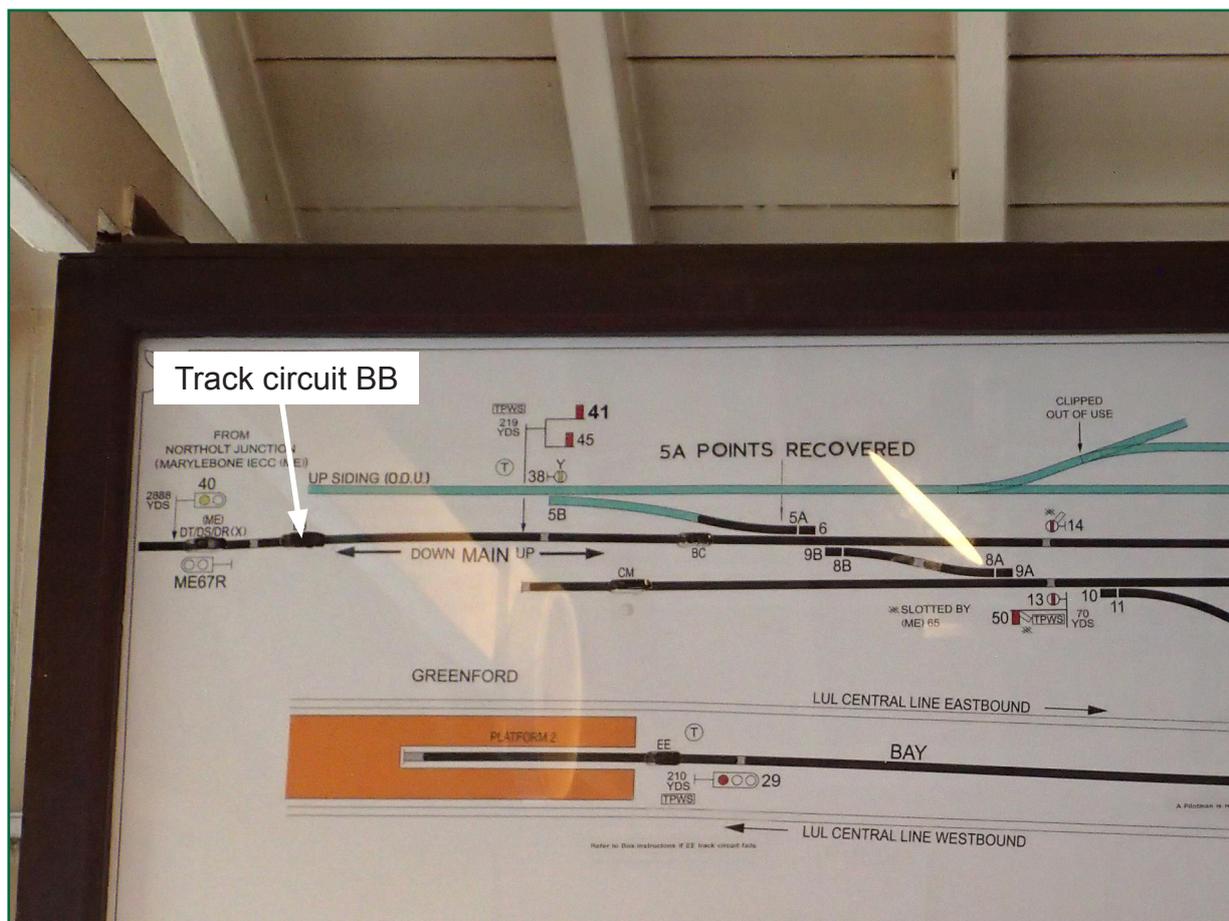
- 10 However, the first train describer berth in the GSM-R system associated with the Marylebone South control area was berth 0067. This train describer berth is linked to track circuits occupying nearly the entire length of the single line between Greenford and South Ruislip and begins adjacent to BB track circuit just to the west of signals GE41 and GE45 (figure 14).

Figure 14: Part of Greenford signal box diagram, showing the line to Northolt Junction

- 11 The effect of including berth 0067 in the ELDA configuration for Marylebone South was that as soon as the next three minute GSM-R poll occurred, the GSM-R system correlated the train radio to Marylebone South in ELDA mode and only displayed it on the Marylebone South signaller's terminal. Depending on exactly when the three minute poll of the train radio occurred, this would have made train 2M30 disappear from the Greenford GSM-R terminal when the train was a relatively short distance past the signal box on the single line.

- 2 *The intent of this recommendation is that Network Rail should improve the robustness of the GSM-R radio system, in respect of signallers' ability to contact train drivers in an emergency.*
