Report of the Investigation
into the grounding of the tanker

BORGA

at Milford Haven
on 29 October 1995

Marine Accident Investigation Branch
5/7 Brunswick Place
SOUTHAMPTON
Hants SO15 2AN

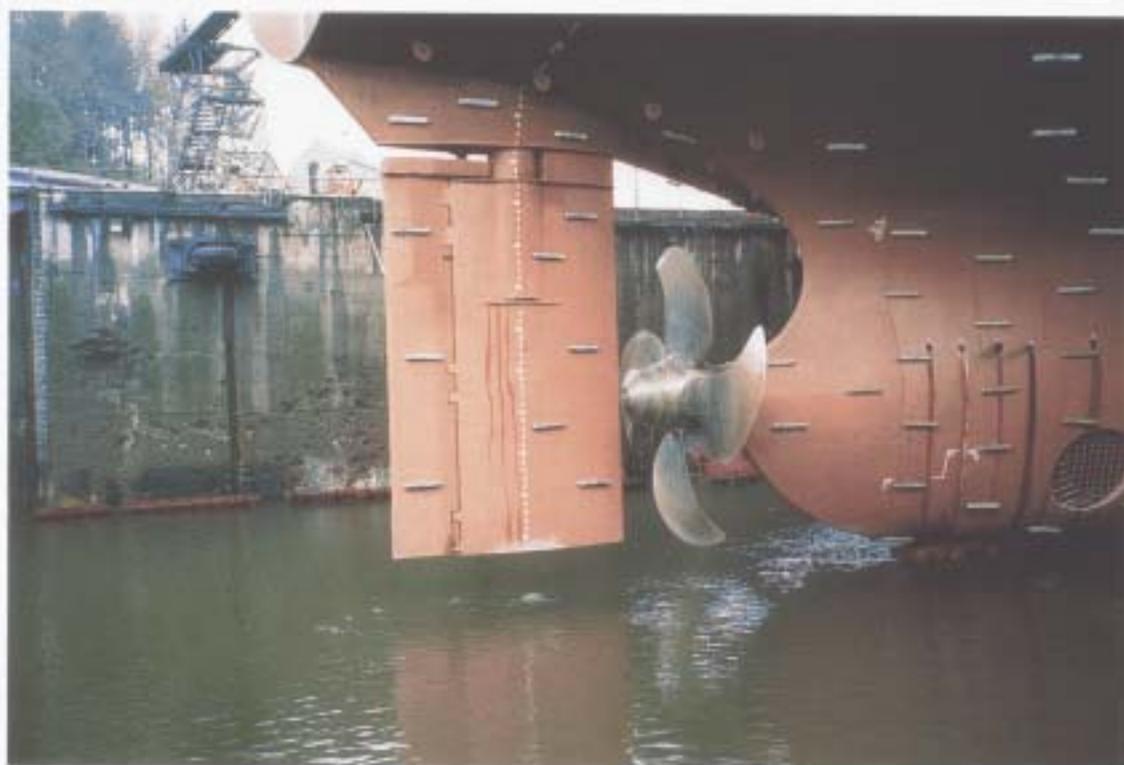
The hull inspection carried out in Hamburg on 7 November confirmed that grounding damage was restricted to the fore end of the vessel. There was no damage to either the rudder or propeller, indeed generally the paint work on the bottom and sides of the hull was undamaged and in good condition.

General view of rudder and propeller from starboard side

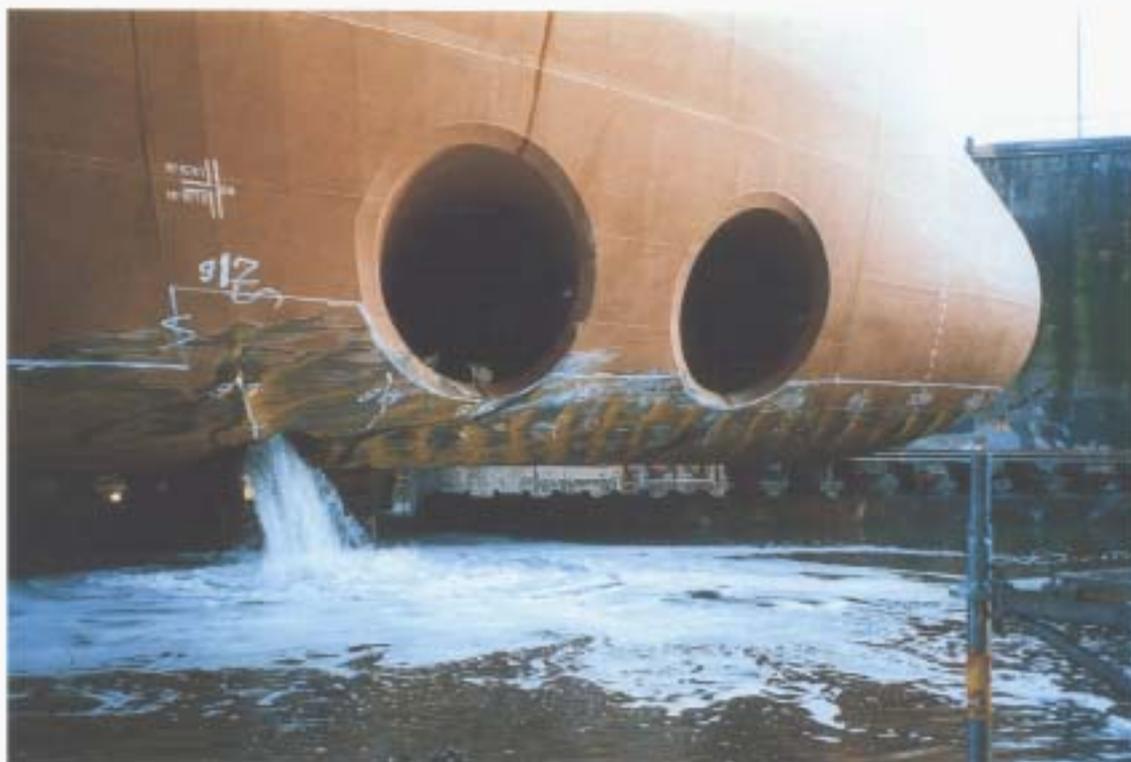
General grounding damage ran from the underside of the bulbous bow aft along to the transverse bulkhead between the forepeak and No 1 tank on the port side and to just abaft the transverse bulkhead between Nos 1 and 2 tanks on the starboard side. A major tank penetration was present on the starboard side near the after end of the forepeak and to a lesser extent on the port side mid length of the forepeak.

A significant damage line could be seen in the area of the bulbous bow running from port to starboard. This damage was roughly semi-circular in shape and ran at an angle of about 70° to the keel line from the port side, just under and forward of the forward bow thrust unit, to the starboard side, under and just aft of the after bow thrust unit (see Figures 5 and 6).

General view from starboard side forward
showing extent of bottom damage on this side

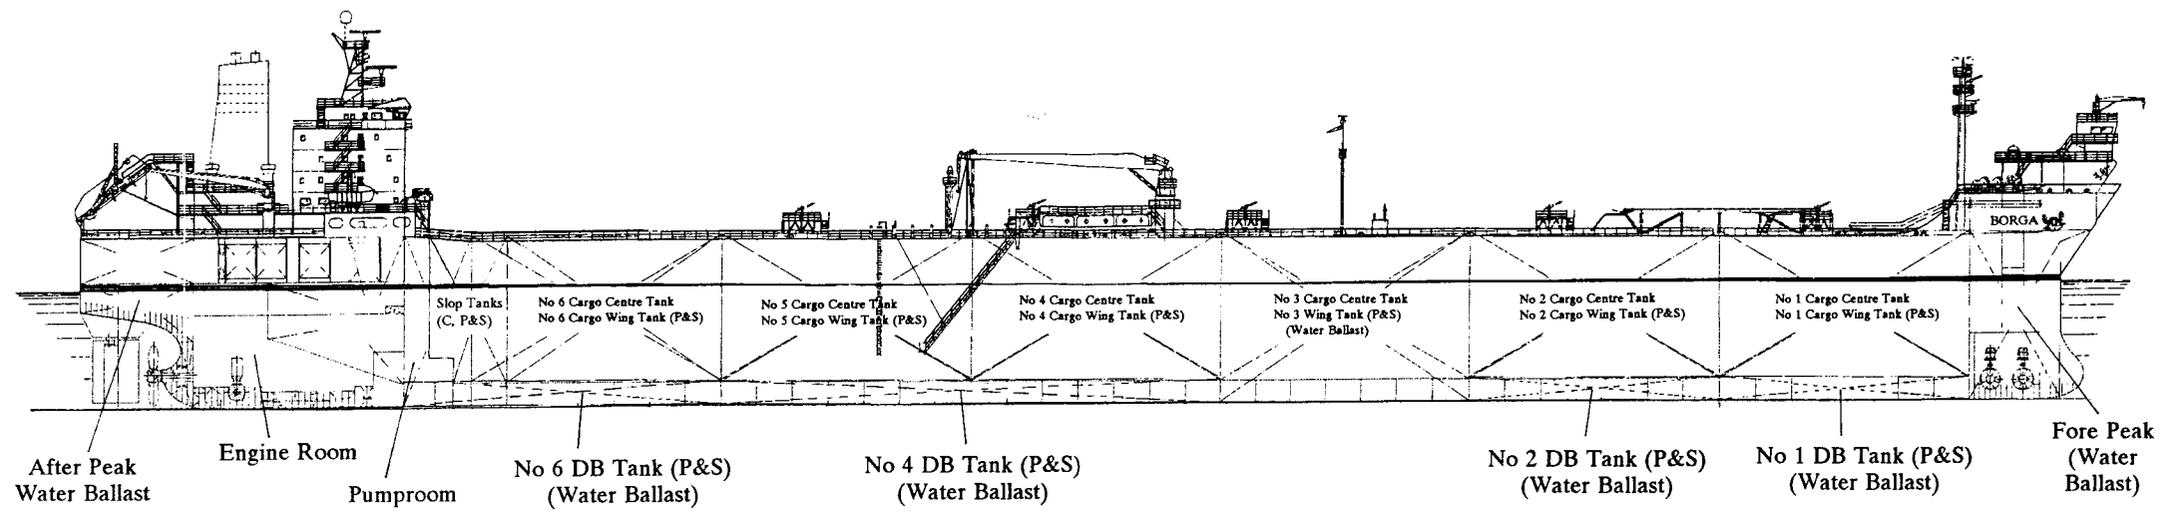
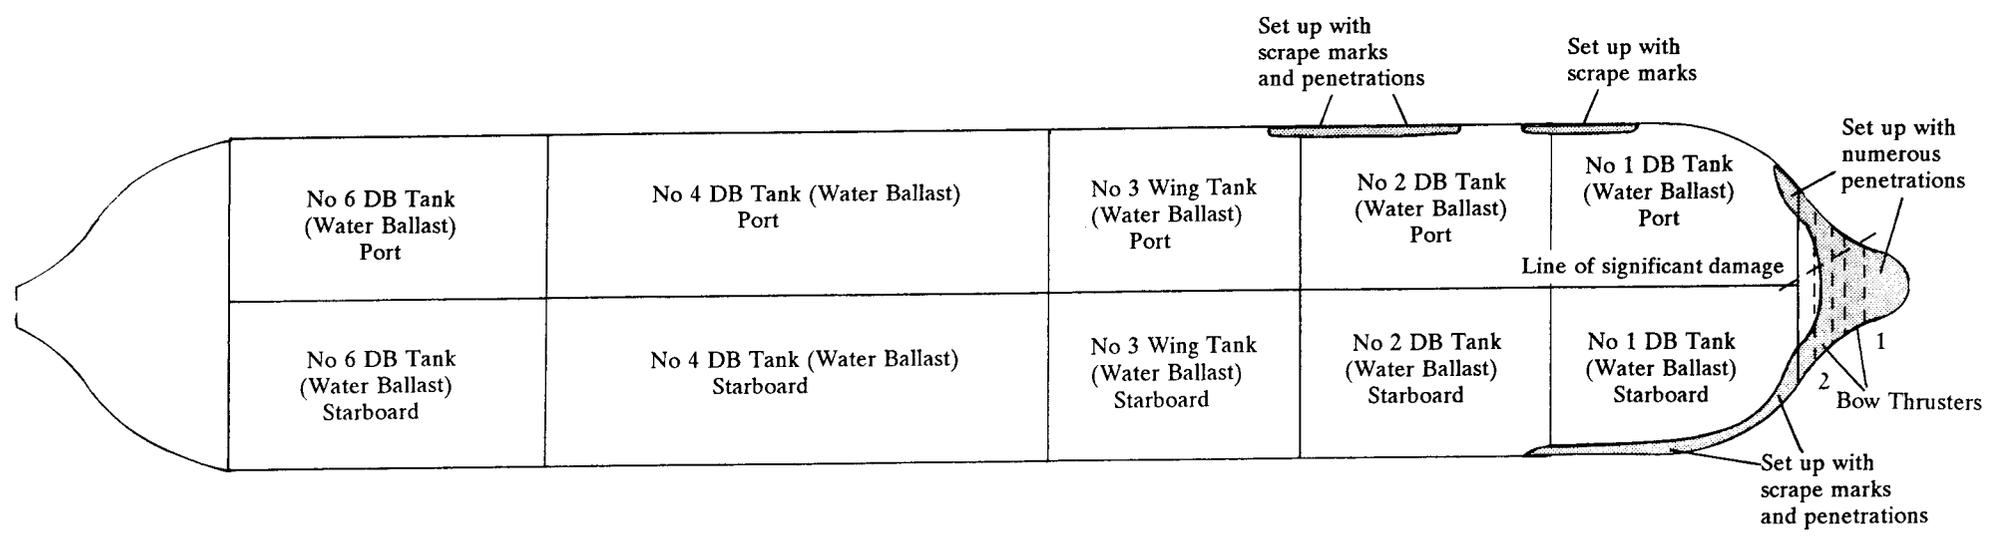
Plan Showing Grounding Damage

There was additional damage on the port side, a short scrape with plating set up in the region of the transverse bulkhead between Nos 1 and 2 tanks, with a more serious indentation in the region of the transverse bulkhead between Nos 2 and 3 tanks. This latter damage was at the turn of the bilge and just forward of the start of the port bilge keel.

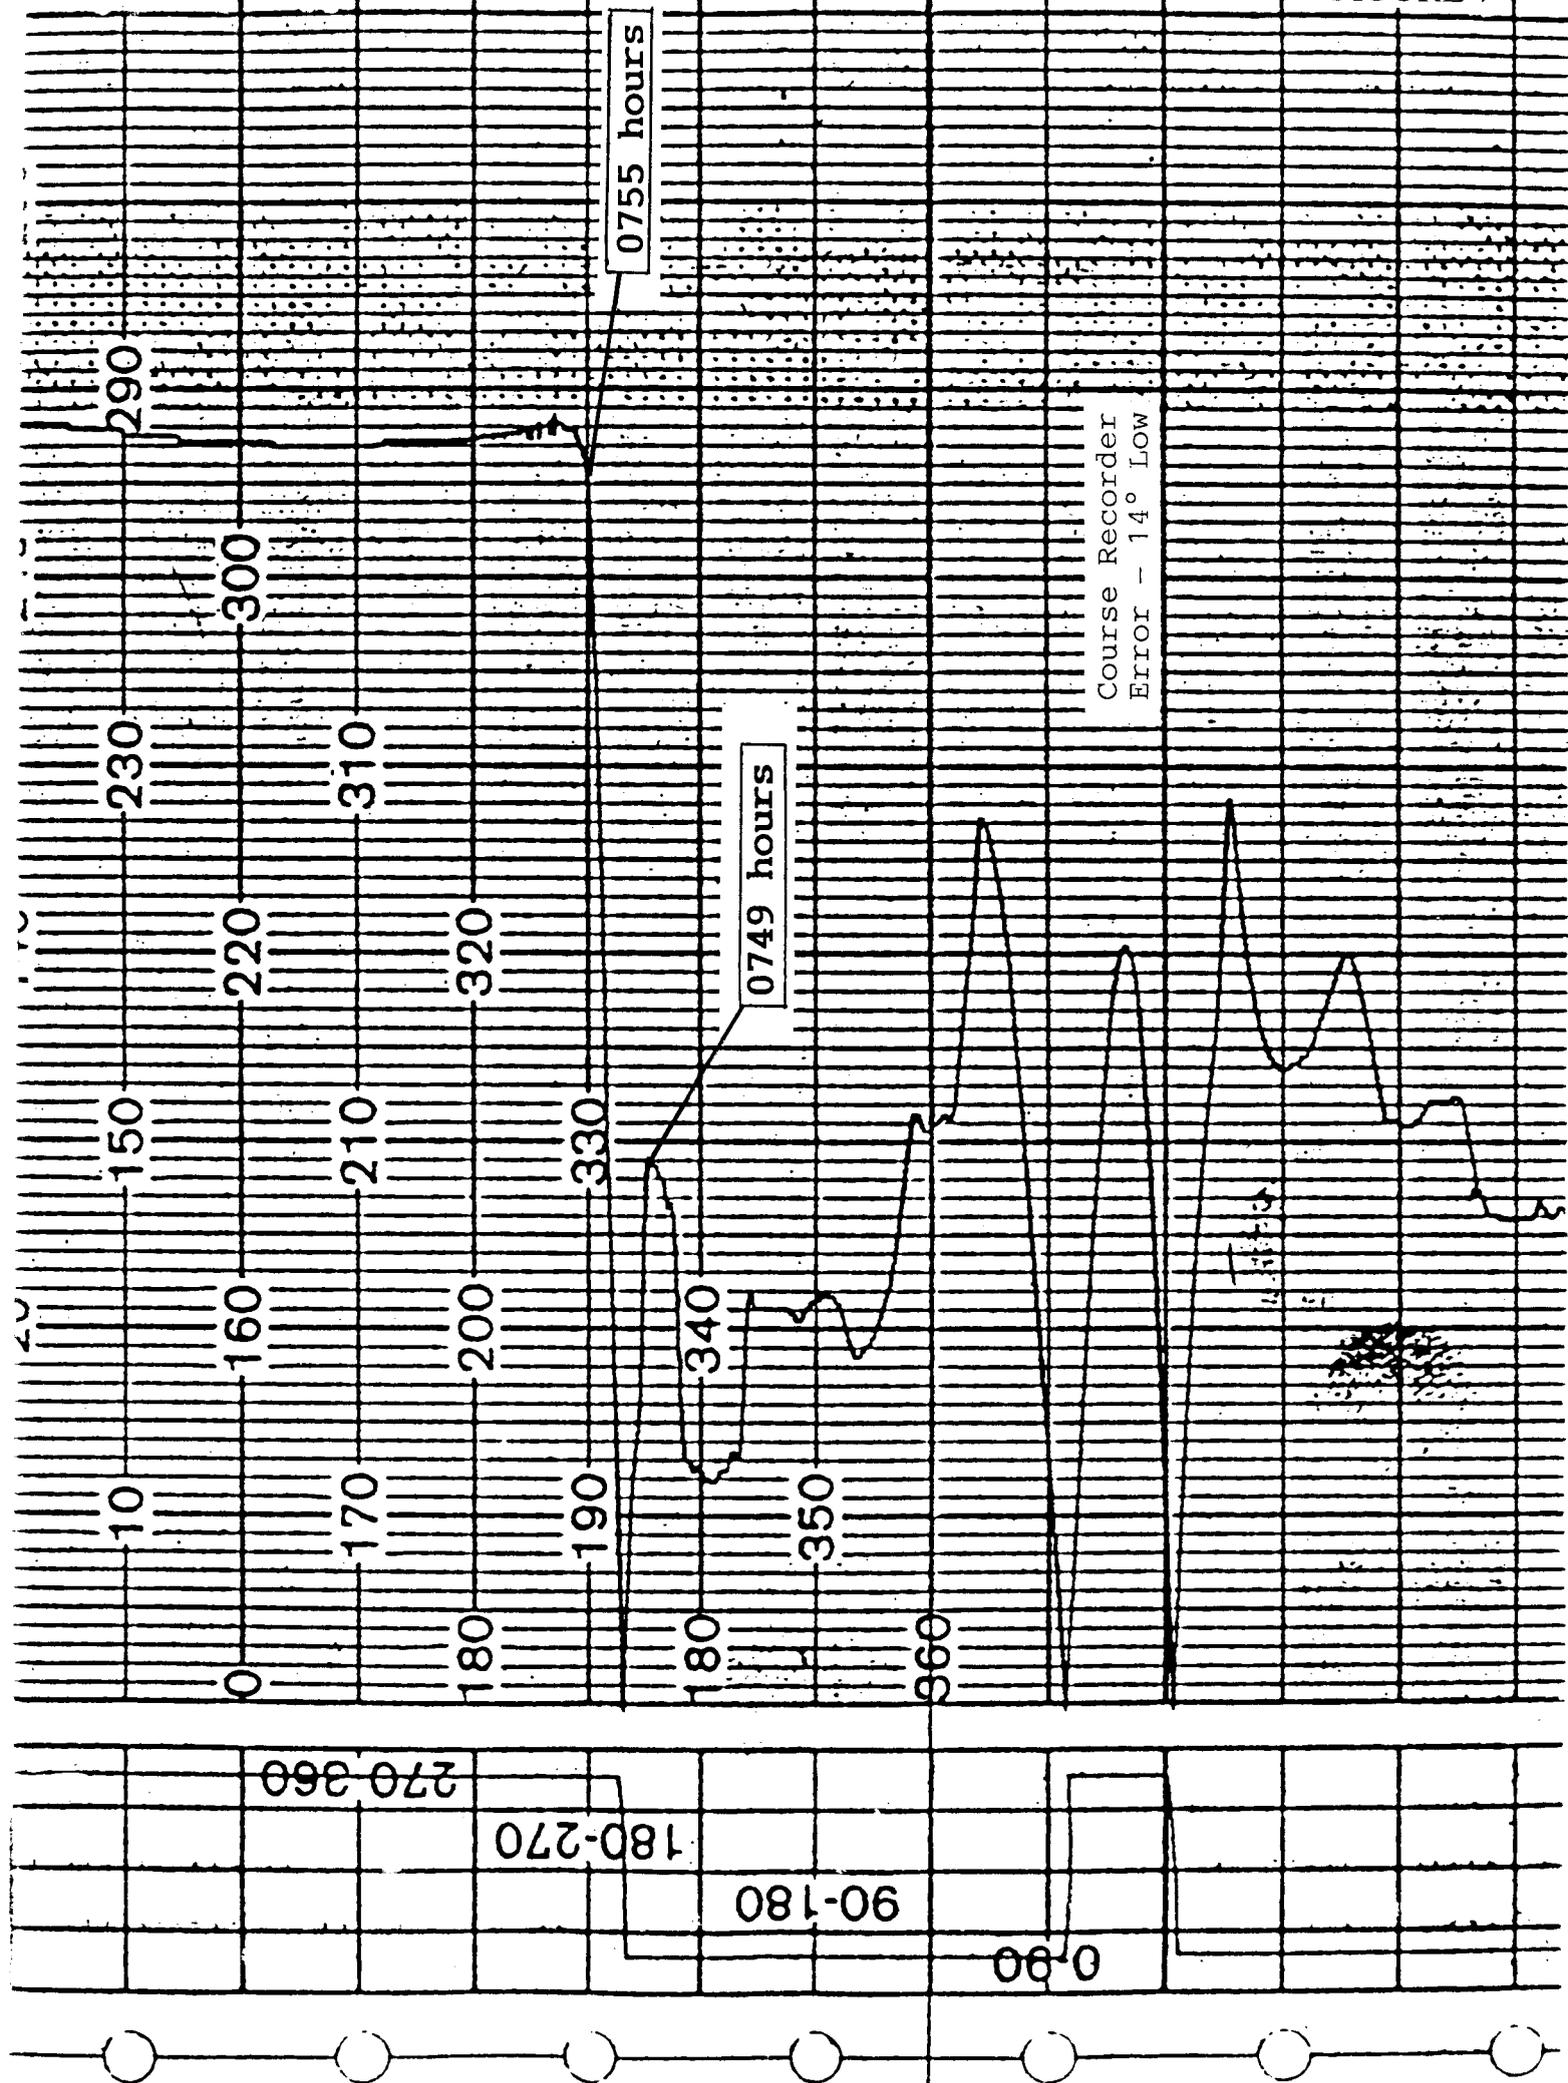
Course Recorder Trace

6.1 The possibility of an error on the approach to, and transit of, West Channel has been considered on the basis of the evidence gathered from the chart in use at the time of the grounding, from observations made by those on the bridge, and from evidence obtained from the course recorder trace.

Although the vessel was reported by the Pilot to have been on the 022° (T) leads at the time of boarding, the charted positions indicate that the vessel was, in fact, to the west of the leading line prior to 0740 hrs. This is supported by the recorded alteration of heading from 036° (T) to 027° (T) at 0740 hrs.
