Report of the Chief Inspector of Marine Accidents
into the loss of the Suction Dredger

BOWSPRITE

with four lives
in the North Sea
on 5 December 1988

Marine Accident Investigation Branch
5/7 Brunswick Place
SOUTHAMPTON
Hants SO1 2AN

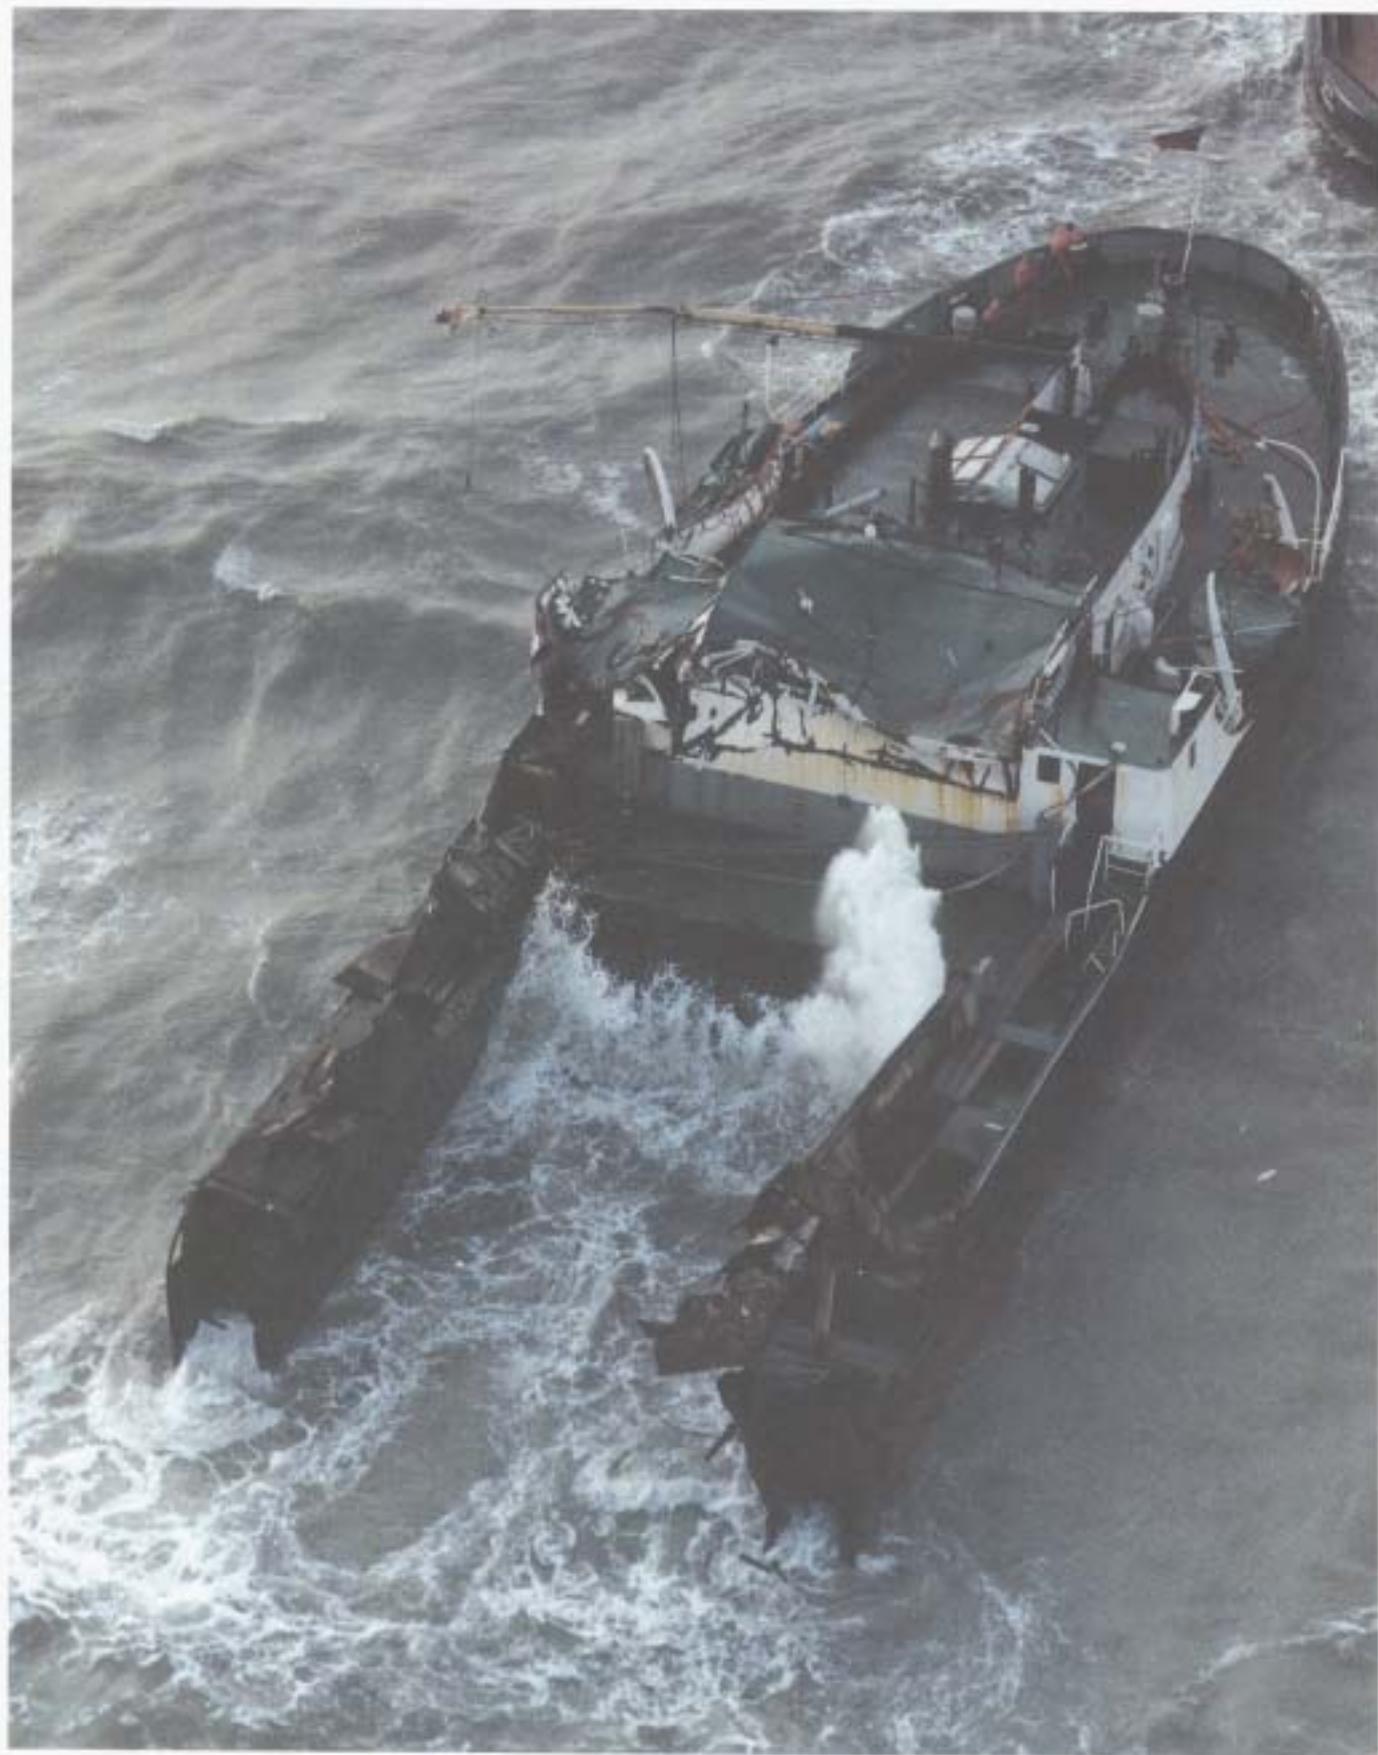
Stern section after the accident

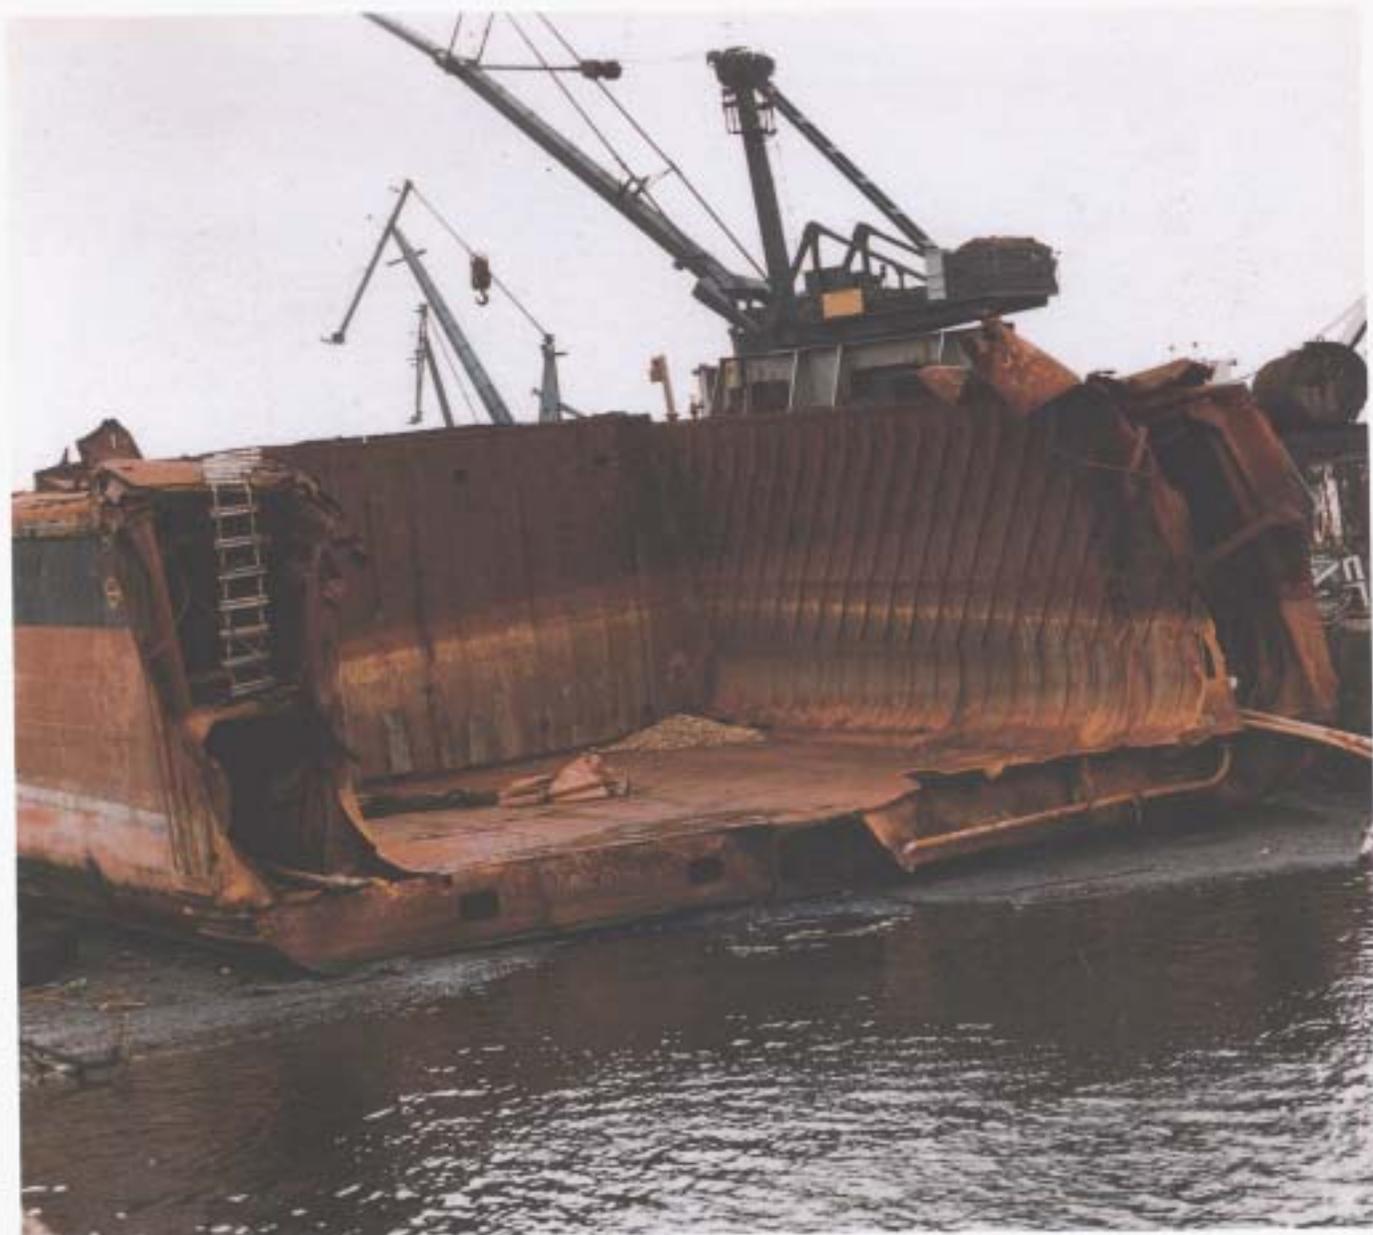
General view of the stern part of vessel

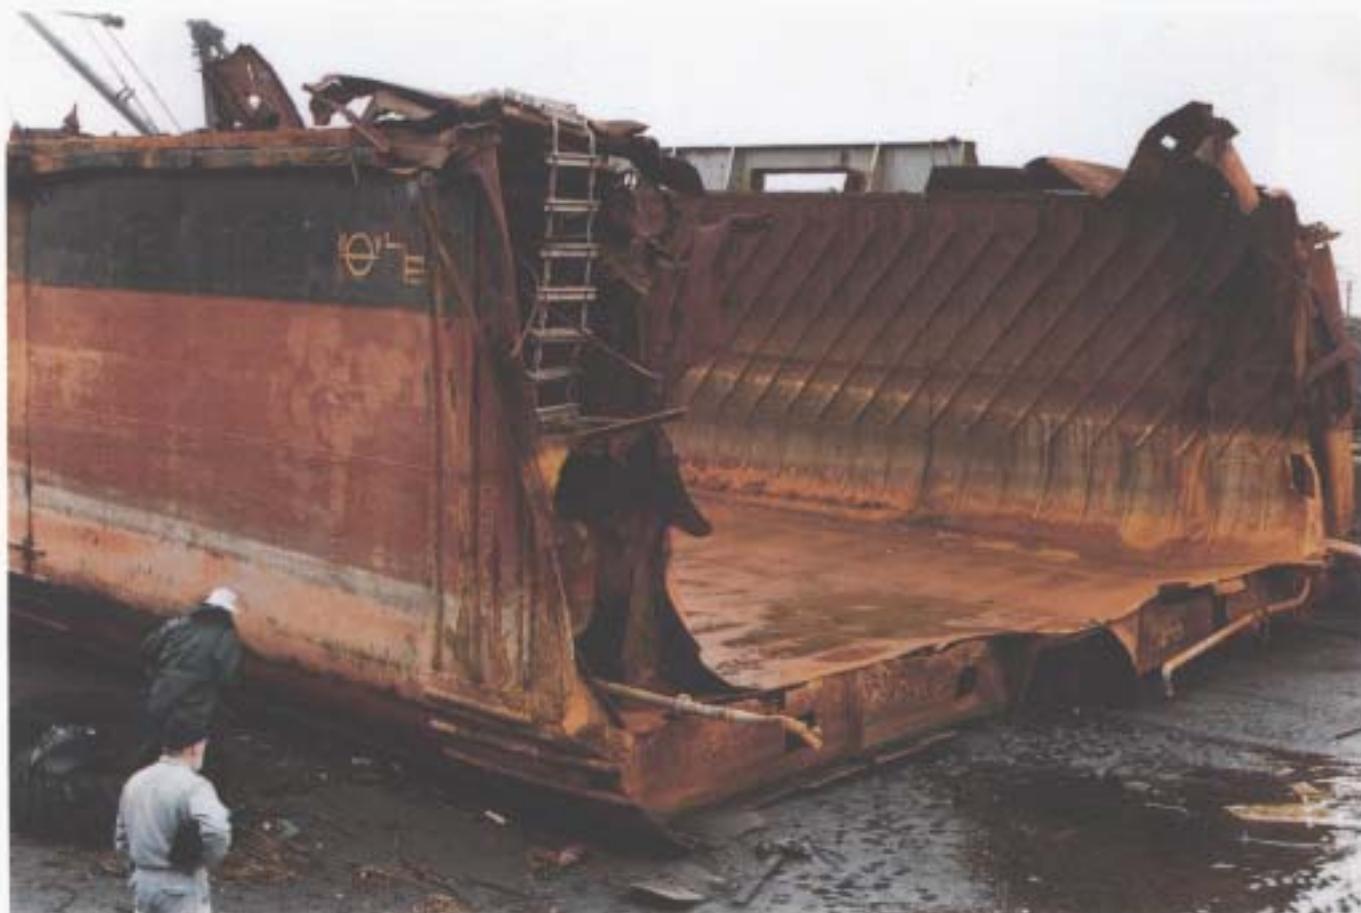
Oblique view of fracture

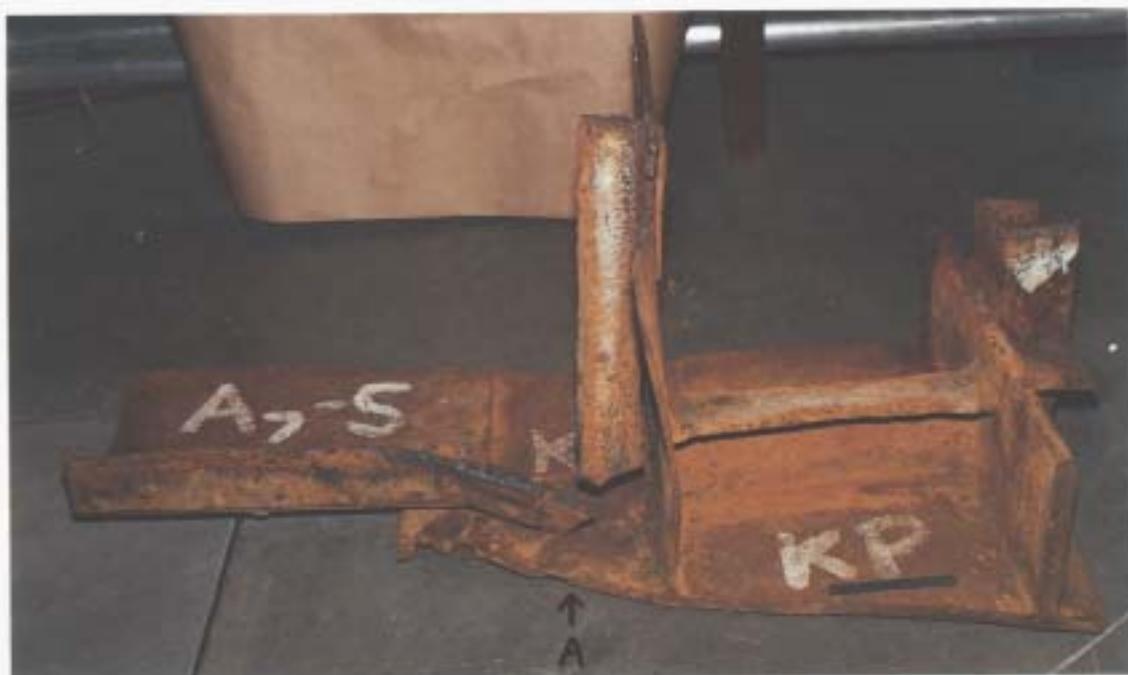
Figure 9

- 6.2.1 The source of brittle fracture in the keel plate (Annex 3 Figures 8 and 9) is associated with a ductile shear fracture of the first 200mm on the starboard side of the plate. The detailed configuration of the chevron markings on the fracture surface at the source of brittle fracture leads firmly to the conclusion that this brittle fracture initiated at mid-thickness of the plate and extended to port. It is therefore a continuation of the ductile fracture at the starboard side of the plate. Thus this brittle fracture of the keel plate cannot be the event that initiated the fracture of the bottom.

Part of A7 (starboard) and part of keel plate.

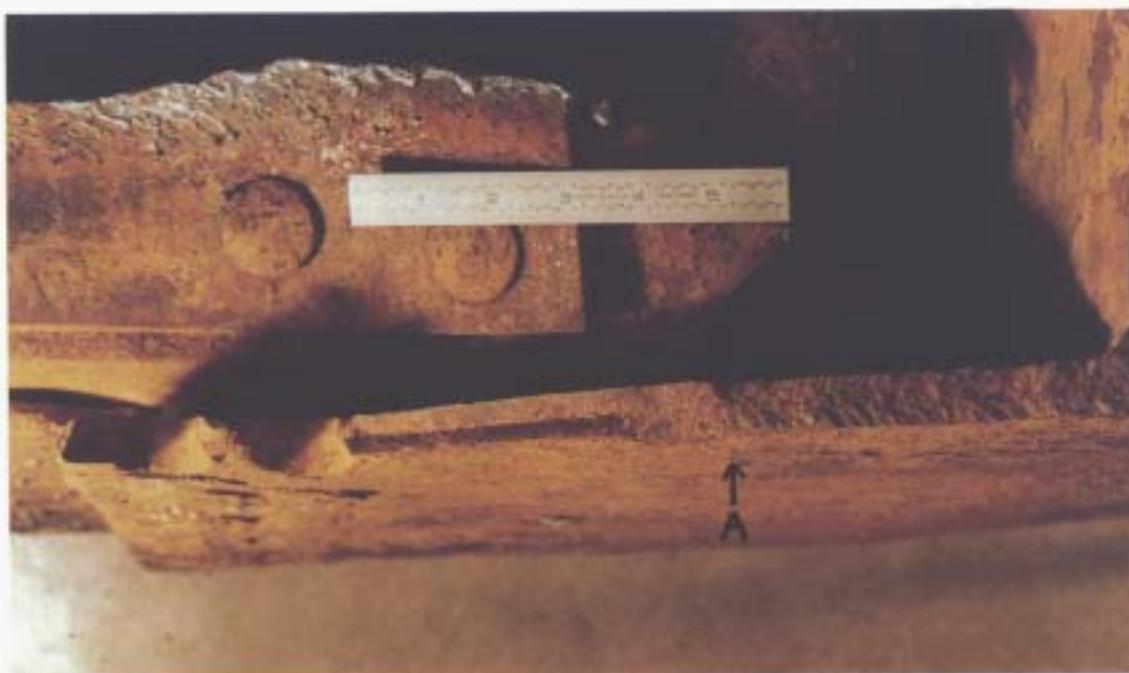
Figure 10

Detail of fracture in keel plate, showing transition from ductile fracture to brittle fracture at A. Fracture has progressed from left to right (starboard to port).

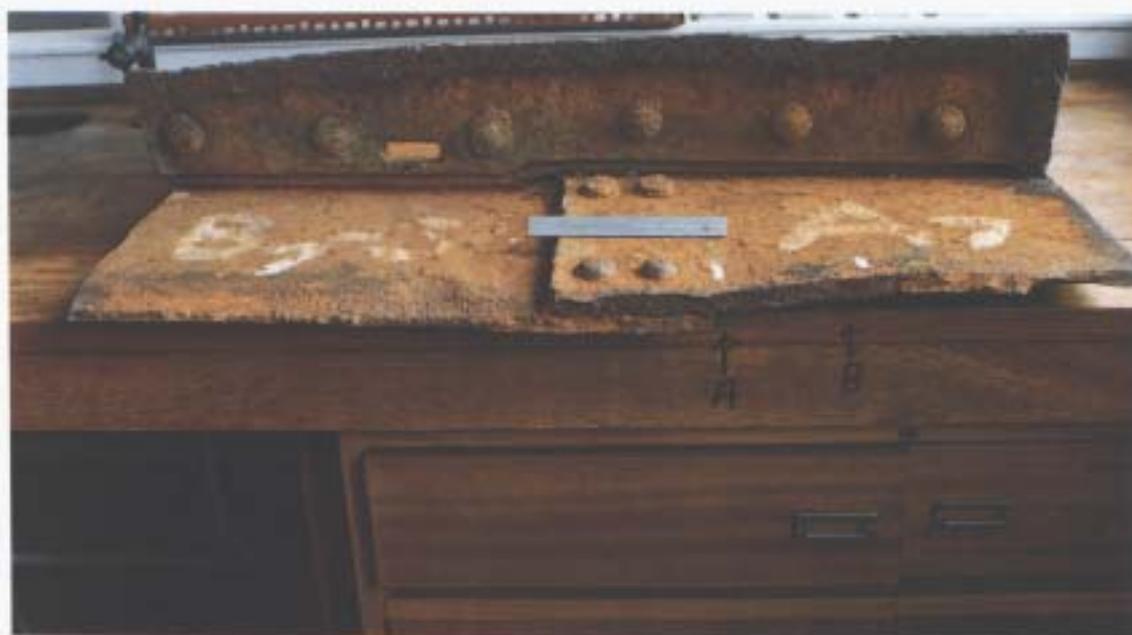
Figure 11

- 6.2.2 The source of brittle fracture at the overlap of the plates B7 and A7 (Annex 3 Figures 10 and 11) is on the bottom of the A7 plate at the junction of the transverse butt weld (joining plates A7 and A8) and the longitudinal fillet weld at the edge of B7. The fracture markings show growth both to port and starboard.

Oblique view of fracture of B7, A7. Note wastage of B7 and sources of fracture A and B.

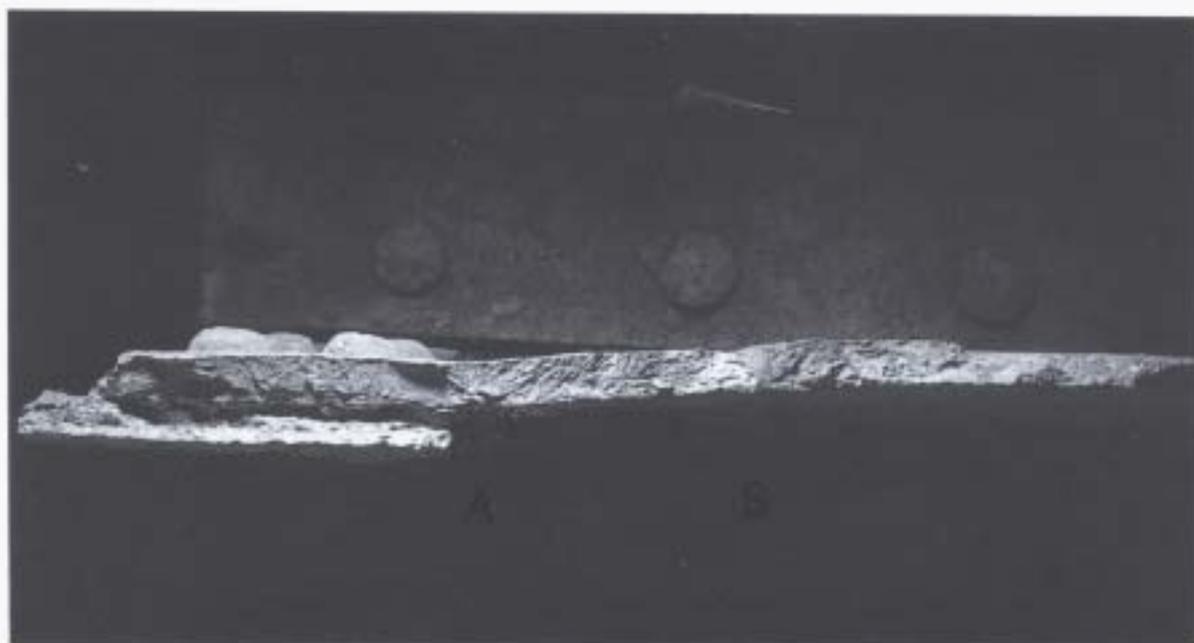
In the port direction the brittle fracture runs out of the weld after 160mm and becomes a ductile shear fracture in the A7 plate itself. In the starboard direction the brittle fracture runs to the edge of the A7 plate. (See Annex 3 Figure 11).

Detail of fracture in A7, showing sources A and B.
