Report of the Investigation into the

Collision between

BRITISH TRENT

WESTERN WINNER

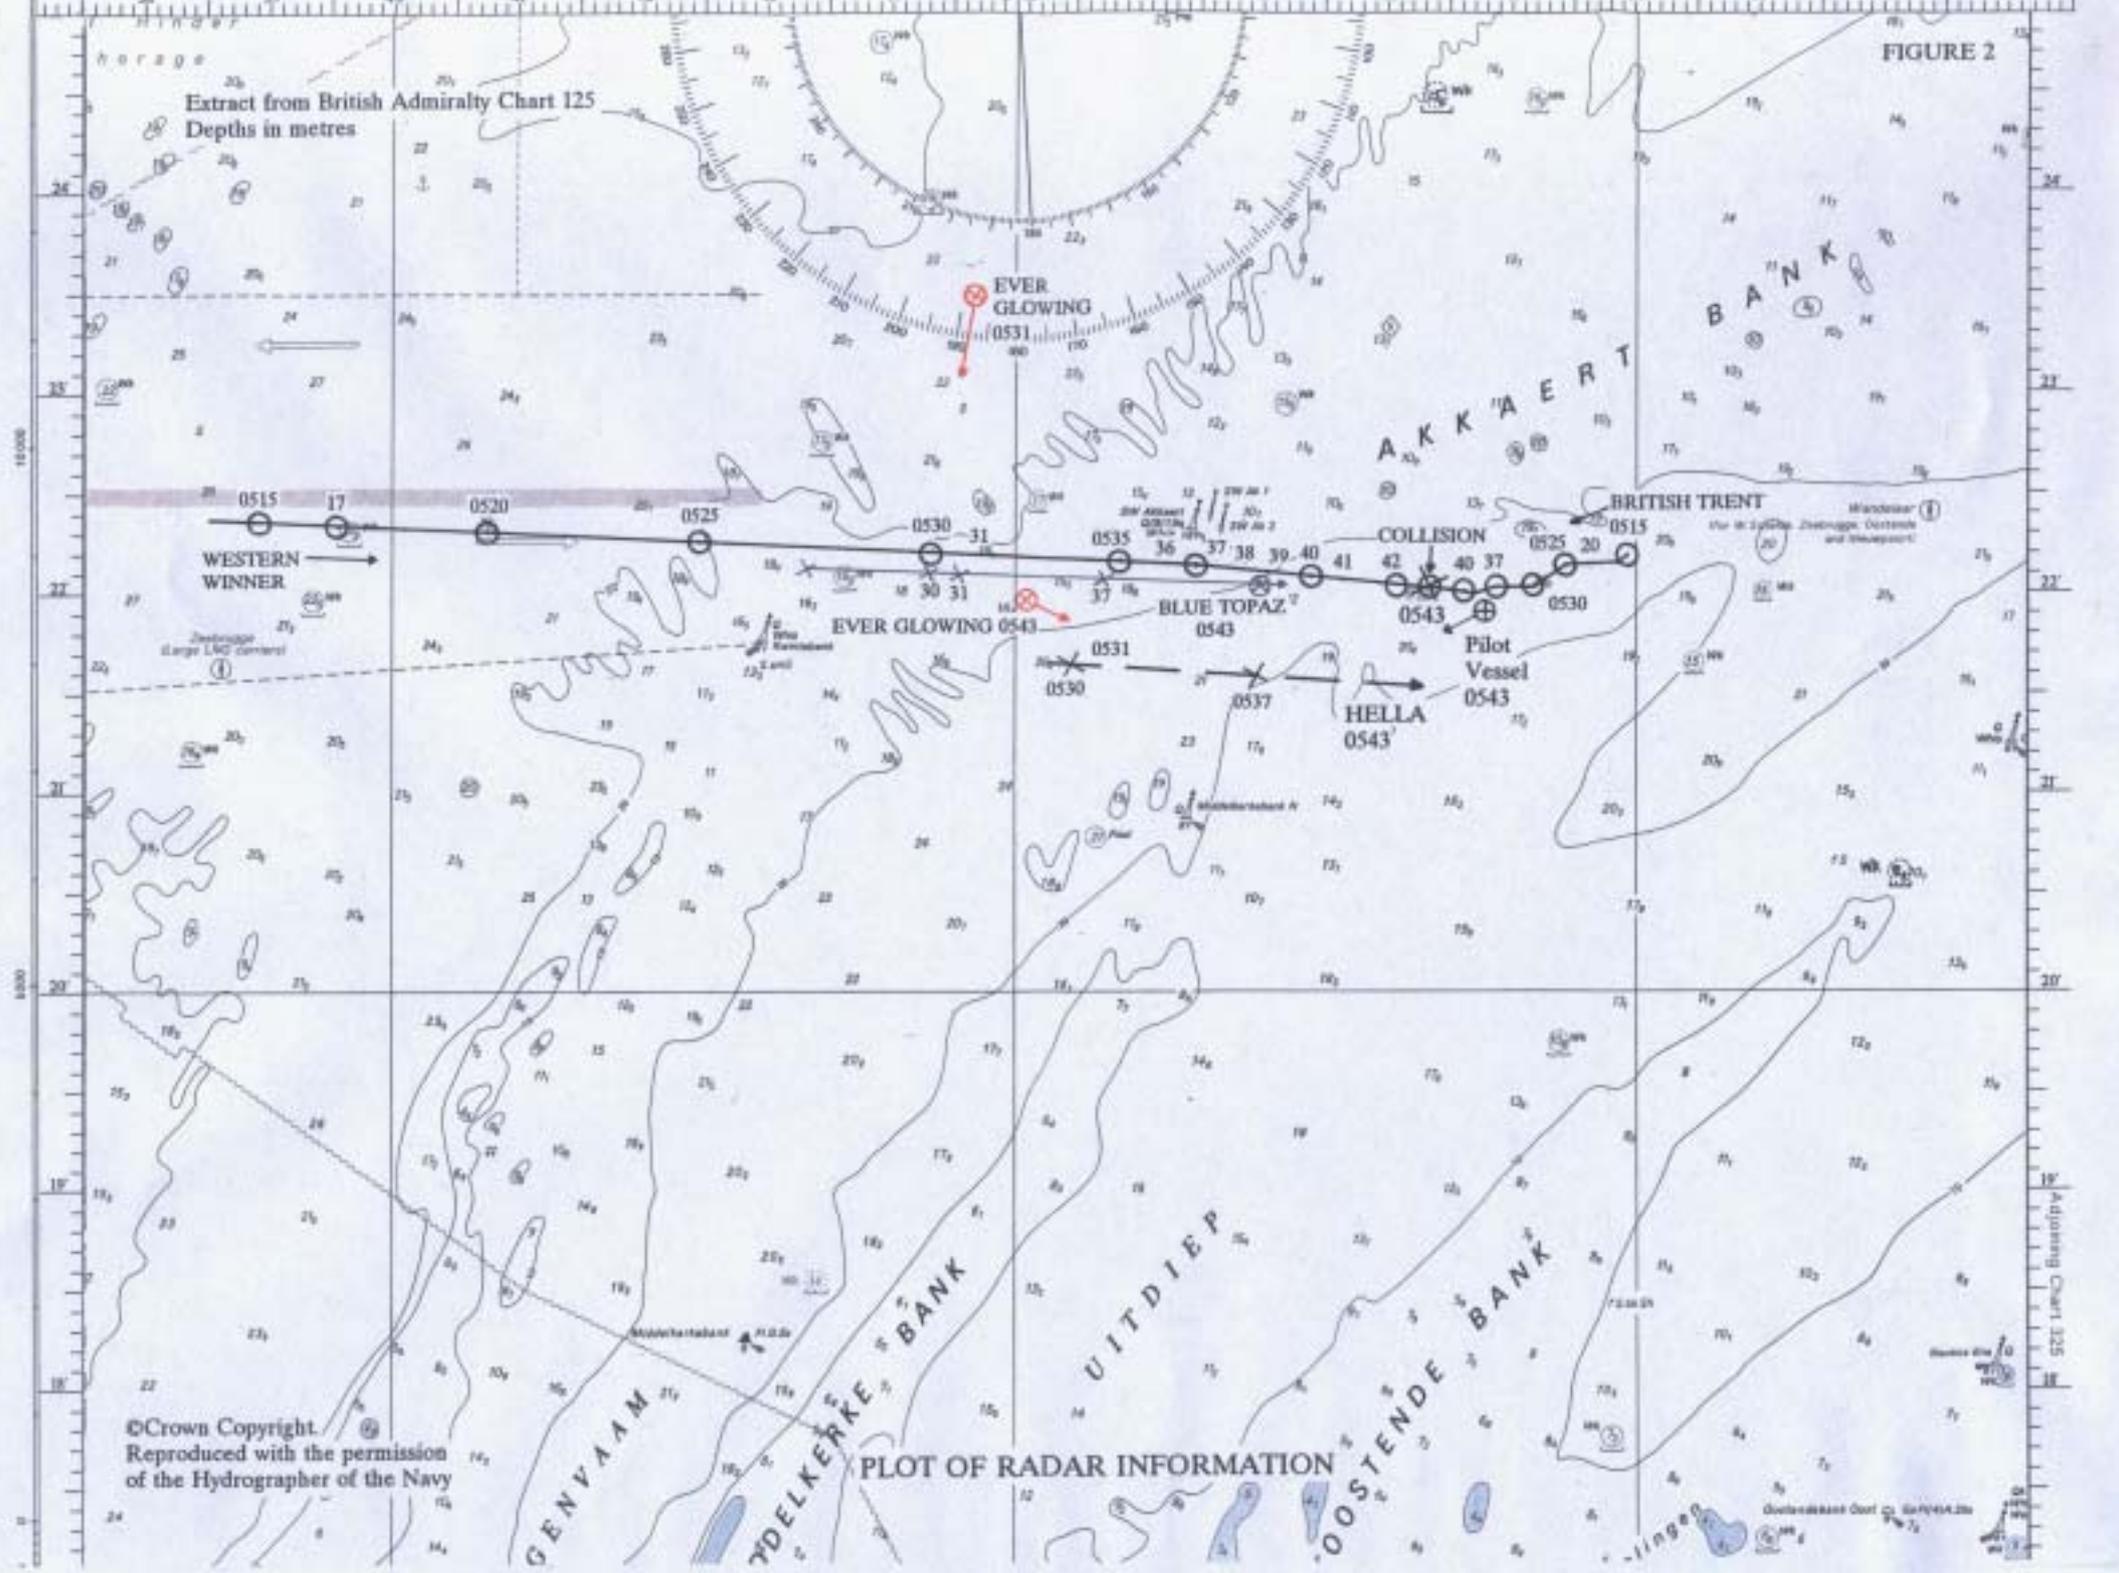
FIGURE 2

4.7 At 0517 hrs WESTERN WINNER altered her course to 093° when the Kwintebank Buoy was bearing 105° x 2.2 miles (see Figure 2). The Third Officer came on to the bridge just before 0530 hrs: the vessel was in automatic steering, the quartermaster having been sent to rig the pilot ladder. The Third Officer changed over to hand steering and started the vessel himself. At 0530 hrs the visibility was reported as being 200 metres and the engines were put on "Stand-by" with harbour speed of 100 rpm.

Extract from British Admiralty Chart 125
Depths in metres

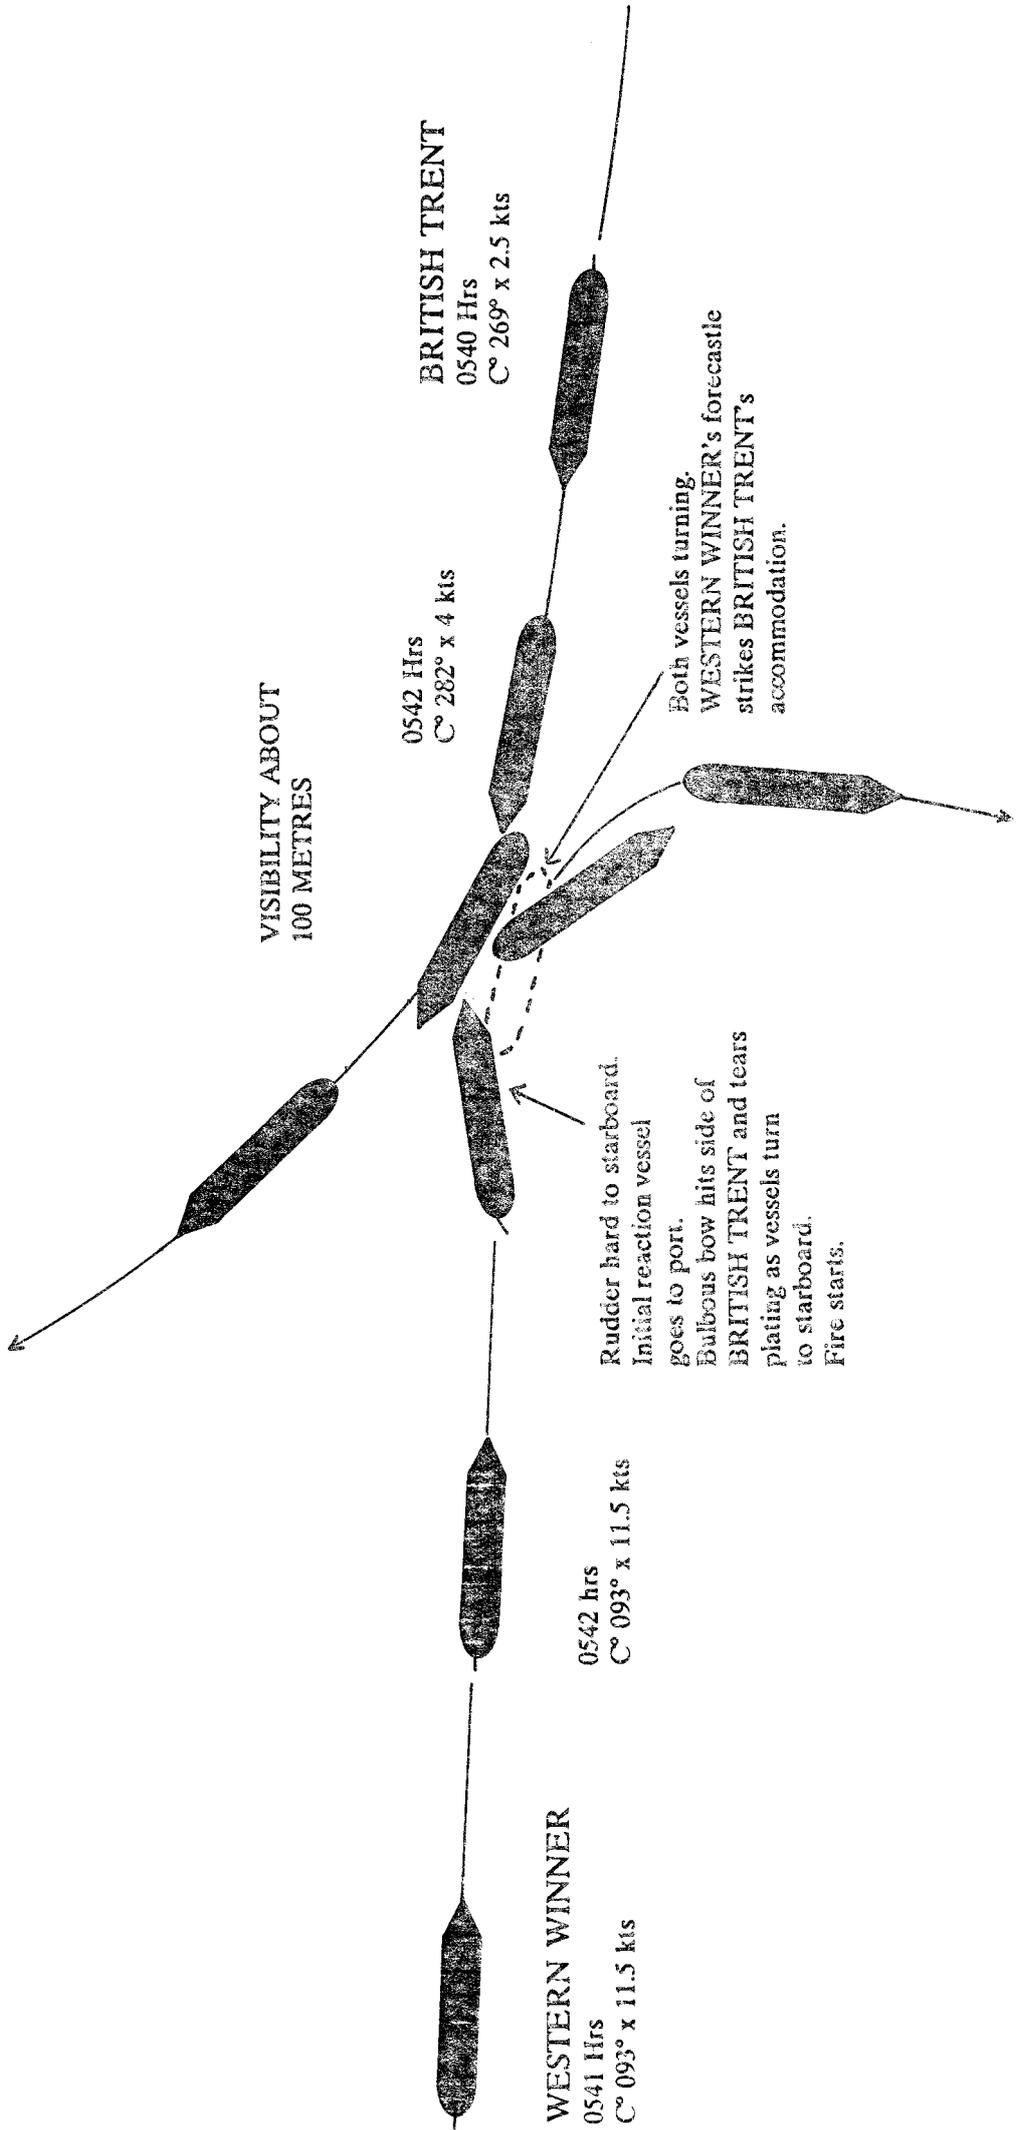
DIAGRAMMATIC SEQUENCE OF EVENTS

The resulting damage to both vessels shows they had side to side contact indicating that they were on nearly reciprocal courses until they both altered course to starboard. Figure 3 is a diagrammatic representation of the sequence leading up to the collision. It is considered that the plating in the way of BRITISH TRENT's Nos 3 and 4 port cargo tanks was torn off by WESTERN WINNER's bulbous bow whilst WESTERN WINNER's hull was damaged by the panama leads on the deck of BRITISH TRENT. The tanker's accommodation was damaged when the port side after end of WESTERN WINNER's forecastle head cut into it as the two vessels passed each other.

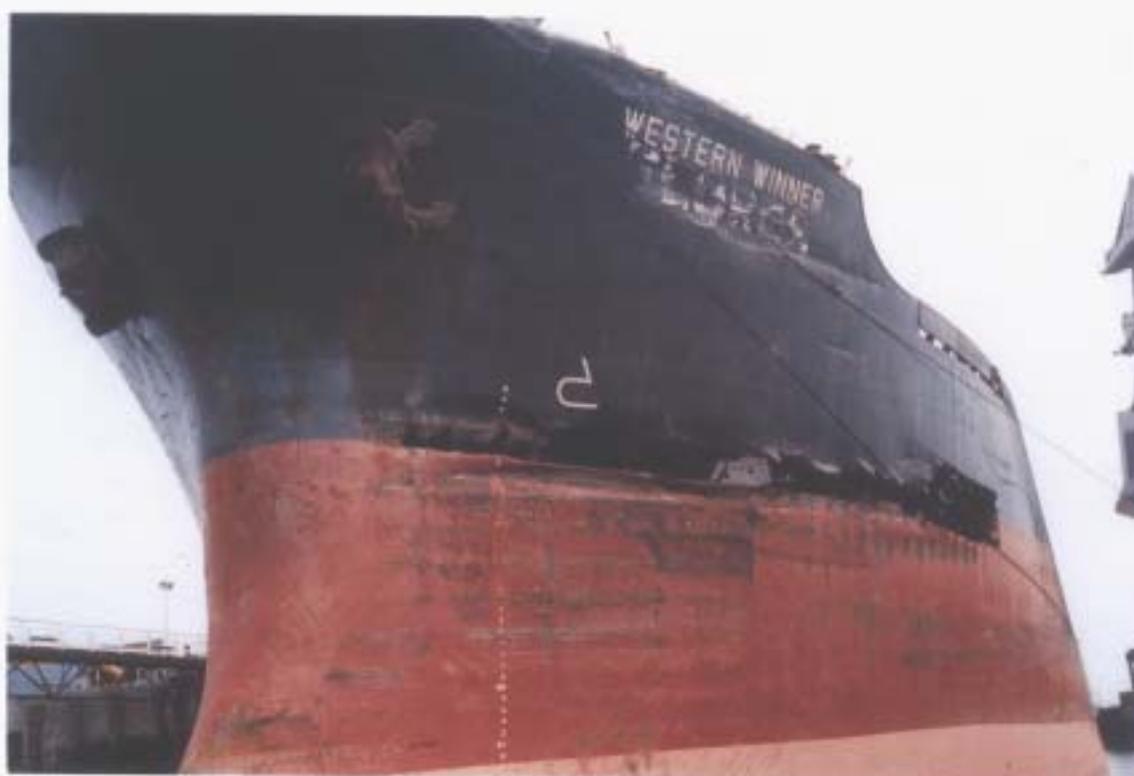
FIGURE 4

WESTERN WINNER - showing extent of damage to Port bow

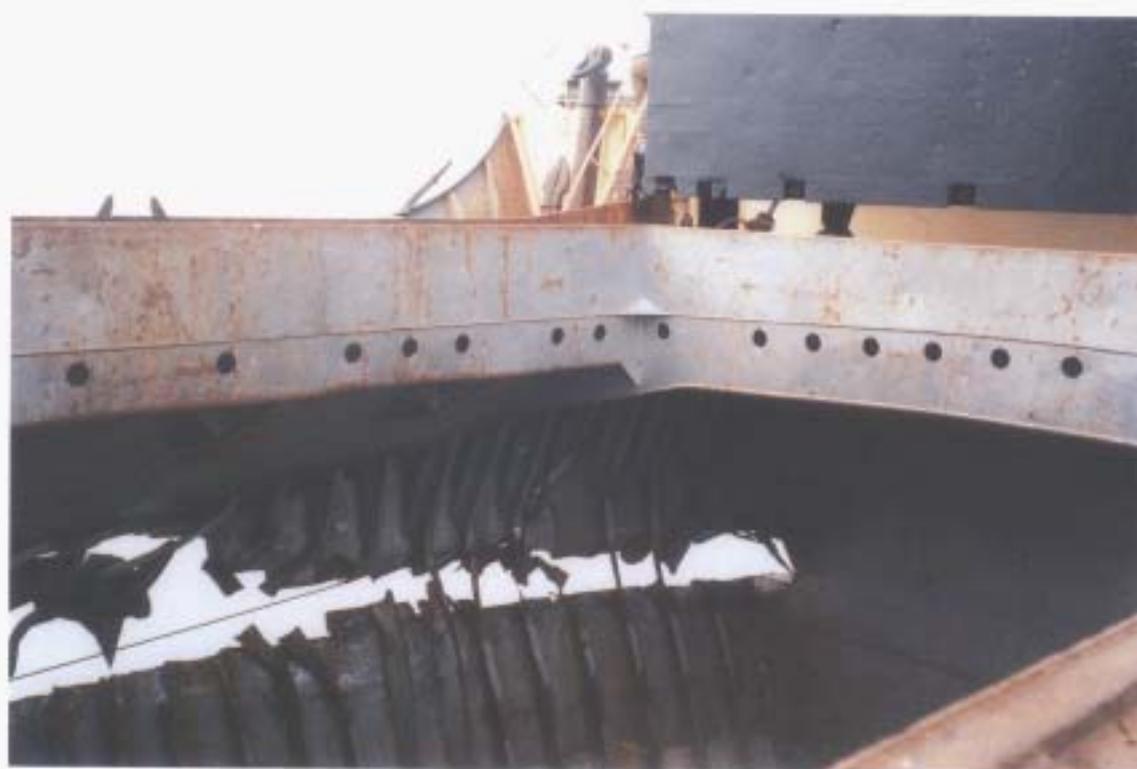
FIGURE 5

WESTERN WINNER - View of above damage looking outboard through No 1 hatch

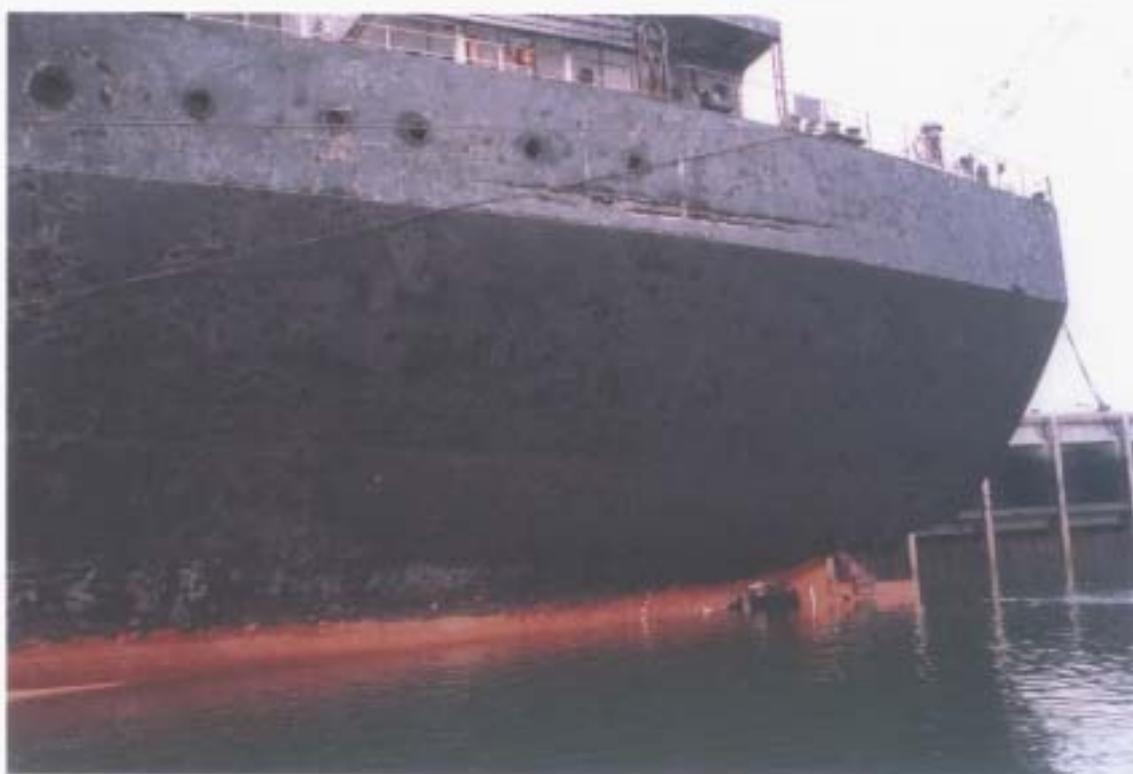
FIGURE 6

Onboard WESTERN WINNER the Master reported hearing a fog signal which sounded very close, and at the same time he saw the bow of a tanker on his port bow. The vessels collided immediately and he ordered the rudder hard to starboard. The stern of WESTERN WINNER pushed into the side of the tanker as the vessels slid along each other's port sides. This caused damage to WESTERN WINNER's after hull in way of the port lifeboat.

WESTERN WINNER - Port quarter showing collision damage and fire scorched paintwork

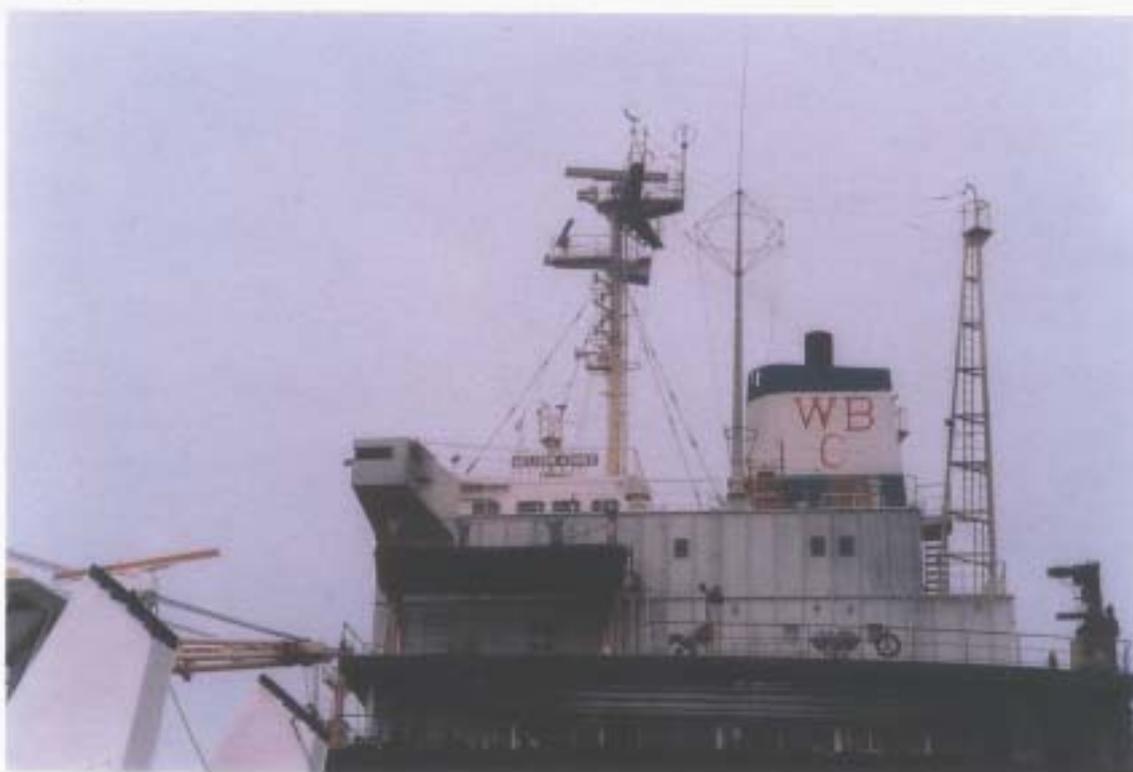
FIGURE 7

WESTERN WINNER - Smoke blackened after accommodation and bridge

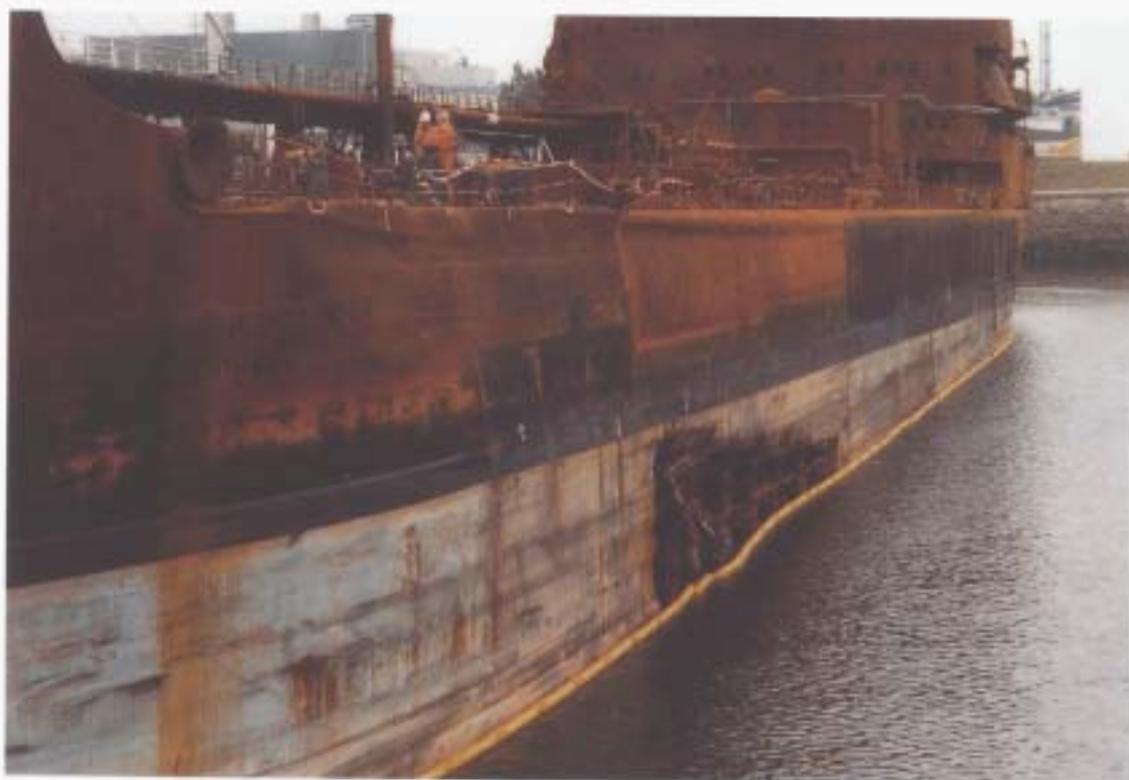
FIGURE 8

- 4.22 BRITISH TRENT's port side was damaged in the collision, the hull was opened up in way of Nos 3 and 4 port cargo tanks and the port side of the accommodation was opened up in way of the Chief Engineer's bedroom. BRITISH TRENT was taken in tow and the fire eventually extinguished by fire-fighting tugs. About 3,600 tonnes of cargo was lost and the remaining cargo was transferred to another tanker off Rotterdam. The accommodation and main deck area were so severely fire damaged that she was declared a constructive total loss.

- 12.9 On BRITISH TRENT the collision ruptured Nos 3 and 4 port cargo tanks and the volatile cargo which spilled out caught fire. It was this fire that led to the dense smoke which caused all personnel to leave the engine-room, the eventual evacuation of the bridge and finally the abandonment of the vessel.

BRITISH TRENT - Port side showing the ruptured tanks and distorted sheerstrake

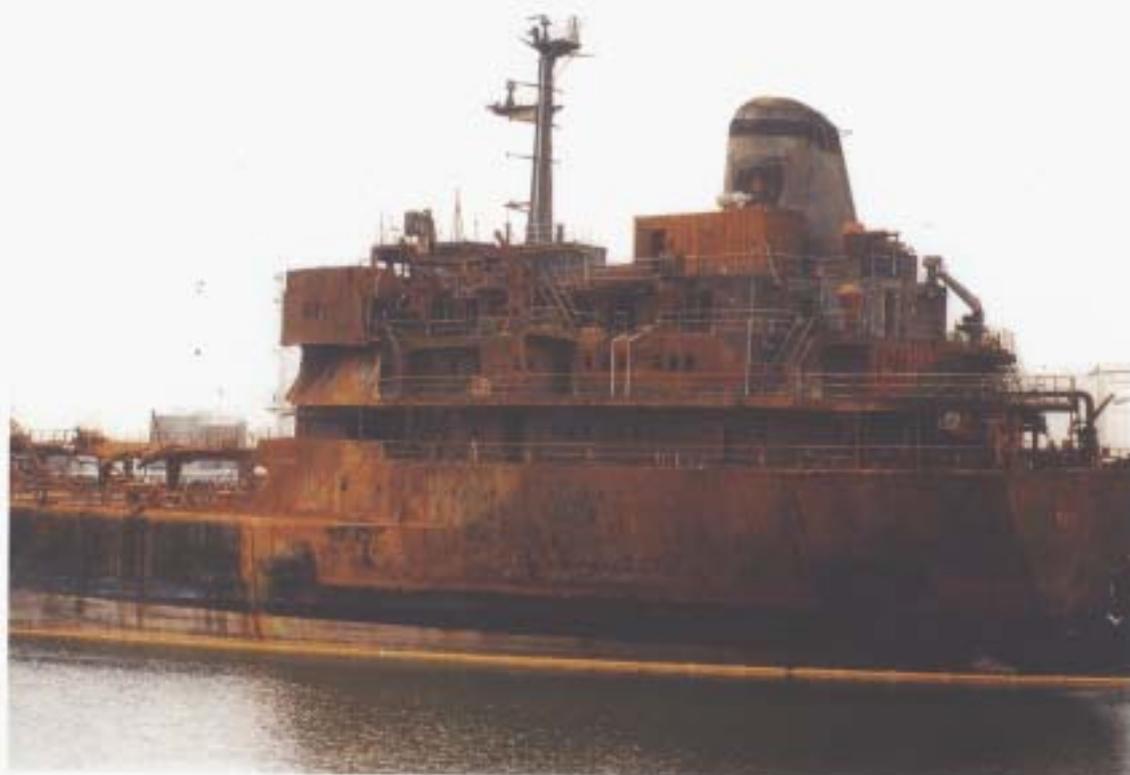
FIGURE 9

BRITISH TRENT - View of port quarter

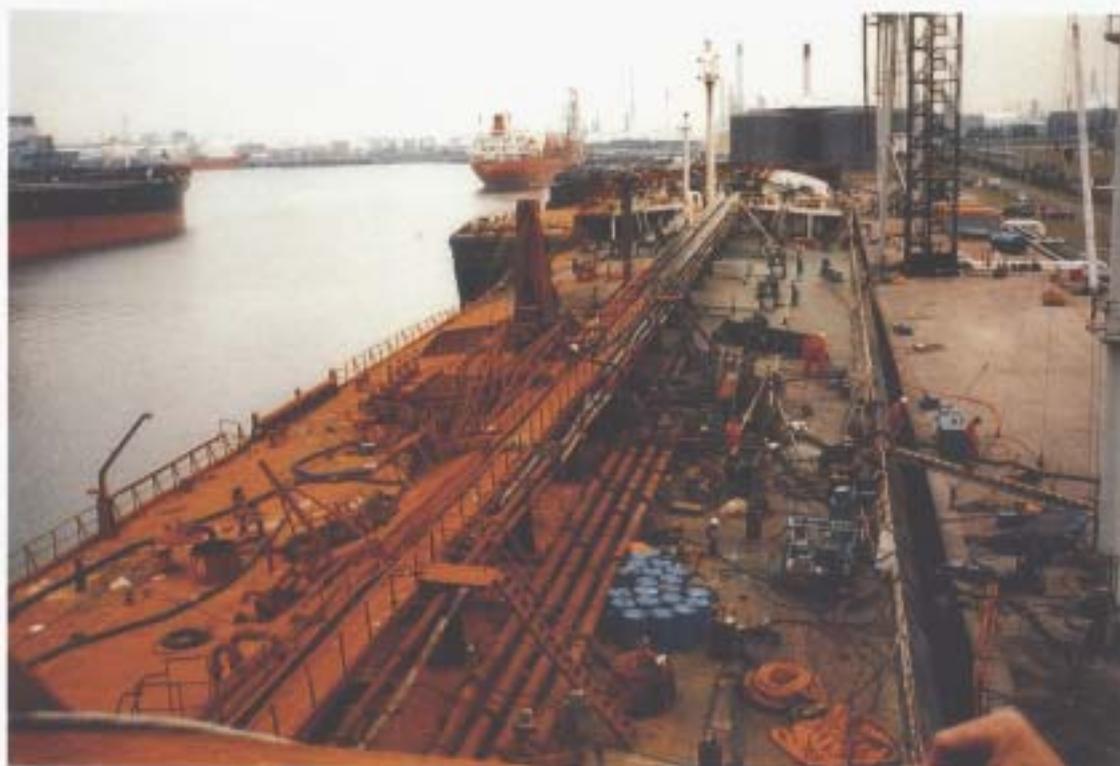
FIGURE 10

BRITISH TRENT - View of main deck clearly showing the boundary between the fire damaged and undamaged areas

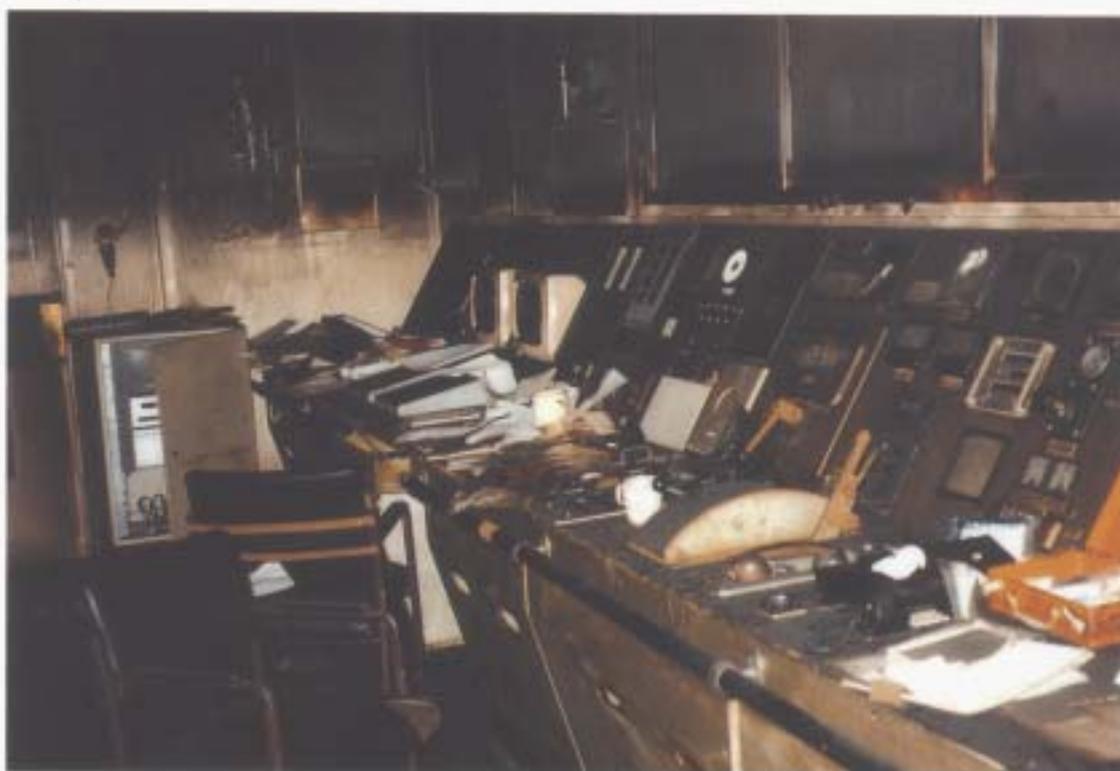
FIGURE 11

Within minutes of the collision BRITISH TRENT's engine control room had to be abandoned because of thick smoke entering the compartment through the air conditioning ventilation inlets. The on-watch engineers left through the engine-room but this space also began to fill with smoke through the ventilation inlets and the engine-room became untenable. The Second Engineer, on his way out of the engine-room via the stairway leading to the crew changing room, paused at the top of the stairs to operate the stop controls for the two forward engine-room ventilation fans but this did not appear to reduce the volume of smoke entering the engine-room.

The engine-room was ventilated by four fans, two on the port side and two on the starboard side of the lifeboat deck. It is probable that the port side fans drew in smoke from the burning petroleum cargo, which was spilling from the ruptured tanks and passing down the port side of the vessel as it moved ahead through the water. The air conditioning unit for the engine control room drew its air supply from one of the port side engine-room fan intakes. The engine control room rapidly became filled with smoke. The Second Engineer stopped the two forward fans as he left the engine-room but the two aft fans were left running. When the Second and Third Engineers later tried to re-enter the engine-room it was completely smoke filled. This prevented them from getting to the lower level of the engine-room to start the main fire pumps. Despite the smoke, the main engine and auxiliaries were reported to be still running at that time.

BRITISH TRENT - Extent of heat and smoke damage in engine control room

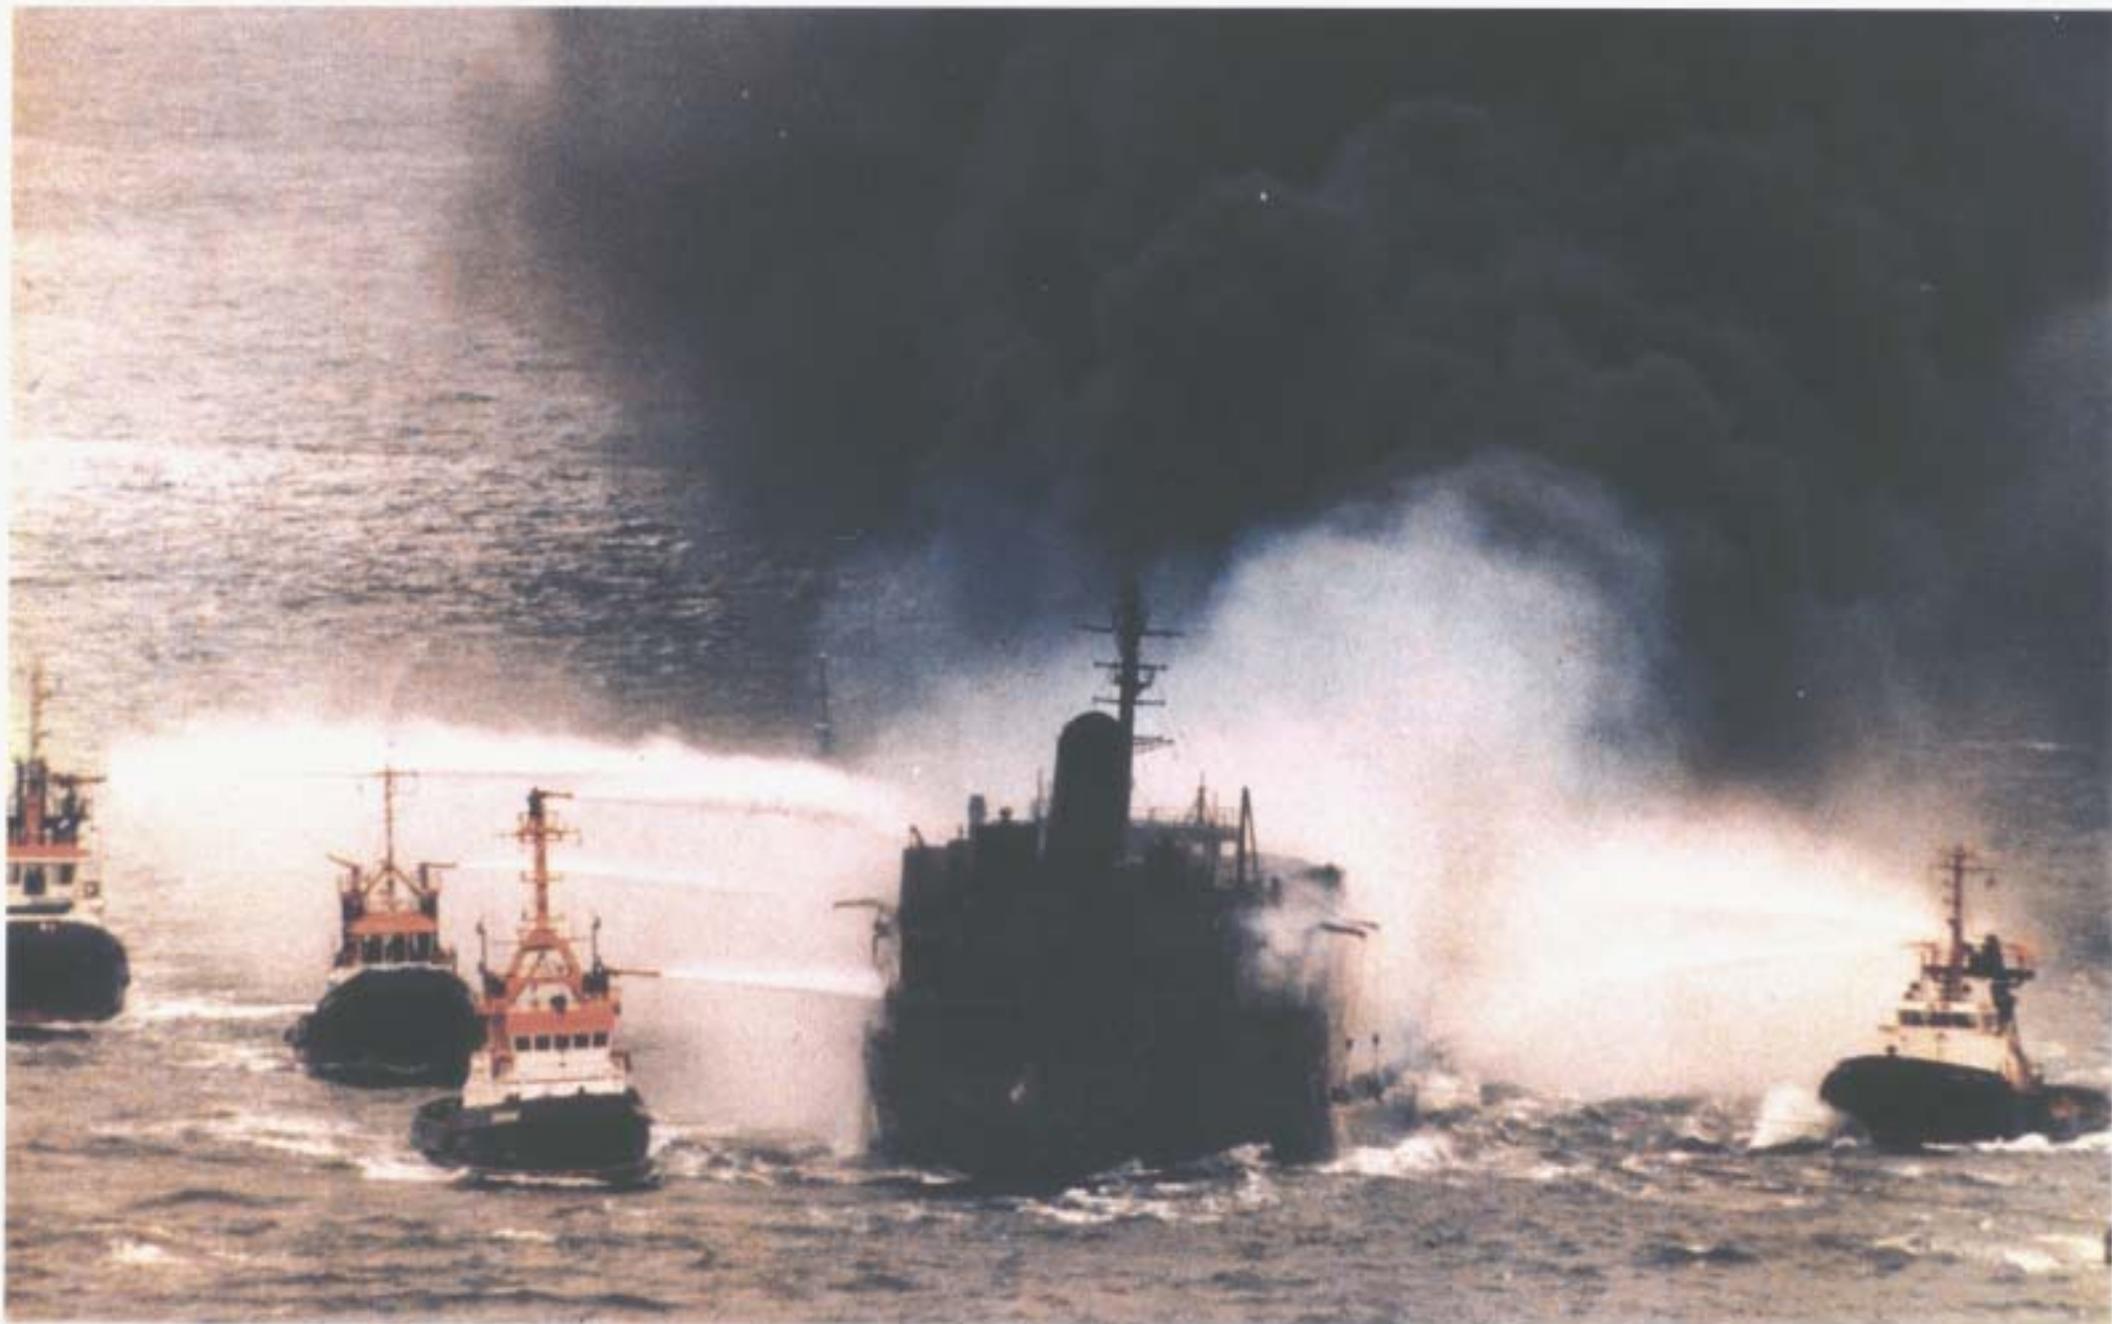
BRITISH TRENT after her abandonment
