Marine Accident Report 3/98

Report of the Inspector's Inquiry
into the Grounding of the Feeder Container Ship

mv CITA

off Newfoundland Point, Isles of Scilly
on 26 March 1997

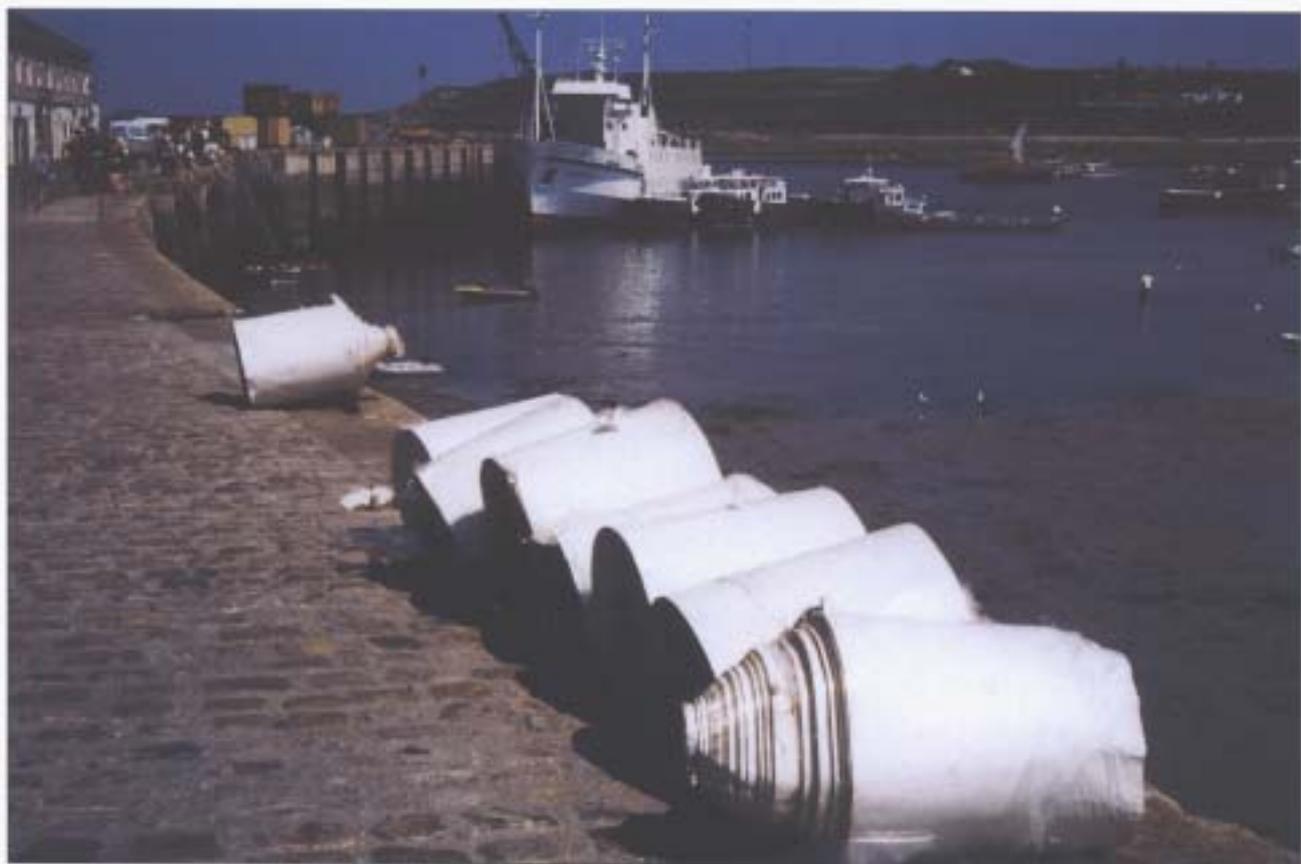
Polyester sheeting on the Jetty at Hugh Town

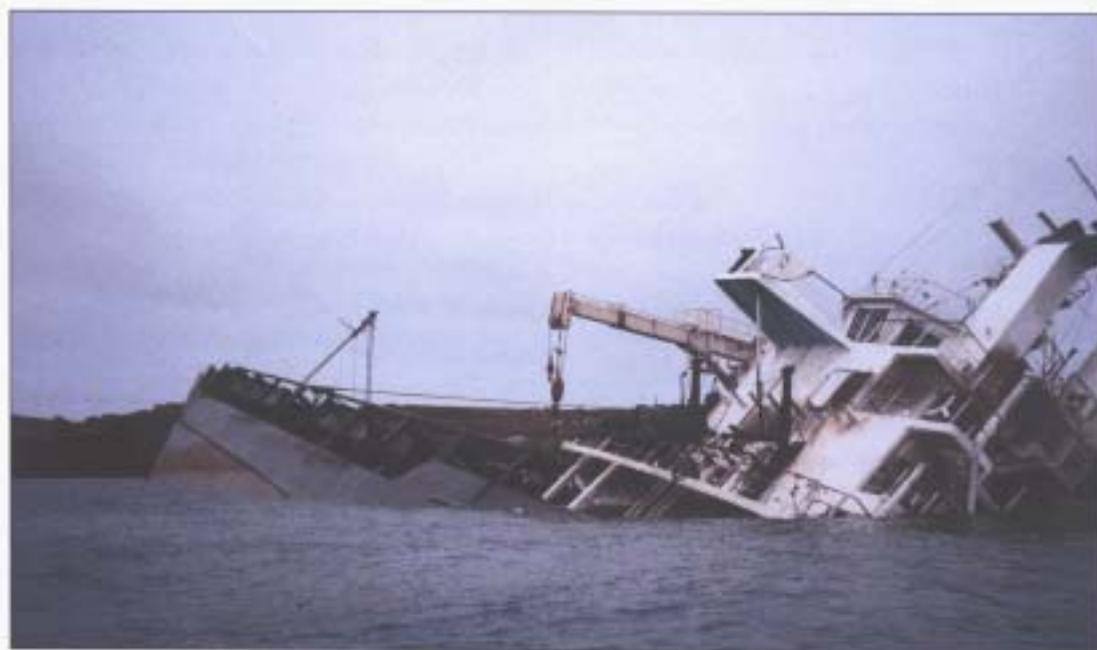
MV CITA aground off Newfoundland Point, Isles of Scilly

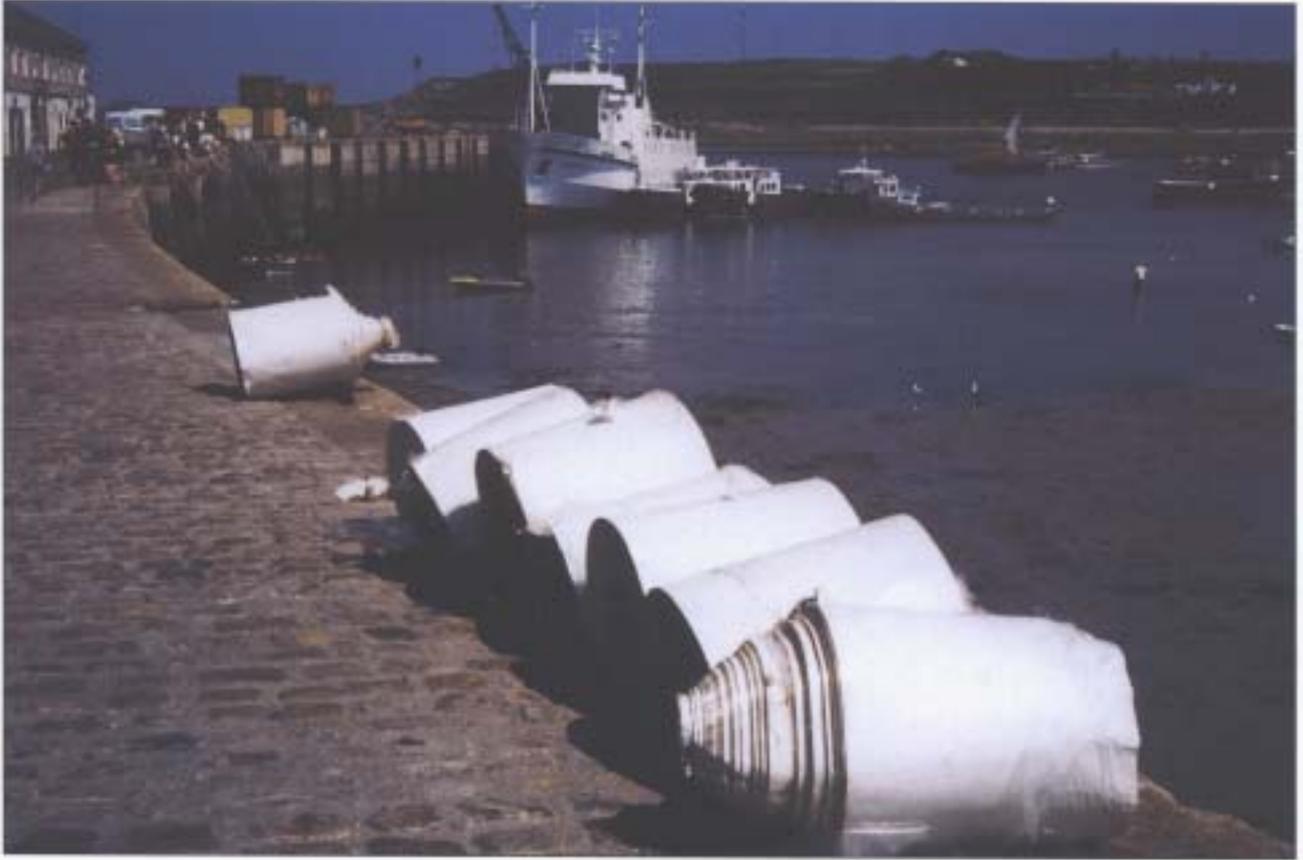
Some containers carried by CITA contained cargo that although not defined as hazardous was damaging to the environment and became very time consuming to recover. Polyester sheeting used in the manufacture of video tapes became a major nuisance.

Polyester sheeting on the Jetty at Hugh Town

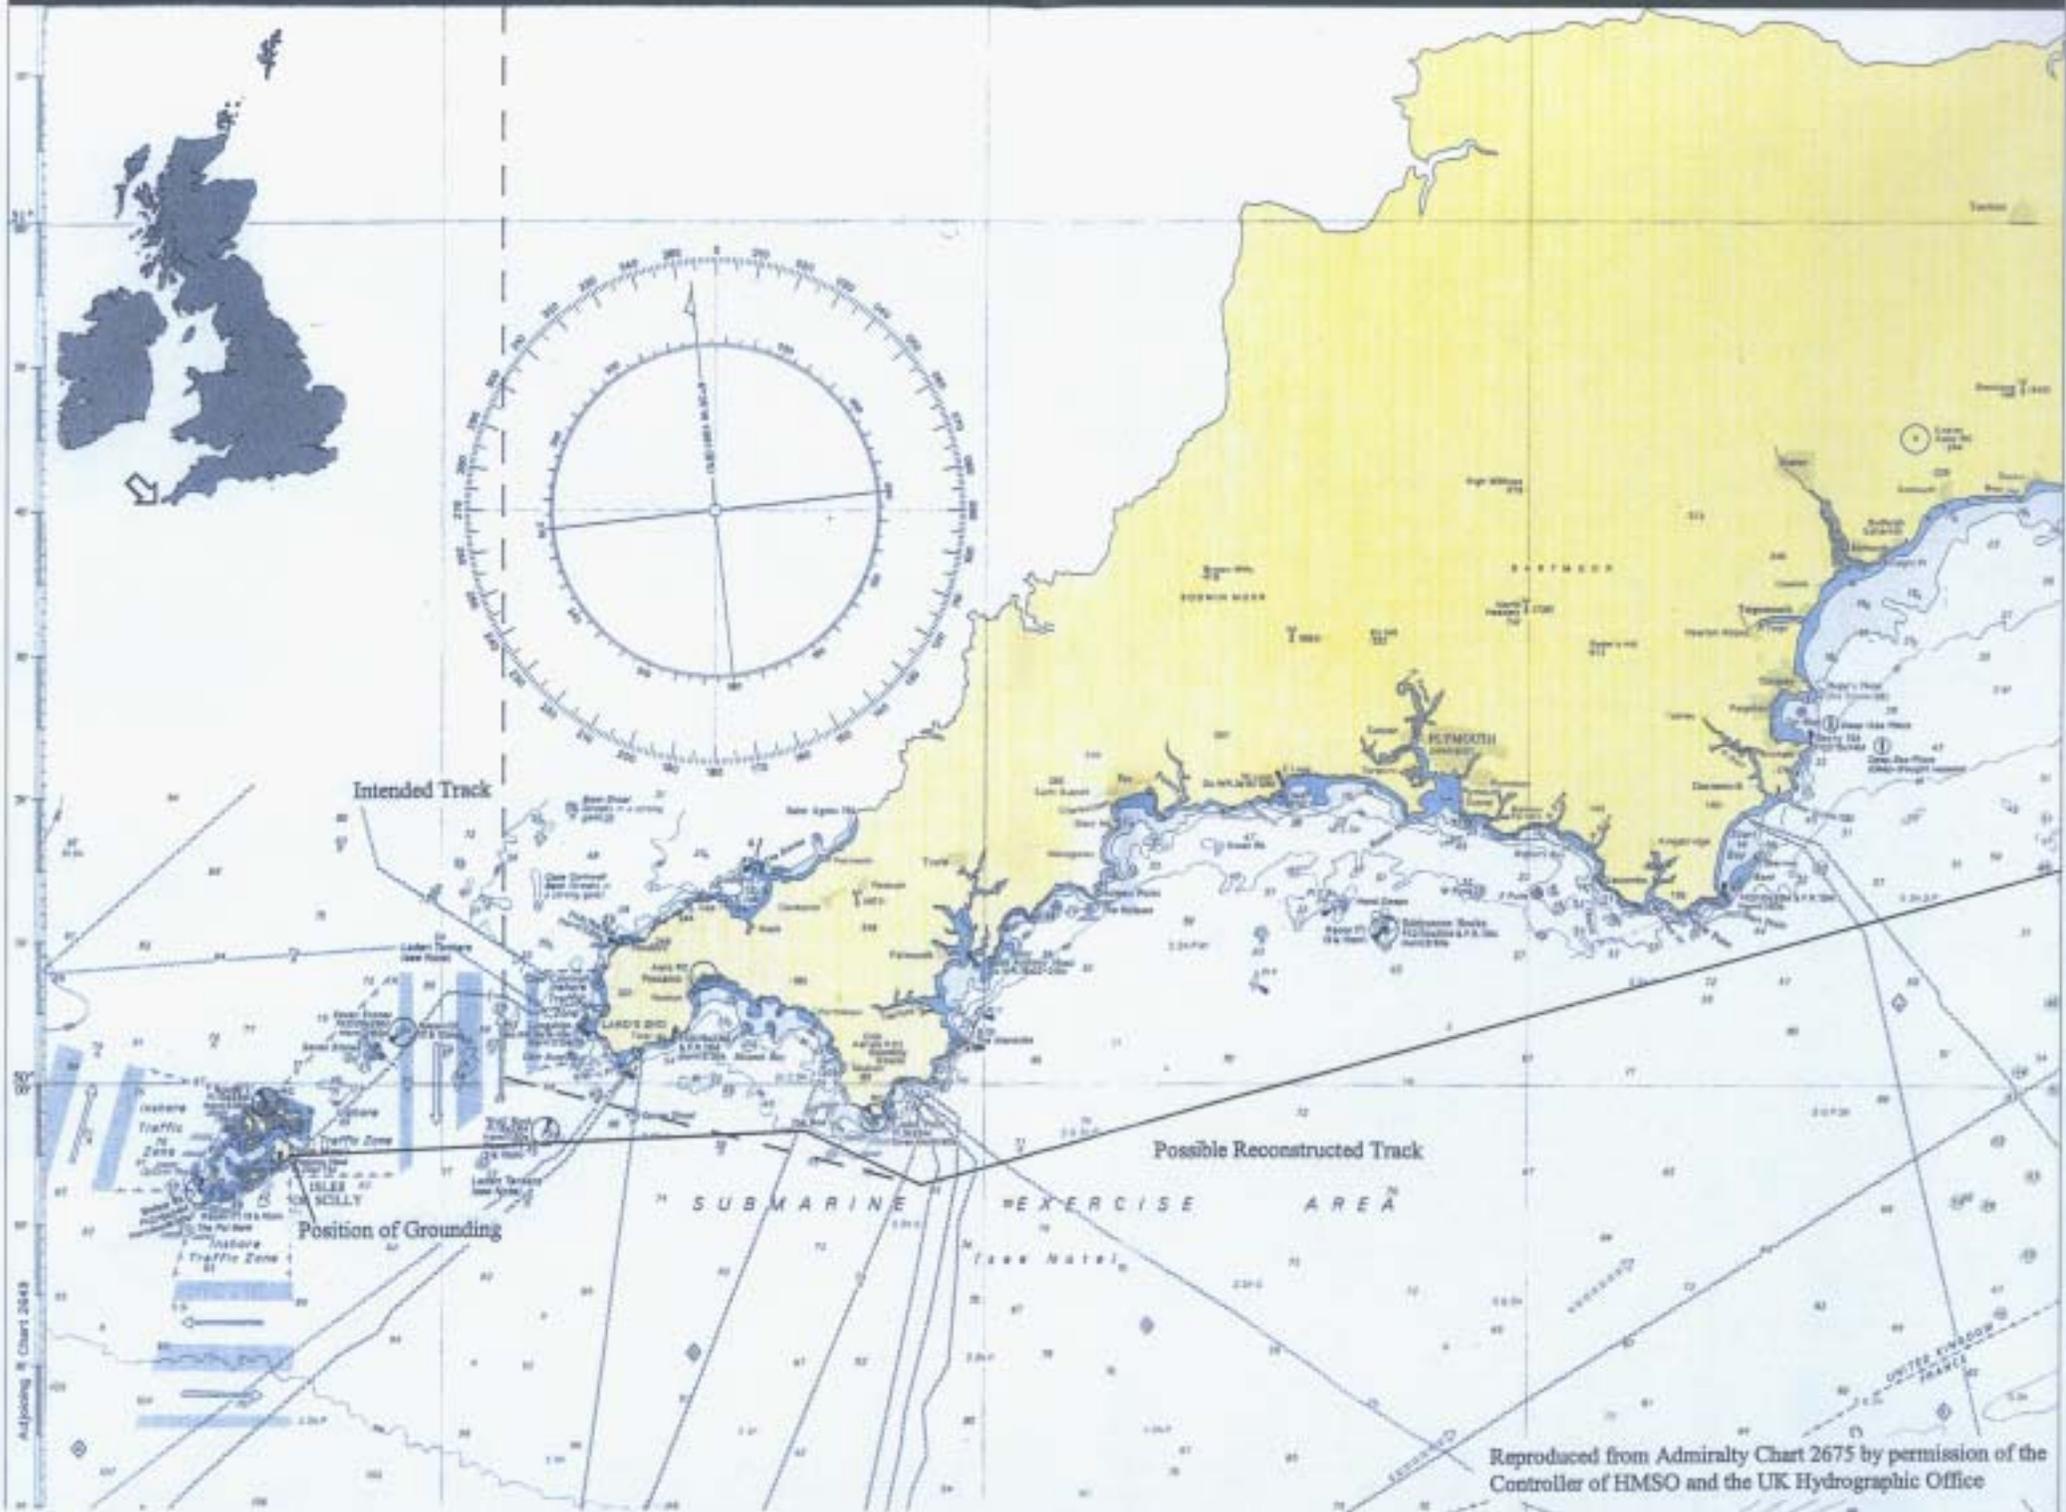
Figure 2: Actual and Intended Tracks of CITA

It appears most likely that the Mate did alter course to starboard to the new track south of Lizard Point. When he subsequently found himself to the north of the planned track he made an alteration of course to port. It is assessed he fell asleep at some time thereafter and before he made any further course adjustment.

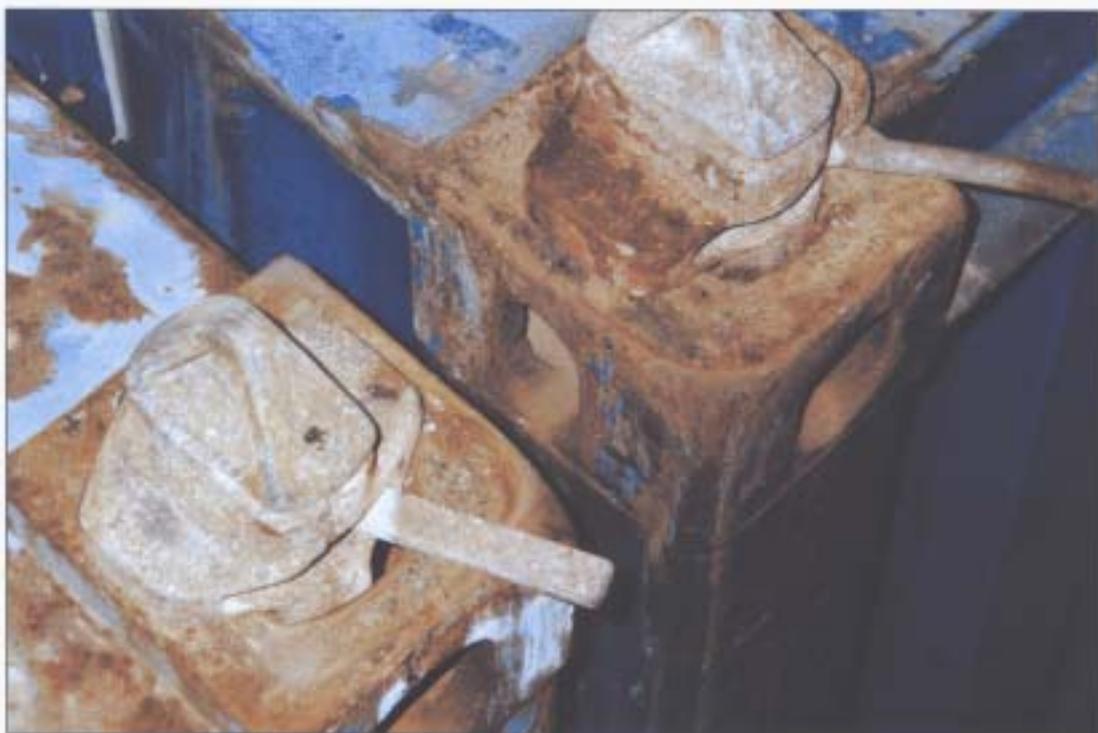
Figure 6a: Fixing and locking arrangement for container stowage

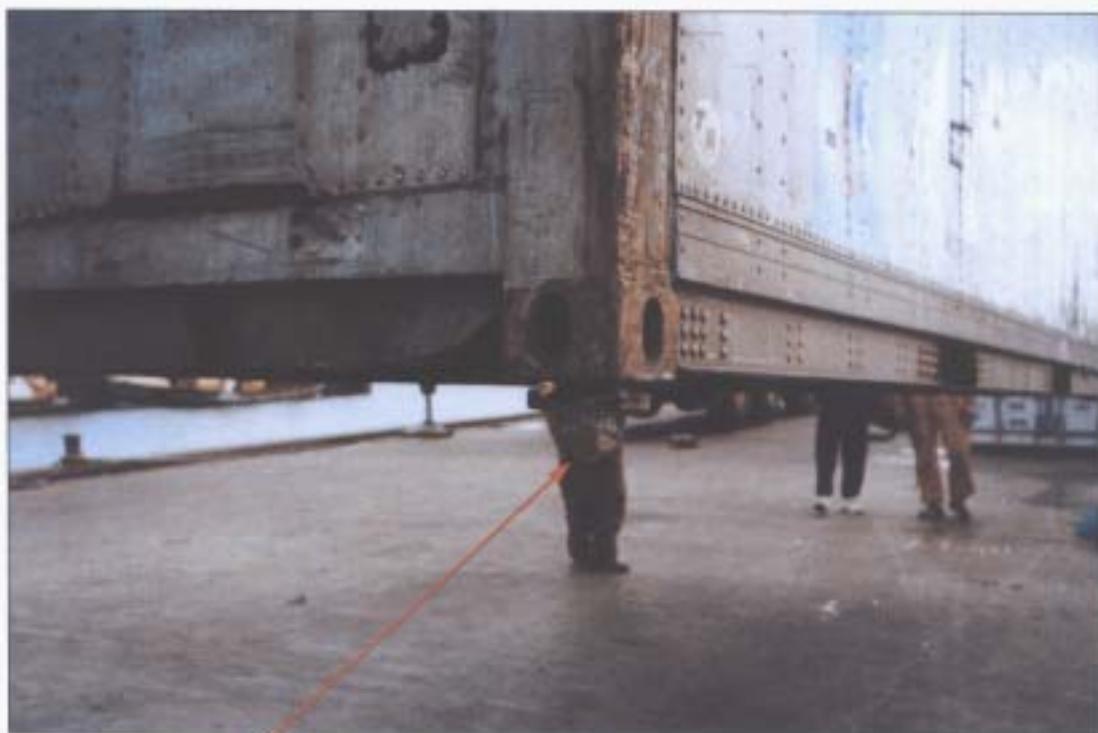
could reasonably be expected on passage to Belfast in the worst foreseen weather conditions. There is indisputable evidence to indicate that the twist locks on some of the recovered containers had been bent by the forces they were subjected to.

Figure 6b: Damaged container twist lock

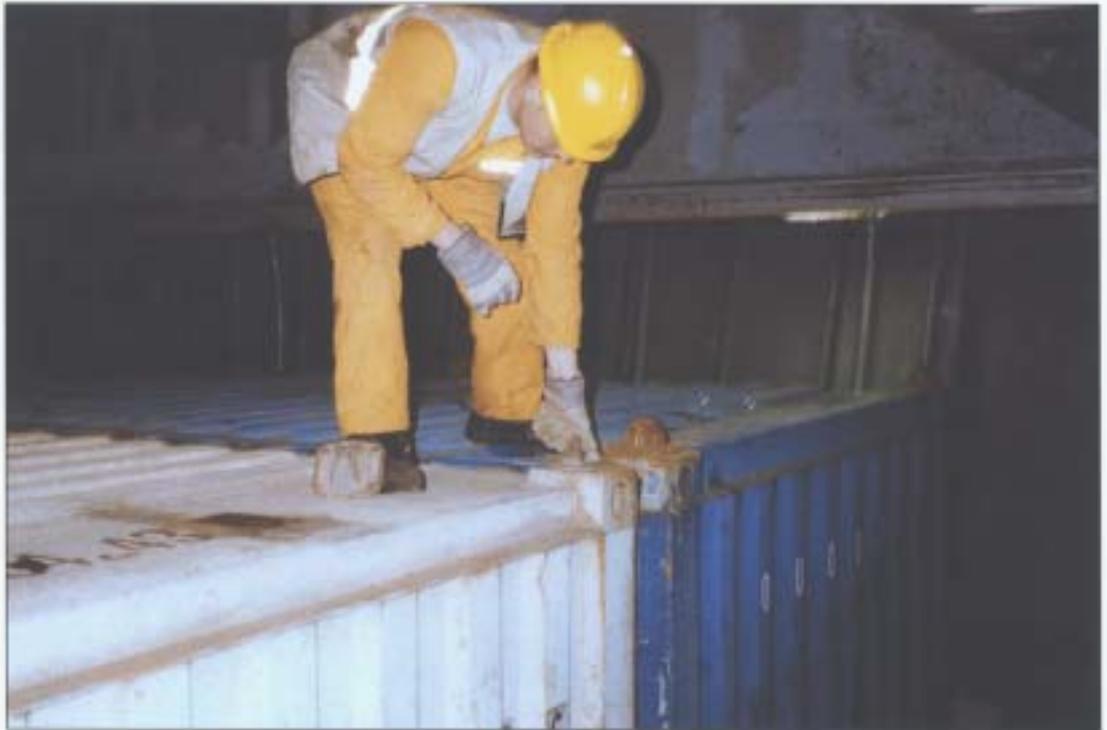
Figure 6c: Fixing and locking arrangement for container stowage

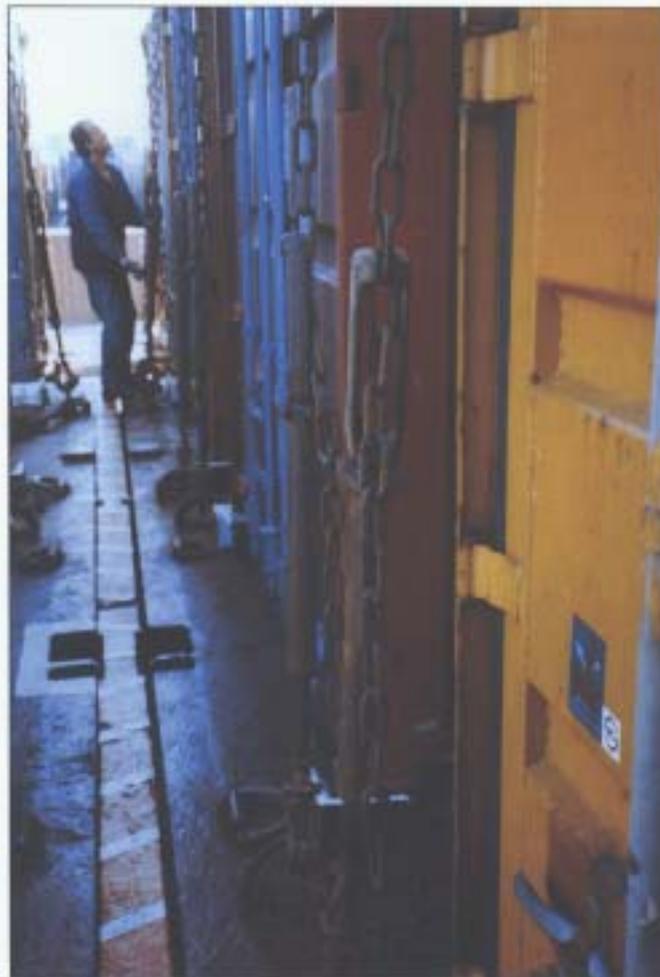
Figure 6d: Container lashings
