Report of the Chief Inspector
of Marine Accidents into the
Reopened Inquiry into the explosion
on the Motor Tanker

ESSO MERSEY

on 4 September 1991 resulting
in the loss of two lives

Marine Accident Investigation Branch
5/7 Brunswick Place
Southampton
Hants SO15 2AN

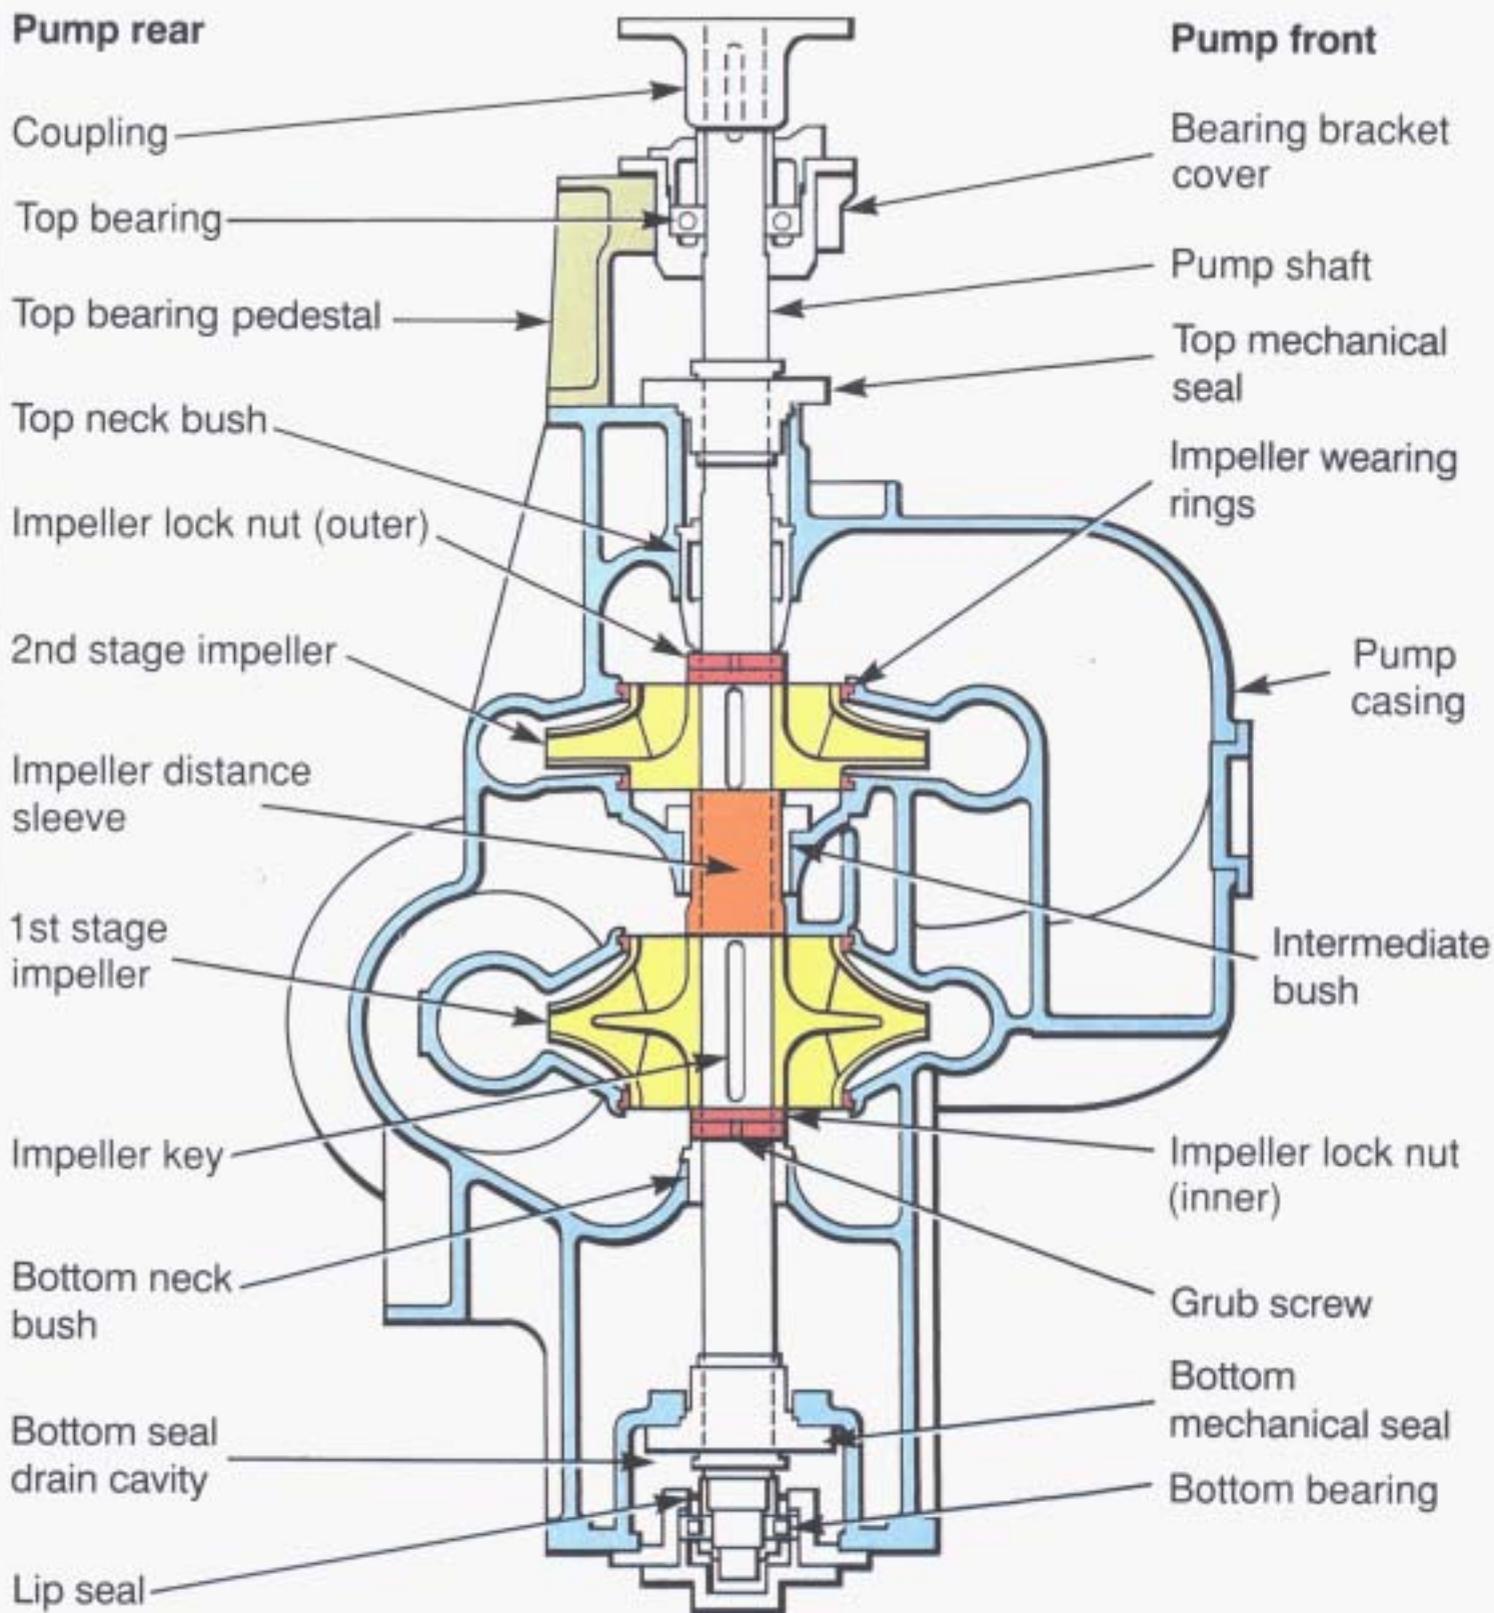
FIGURE

- 3.3 The contractor selected for the work was a firm which had been recommended to Esso's Operations Manager by the Technical Department at the Esso Milford Haven Refinery. Subsequent to meetings between Esso, their consultants and the contractor, the scope of work to be accomplished was agreed in an exchange of correspondence. The contractor did not recommend to shrink fit the impellers because of the need to adjust the position of the shaft to suit the casing and the need to remove one impeller to fit impeller wear rings and the intermediate bush housing after balancing and before finally fitting the assembly into the pump casing. However, Esso decided that the impellers should be an interference fit onto the shaft. Two drive keys were fitted to each impeller instead of one key as used in the original Weir design. Other features of the modification included: a new type of top and bottom pump seal; a stainless steel impeller distance sleeve with a sliding fit on the shaft which, like the original Weir design, was located in position by one of the impeller keys; an intermediate bush lined with "Deva" metal, a sintered bronze bush impregnated with carbon graphite. Like the original Weir design, the two impellers and impeller distance sleeve were secured in the correct position on the shaft by impeller nuts, (inner nuts). However the original design specified that the impeller nuts were locked tight by two grub screws located radially around each nut. With the modified design, the nuts were specified to be locked by locking nuts, (outer nuts), with an additional locking feature which comprised two grub screws positioned longitudinally through each outer nut and screwed against the face of the inner nut which is in contact with the adjacent face of the outer nut, (see Figure).

- 5.5 The same conclusion is reached with the grub screws. Examination in 1991 of the damaged No 4 cargo pump revealed that the two locking grub screws for the locknut of the first stage impeller, (the lower impeller), were missing therefore the material for these grub screws could not positively be identified. However, they were probably made in the same material as the grub screws which were found corroded and ineffective in the upper locknut of the second stage impeller and observed to be plain carbon steel. Corrosion of the grub screws could be expected since, like the plain carbon keys, they were in contact with stainless steel operating in an electrolytic solution.

- *The first stage impeller outer locking nut had backed off 7/32" from its mating nut. This locking nut should have been fitted with 2 locking grub screws. Both were missing. These may not have been fitted, or if fitted vibrated out and disappeared, or they were fitted and corroded away completely.*
