Report of the Chief Inspector of Marine Accidents
into the explosion on the Motor Tanker

ESSO MERSEY

on 4 September 1991 resulting
in the loss of two lives

Marine Accident Investigation Branch
5/7 Brunswick Place
SOUTHAMPTON
Hants SO1 2AN

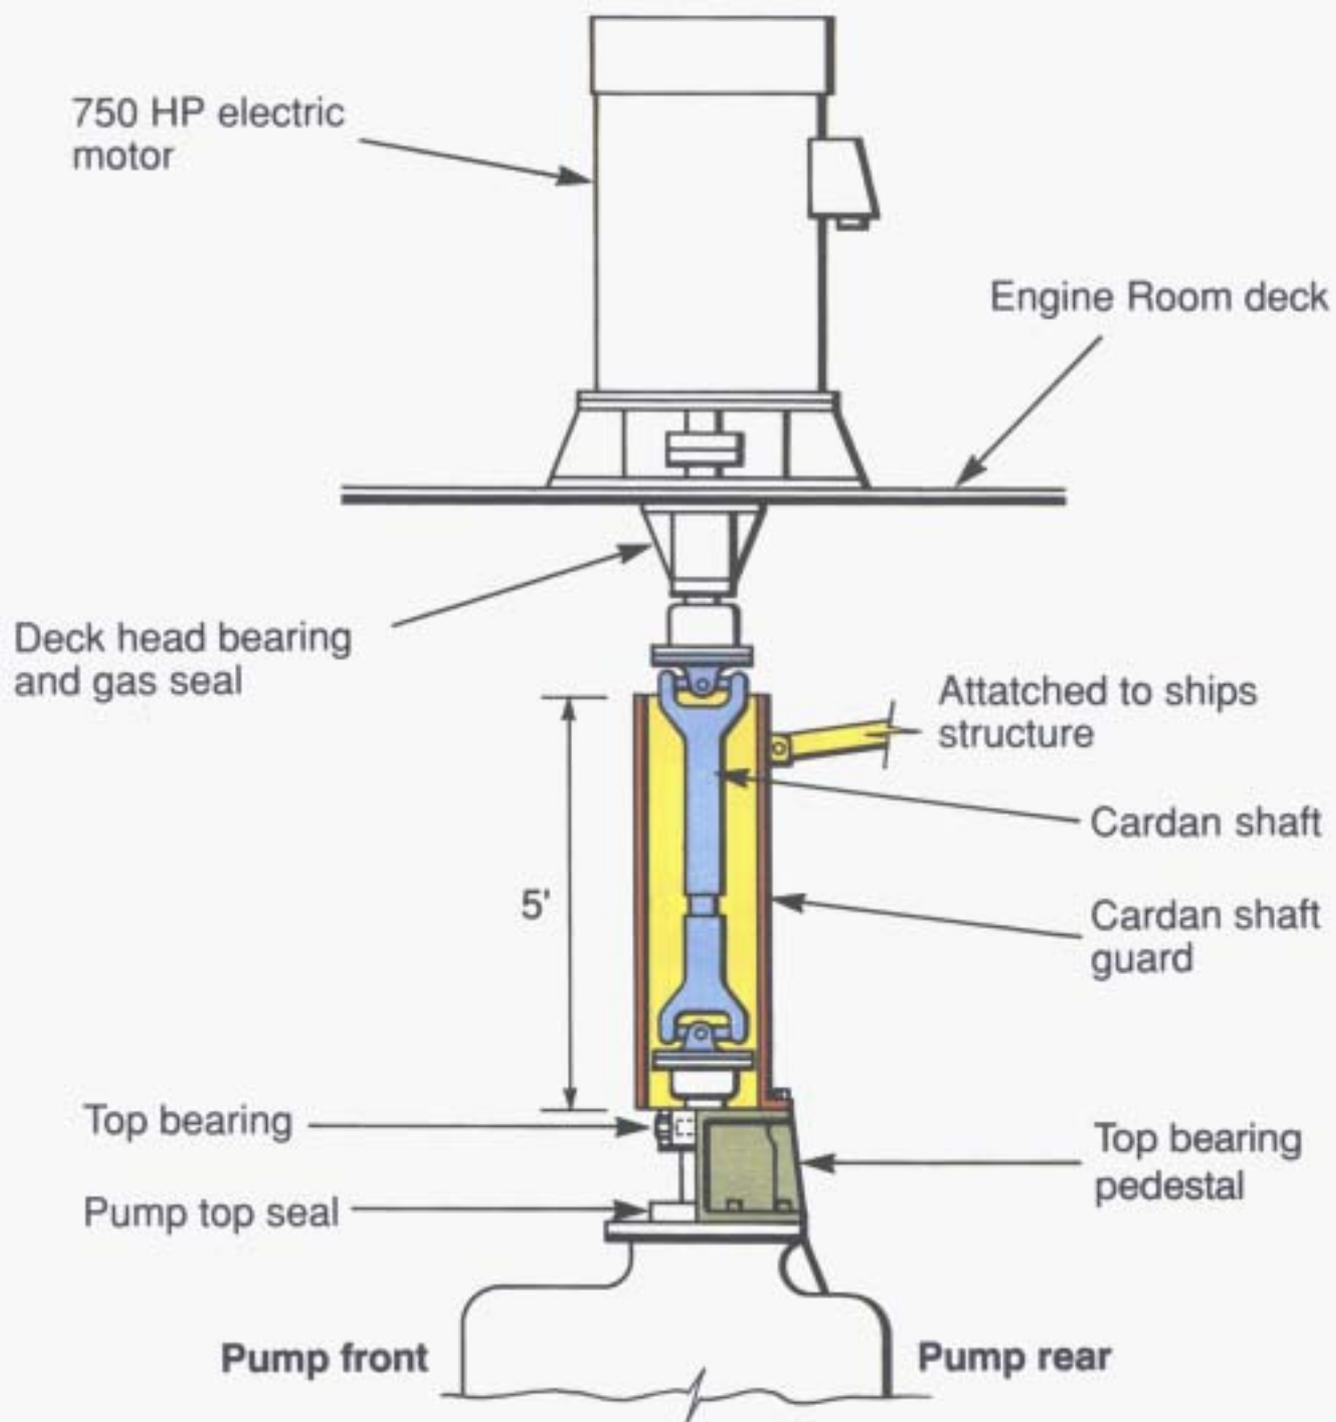
Cargo pump, Cardan Shaft and Guard

Relatively little external damage to the pump was visible but the preliminary examination identified the following points: (see Figures 3 and 4)

- Bottom mechanical seal leaking.
- Top mechanical seal totally failed.
- All 4 top bearing housing pedestal securing bolts missing.
- One locating dowel (outboard) inoperative and one very loose (inboard).
- Cardan shaft guard upper bracket securing bolt missing.
- Cardan shaft guard lower bracket failed.
- Cardan shaft guard securing bolts to pedestal, two missing with centre one loose.

The high vibrations in the machine were sufficient to loosen the bolts in the cardan shaft guard and the top bearing pedestal. It would appear that these bolts came out over a lengthy period of time with the last remaining bolt being the second from the starboard side.

The final bolt in the top bearing pedestal worked its way out allowing the pedestal to swing about the remaining dowel. This movement then shattered the seal secondary containment carbon and severely chipped the primary seal faces on both the top and bottom seal causing major seal leakage.

- Replace pedestal fixing bolts with studding and secure the studding using "loctite" adhesive. Ensure the studs are bottomed out in the holes. Use "nyloc" (self locking) nuts when attaching the pedestal to the pump body.
(Complete)

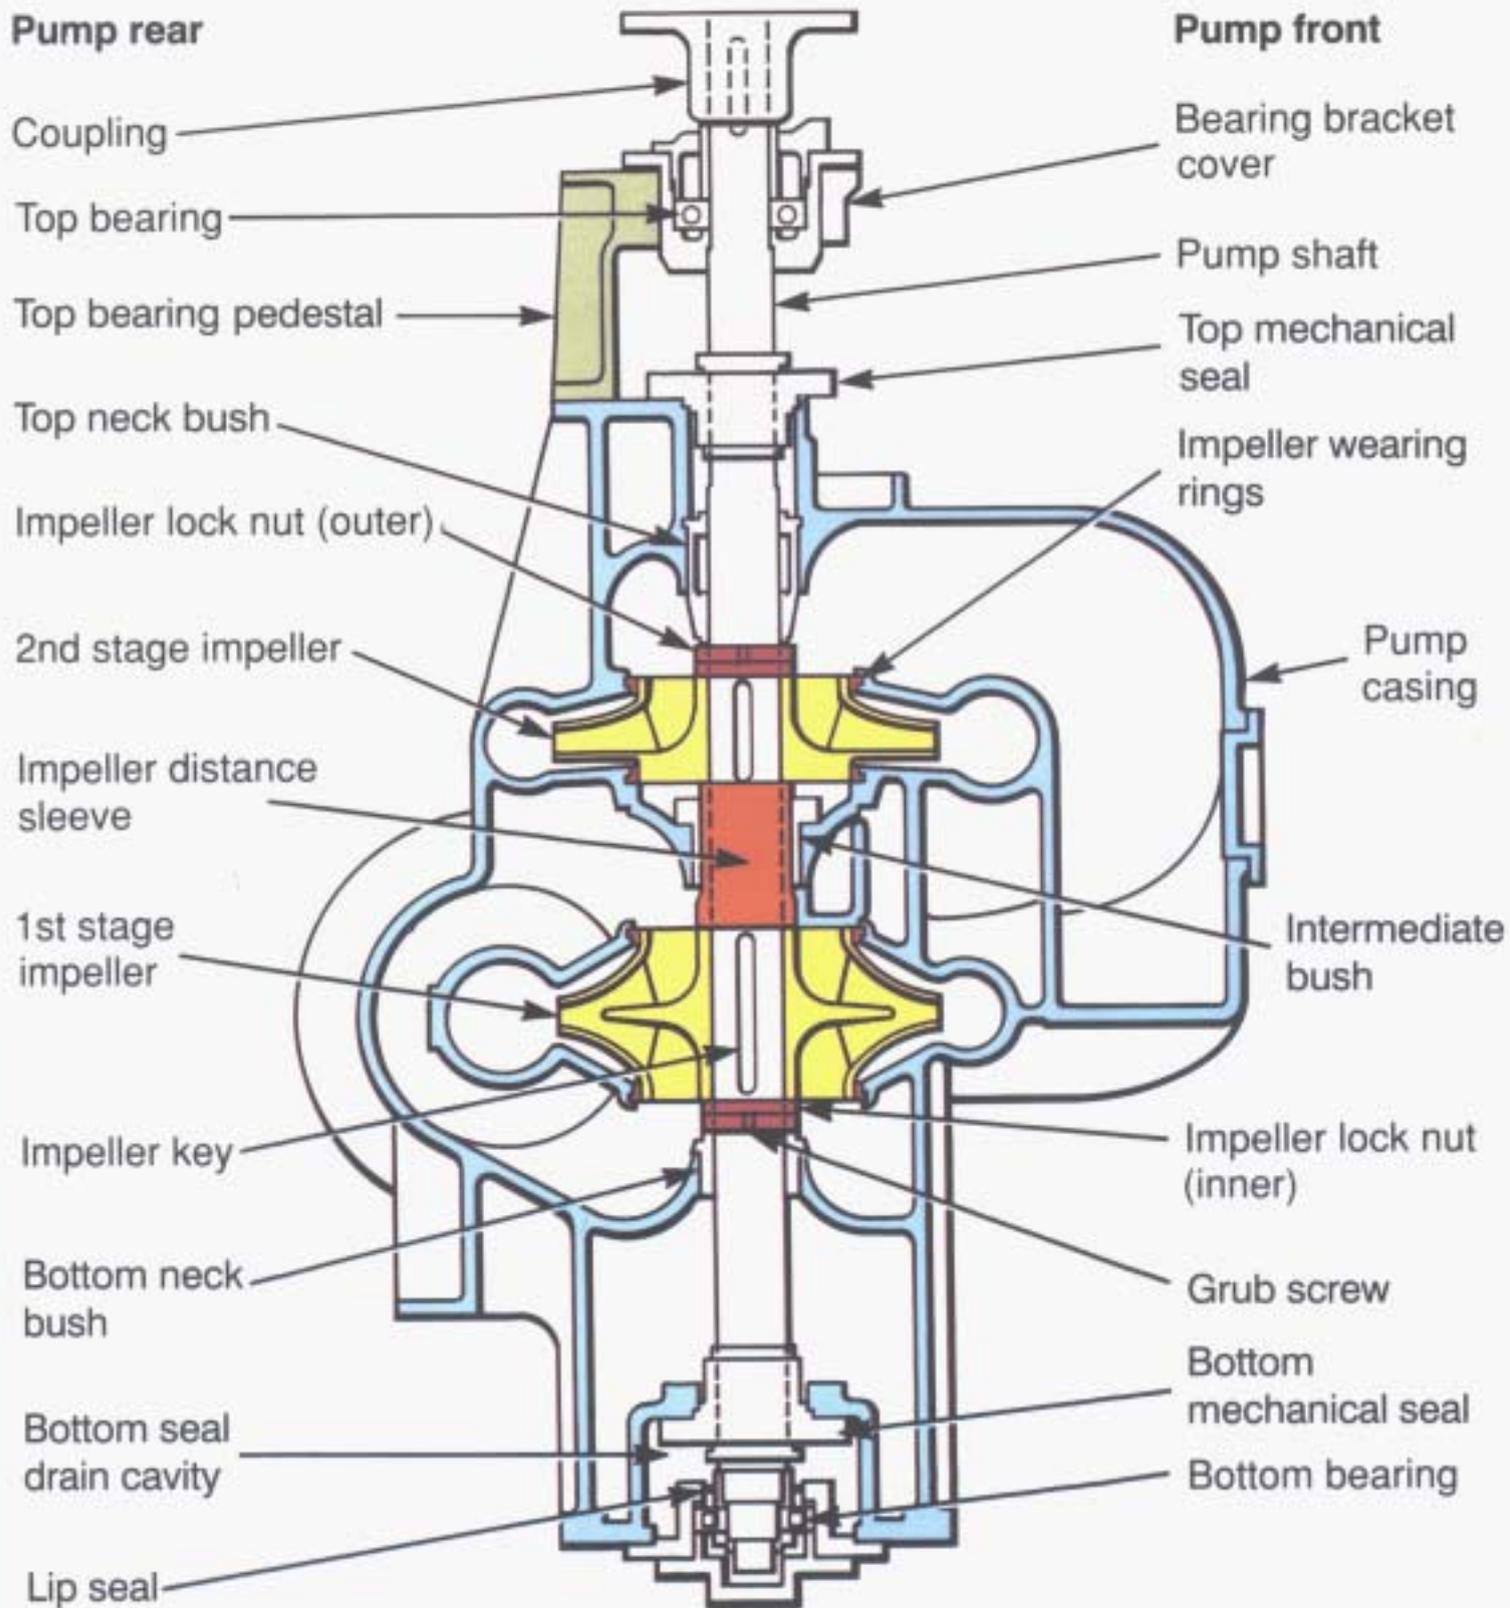
Cargo Pump in detail

- The top mechanical seal had totally failed. The primary seal had large pieces of its face material missing and some chips out of the carbon face. The seal face was a hard compound sprayed on to a brass alloy base and machined/lapped flat.

- The secondary seal had broken up and disappeared completely.
- The seal sleeve had been rubbing on the seal plate and seal carrier causing heavy grooving in the sleeve. Some of the seal drive screws had worked loose and one had dropped out, this screw was found on the pump casing while the pump was in the ship.

- The bottom bearing was in a heavily rusted condition and the outer track was running $\frac{1}{4}$ " axially out of position to the inner race. The grease point was fitted and although no lubricant remained on the bearing itself, grease was found in the "O" ring groove in the bearing end cap. This indicated that the bearing was grease packed during assembly on the last occasion that the bearing had been replaced/renewed. The threaded plugs were found to be missing from the two tapped holes situated at the top of the bearing carrier. Brass sleeves in these holes formed an isolation barrier between the lubrication groove and tapped hole. These holes facilitate drifting the outer bearing clear of the carrier. The outer bearing cavity would have had to be full of grease and under pressure before any lubricant could have escaped through these openings.

- The "O" ring seal to the bottom bearing cover was not fitted.
- The lip seal protecting the bottom bearing had swollen when the bottom seal had leaked product onto it and caused it to fail.

- The bottom mechanical seal was severely damaged with sections of the primary seal face chipped off. The secondary containment carbon seal had totally disintegrated and particles of carbon were found in the bottom seal leak chamber. All drive screws etc were intact in this seal.

- The first stage impeller outer locking nut had backed off $\frac{7}{32}$ " from its mating nut. This locking nut should have been fitted with 2 locking grub screws. Both were missing. These may not have been fitted, or if fitted vibrated out and disappeared, or they were fitted and corroded away completely.

The lower wear ring on the 2nd stage impeller had come off the impeller and was resting in the intermediate piece. With this ring off there was a clearance of $\frac{7}{16}$ " between impeller and case wear ring.

The lower impeller, 1st stage outer locknut came loose and backed off. This allowed the locknut holding the 1st stage impeller to free sufficiently to allow the 1st stage impeller to move on the shaft and allow free movement of the interstage sleeve between the impellers. The cause of the initial slackness in the impeller outer locking nut was not positively identified. However, it was noted that the locking grub screws were absent and that the products of corrosion was evident in the 1st stage impeller lock nut grub screw holes. The debris found in the threaded holes was such that it was not possible to say whether grub screws had been refitted after a 1989 overhaul and the material had corroded away or simply that the screws had not been replaced.

The resultant mechanical looseness in the rotating unit made it less stiff and brought the critical running speed of the rotor close to the actual running speed of the machine. This looseness caused imbalance in the rotor and increased the vibration levels. Discolouration of the faces of the locknuts indicated that they had been loose for some time.

One of the top bearing pedestal dowels was not fitted; this was likely to mean that the pump shaft was not running through the centre of the casing. This being the case it caused instability through the centre bush and affected wear ring clearances, thus further increasing vibrations.

The lower wear ring on the 2nd stage impeller most likely came into contact with the casing wear ring, heated, expanded and started to move off the impeller. This caused further rubbing and heat until it finally came off and rested in the intermediate piece. This put the rotor further out of balance.

- Identify and install mechanical seals with secondary containment seals and seal leak detection alarms. As part of this work, review the continued use of seals with hard coat sprayed faces in this service. If practicable, the alarm should be routed to the cargo control room.
(Actioned)
