**REPORT OF THE INVESTIGATION  
INTO THE LIFEBOAT ACCIDENT ON BOARD  
mv HOEGH DUKE  
AT SURABAYA, SUMATRA  
ON 20 AUGUST 1992**

The accident was investigated by the United Kingdom Marine Accident Investigation Branch (MAIB) on behalf of the Cayman Islands Authorities. This report is published also on their behalf.

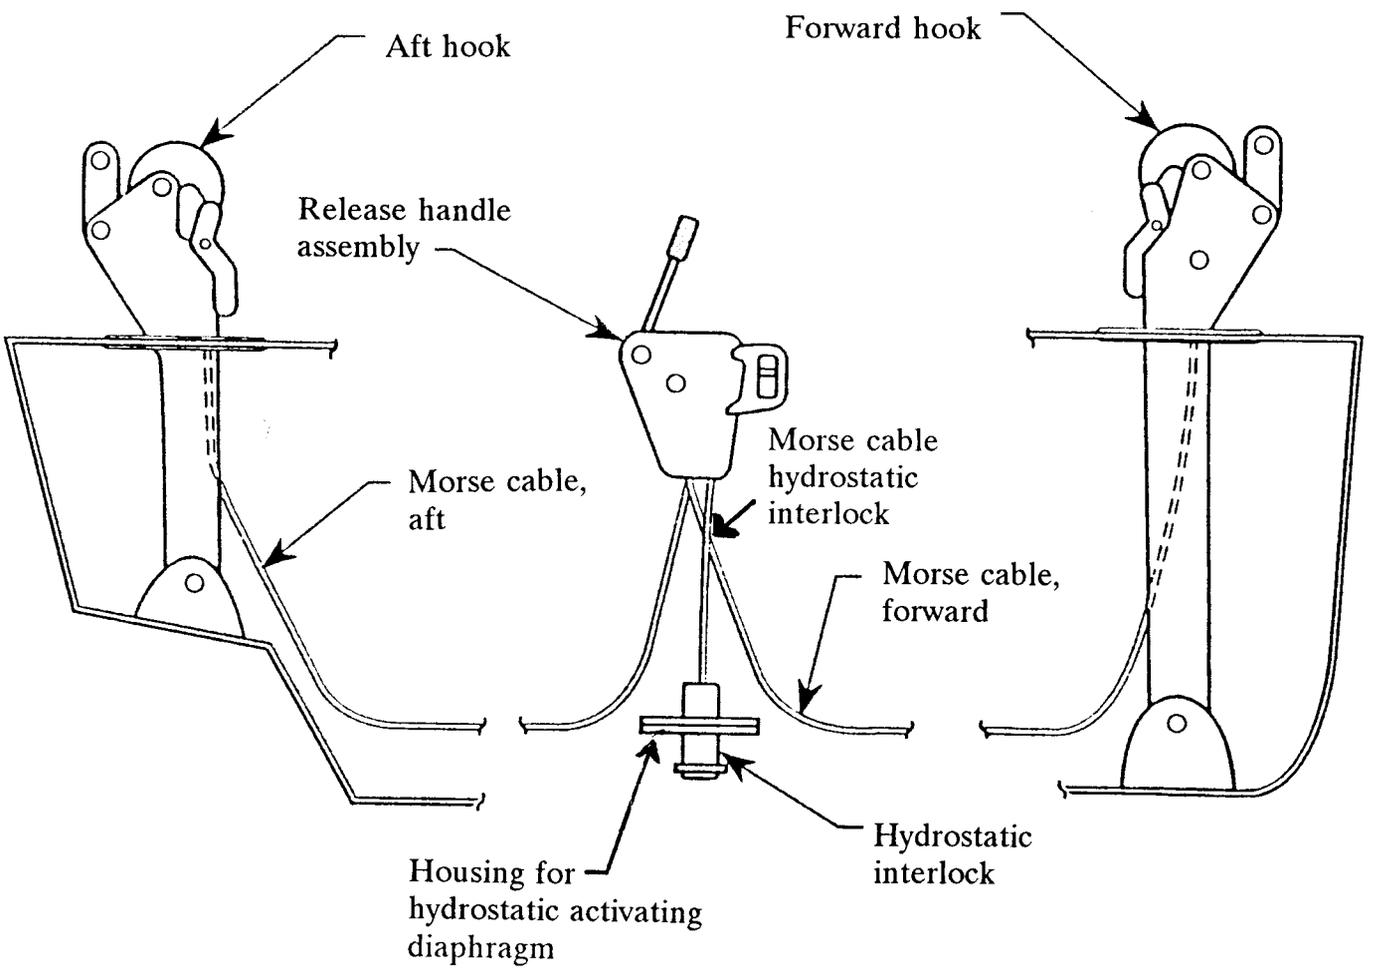
FIGURE 1

The general arrangement of the release mechanism assembly is shown in Figure 1. To release the hooks from the fall wires, the release handle of the release handle assembly, which is situated at the coxswain position inside the enclosed lifeboat, is pulled aft to operate the forward and aft morse cables simultaneously causing the hooks to swivel into the open position. The release hook assembly is shown at Figure 2.

Release mechanism general assembly

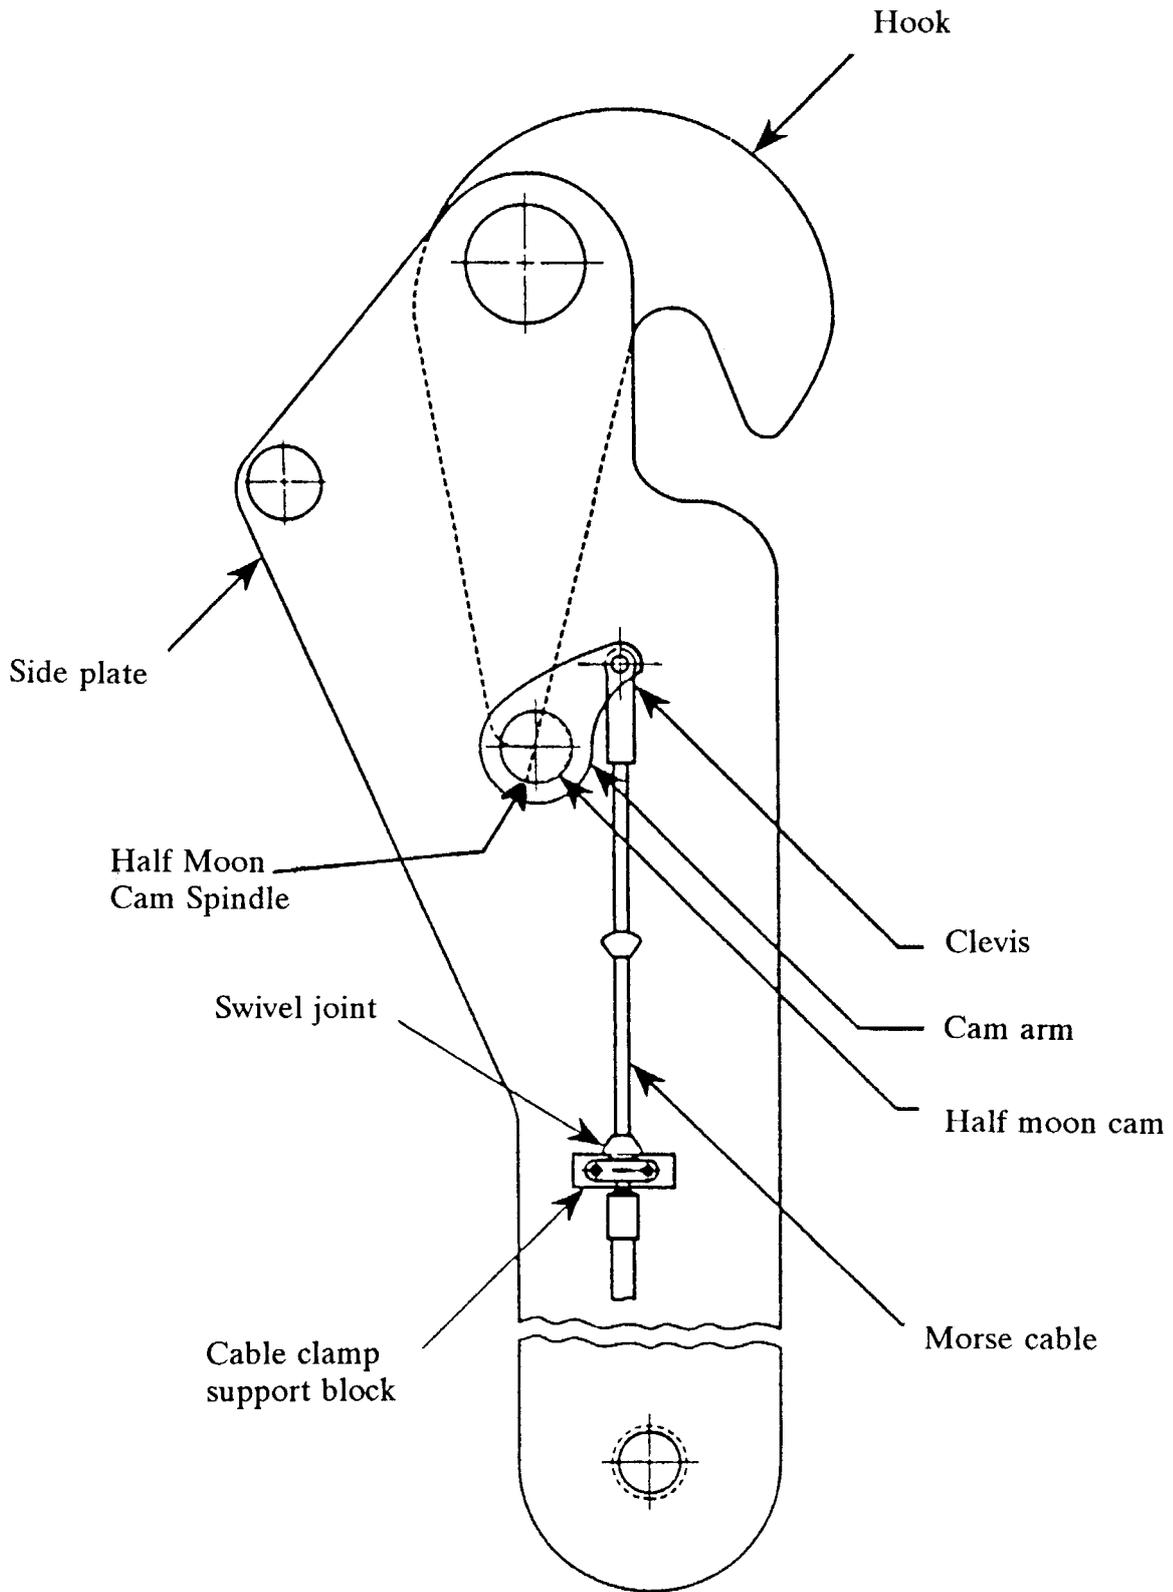
FIGURE 2

Release hook assembly

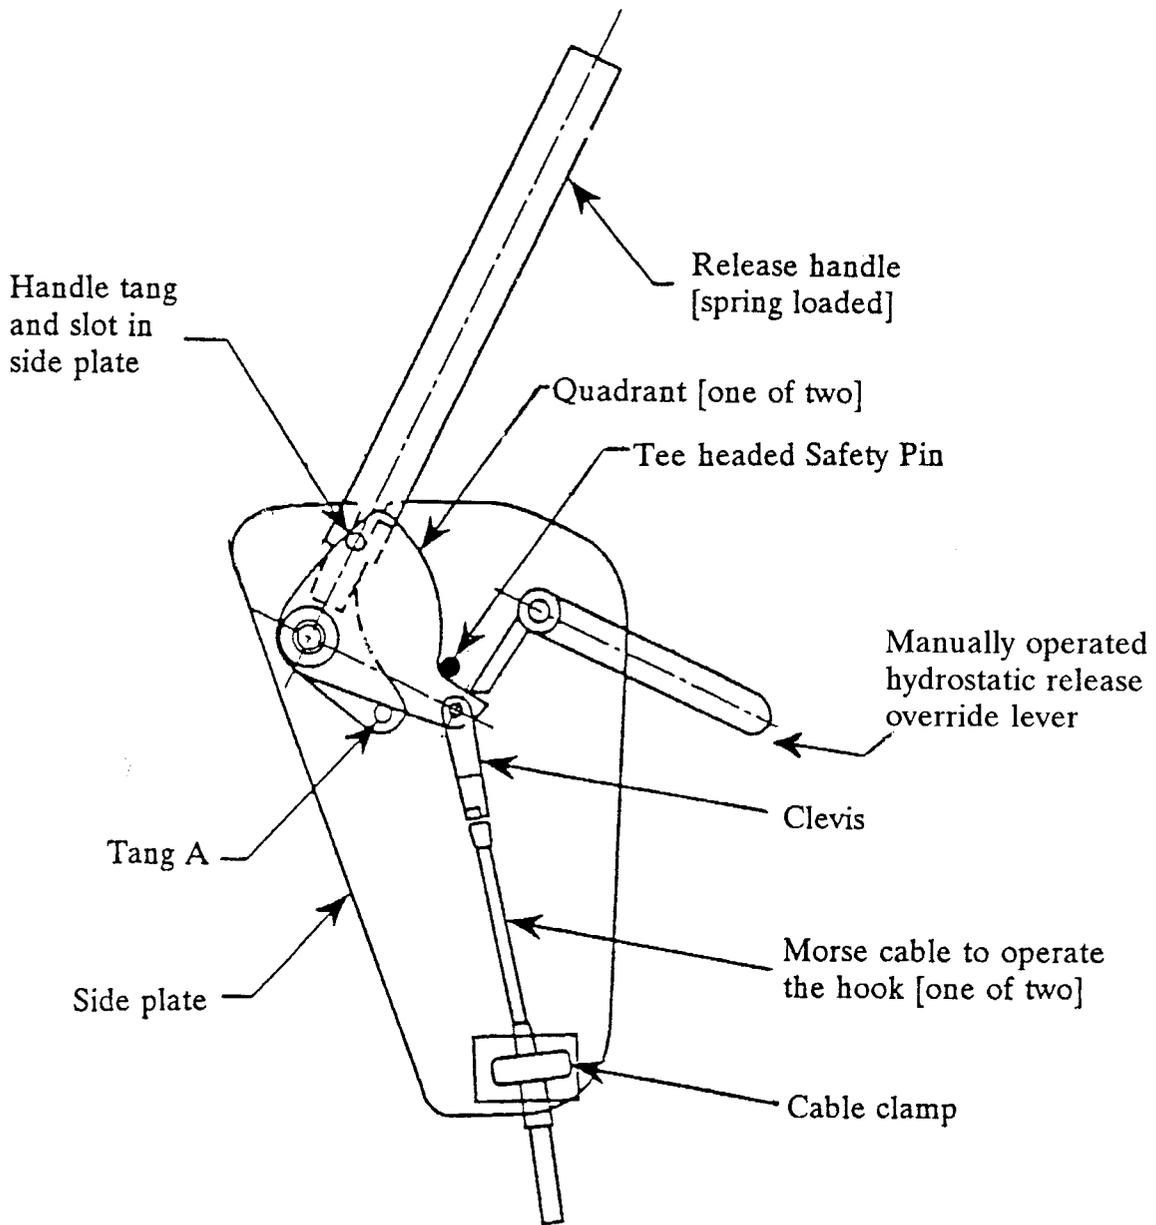
FIGURE 3

The release handle assembly illustrated in Figure 3 incorporates three safety devices to prevent inadvertent release of the hook.

Release handle assembly with safety pin location

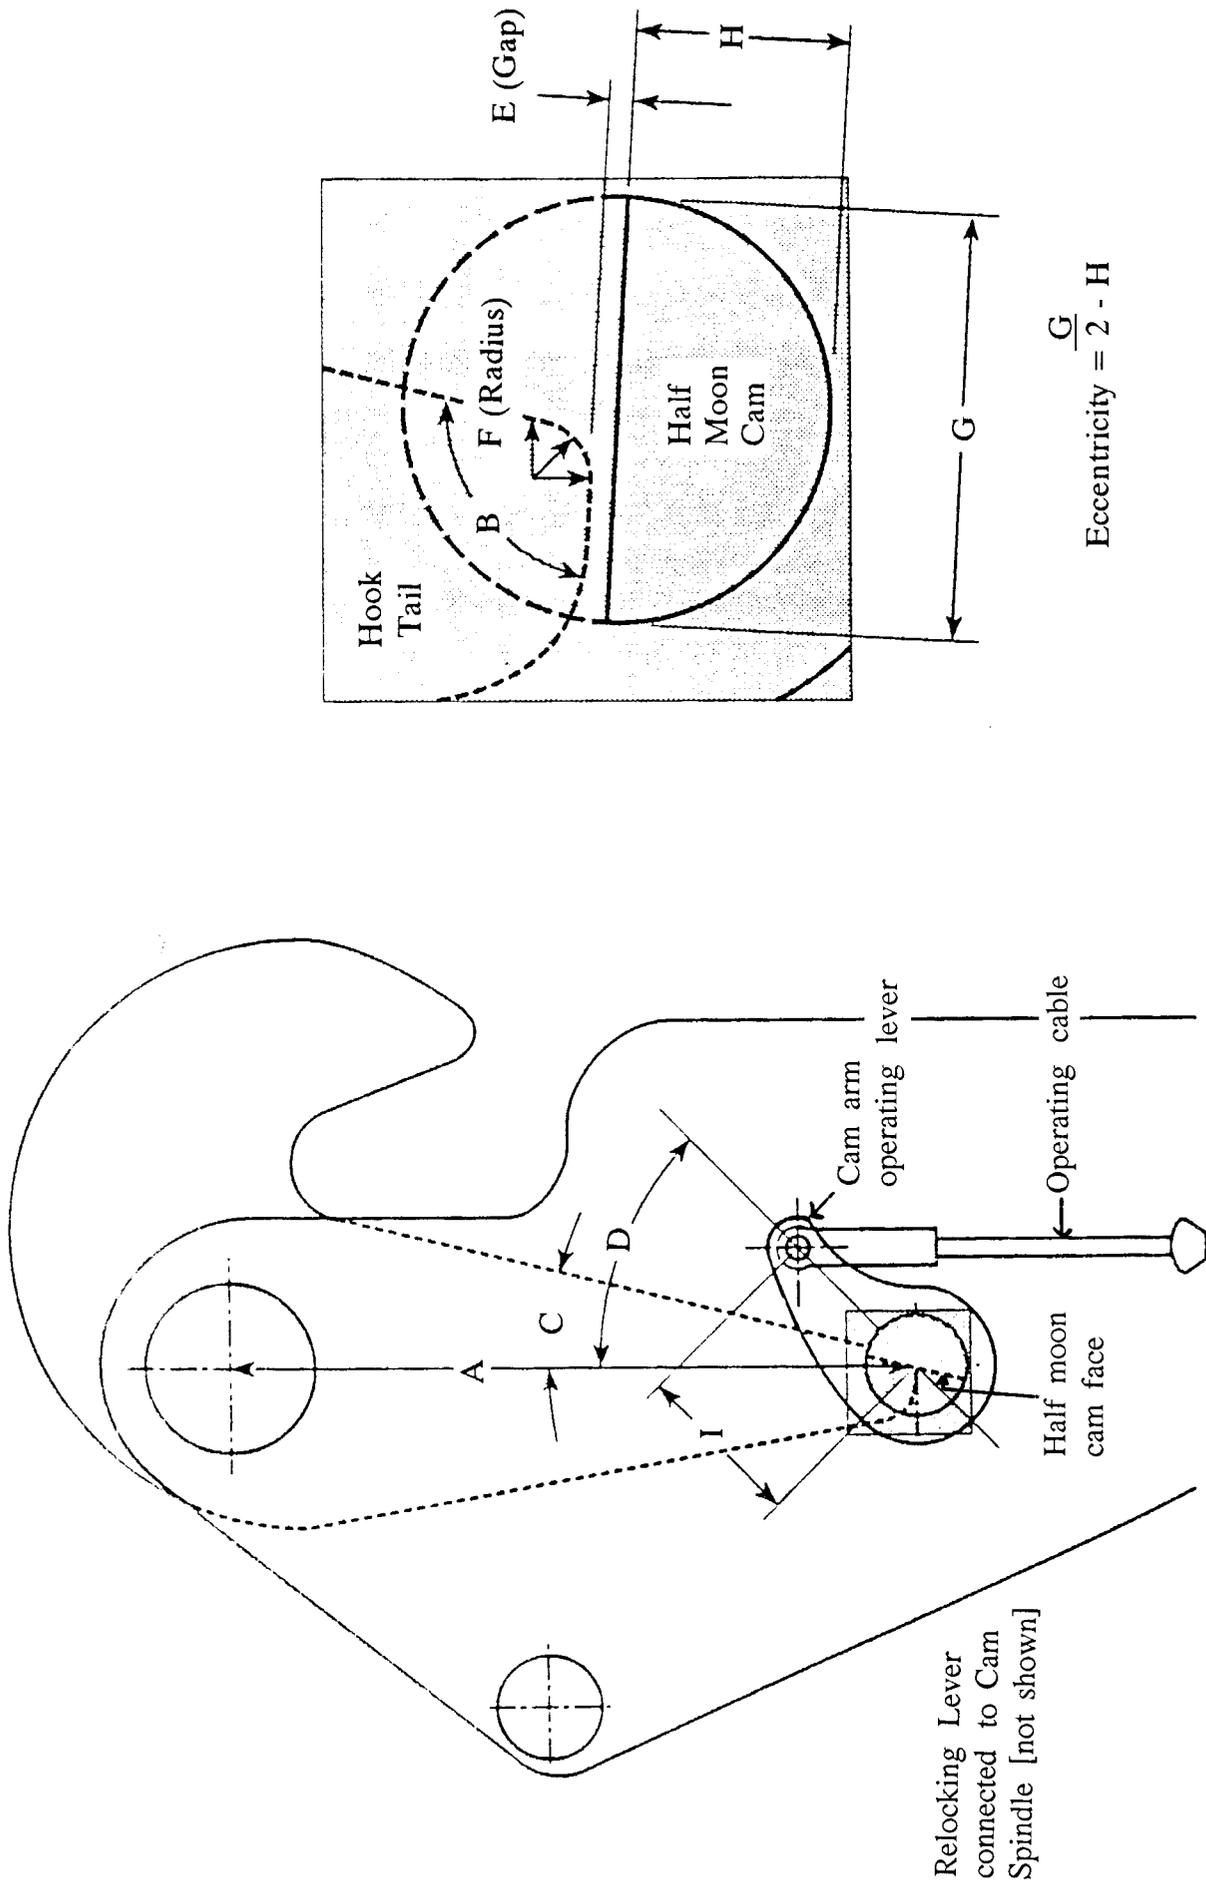
FIGURE 4

Details of the geometric relationship between the tip of the hook and the half-moon cam which constrains it in the locked position are illustrated in Figure 4. Key dimensions are the gap between the hook and cam (in the open position), eccentricity of the cam, and the radius of the tip of the hook. These dimensions control the nature of the interaction forces between the hook and the cam (Figure 5).

Release hook dimensions

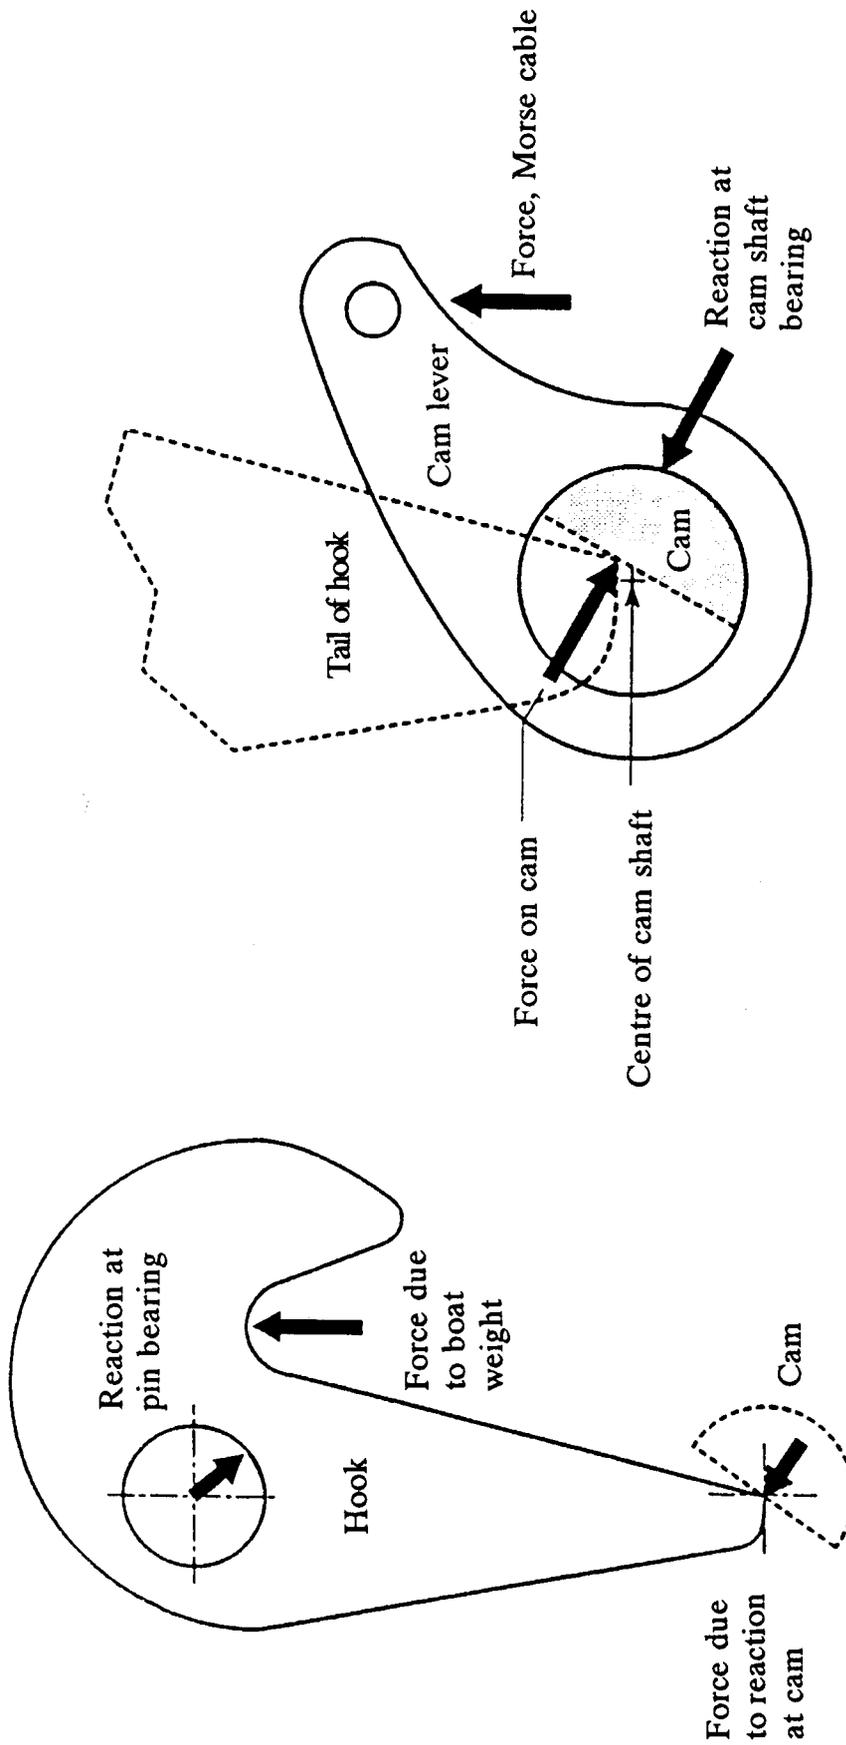
FIGURE 5

Chevron Tankship Company of San Francisco commissioned a comprehensive investigation into the mechanics of this type of release mechanism as a result of a similar accident on the CHEVRON PERTH in 1991. It was found that the compressive load on the operating cable increased in proportion to the cam angle with respect to the hook tail (Figure 5).

Free body diagrams of release hook and half moon cam, shaft, and lever

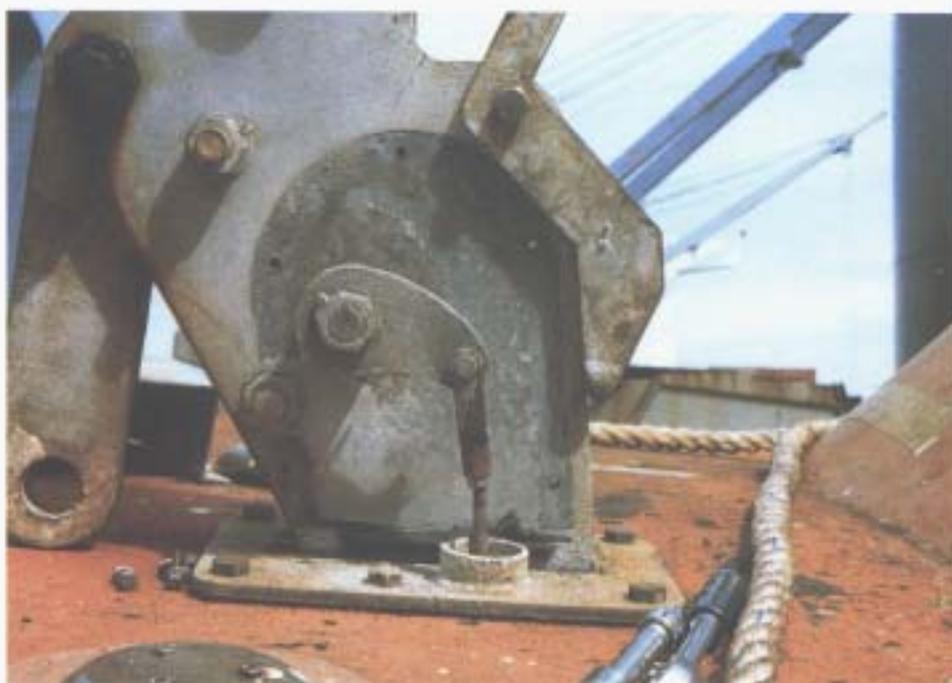
FIGURE 6

6. The "Morse" operating cable connecting the release handle to the aft hook was slightly bent at the screwed rod indicating that an undue compressive force had acted on the cable at some stage, (Figure 6). The inner operating cable was partially seized in its sleeve. The reason for seizure was investigated by consultants employed by Leif Hoegh who found that at the hook end section of the cable, the crimped mild steel end fitting and the clevis fork were heavily corroded, with a tendency to cracking of the former. It was confirmed using a stereo microscope that deposits consisting of a mixture of salt and corrosion products were present on the inner operating cable, inside the support tube and inner plastic liner. Pitting corrosion on the inner cable was evident but considered negligible. Tests confirmed that the cable was made of authentic stainless steel.

Aft hook side view cock position 90°

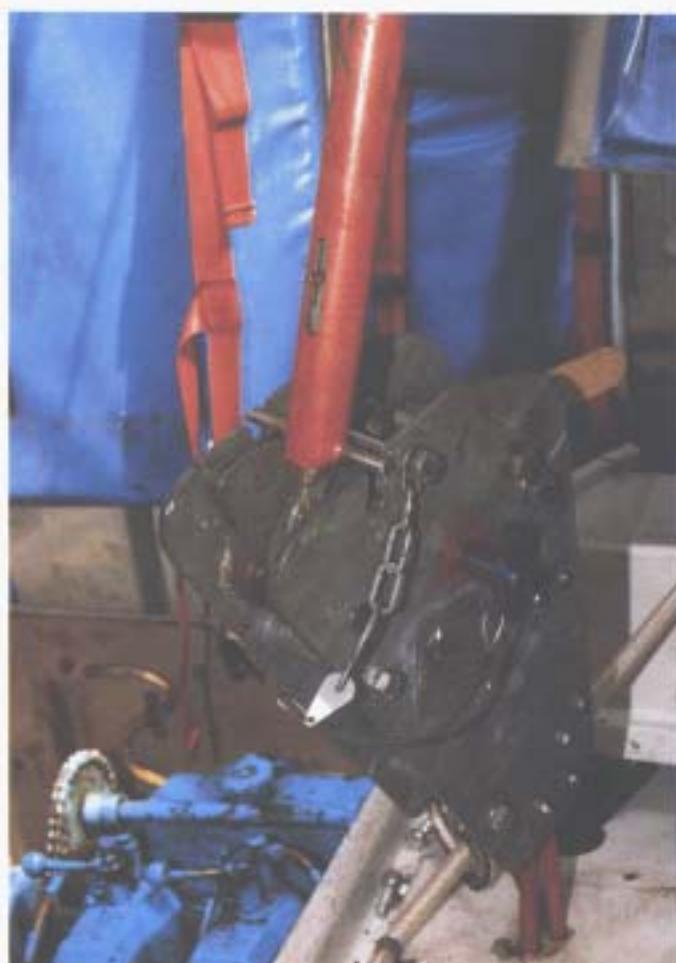
FIGURE 7

8. In Singapore, the Tee-headed safety stop pin on the release handle unit was found to be fully housed and undamaged, but it was deduced that because of the relative position of the pin and operating quadrants the pin could only have been partially inserted before the accident, removed subsequent to it and then later re-inserted fully. Pin removal probably took place during the inspection in Surabaya (Figure 7).

Release handle assembly pin fully home  
(as found by Inspector)
