Report of the Investigation into the
over-pressurisation of a cargo tank
on the Oil Tanker

MOBIL PETREL

at Fawley Oil Terminal
on 7 November 1989

Marine Accident Investigation Branch
5/7 Brunswick Place
SOUTHAMPTON
Hants SO1 2AN

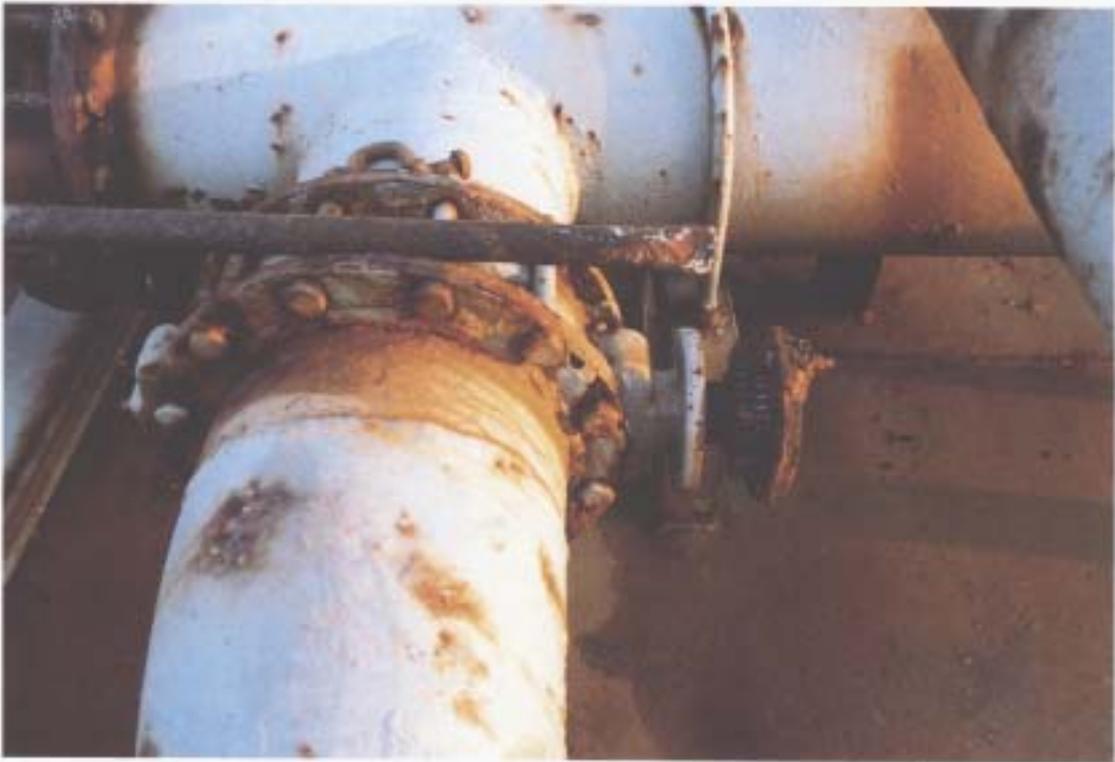
Fig 3A. View of No 2B Centre Cargo Tank Inert Gas Branch Valve

The hand wheel and gear mechanism had been replaced by a hand lever on the I.G. branch valves on Number 2B centre and Number 1 starboard wing cargo tanks. [Fig 3]

In Rotterdam, the hand lever on the Number 2B centre cargo tank valve had been broken and its open and closed position was not obvious.

The hand lever on the valve on Number 2B centre cargo tank had corroded to a point of failure with disastrous consequences. Ship's staff were negligent in not reporting the defect to Shore Management and for not ensuring that an effective repair was made before the valve was used in a cargo operation.

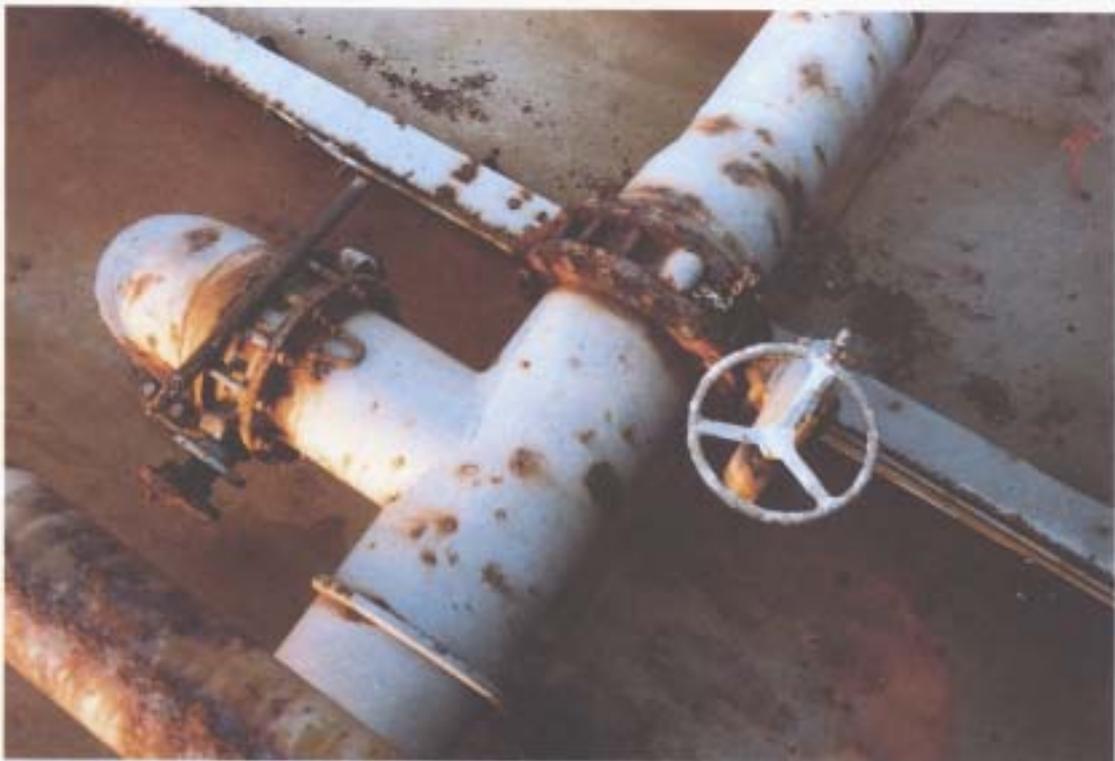
Fig 3B. Different View of No 2B Centre Cargo Tank Inert Gas Branch Valve
