Report of the Investigation  
into the Lifeboat Accident on  
**PRIDE OF HAMPSHIRE**

on 25 September 1994

Marine Accident Investigation Branch  
5/7 Brunswick Place  
SOUTHAMPTON  
Hants SO15 2AN

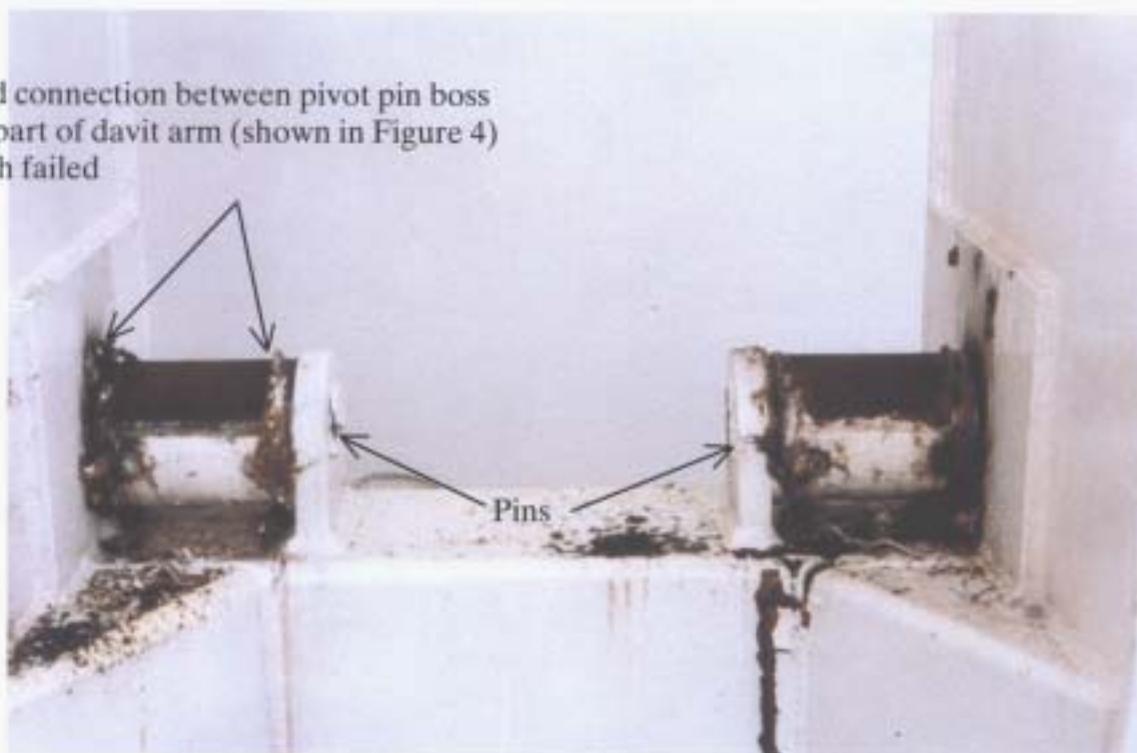
FIGURE 3

The welded joint connecting the lower end of the forward davit arm to the pivot pin boss appeared defective. Discolouration of the cracked surface indicated that the weld was cracked before the accident. Sections of the weld run showed lack of penetration (see Figures 3 and 4).

Visual examination of the pivot pin boss welds indicated that they were of inferior quality, lacking in penetration and root fusion over part of their length. The appearance of the fracture surfaces suggested that the weld on both pivot pin bosses had failed by ductile tearing due to overloading.

Although these fillet welded joints had suffered damage subsequent to failure of the suspension link, it was apparent that the quality of the welded joints was substandard because of incomplete penetration and lack of fusion.

Weld connection between pivot pin boss and part of davit arm (shown in Figure 4) which failed

No 2 forward davit pivot pin bosses indicating rupture along welded joint

This investigation indicates that random testing of structural welds is ineffective in exposing critical defects. Important applications, such as the fillet welded joints connecting the davit arm to the pivot pin bosses, should be specifically tested by non-destructive methods (magnetic particle inspection) for the presence of defects.

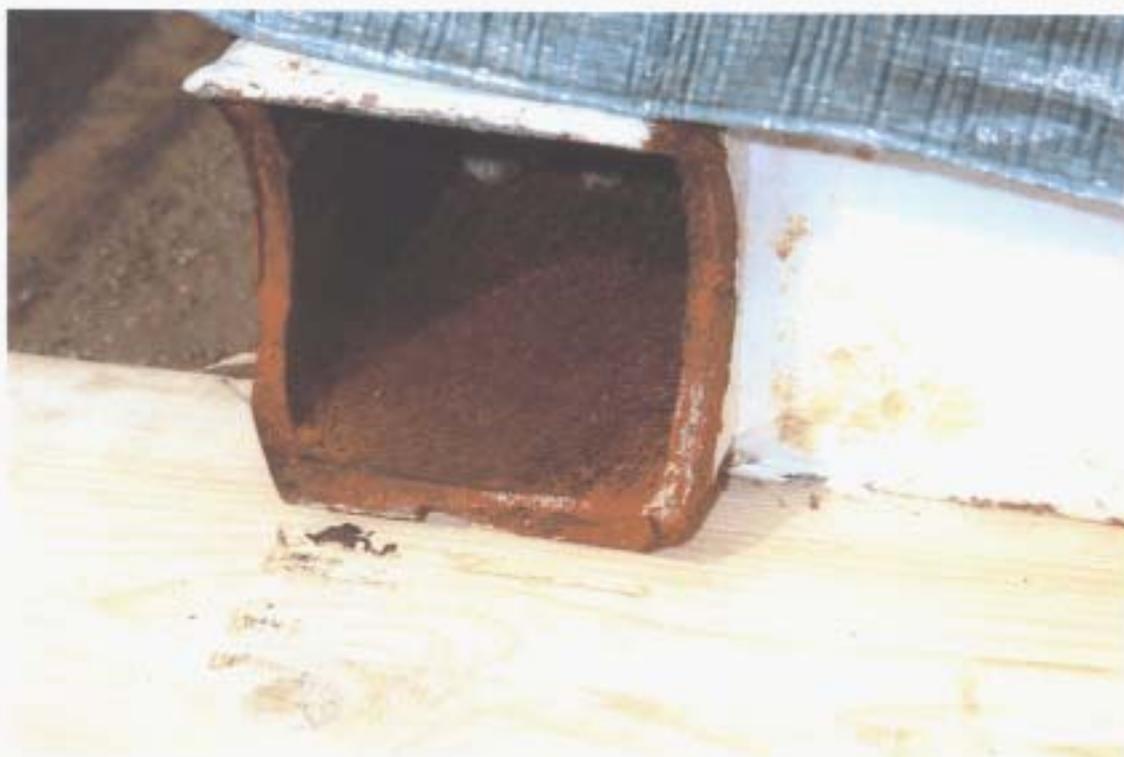
FIGURE 4

Part of No 2 davit arm indicating lack of penetration forward along joint where it was welded to the pivot pin boss

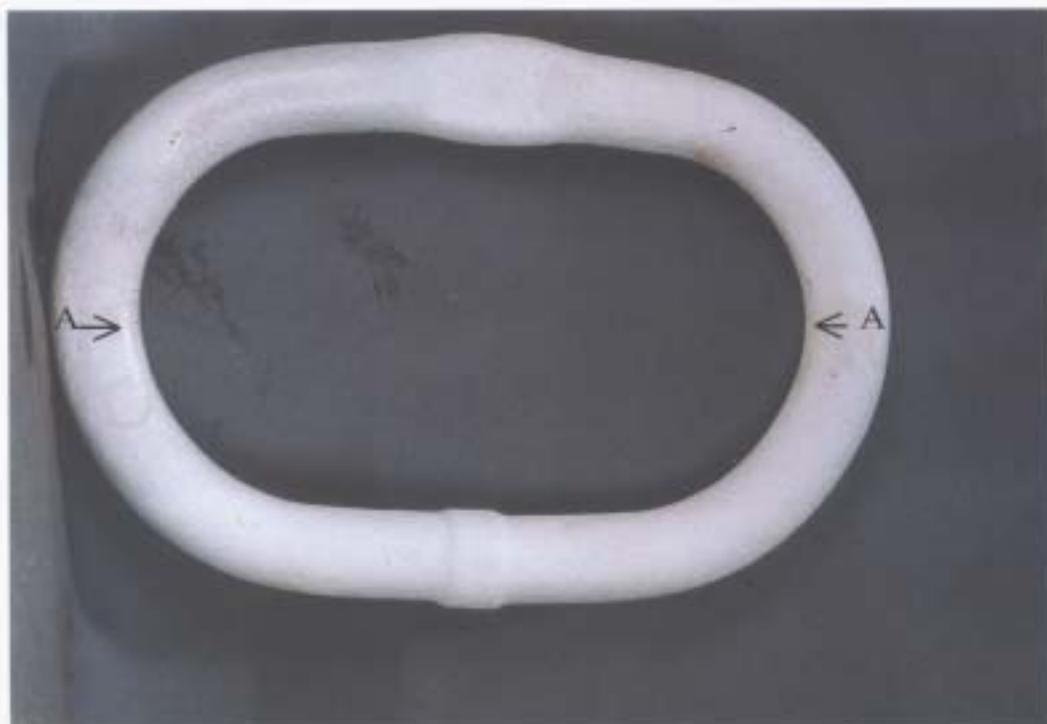
FIGURE 5

6.2 Magnetic particle inspection of the suspension links confirmed the existence of cracks situated at the intrados at each end of both suspension links where contact was made with the D shackle and the lifeboat hook. An example of these cracks is indicated by the arrows in Figure 5. There was no evidence of cracking on the other surface regions.

General view of the suspension link 'A' of No 1 lifeboat davit showing position of cracking at intrados - arrowed A

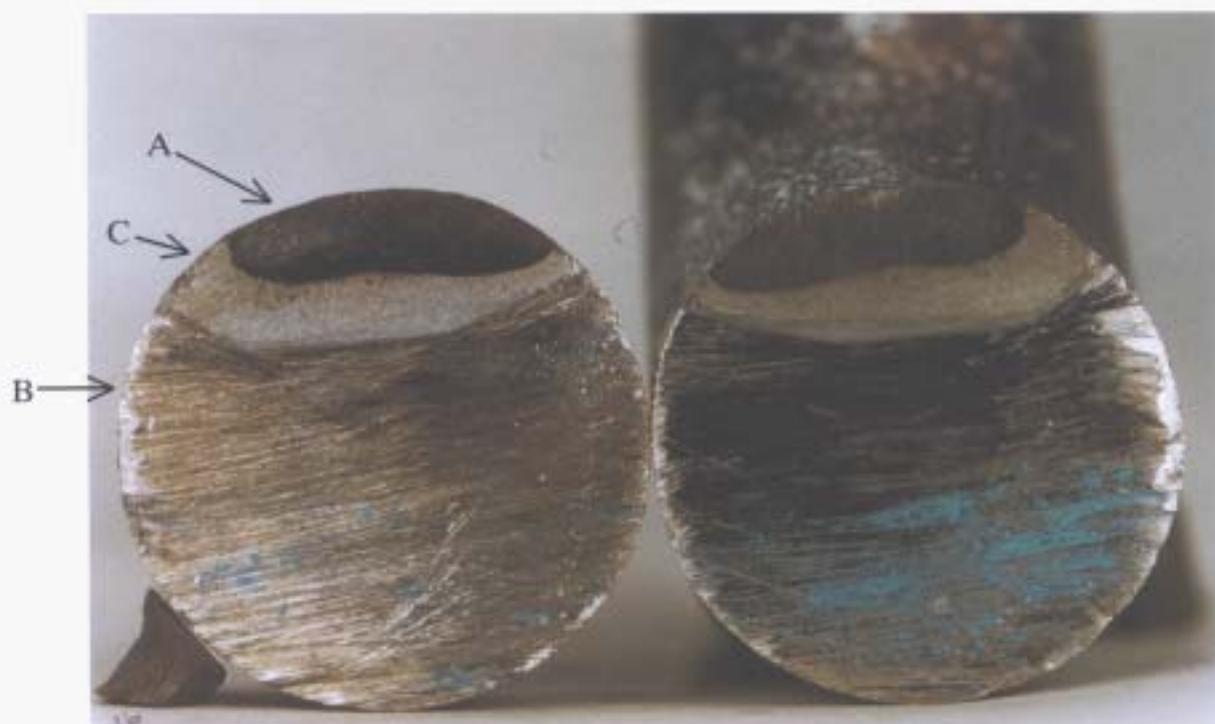
FIGURE 6

Figure 6 shows a section of the mating fracture surfaces of one of the suspension links. The fracture surfaces of the pre-existing cracks, indicated by the blackened area at arrow A, show that fractures had occurred without any noticeable deformation accompanying the failures.

An analysis of the corrosion product, in way of the blackened area, indicated corrosion of the steel caused by a marine environment.

Typical appearance of mating fracture surfaces

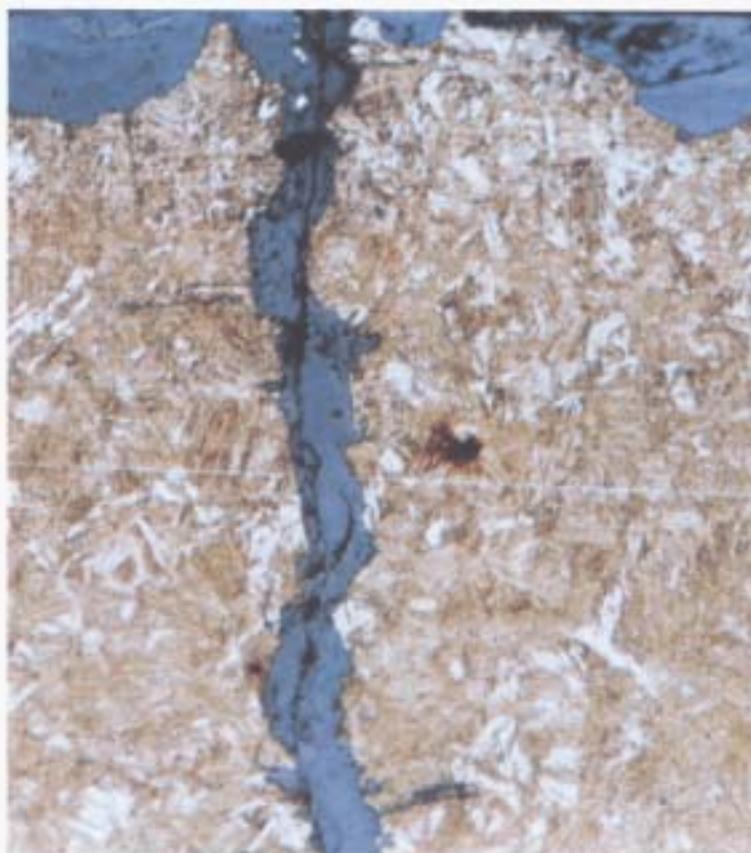
FIGURE 7

Etched sections (Figure 7) showed that the regions of cracking were found to be martensite (a hard, strong, brittle needle-like structure produced by rapid quenching of the link). The presence of martensite and the absence of any prior deformation in the vicinity confirmed the brittle nature of the fracture surface. Figure 7 also indicates corrosion products on the surface of the link and within the cracks.

Etched Section in regions of cracking showing martensite

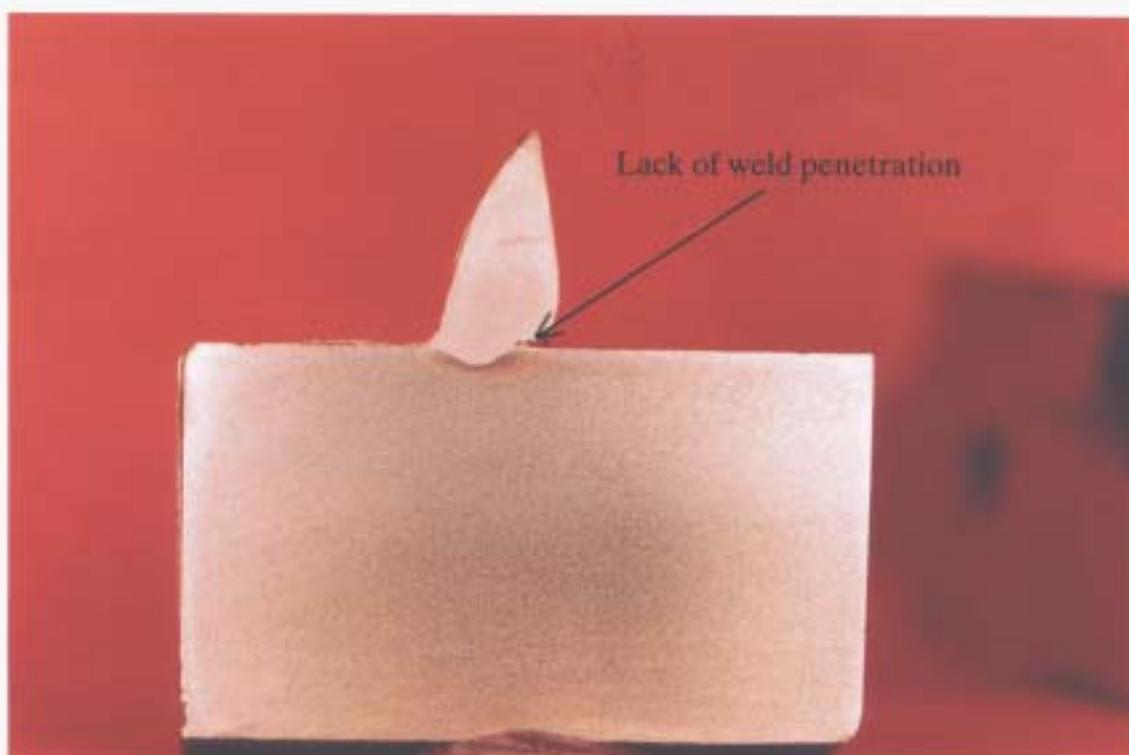
FIGURE 8

Macro and micro examination of the pivot pin boss welds were undertaken which identified weld root cracking and slag inclusion. Figure 8 shows a typical sample of the faults found.

Macro Section B1
