Report of the Investigation into the
Grounding of Passenger Vessel

QUEEN ELIZABETH 2

on 7 August 1992

Marine Accident Investigation Branch
5/7 Brunswick Place
SOUTHAMPTON
Hants SO1 2AN

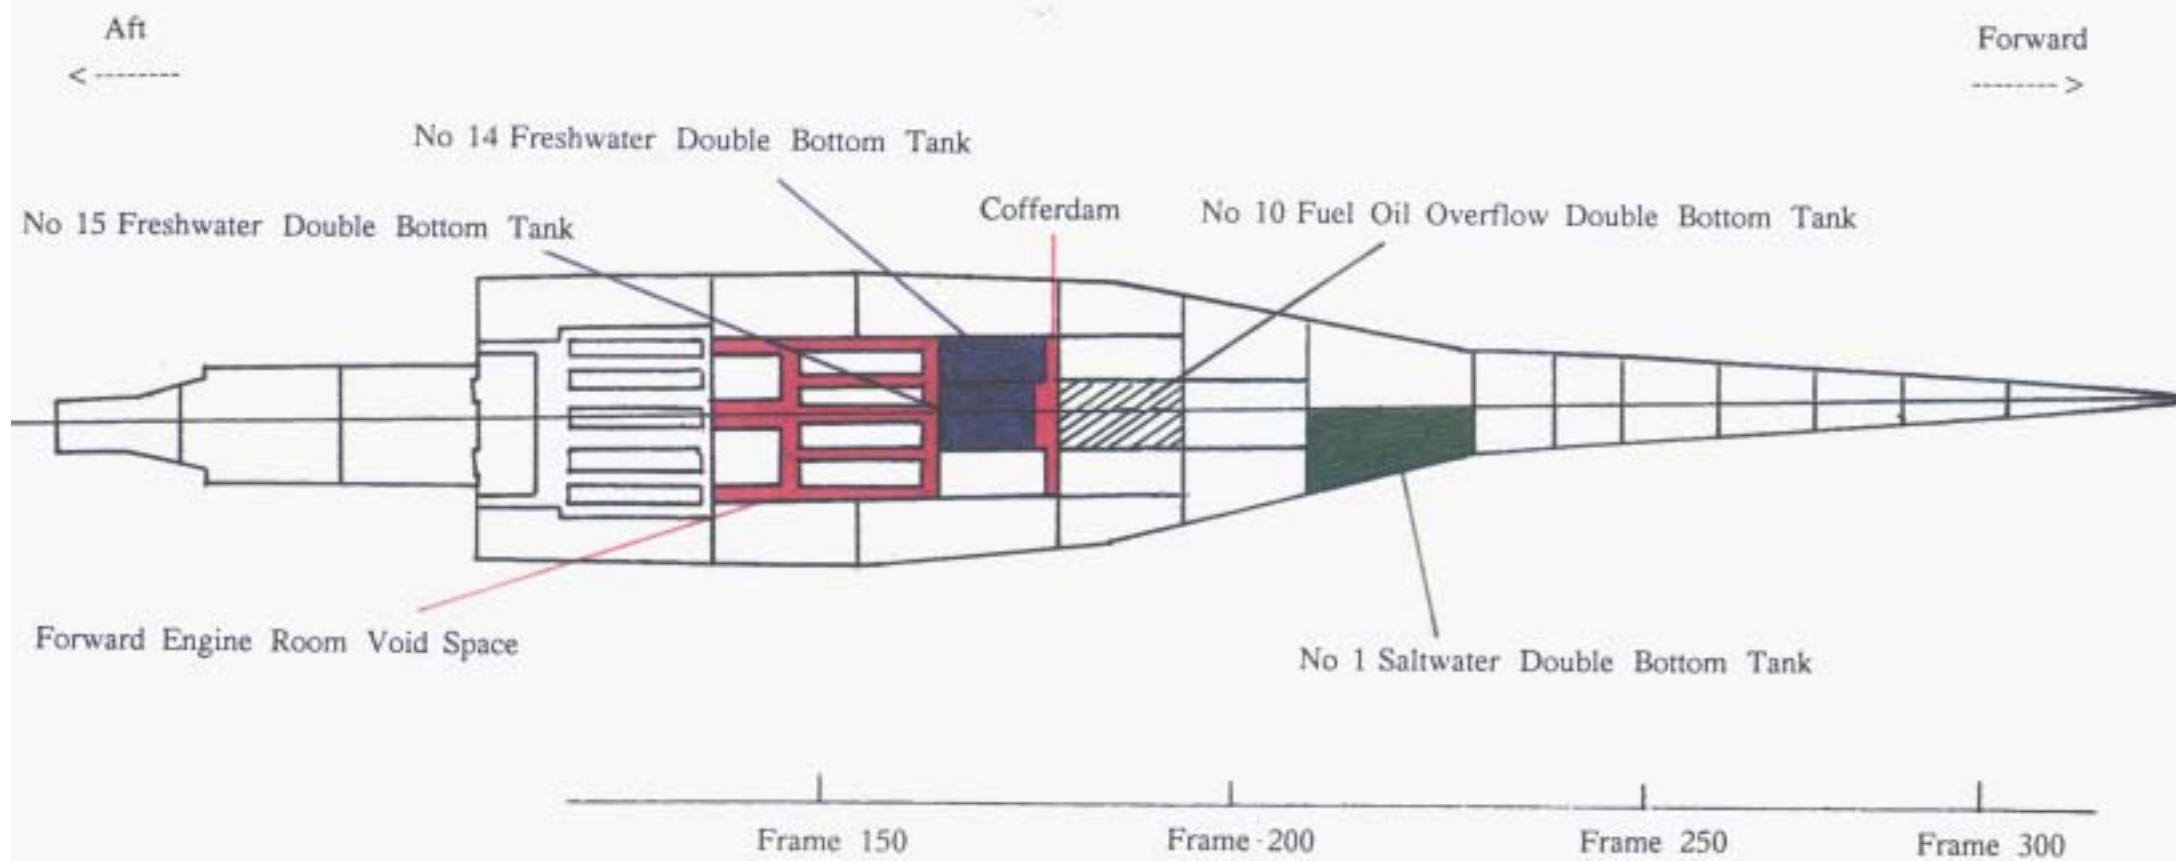
TANK PLAN (Not to scale)

A sounding pipe for No 1 Saltwater Double-Bottom Ballast Tank was found to be fractured within the Forward Tunnel space of the Engine Room and water was observed to be issuing from the pipe into the space. A wooden bung was inserted into the pipe in order to stem the flow and ballast pumping operations were commenced from No 1 Saltwater Double-Bottom Ballast Tank to the sea.

No 15 Freshwater Double-Bottom Tank, which had previously been slack, was found to be full and pressurised.

A cofferdam, located between No 13, 14 and 15 Freshwater Double-Bottom Tanks and No 8, 9 and 10 Fuel Oil Double-Bottom Tanks, was also found to be full.

No 14 Freshwater Double-Bottom Tank was found to be pressurised. The contents of No 14 and No 15 Freshwater Double-Bottom Tanks were sampled and found to contain saltwater.

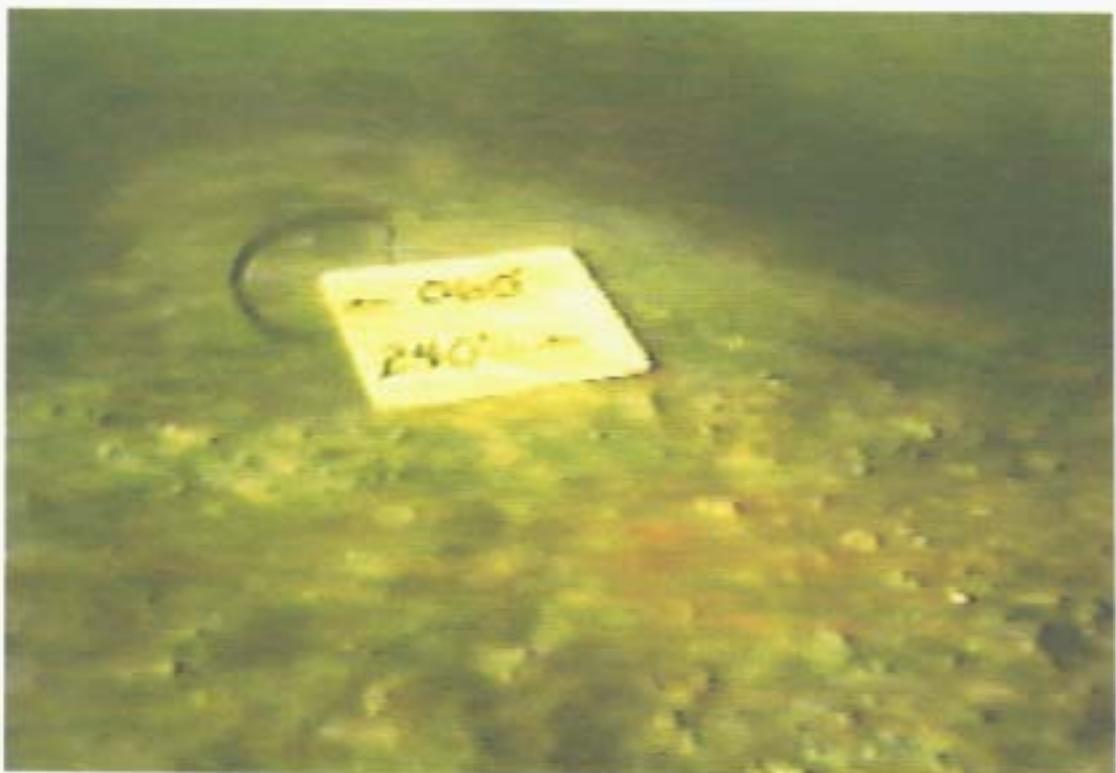
FIGURE 4 - RED ROCK I

The weighted buoys were then dropped in a depth of 36 feet located approximately 450 metres north-east of the reported position. Divers followed the ground line between the buoys and discovered a solitary boulder some 12 feet in diameter. The top of the boulder (subsequently termed "Red Rock I") was observed to be flat and clear of marine growth. The divers took some samples of a red-coloured material which they found on the top surface of the rock. Pneumatic depth gauge measurements were then taken and a least depth of 34.5 feet below chart datum (adjusted for predicted tides) was recorded.

It is considered that QUEEN ELIZABETH 2 initially grounded on "Red Rock I". The effect of the hull contacting with and passing across the top surface of the rock was to remove marine growth from the contact area of the rock. After approximately 12 seconds, the vessel grounded heavily on "Red Rock II". The evidence suggests that this second contact was much heavier than the first and caused several boulders to be disturbed as the hull passed across the top surface of the rock.
