Report of the Investigation
into fire on board
Ro-Ro Passenger Vessel

SALLY STAR

on 25 August 1994

Marine Accident Investigation Branch
5/7 Brunswick Place
SOUTHAMPTON
Hants SO15 2AN

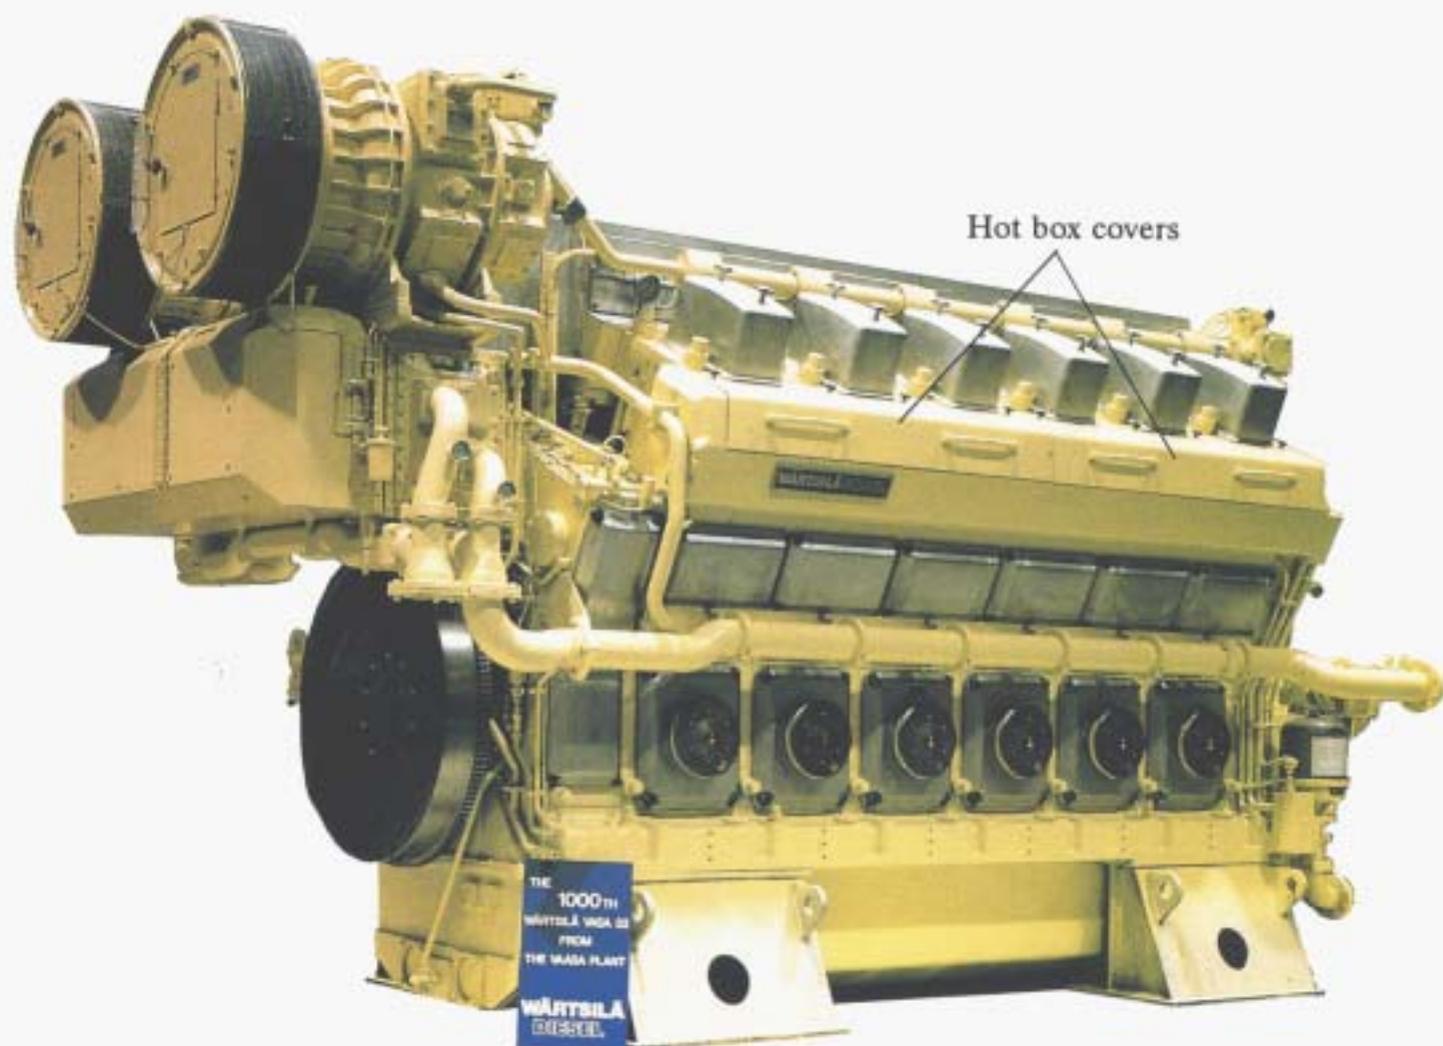
Wartsila Vasa 32 Engine

- 4.2 An inspection by ship's staff shortly after the fire was extinguished, established that the hot box covers to the inboard bank of No 4 main engine were displaced and sitting on the walkway between Nos 3 and 4 main engines, at cylinder head level. Found within the hot box of No 4 main engine was a fractured socket-head screw on a flange of the low pressure fuel rail serving the high pressure fuel pump of No 5 cylinder of the inboard bank. This screw was one of two intended to secure this flange; the other screw was in place but only finger tight.

- 5.1 There can be little doubt that the primary source of combustible material for this fire was fuel oil and vapour leaking from the flange on No 4 main engine on which the screw had fractured. It is probable that the leaked oil vapour ignited once it was in contact with a hot surface. The hot box covers serve as baffles to contain liquid fuel leaks within the space before draining to the fuel drain tank. The covers were found on the platform between the Nos 3 and 4 main engines. These covers may have been displaced during fire fighting or more likely were blown off as a result of ignition of vapour within the hot box space. With the covers displaced, oil would have been free to spray from the defective flange onto both Nos 3 and 4 main engines, leading to the damage described. The extent and intensity of the fire would probably have been much less had the hot box covers remained in place.

Comparison of the two socket screws in this flange showed that the hexagonal socket of the failed screw was slightly deformed, indicating that there had been several tightening operations with a hexagon key. The head of the intact screw showed no similar deformation. It is possible that there may have been repeated attempts at tightening the flange to endeavour to reduce leakage from the joint. The vessel's records indicated that the ship's staff were concerned about the effectiveness of the flange joint "O" rings and that frequent inspections of the joints had been made. This suggests that small leakage from these flanges had been a long term problem. The possibility therefore exists that the failed screw had been re-tightened or re-used more frequently than the intact screw. The appearance of the fracture surfaces on the failed socket-head screw indicated that the failure mechanism was one of fatigue.

Expert metallurgical examination of the failed flange screw concluded that it failed as a result of a slow progression of a fatigue crack over many loading cycles. Evidence from spring washer markings on the bolt head suggests that it had been tightly secured in its early history, unlike its counterpart which might possibly never have been tightened properly. In terms of microstructure and hardness both screws were identical. The leakage of fuel was probably a result of the combined effects of one loose screw and final breakage of the other due to possible robust use and progressive fatigue cracking.
