**Report of the
Investigation into the grounding
of the Passenger Ro-Ro Ferry**

STENA CHALLENGER

on 19 September 1995

Blériot-Plage, Calais

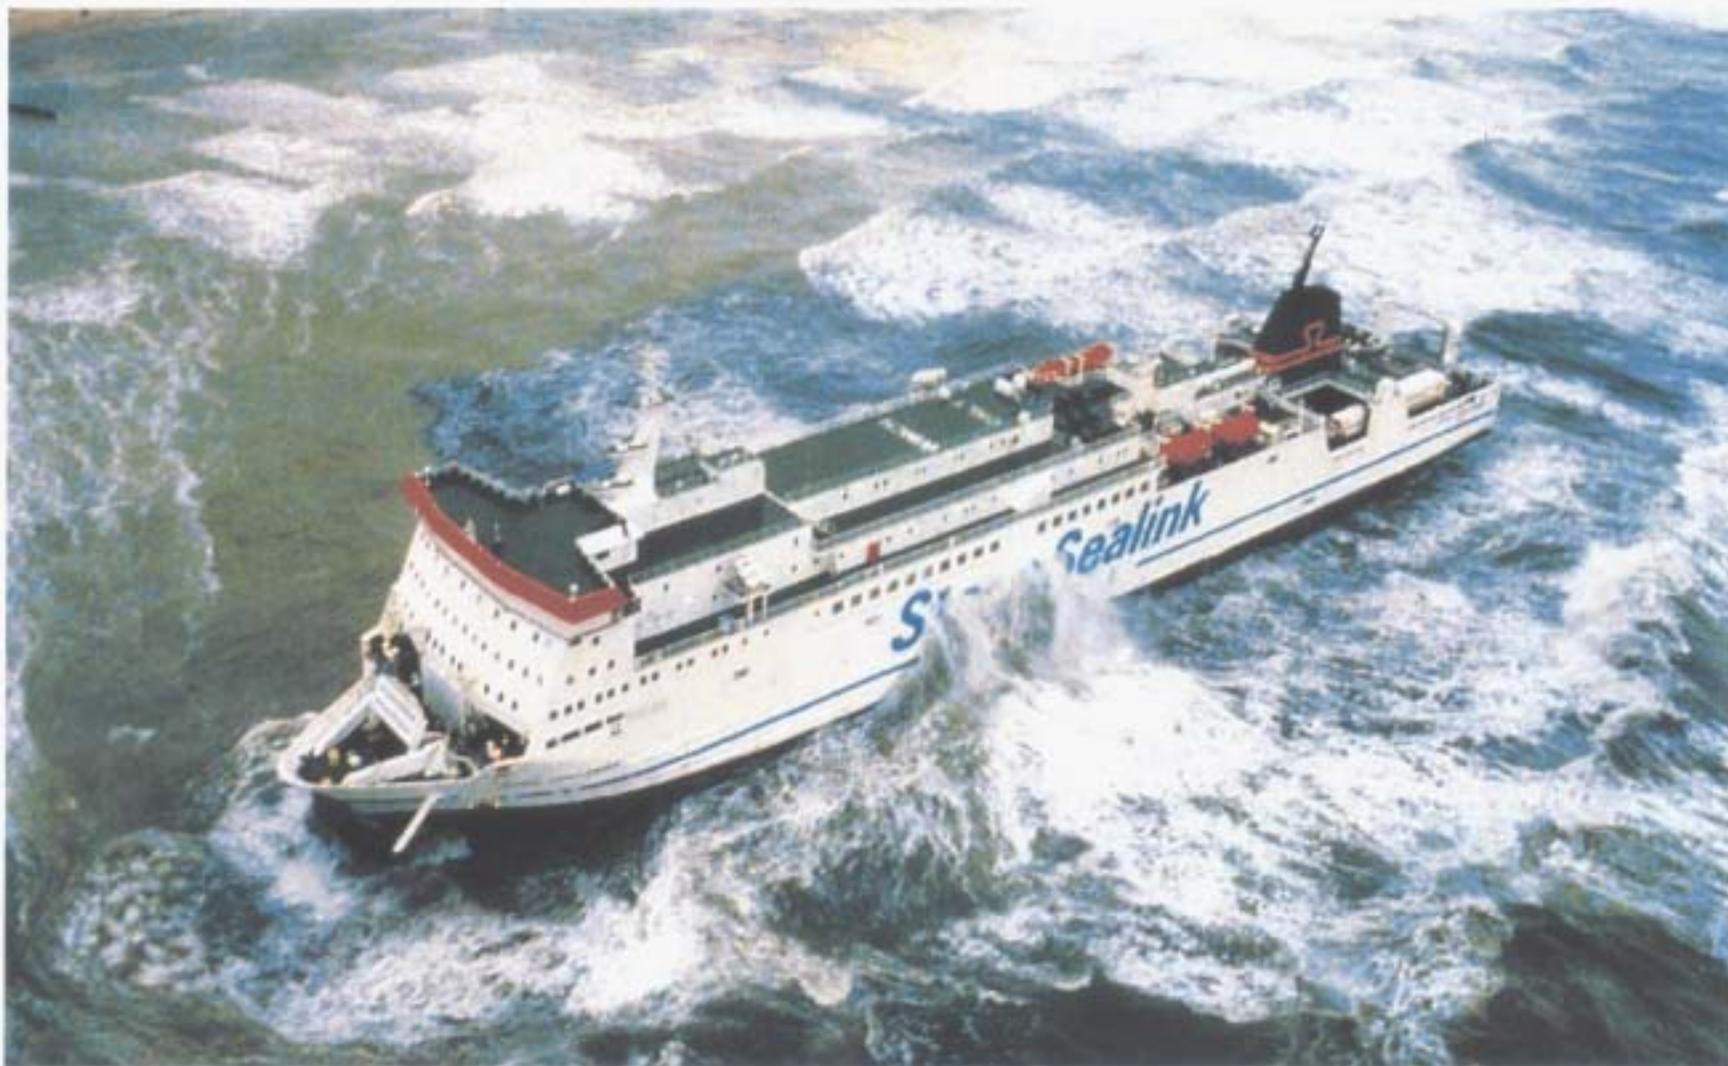
FIGURE 1

Power was reduced and the vessel continued towards the harbour entrance. When it was realised that the vessel was not in the centre of the channel and was drifting to the south and not answering the helm more power was applied. The bow thrusters were also activated but the vessel would not turn head to wind. Within a few minutes the vessel grounded on the gently sloping sandy beach about 1.3 miles to the west of Calais Harbour entrance.

- 3.9 During the subsequent inspection of the hull in dry dock STENA CHALLENGER was found to have a significant amount of damage to the bottom plating and internal stiffening in the amidships area port and starboard and to the starboard forefoot. It is not known how much of this damage was caused at the time of grounding, while the vessel was aground, or during attempts to refloat her. There was no hull penetration.

STENA CHALLENGER - aground at Blériot - Plage

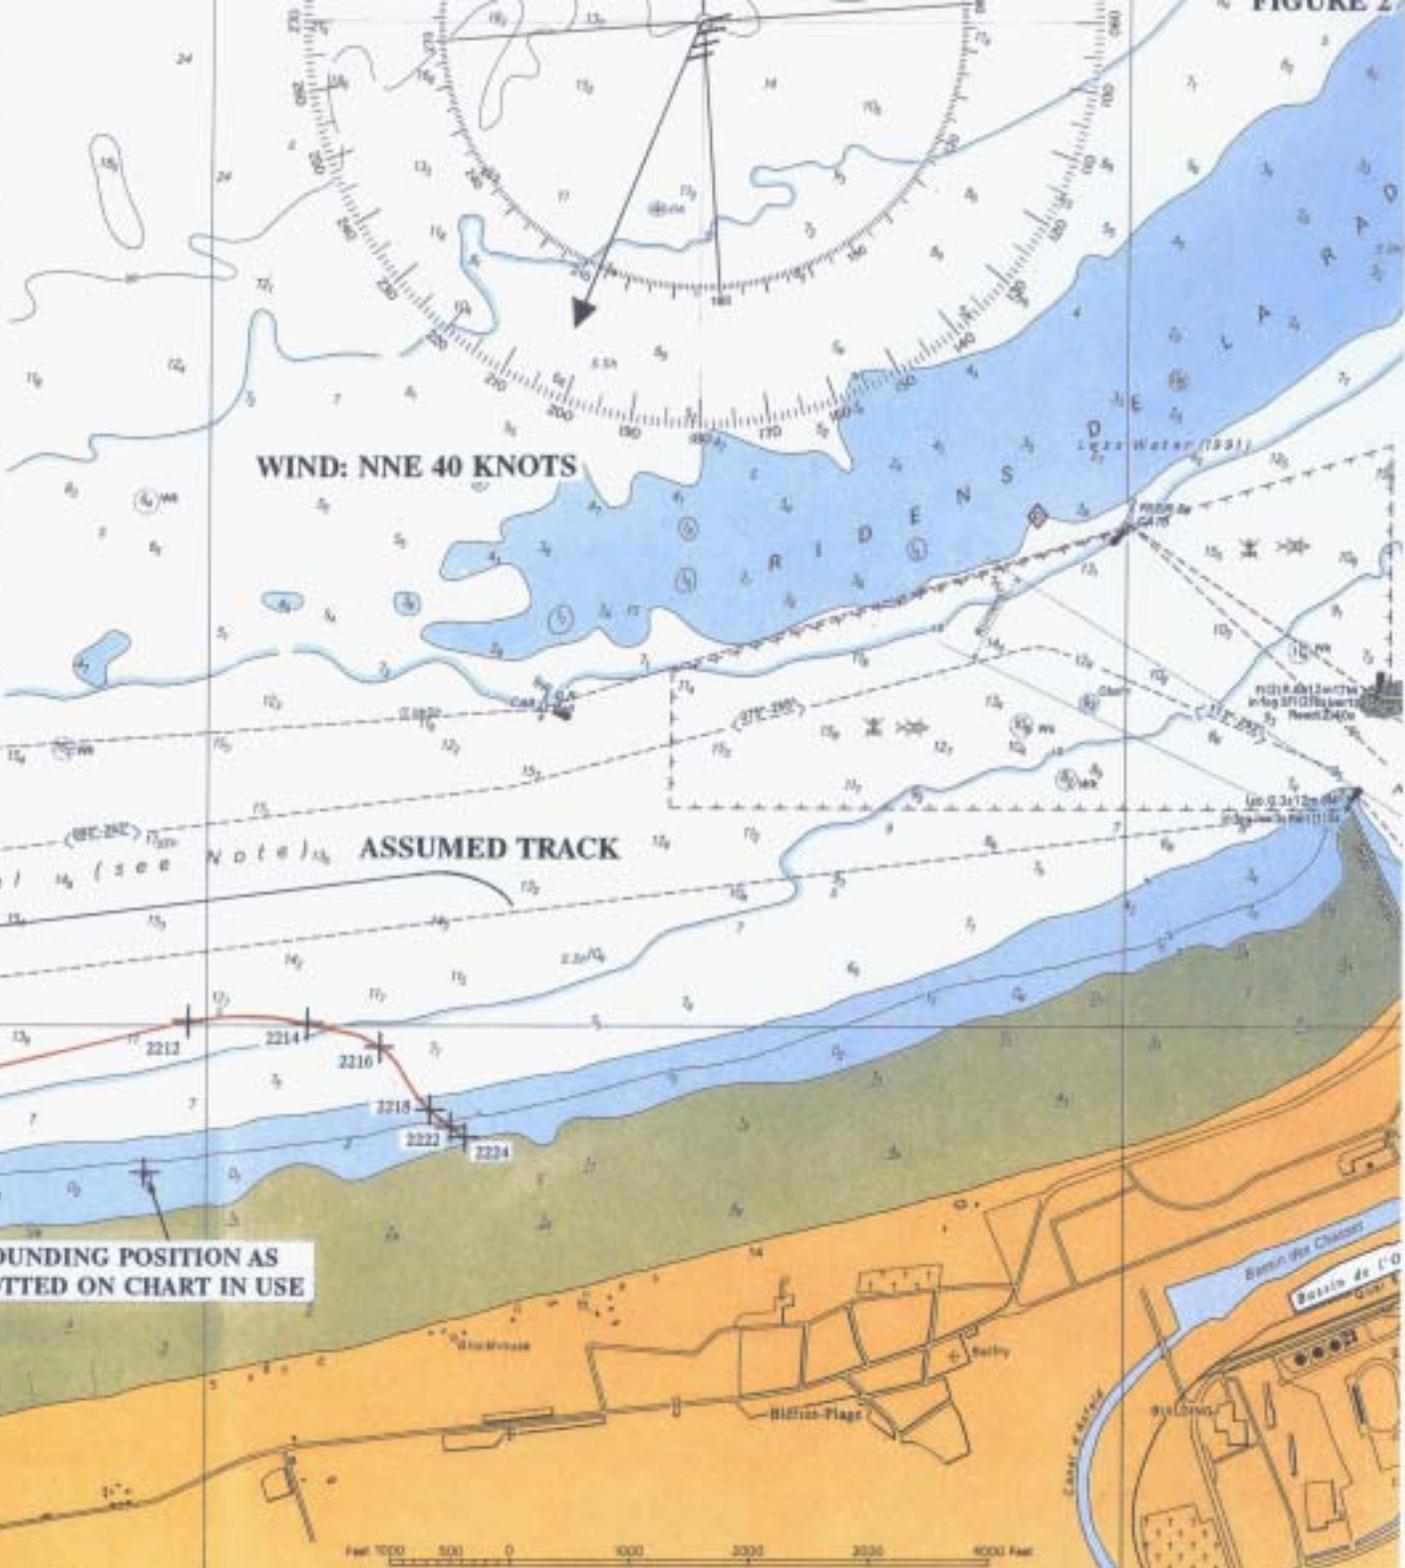
On this occasion the Master was conning the vessel and monitoring the position and progress by means of visual reference to the lights shown by the channel marker buoys and those at the harbour entrance, combined with estimates of range using radar range rings. With the vessel having to allow up to minus 18° for leeway in the strong on-shore wind these lights would have appeared in unusual positions relative to the vessel's heading thus making the Master's assessment of the vessel's position and progress more difficult. The problem was further exacerbated by the southern limit of the channel not being marked between CA5 buoy and the harbour entrance, a distance of 2.7 miles (see Figure 2).

- 2218 hrs AHEAD PITCH BEING INCREASED FURTHER; BOW THRUST TO PORT; RUDDERS HARD TO PORT
- 2219 hrs FULL AHEAD; RUDDERS HARD TO PORT; BOW THRUST TO PORT

- 2220 hrs PRIDE OF BURGUNDY CLEARS HARBOUR ENTRANCE; FULL AHEAD; RUDDERS HARD TO PORT; BOW THRUST TO PORT
- 2224 hrs CALAIS PORT RADIO TO STENA CHALLENGER "IT'S GOOD FOR YOU NOW"; STENA CHALLENGER AGROUND

WIND: NNE 40 KNOTS

TIDAL STREAM: 1 KNOT

ACTUAL TRACK
