Marine Accident Report 2/98

Report of the Inspector's Inquiry
into the loss of the Fishing Vessel

“GORAH LASS”

with three lives on 11 March 1997
off Portreath, North Cornwall

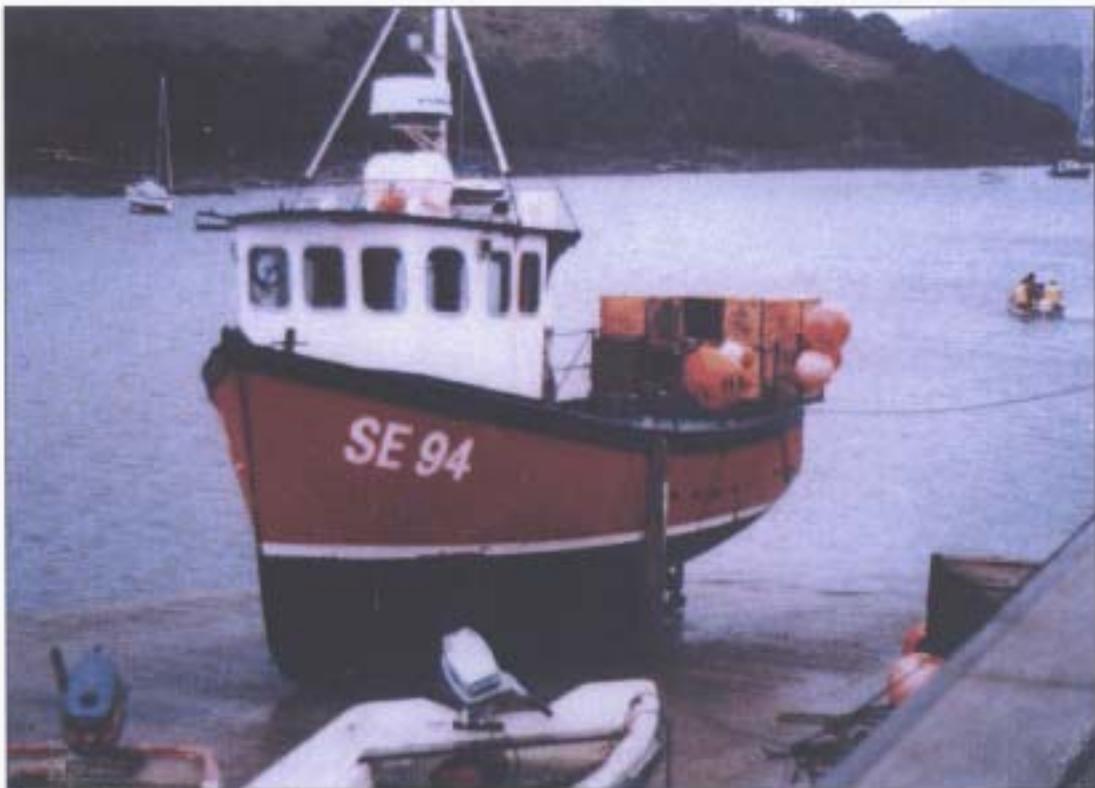
Figure 5: GORAH LASS as a Crabber (Photograph courtesy of Cygnus Marine)

Note: Since this time the following changes have been made:

- the liferaft has been removed;
- the platform aft has been removed;
- an after gantry which supports a small mast and the mizzen sail has been fitted;
- the for'd mast has been renewed in stainless steel;
- handrails have been fitted along the port side of the after deck.

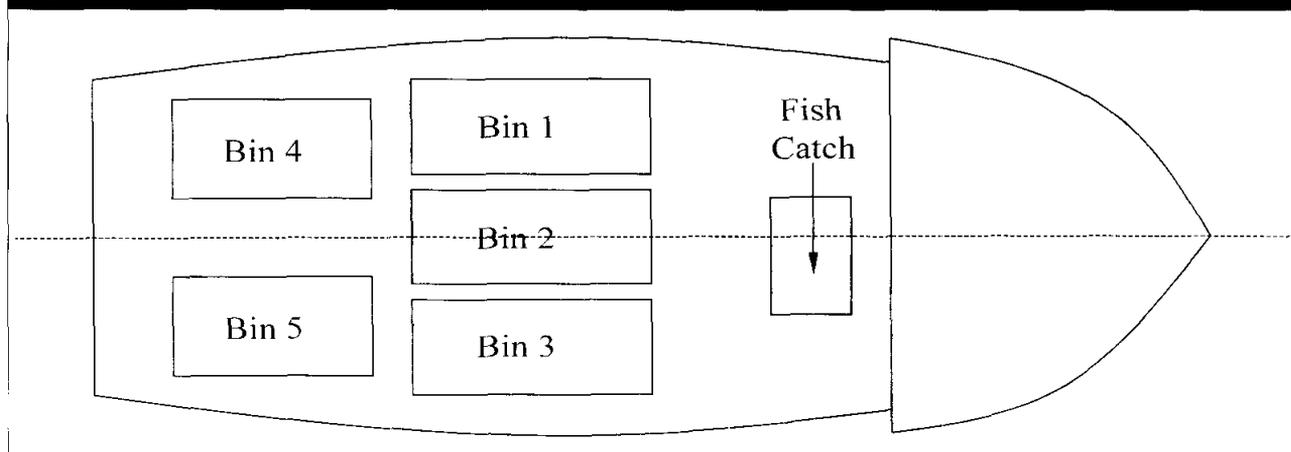
Figure 6 Layout of bins and catch

During the passage to and from the fishing grounds, the six bins on GORAH LASS were stowed as indicated in Figure 6. Three of the bins (Nos 1, 2 and 3) fit tightly across the middle of the after deck and are unable to move sideways. Some small movement is possible in the two after bins (Nos 4 and 5) and in the forward smaller bin which is dedicated to the catch.

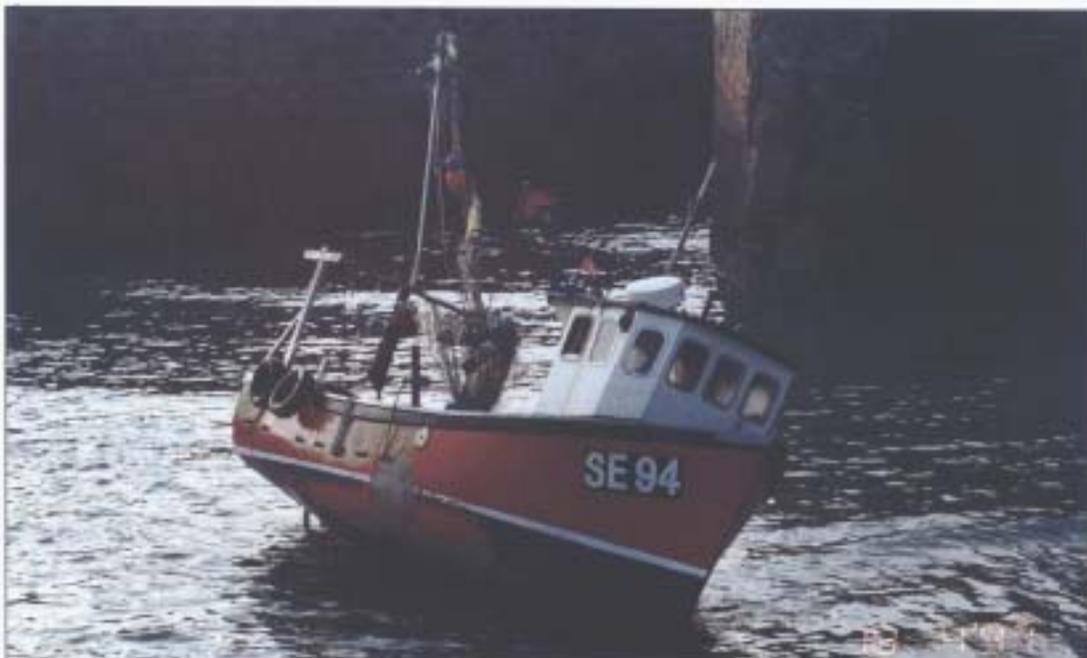
Figure 7: "GORAH LASS" drying out at Portreath. Note: Damage to starboard side caused by contact with net hauler after the accident

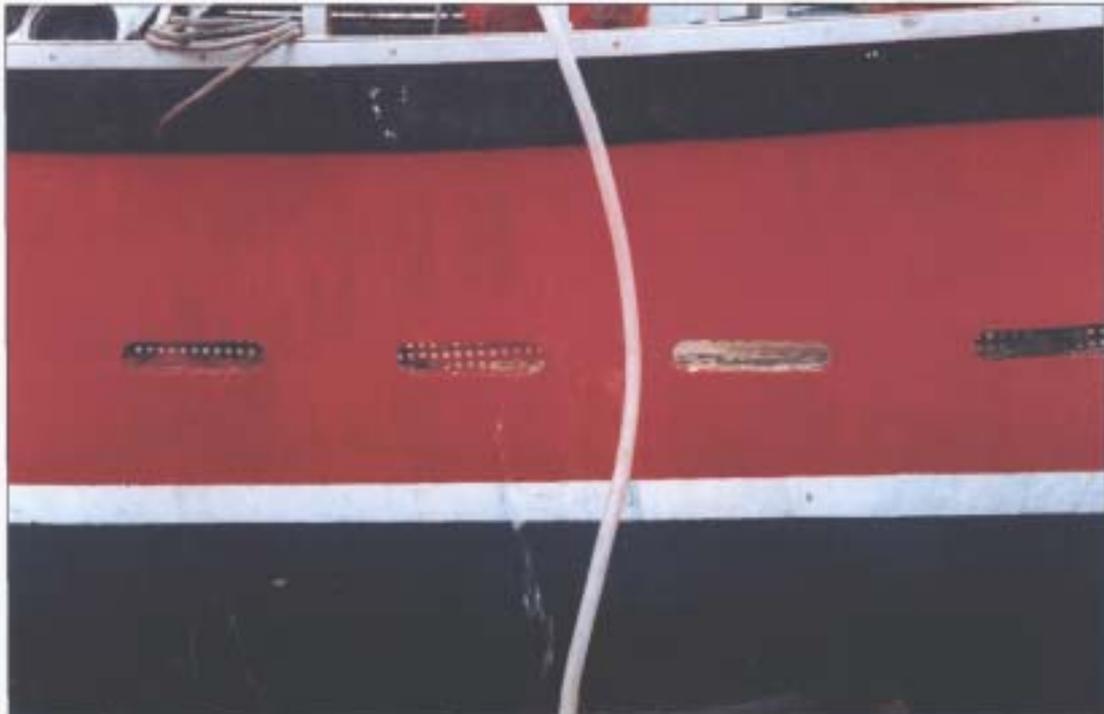
Figure 8: Plastic mesh blocking scuppers of "GORAH LASS"

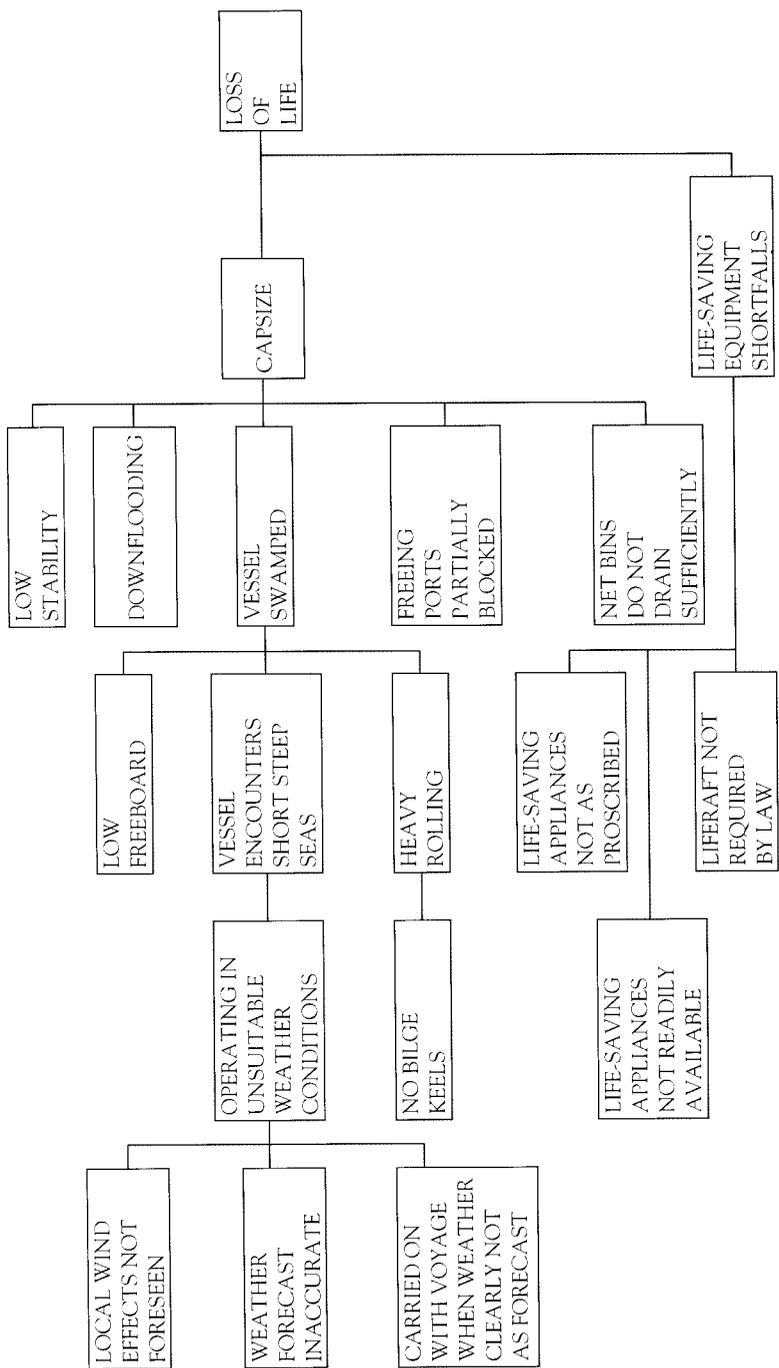
3.1 ACCIDENT FACTOR DIAGRAM

The following figure indicates diagrammatically the main factors which culminated in the loss of the vessel and the consequent loss of life.
