Report of the Investigation  
into the loss of the Fishing Vessel  
**HEATHER BLOOM INS 110**  
with the loss of one life  
on 3 December 1994

Marine Accident Investigation Branch  
5/7 Brunswick Place  
SOUTHAMPTON  
SO15 2AN

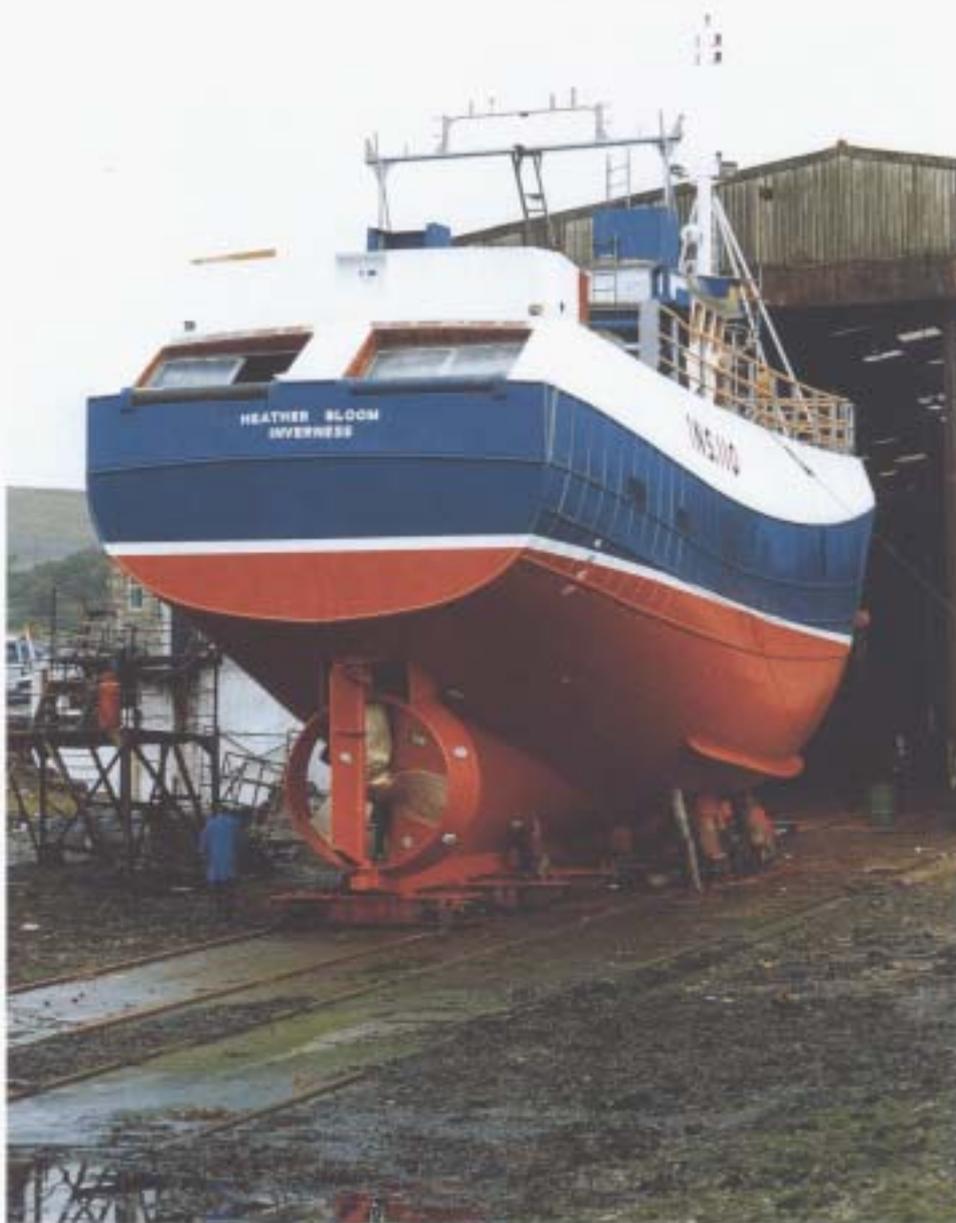
FIGURE 7

HEATHER BLOOM near completion,  
showing the transom openings and doors

- 9.3 The Marine Safety Agency is recommended to take steps when conducting fishing vessel safety surveys, to ensure that any transom doors (section 6.2) fitted to fishing vessels can be opened and closed efficiently and easily.

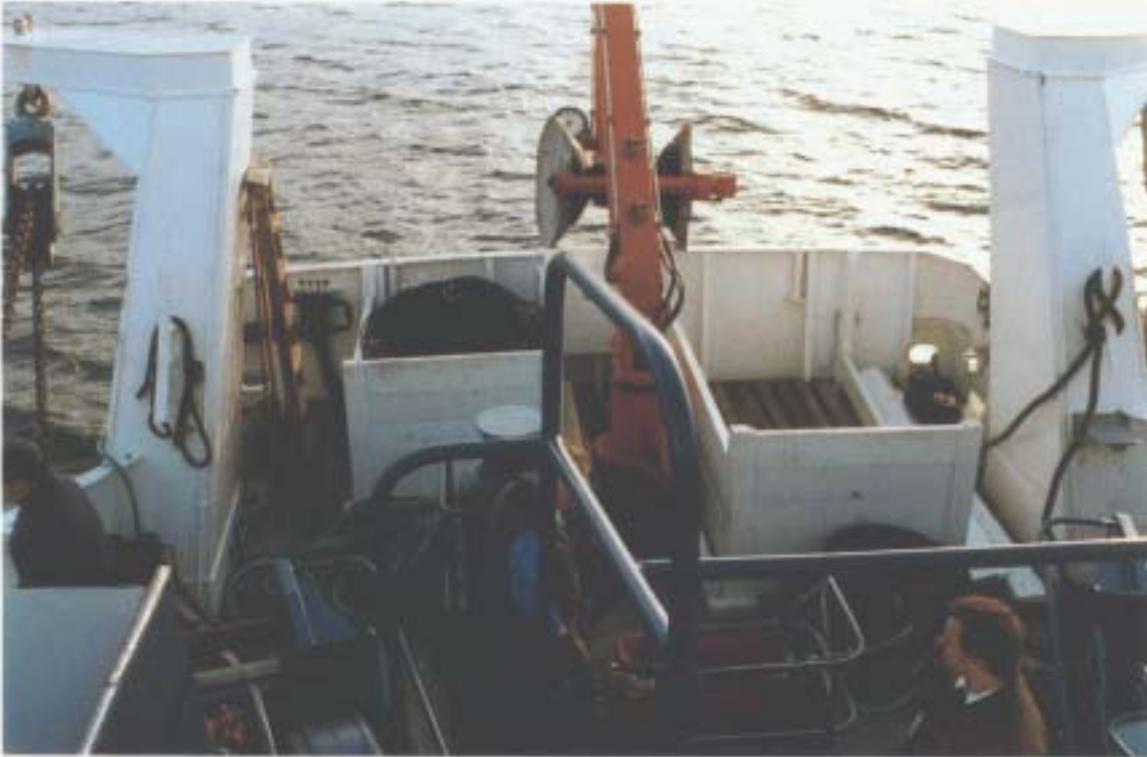
View of After Shelter deck

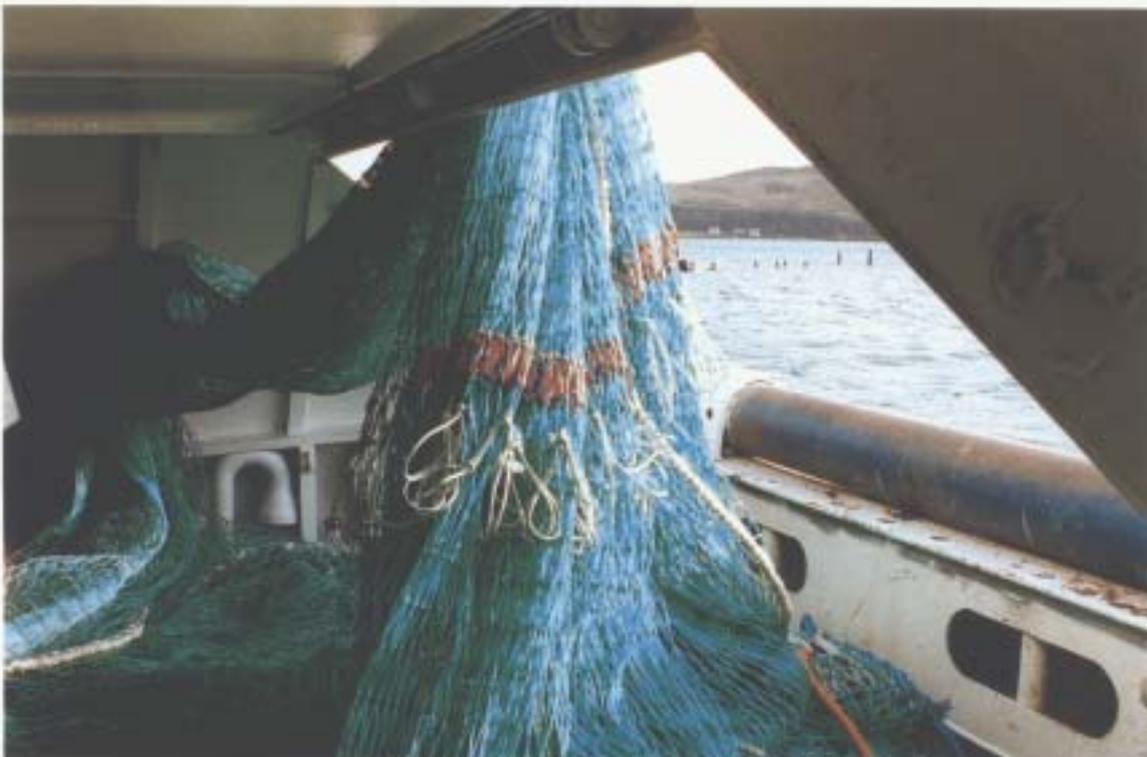
FIGURE 8

Transom door opening
