Report of the Investigation

MFV MARGARET AND WILLIAM II

in the Western Approaches

on 4 September 1991

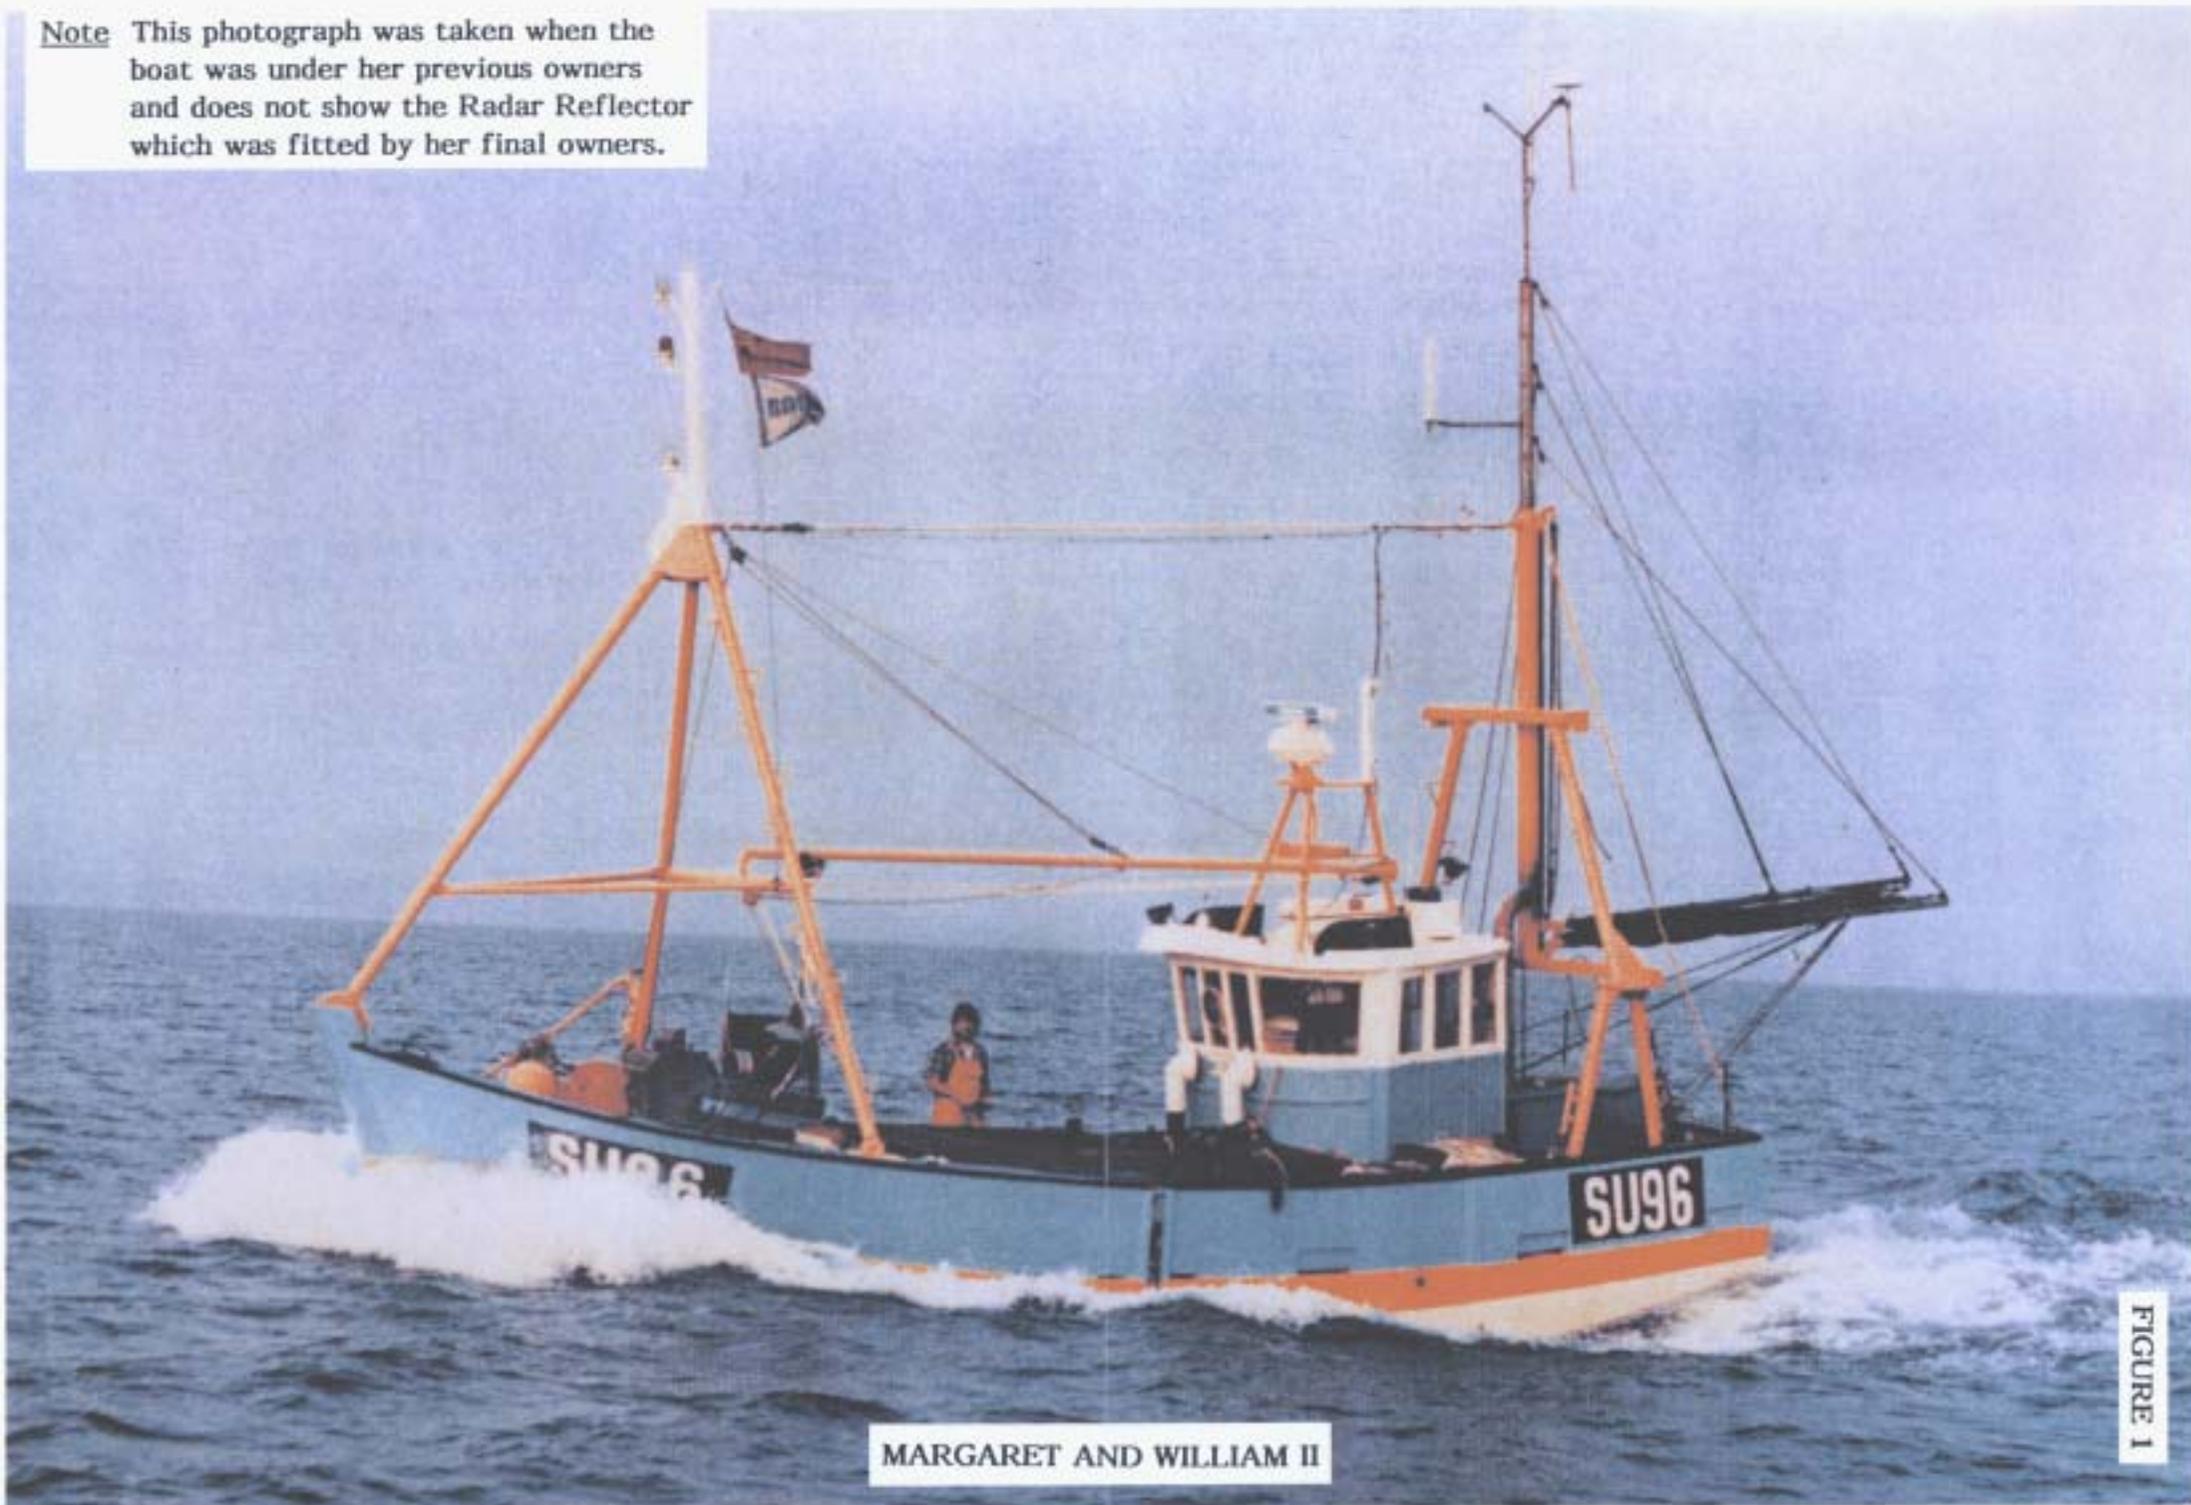
FIGURE 1

MARGARET AND WILLIAM II was a wooden fishing vessel built in 1978 in France. She was originally built for trawling, but in her final ownership was used as a gill netter. There are no drawings available for reference purposes. A photograph of the boat is at Figure 1.

Note This photograph was taken when the boat was under her previous owners and does not show the Radar Reflector which was fitted by her final owners.

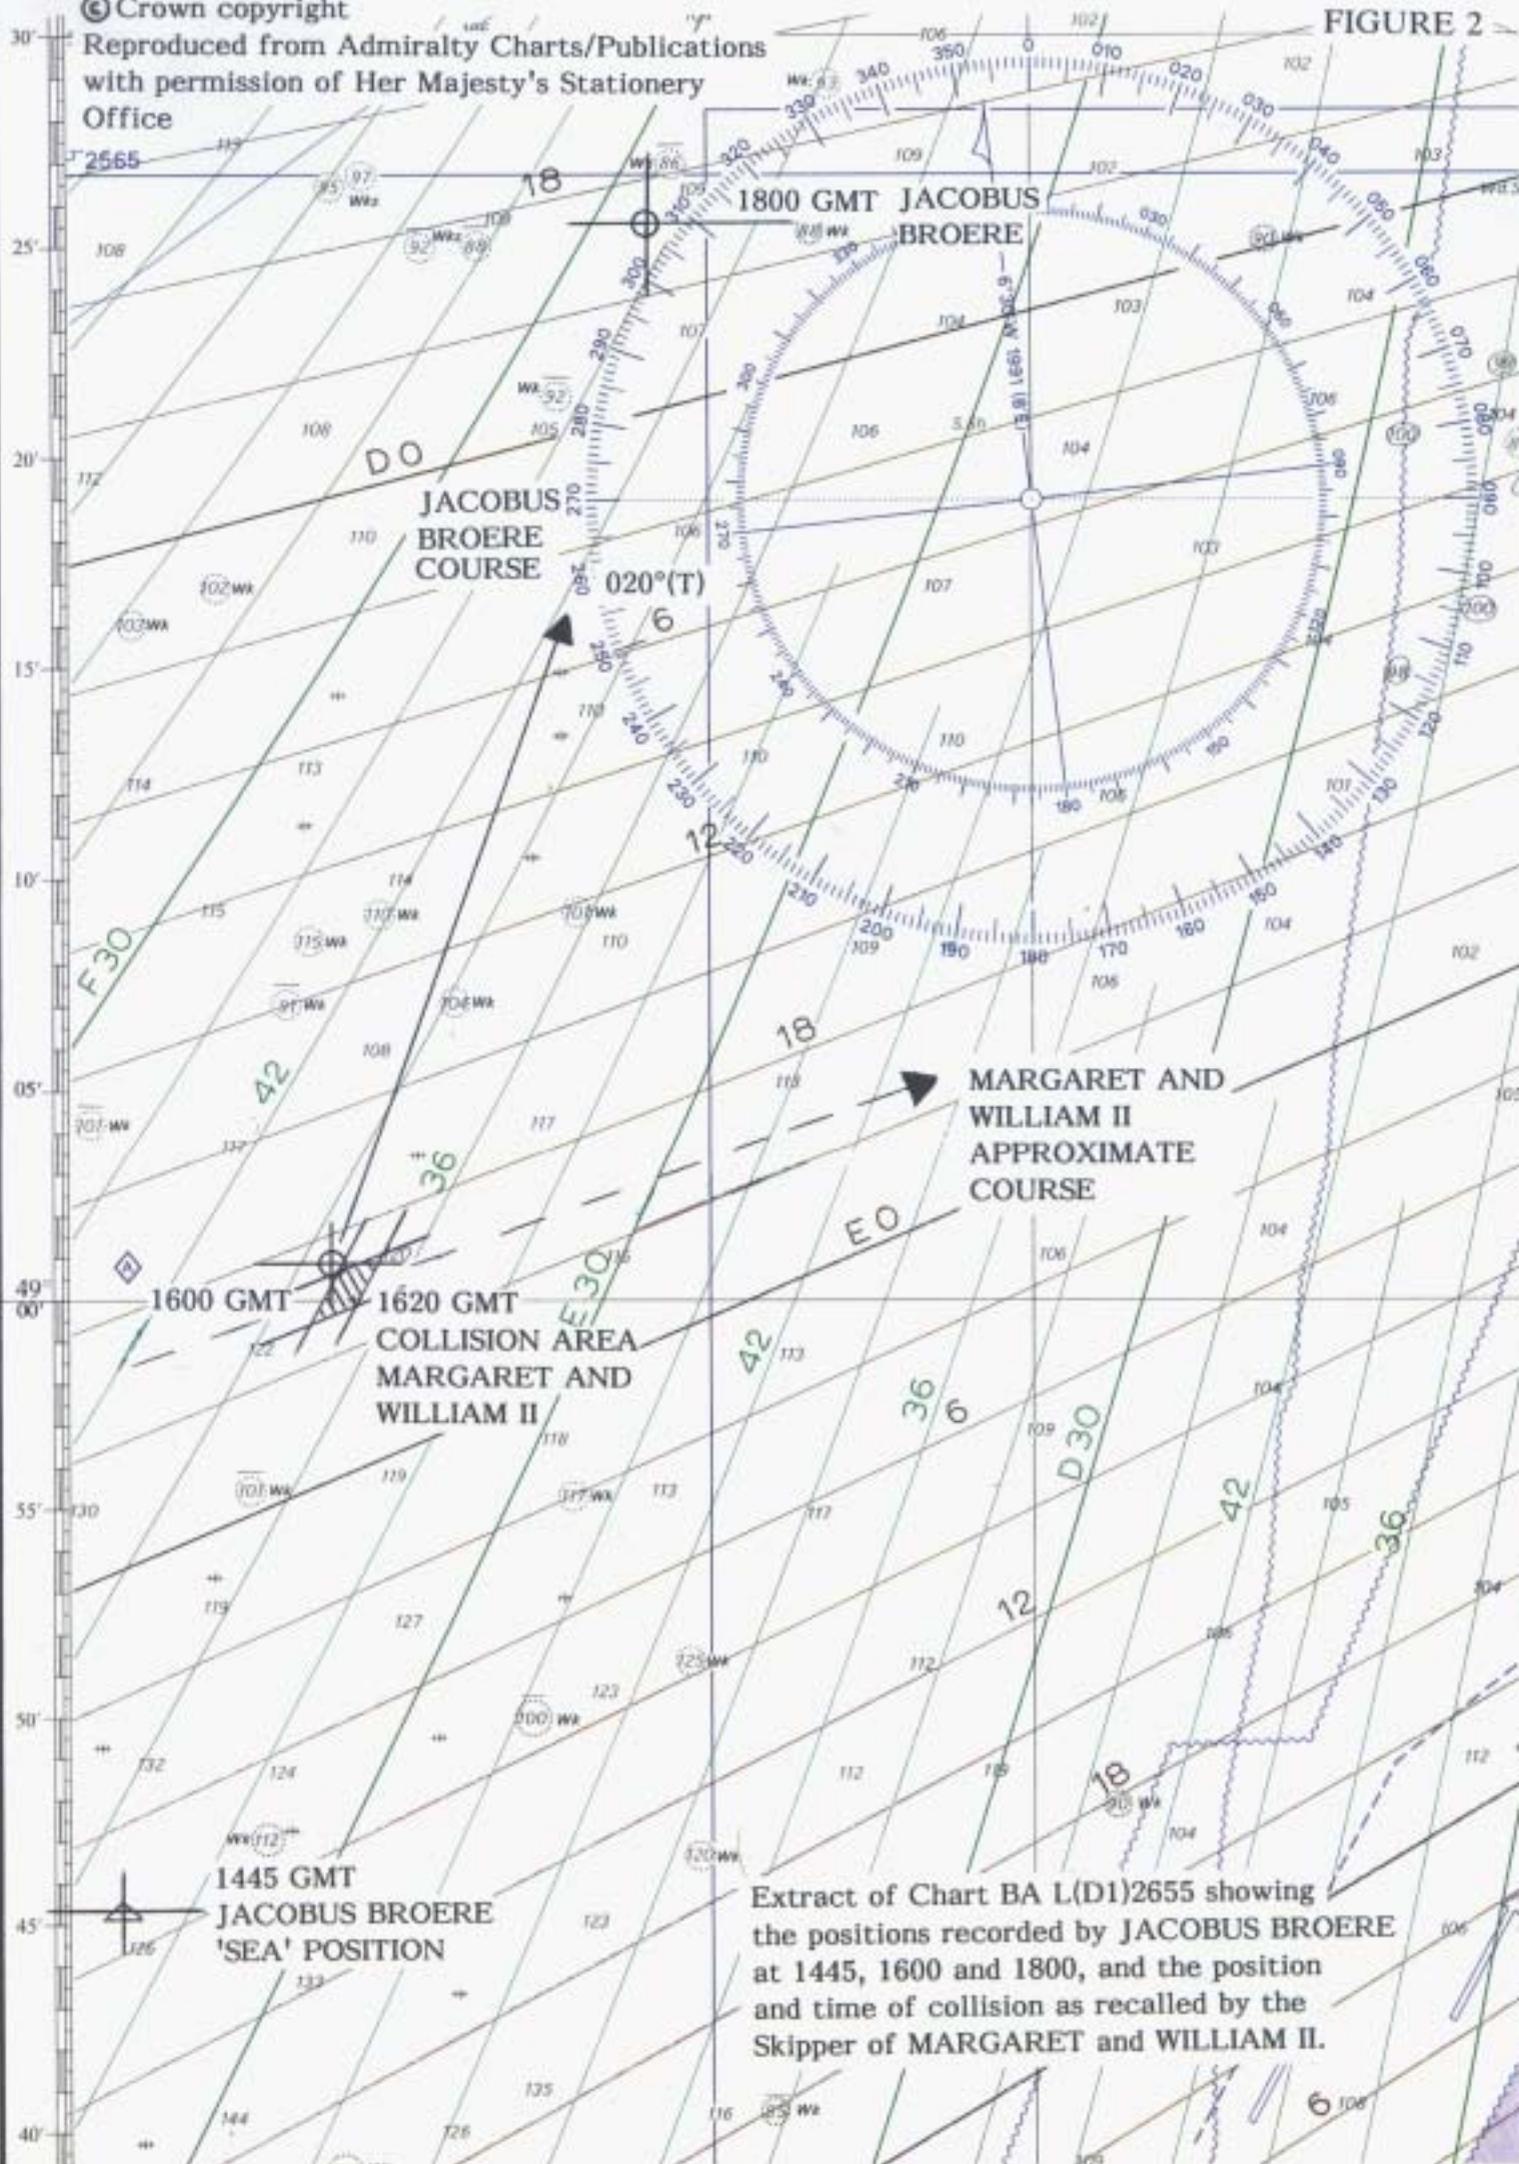
FIGURE 2

5.16 The chartlet at Figure 2 shows the track of JACOBUS BROERE, as taken from her chart, the approximate course of MARGARET AND WILLIAM II, and the probable area of collision based upon the Skipper's recollection of the Decca readings. Figure 3 shows the deduced approach of the two

Extract of Chart BA L(D1)2655 showing the positions recorded by JACOBUS BROERE at 1445, 1600 and 1800, and the position and time of collision as recalled by the Skipper of MARGARET and WILLIAM II.

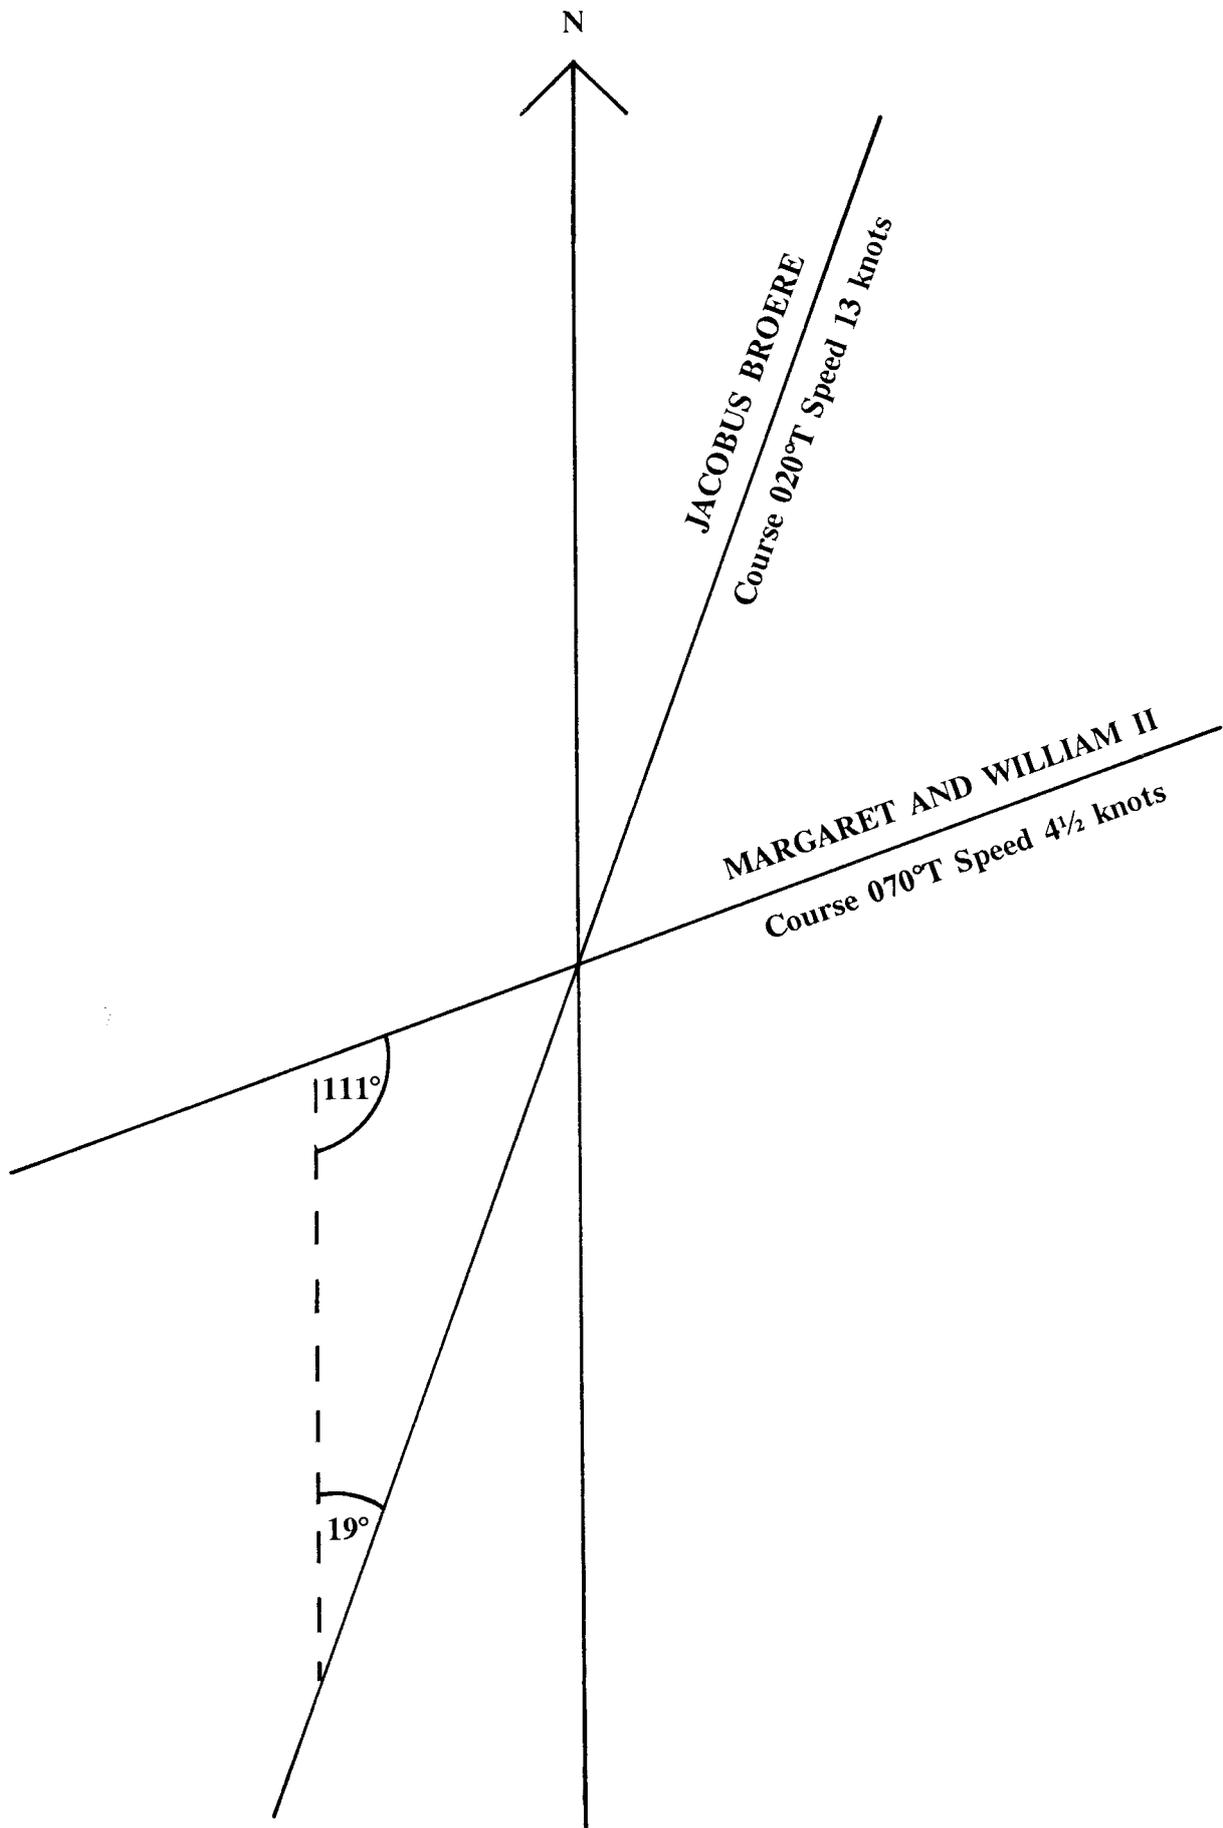
DEDUCED APPROACH OF VESSELS

vessels to each other, and their aspects. The course and speed of JACOBUS BROERE is taken as 020°T and 13 knots (from her charted positions) and that of the fishing vessel as 070°T and 4½ knots. It will be seen that on this basis JACOBUS BROERE was coming up from a direction very close to two points abaft the beam of MARGARET AND WILLIAM II; however, there is uncertainty as to the exact courses and speeds (especially of the fishing vessel) and any error in those assumed would lead to an appreciable difference in this bearing. In strict terms, therefore, the approach may have been a crossing situation under the International Collision Regulations, when Rule 15 would apply and MARGARET AND WILLIAM II was required to give way; or an overtaking situation, when under Rule 13 JACOBUS BROERE should have given way.

5.17 The exact approach bearing is, however, very limited in its significance in this accident, for two reasons. Firstly, Rule 13 says: "When a vessel is in any doubt as to whether she is overtaking another, she shall assume that this is the case and act accordingly."

Secondly, the Collision Regulations also say at Rule 19 that in restricted visibility, a vessel detecting another by radar shall "determine if a close-quarters situation is developing and/or risk of collision exists. If so, she shall take avoiding action in ample time" The visibility at the time of the accident was sufficiently restricted for it to be likely that other vessels would be detected by radar well before they were seen by eye. Either or both vessels would be expected to have taken early avoiding action under this Rule had their radar watch been such that the other vessel was so detected.
