## Marine Accident Report 1/98

Report of the Inspector's Inquiry  
into the sinking of the Fishing Vessel

**PESCADO PH409**

with the loss of life of all six of the crew  
in February 1991

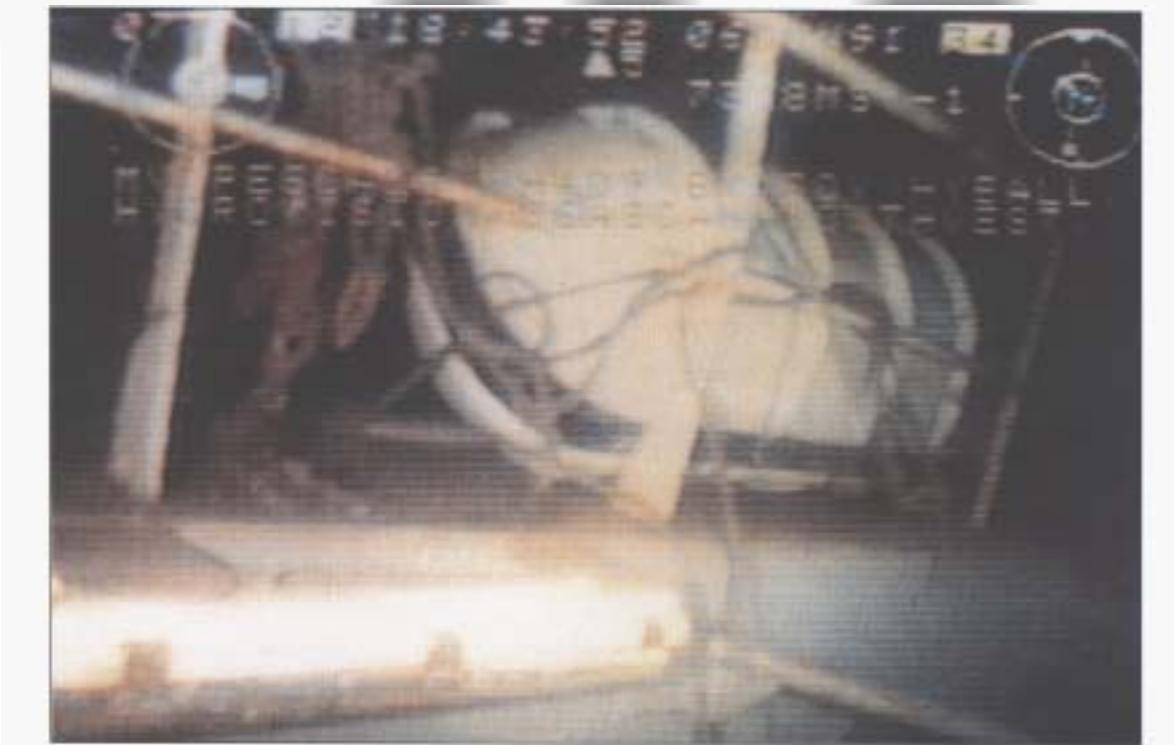
An inflatable liferaft in its fibreglass container, was seen on the port aft side on top of the deckhouse. Although it appeared not to be secured by any means other than its painter attached to the adjacent rail, it had not floated free. The rails were bowed. The surveys revealed no sign of a HRU fitted to the liferaft, or a EPIRB.

Figure 3: Underwater photograph shows liferaft against guard rails

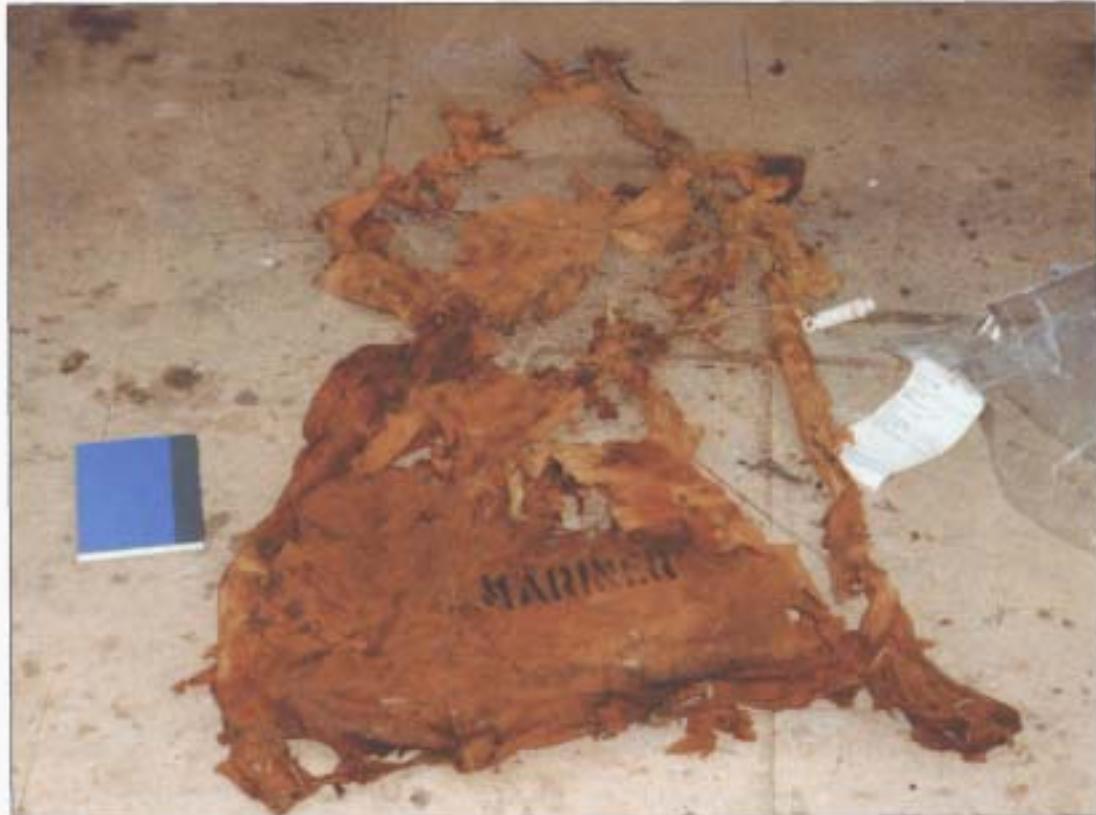
Figure 5: Disintegrated lifejacket recovered with PESCADO

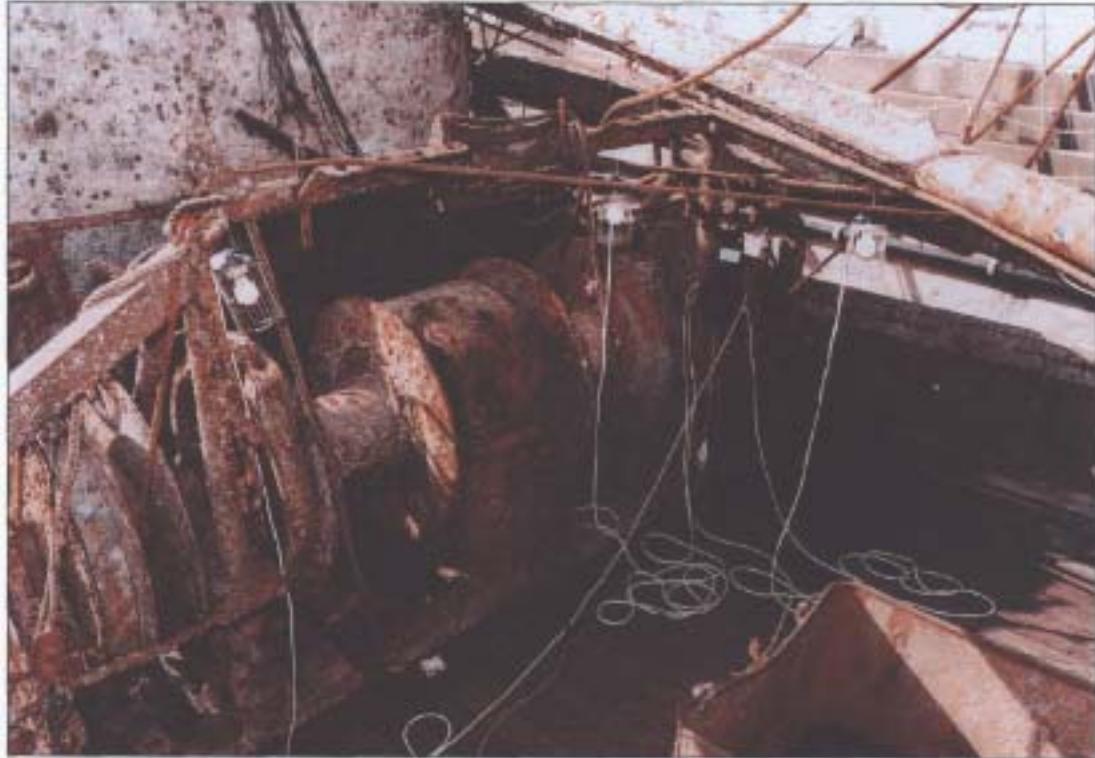
There was no wire on the port and starboard towing warp drums. The topping wires were taut from the starboard drum to derrick and slack on the port side. The clutches and brake settings were as observed during the underwater survey, see Section 1.9.4.

The control lever to the hydraulic power drive from the main engine was confirmed in the engaged position.

Figure 6: View of the fishing winch after vessel's recovery. [Photograph by courtesy of the Chief Constable of the Devon and Cornwall Constabulary]

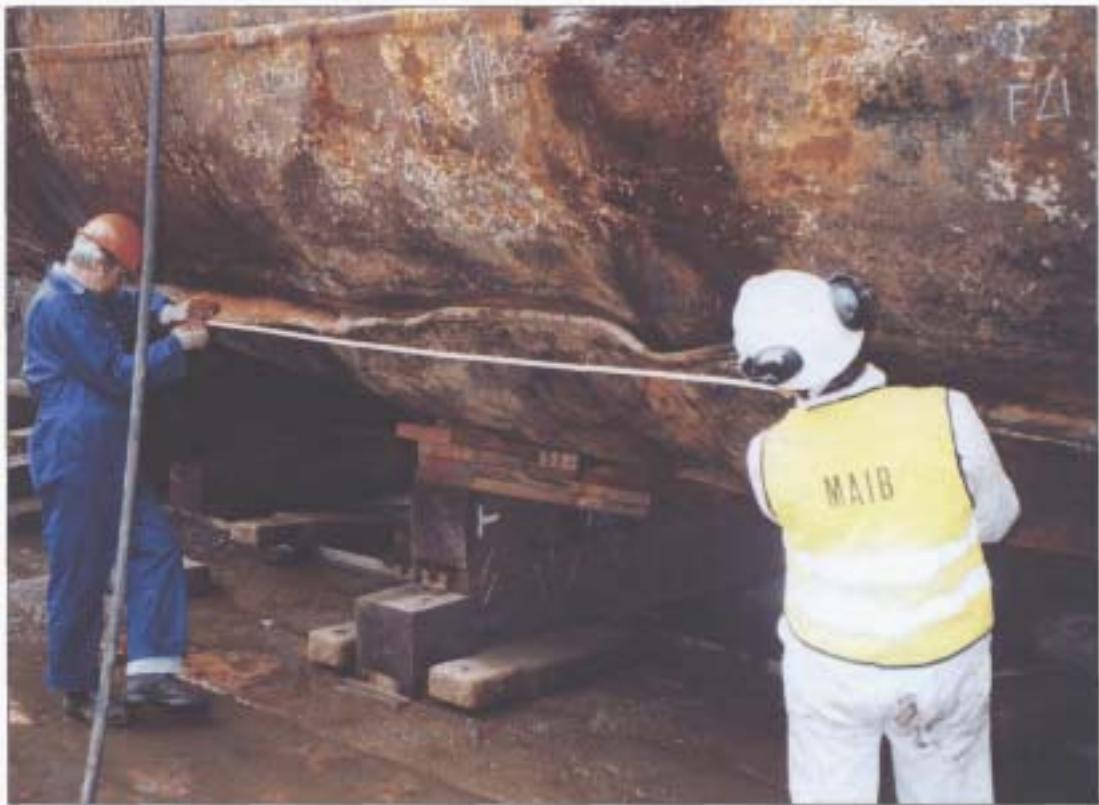
Part of the bilge keel on the starboard side was found pushed upwards against the hull. The damage was tucked in at the turn of the bilge and was well inside the breadth of the vessel. The observed damage form was waved and distorted with impact to the hull plating, extending about two metres (about 9% of the vessel's length). The plating had not been penetrated, but was stove in either side of the forward engine room bulkhead. This can be seen in Figure 7 below. As no angular impact damage has been seen the impact which caused the damage was applied at a right angle to the hull. The framing inboard also showed distortion damage.

Figure 7: Damage in way of starboard bilge keel

The vessel's structure in the vicinity of the damage was analysed by a number of professional structural engineers and MAIB Inspectors. An extremely detailed inspection was made of the indented part of the hull which revealed there was no evidence of "steel to steel" contact which would have occurred had there been a collision with another vessel. It is therefore concluded that the damage was not caused through contact with another vessel but by uniform pressure exerted on that part of the hull where it impacted heavily on the sea bed that comprised a sand upper surface on a solid base.

The MAIB tested the hypothesis that the distortion to the bilge keel observed on PESCADO, was the result of a collision with the bulbous bow of a merchant ship. It was found that such an impact would be most likely to force the bilge keel downwards, as is indeed shown in Figure 11, and not upwards as on PESCADO, see figures 7 and 12 .

The damage observed on the hull of PESCADO is shown in Figures 7 and 12. Whilst it appears similar (only a comparison of photographs of the respective damage has been made) to that observed after a collision between a fishing vessel and the bulbous bow of a small tanker (reported above), it differs in one significant respect – the bilge keel is deflected up and not down. However, this comparison supports the conclusion reached by the MAIB as the result of some basic calculations for PESCADO; in a collision where the initial impact is transmitted through a bulbous bow the bilge keel will almost certainly be deflected downwards. Thus it is concluded that the damage observed on PESCADO was unlikely to have been caused by an impact with a bulbous bow.

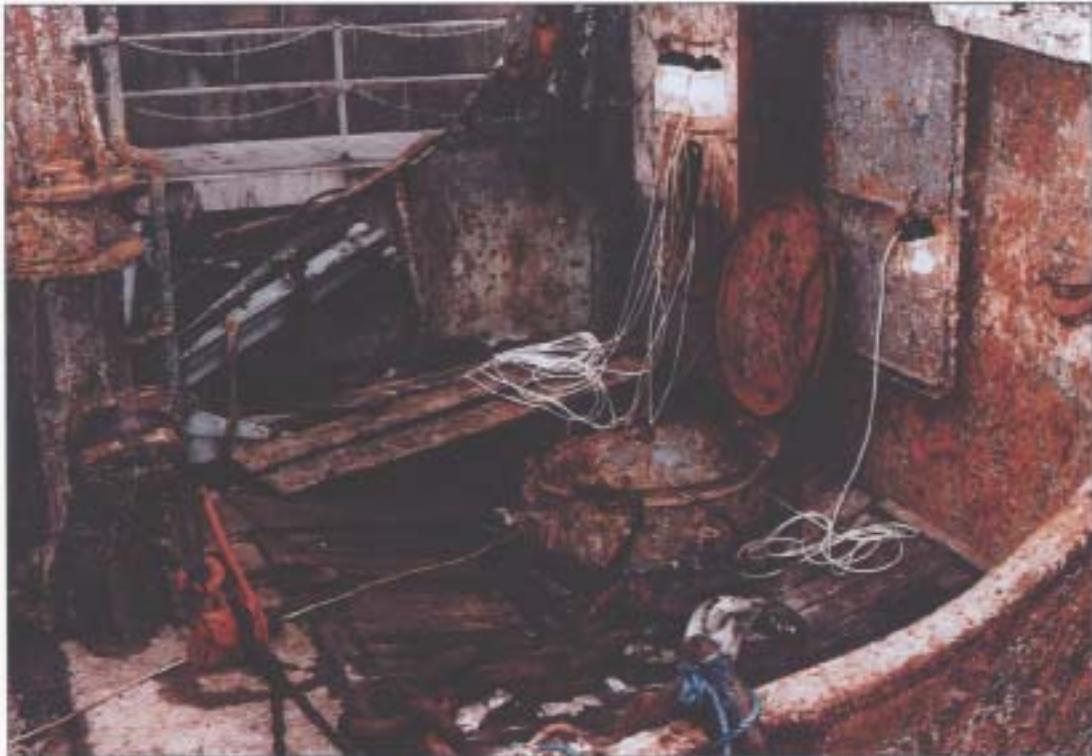
The damage to the deck sheathing, seen on the wreck, occurred as a result of pressure difference. As the vessel sank, atmospheric pressure was maintained in the closed net compartment allowing hydrostatic pressure to build-up on this structure. The resultant weakest part which was the deck, failed, to allow the net space to flood with loss of buoyancy.

Figure 8: View of fore deck showing damage to deck sheathing. [Photograph by courtesy of the Chief Constable of the Devon and Cornwall Constabulary]

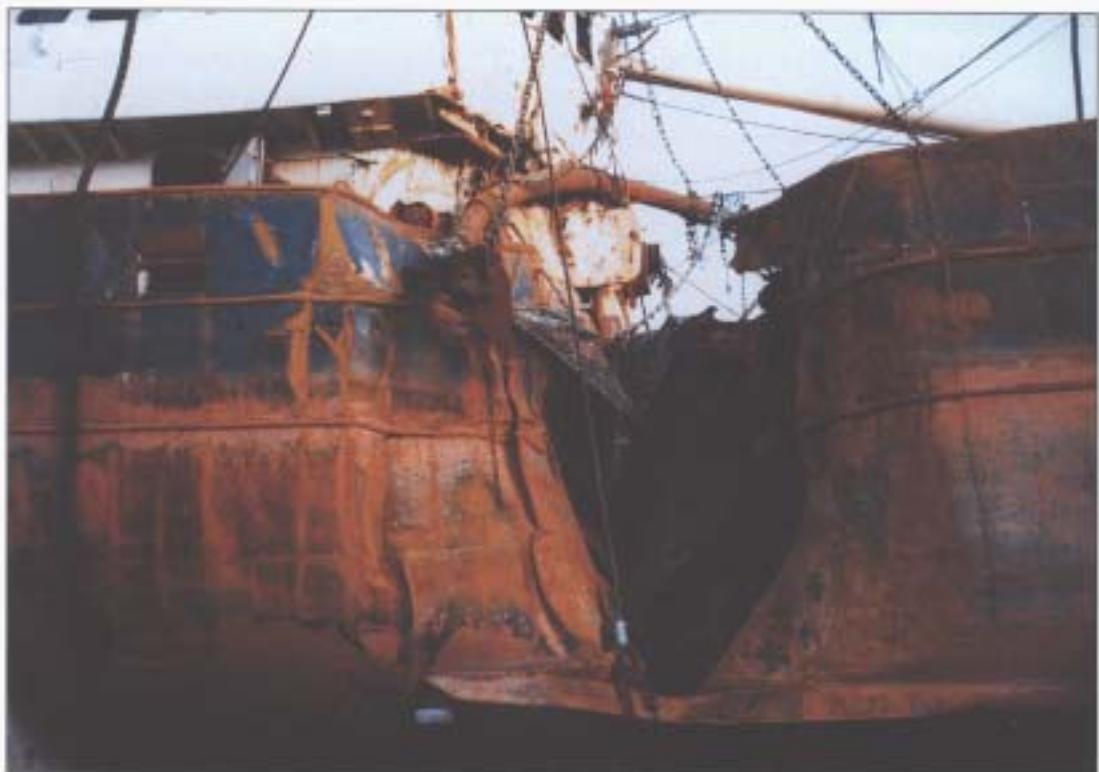
Figure 9: Damage to FV LARISSA shows serious hull failure (Note the bilge keel is bent down and split from the hull)

The damage seen in Figures 9 and 10 are extensive and resulted in the tragic loss of both vessels and their crew. WILHELMINA J was fishing in thick fog when she was in collision with a 8,714 GT vessel. LARISSA was not fishing but crossing a Traffic Separation Scheme in moderate visibility when she collided with a 11,356GT vessel fitted with a bulbous bow.

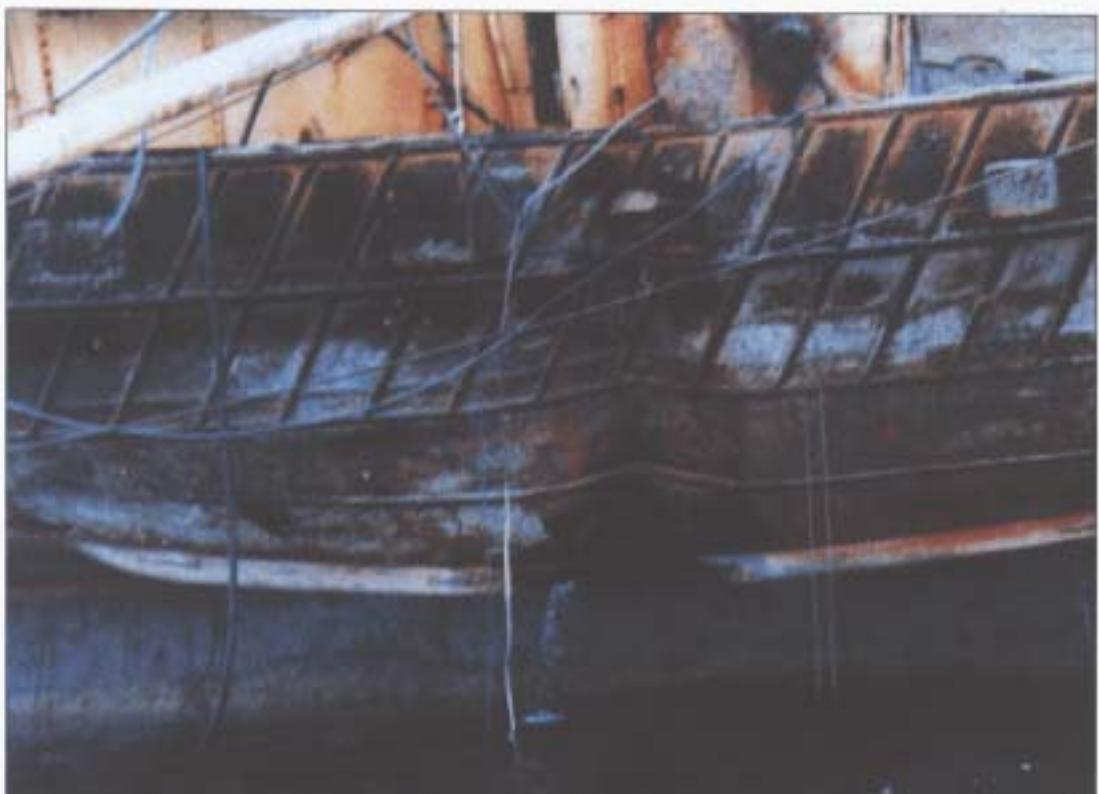
Figure 10: Damage to WILHELMINA J is severe with hull failure from keel to top of rail with damage to derrick and associated gear

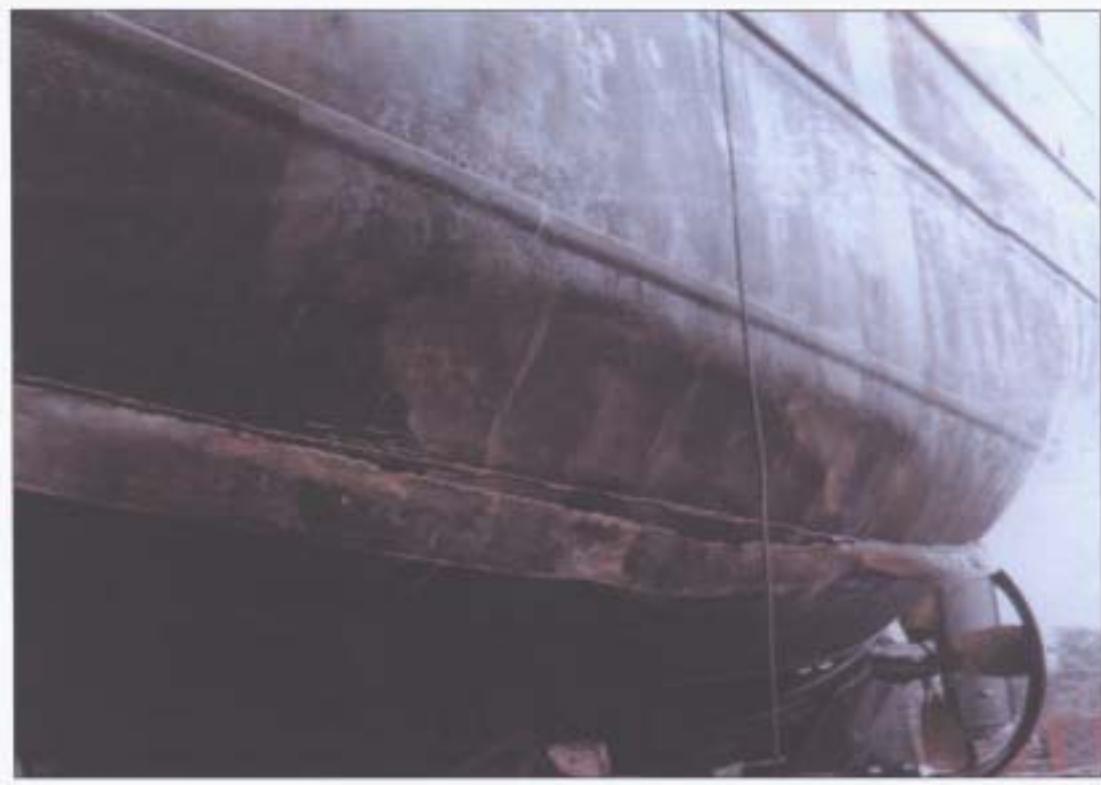
The most obvious difference between this damage and that seen on PESCADO is that on this vessel the bilge keel was bent downwards whilst on PESCADO it was bent upwards. No details on the geometry of this damage were available to compare with the “flattened” bilge plating seen on PESCADO.

Figure 11: Photograph shows minor collision damage with bulbous bow vessel (Note bilge keel is deflected downwards and split away from the hull) [Photograph courtesy of Hodge Jones and Allen, Solicitors]

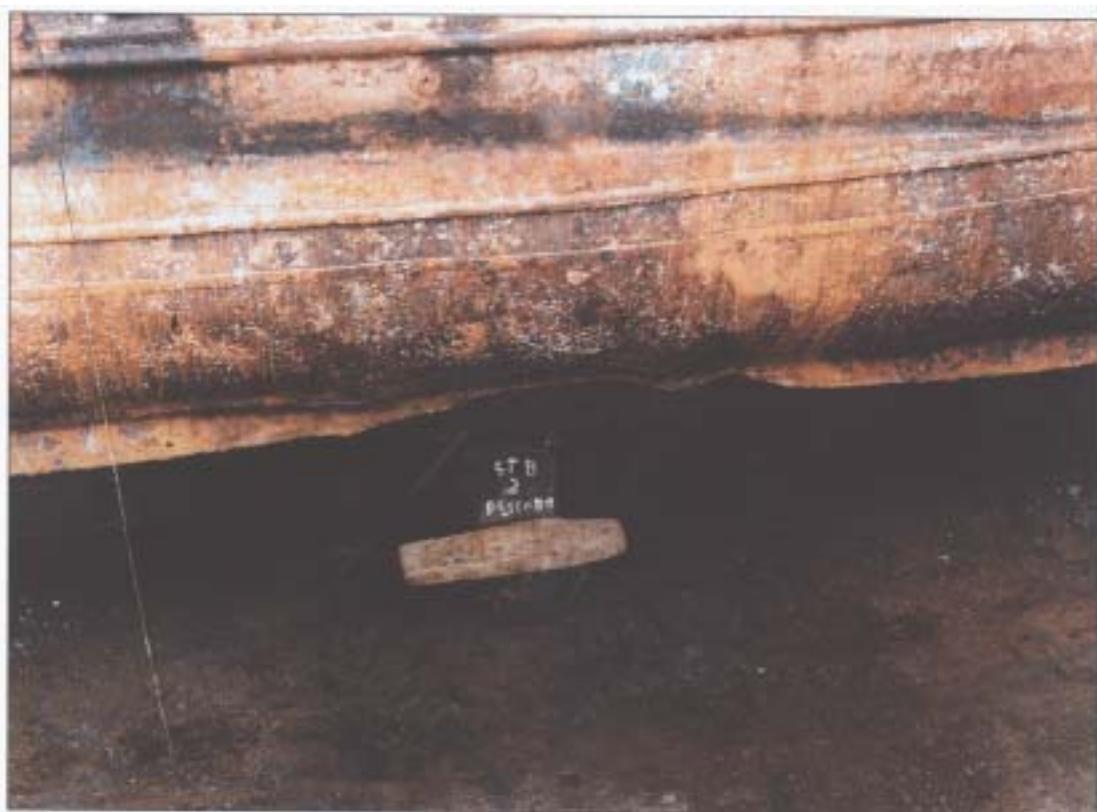
The hull was very rusty and covered with marine growth. The port side was undamaged while the starboard side was intact except for the local damage shown in Figures 7 and 12.

Figure 12: Local damage to PESCADO's starboard side as seen in dry dock [Photograph by courtesy of the Chief Constable of the Devon and Cornwall Constabulary]

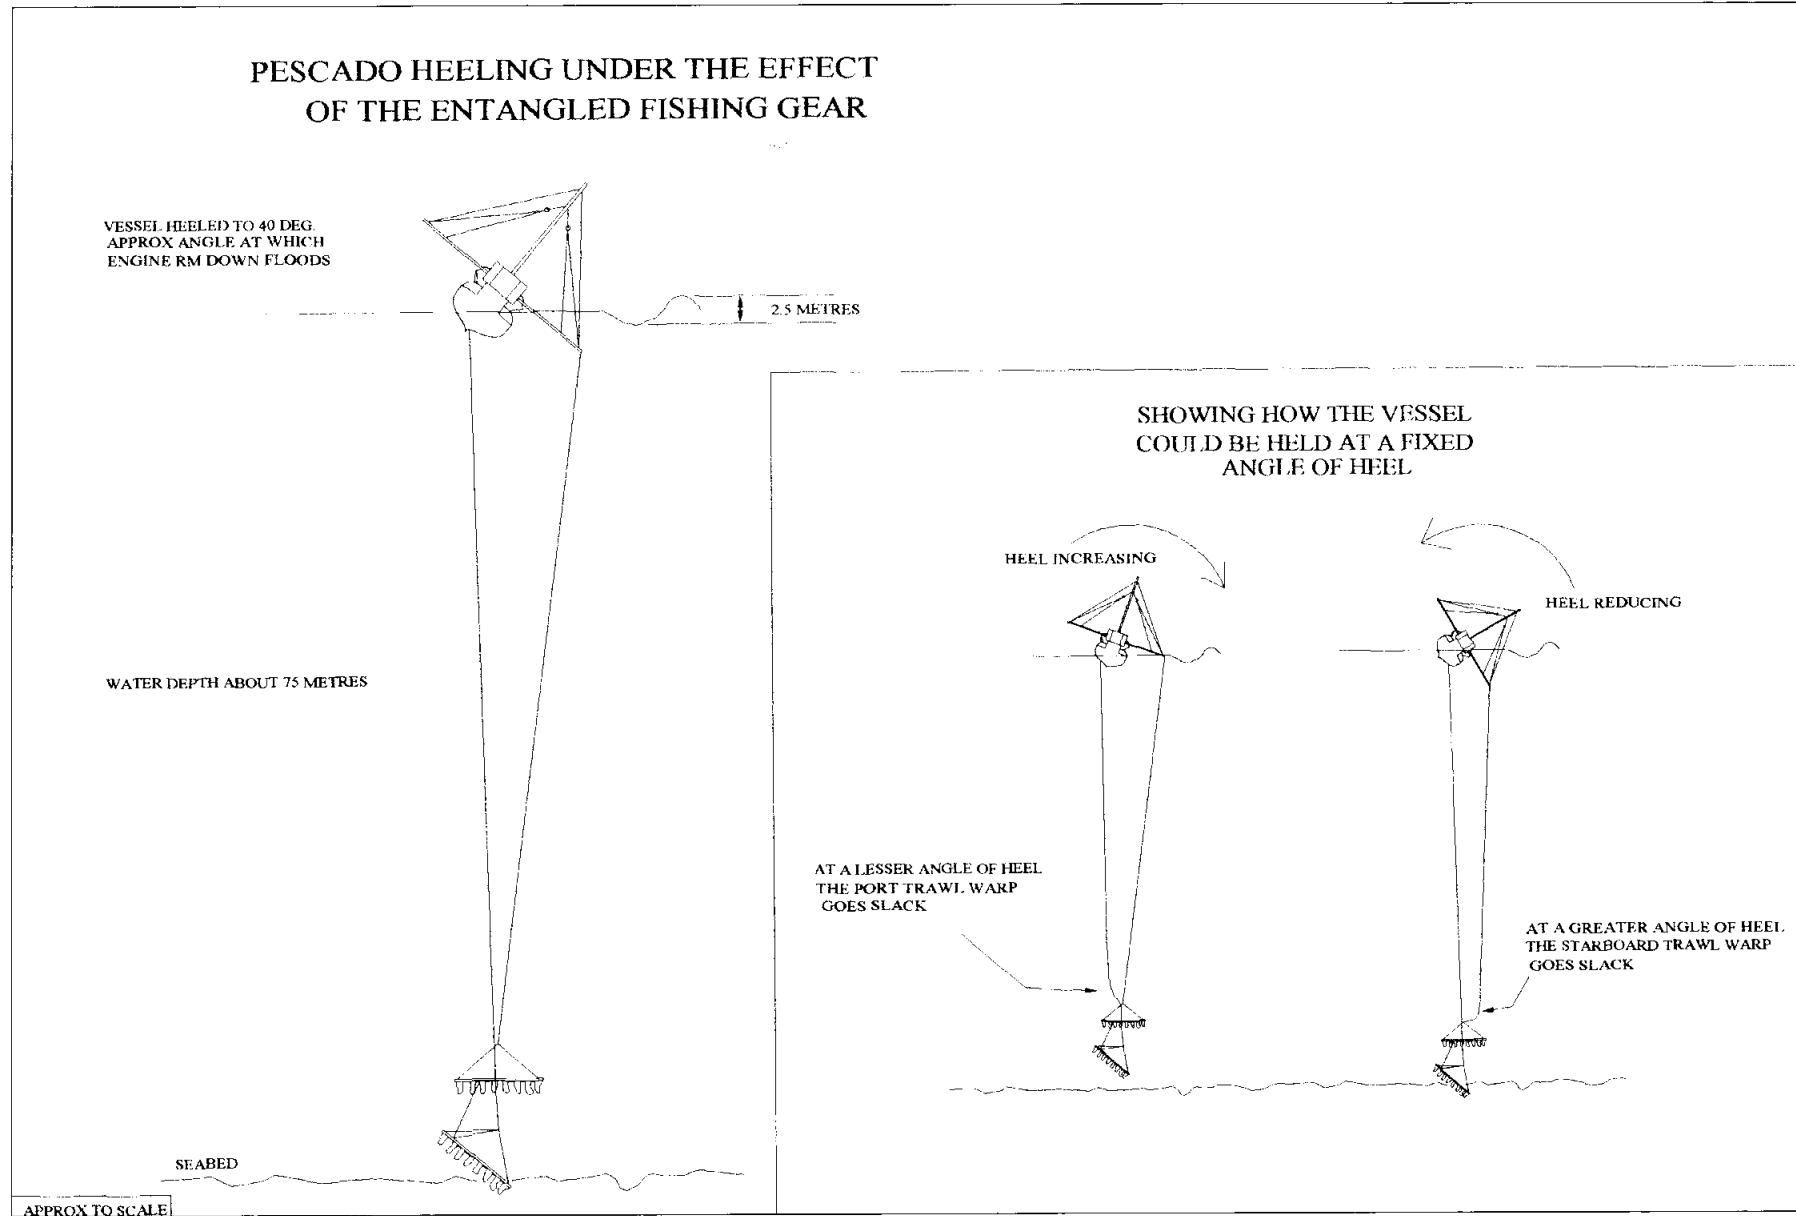
Figure 13

The weight of both sets of gear coming onto the extended starboard derrick, as seen in Figure 13, would have induced a much larger angle of heel than expected.
