Report of the Investigation into the
Sinking of the Fishing Vessel

PREMIER

with the Loss of six lives
on 12 December 1990

Marine Accident Investigation Branch
5/7 Brunswick Place
SOUTHAMPTON
Hants SO1 2AN

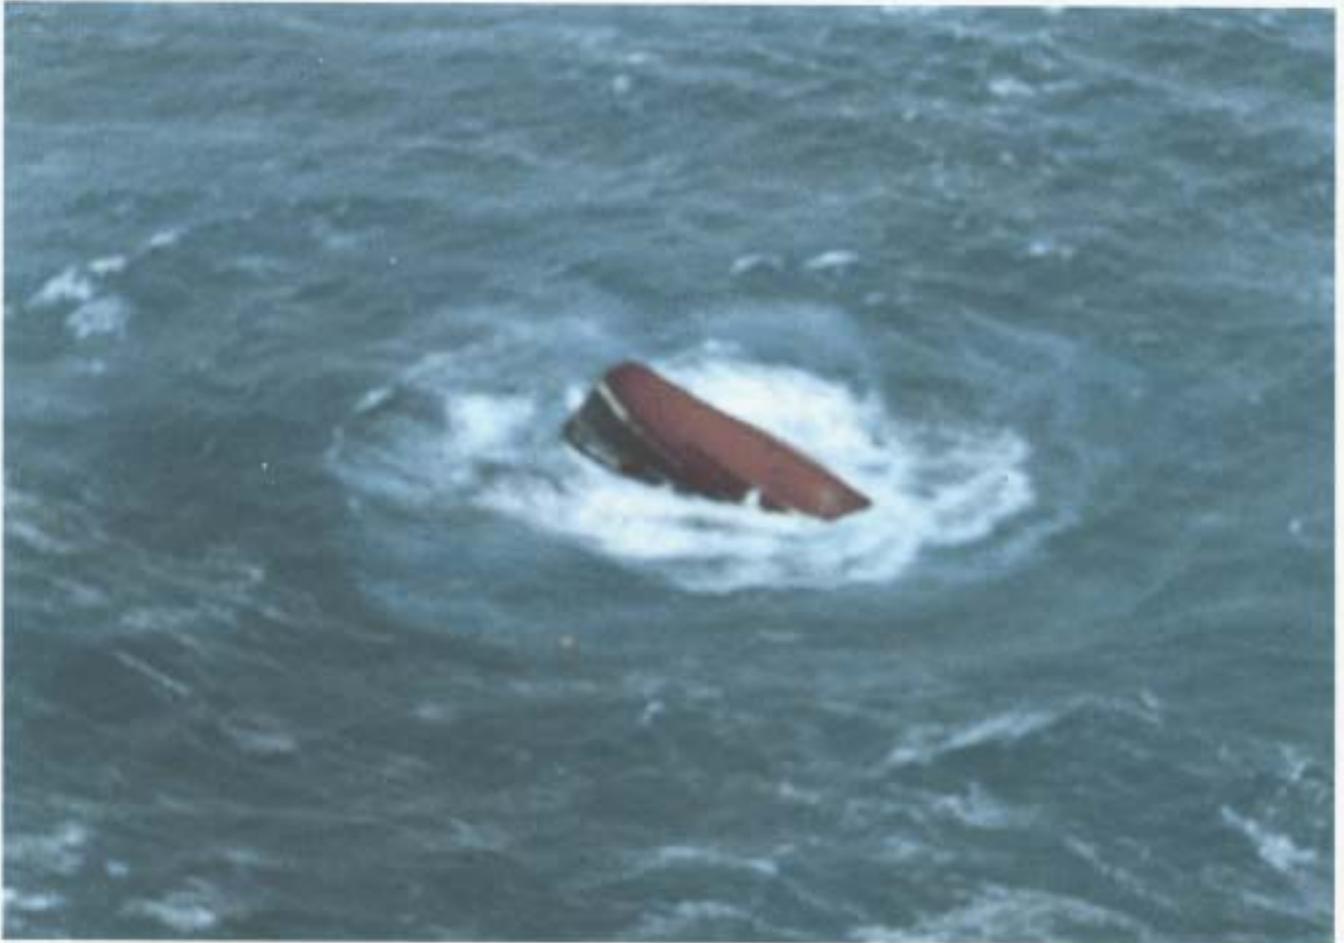
Figure 2

- 3.6 A full scale Search and Rescue Operation was mounted which included three helicopters, nine surface craft and the Lerwick Lifeboat, plus two RAF Nimrods. The capsized vessel was located at 0822 hours, and a winchman was lowered to the vessel and to inspect an inflated liferaft, which he found to be empty. In the course of this operation, the winchman was injured (see Figure 2).

FV PREMIER after capsized

and prior to sinking
