Marine Accident Report 4/98

Report of the Inspector's Inquiry
into the loss of the Fishing Vessel

WESTHAVEN AH 190

with four lives on 10 March 1997
in the North Sea

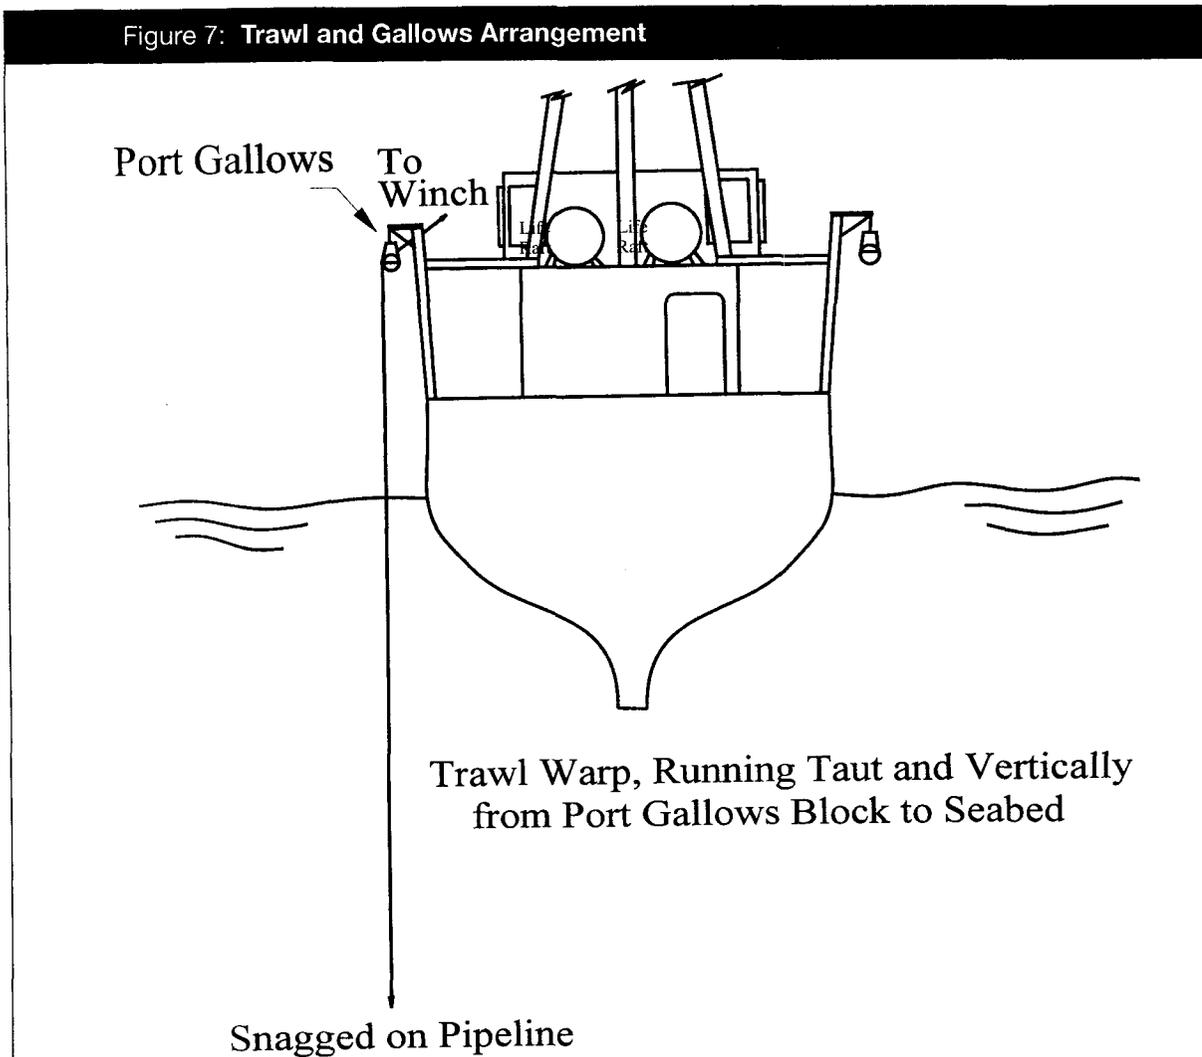
Figure 7: Trawl and Gallows Arrangement

The tension in the port trawl warp, caused by the efforts to pull the gear free, would have exerted an almost vertical pull at the port gallows block, as shown in FIGURE 7. Calculations have indicated that a vertical force of about 10 tonne, acting at the port gallows, would have been required to capsize WESTHAVEN. This force is considerably less than the breaking strength of the port trawl warp.

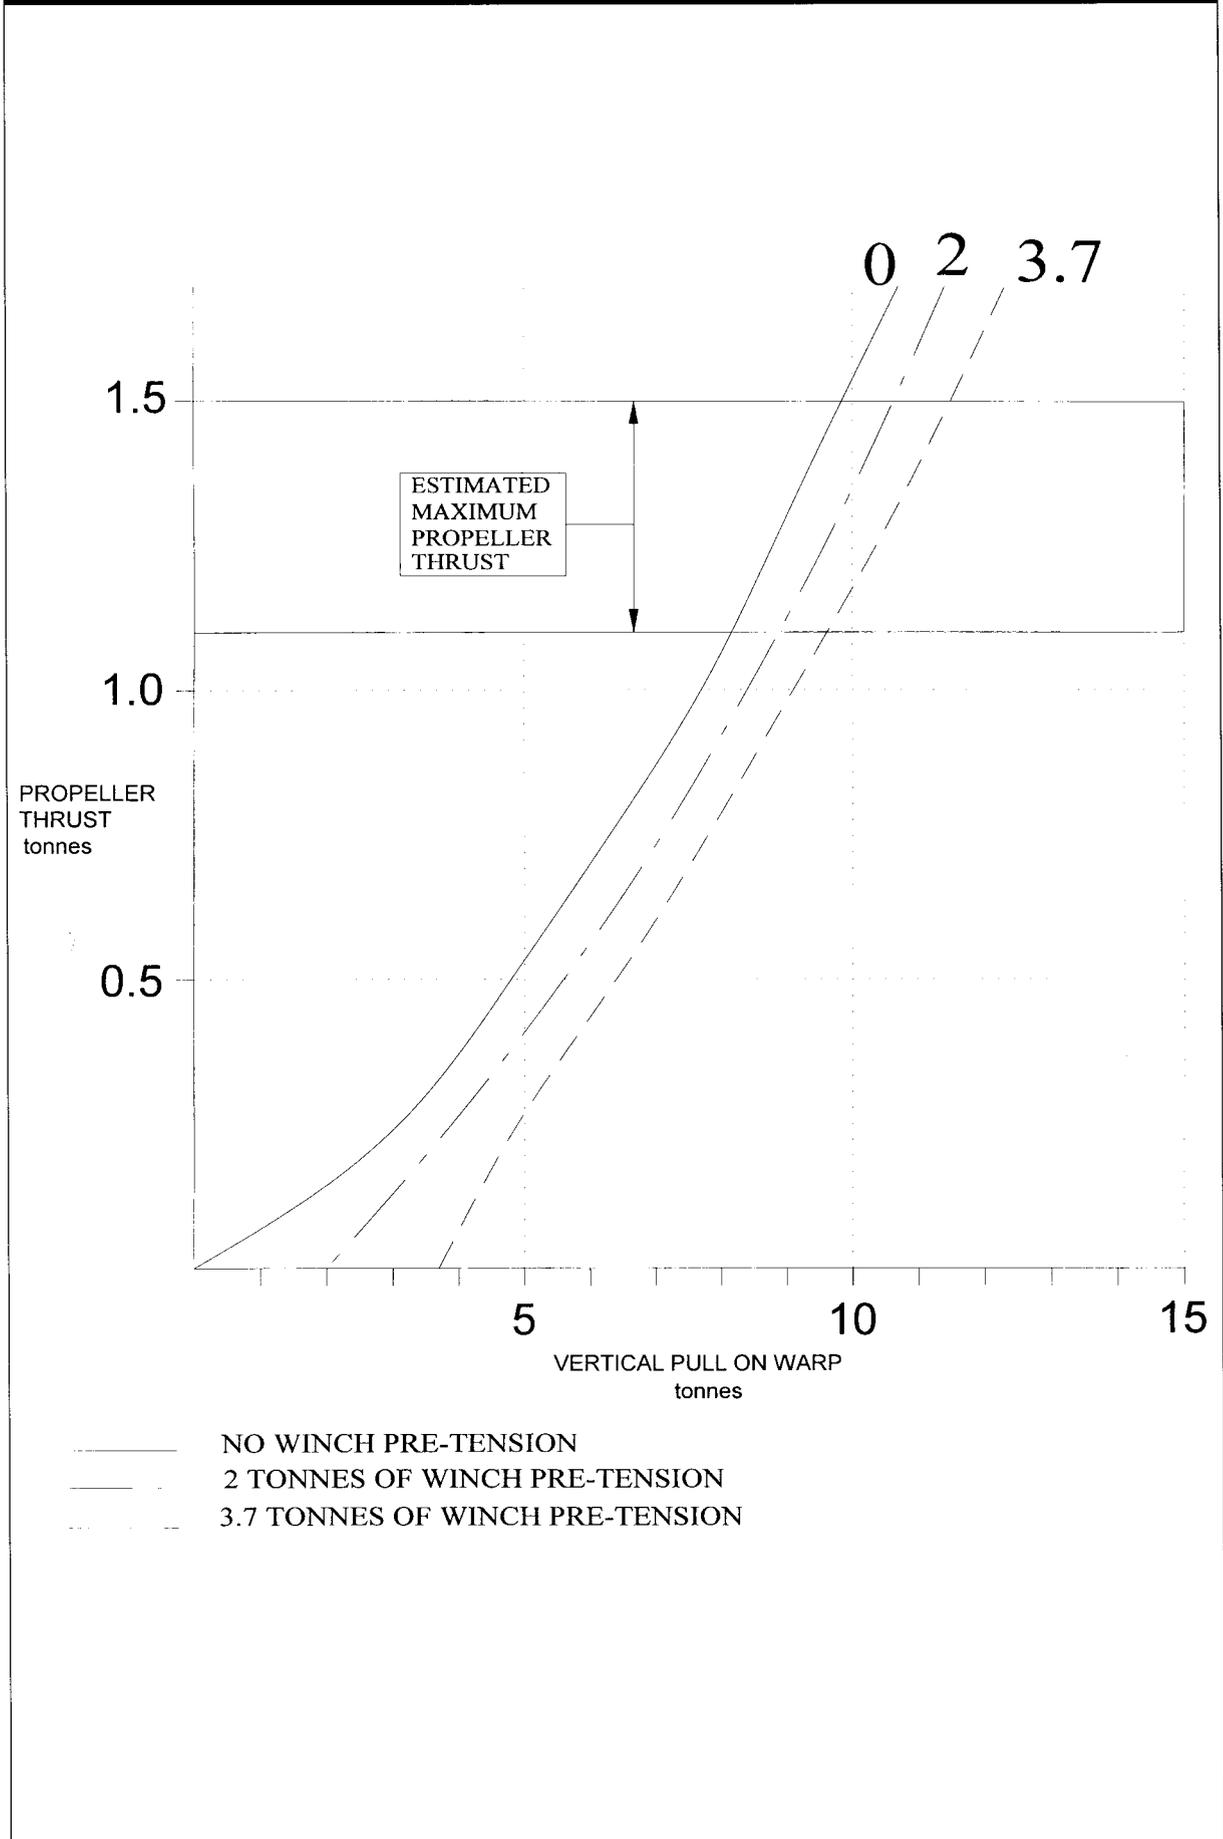
Figure 8: The effect of winch pre-tension and applied propeller thrust on the vertical pull at gallows

Diagrams linking the effects of winch pull, propeller thrust and swell, are shown in FIGURES 8 to 11. It can be seen from FIGURE 9 that until the point where the edge of the main deck becomes immersed, the angle of heel increases roughly in proportion to the pull on the warp. However, as soon as the deck edge becomes immersed the angle of heel increases rapidly. At the same time, and with escalating effect, the pull on the warp reduces the angle at which the maximum righting lever (maximum GZ) occurs. The point at which these two curves cross is the point at which the heel of the vessel would increase uncontrollably under only the slightest additional pull on the warp, in effect the point at which a capsize is inevitable. At this point the righting lever becomes zero – the point of vanishing stability. For WESTHAVEN the point of vanishing stability would have occurred when the vertical pull from the warp was about 10 tonne.

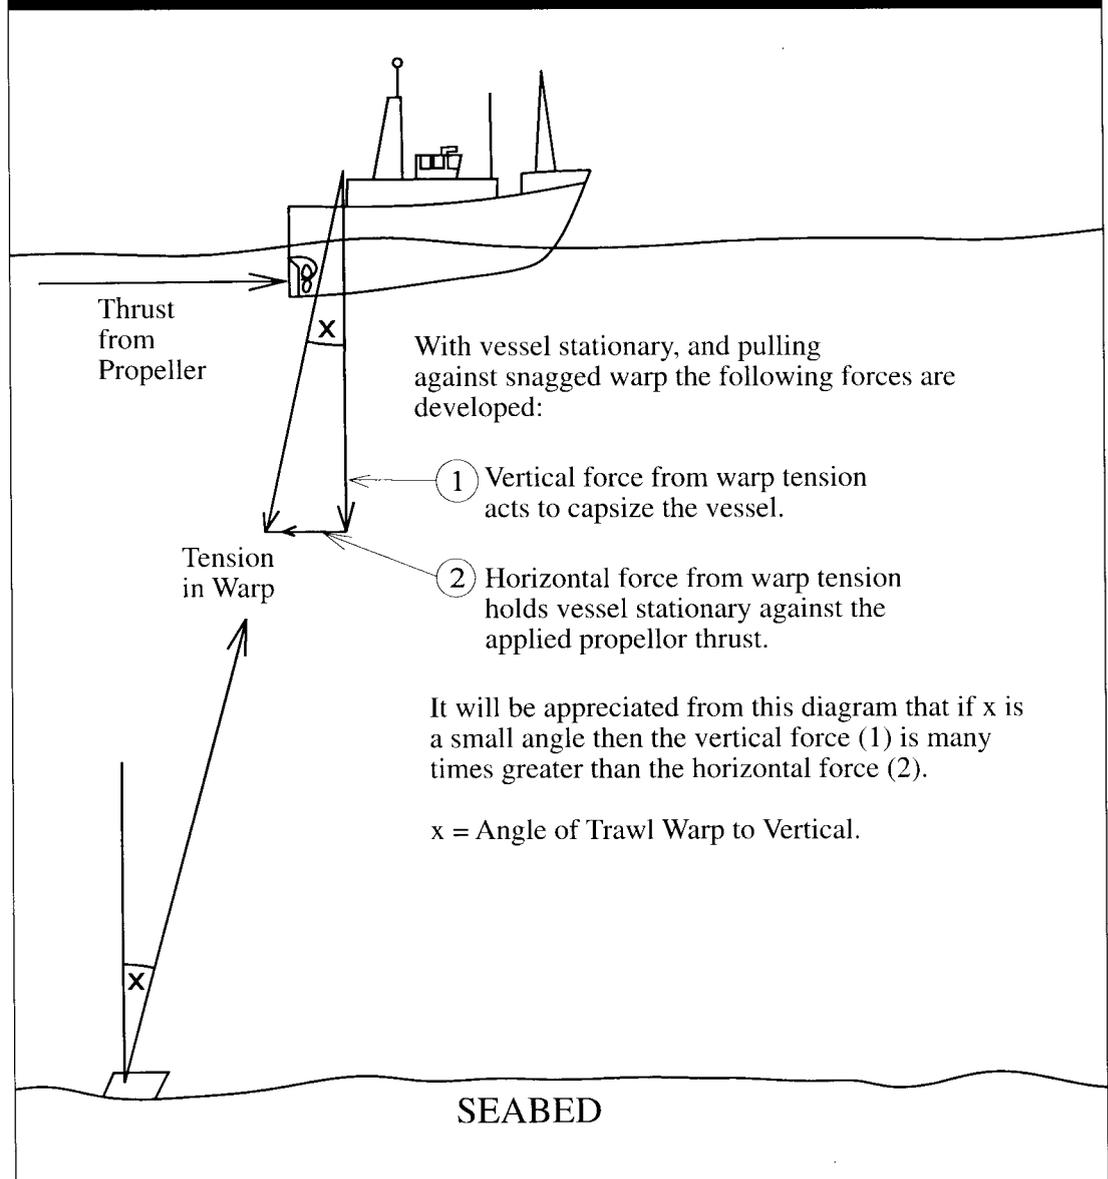
Figure 12: The relationship between propeller thrust and warp tension

WESTHAVEN's engine could produce a maximum thrust from the propeller, at zero forward speed, of between about 1.1 and 1.5 tonne. This is sufficient to produce a downwards force from the taut trawl warp, acting at the port gallows block, of about 8 to 10 tonne. This is explained in FIGURE 12.

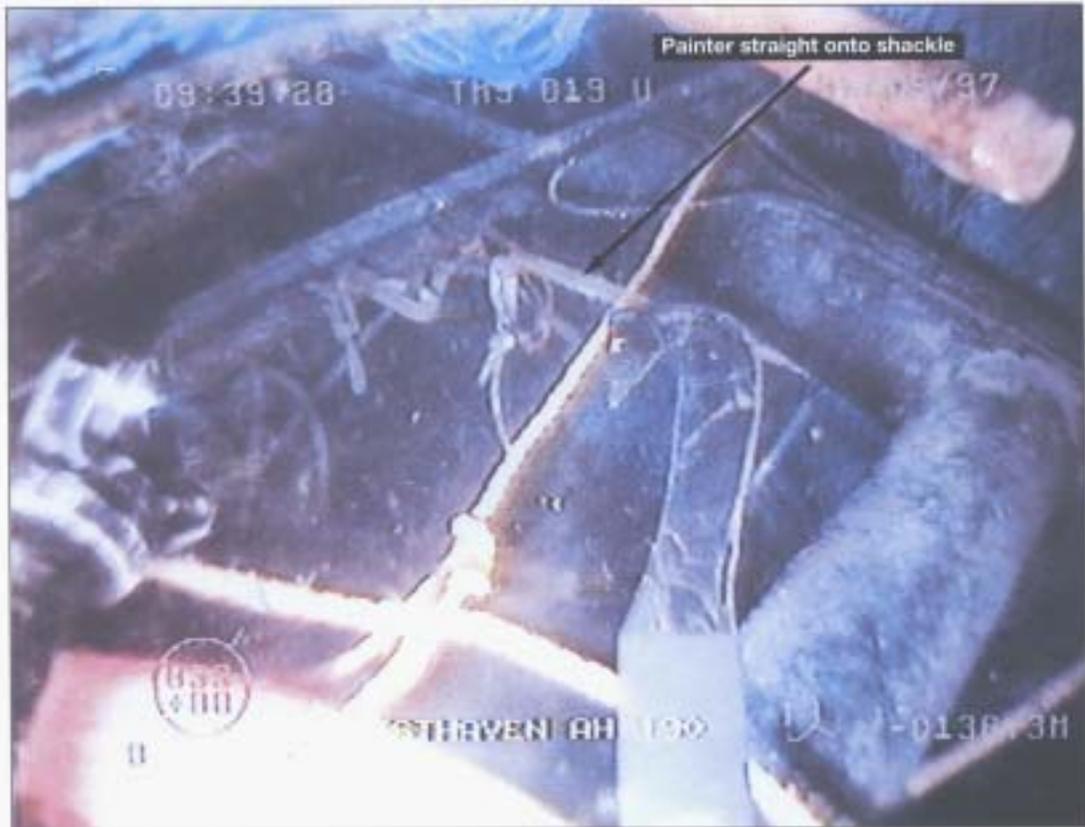
Figure 15: Close-up of the point of attachment of the Port Liferaft Painter

- a The painter to the port liferaft had been connected directly to a strong point and not through the weak link.
- b The remains of a second liferaft attachment point was observed in the same location as the port liferaft connection.
- c The securing point for the starboard liferaft painter could not be examined.
- d The positions of the dog clutch levers on the winches indicated that all three winch clutches were out.
- e There was no sign of the starboard trawl door.
- f The starboard and centre winchdrums were found full of warp
- g The one trawl warp leading from the wreck led to the port trawl door.

The underwater survey conducted on 1 May enabled a close examination to be made of the means by which the port liferaft had been attached to the vessel. It was established that the painter had been secured directly to the vessel, bypassing the weak link in the process. Therefore, the weak link was not able to fulfil its correct function. A photograph taken from the underwater video record showing the connection of the port liferaft painter, is shown in FIGURE 15. The point of attachment of the starboard liferaft painter could not be examined by the ROV.

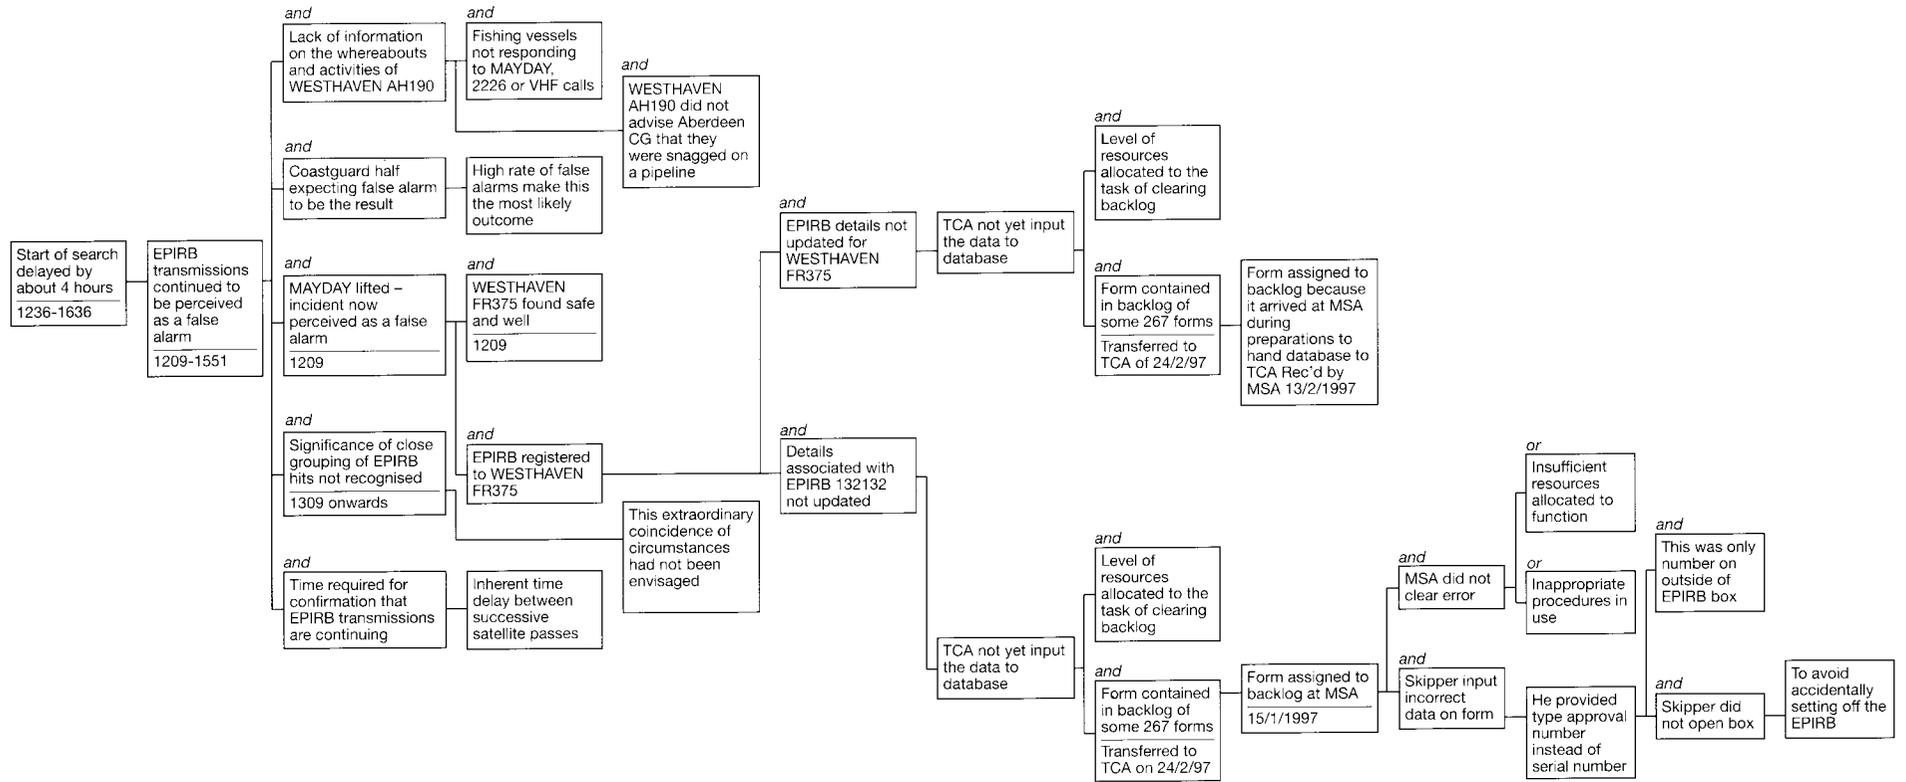
Figure 19: Factors contributing to the delayed start of the search

There were two necessary and independent conditions which had to be met for EPIRB 132132 to have been incorrectly attributed to WESTHAVEN FR375. The first condition was the failure to update the database record for EPIRB 132132 to reflect the change of

ownership of WESTHAVEN. The second condition was the failure to reflect the change of ownership for the fishing vessel CRYSTAL RIVER and register her under the new name WESTHAVEN, and port number FR375. Had either record been updated correctly the initial confusion experienced on 10 March 1997 would not have occurred; since whenever a database EPIRB record is updated with a new vessel name and port number a check is made to ensure the details given are not duplicated.

Neither record had been updated because a backlog of some 250+ EPIRB registration forms had built up in the MSA. This comprised predominantly of registration forms requiring additional work prior to being entered to the database. Information was either missing from these forms, or was in error. Clearing these was potentially time consuming. Notwithstanding these difficulties, the MSA should have dealt with the matter promptly.
