**Fatal manoverboard from the creel fishing vessel**

***Barnacle III***

**west of Tanera Beg**

**13 May 2014**

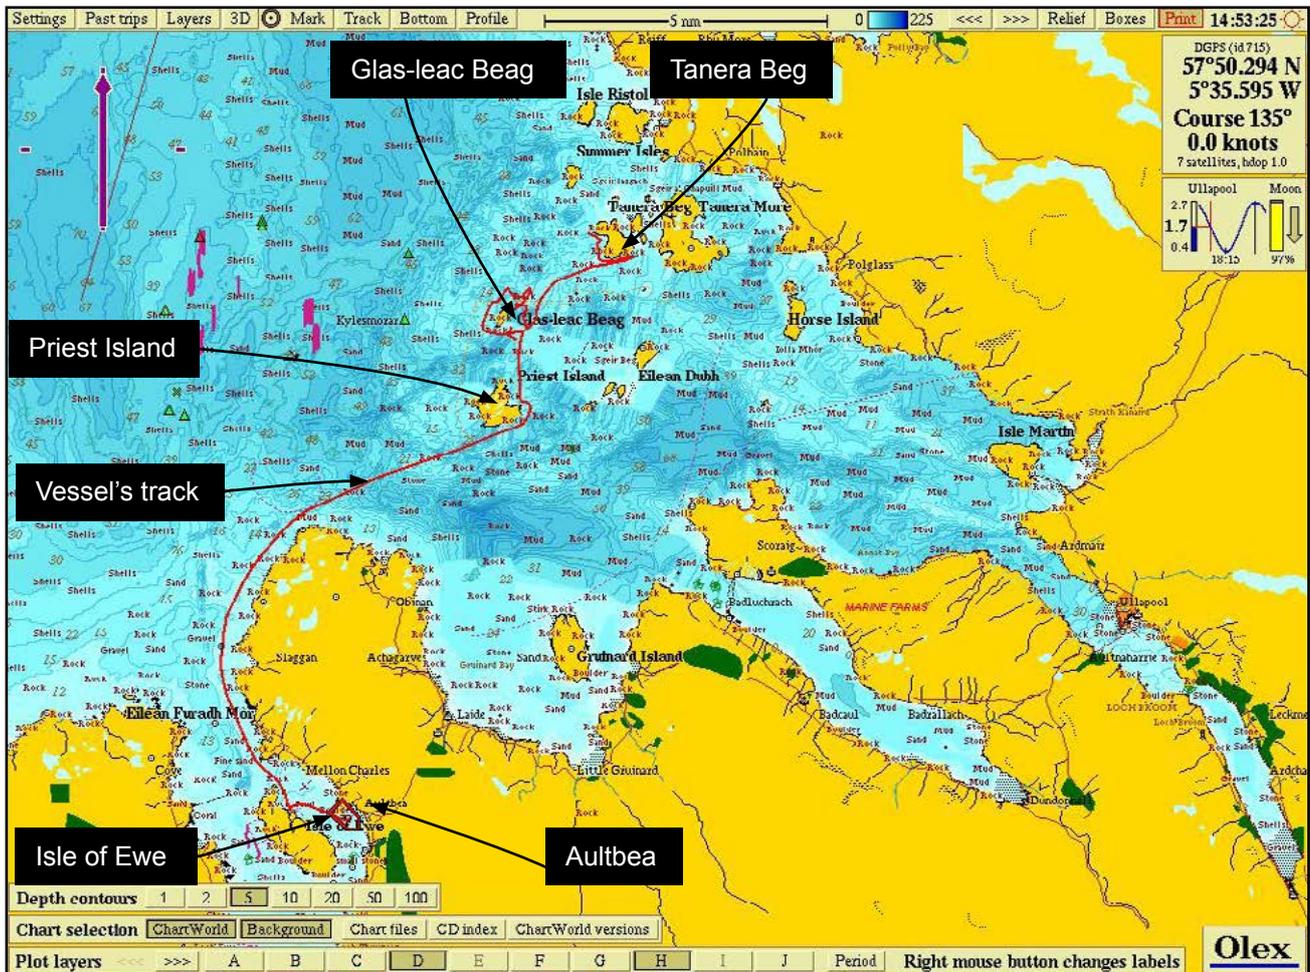
**Figure 2:** Olex navigation system screenshot showing an overview of *Barnacle III*'s movements on the day of the accident

Early on 13 May, *Barnacle III*'s skipper made the short passage from the vessel's mooring at the Isle of Ewe across to Aultbea's pier alone. At about 0555, his crew member Gary Forbes joined the vessel and, shortly afterwards, it sailed towards the fishing grounds via the skipper's pontoon in Loch Ewe. At the pontoon, Gary assisted with landing prawn creels, which had been loaded on board the vessel the previous evening, to the pontoon for drying. Once the creels were landed, the skipper navigated *Barnacle III* towards Priest Island (**Figure 2**) while Gary rested in the vessel's cabin.

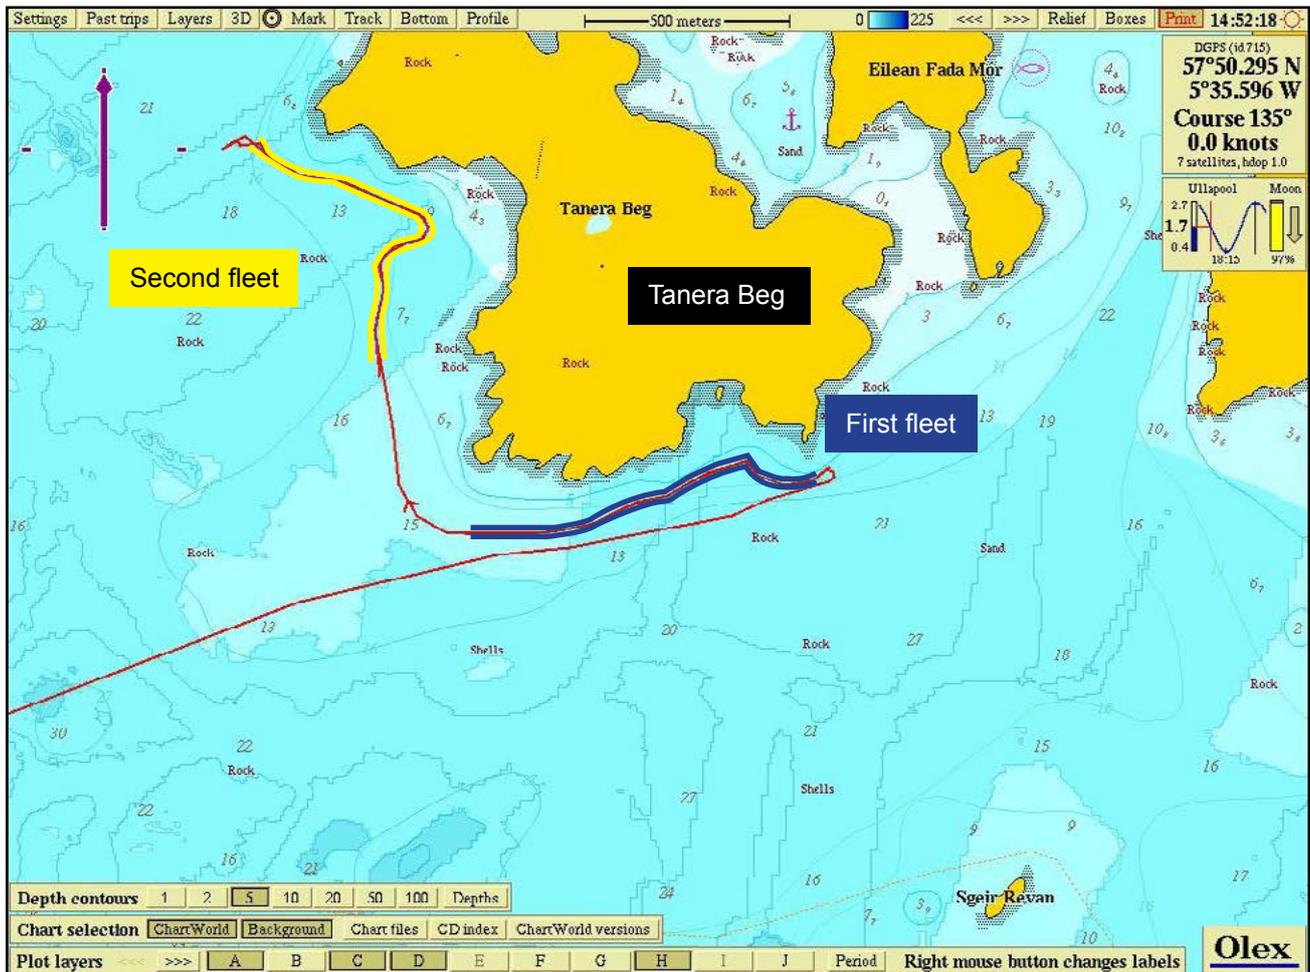
**Figure 3:** Olex navigation system screenshot showing positions of the two fleets shot by *Barnacle III* off Tanera Beg

At 1016, the first of the two fleets was shot to the south of Tanera Beg (**Figure 3**); this took about 4 to 5 minutes. The skipper then manoeuvred the vessel to the west side of the island to shoot the second fleet and, at 1023, instructed Gary to release the fleet's first weight.

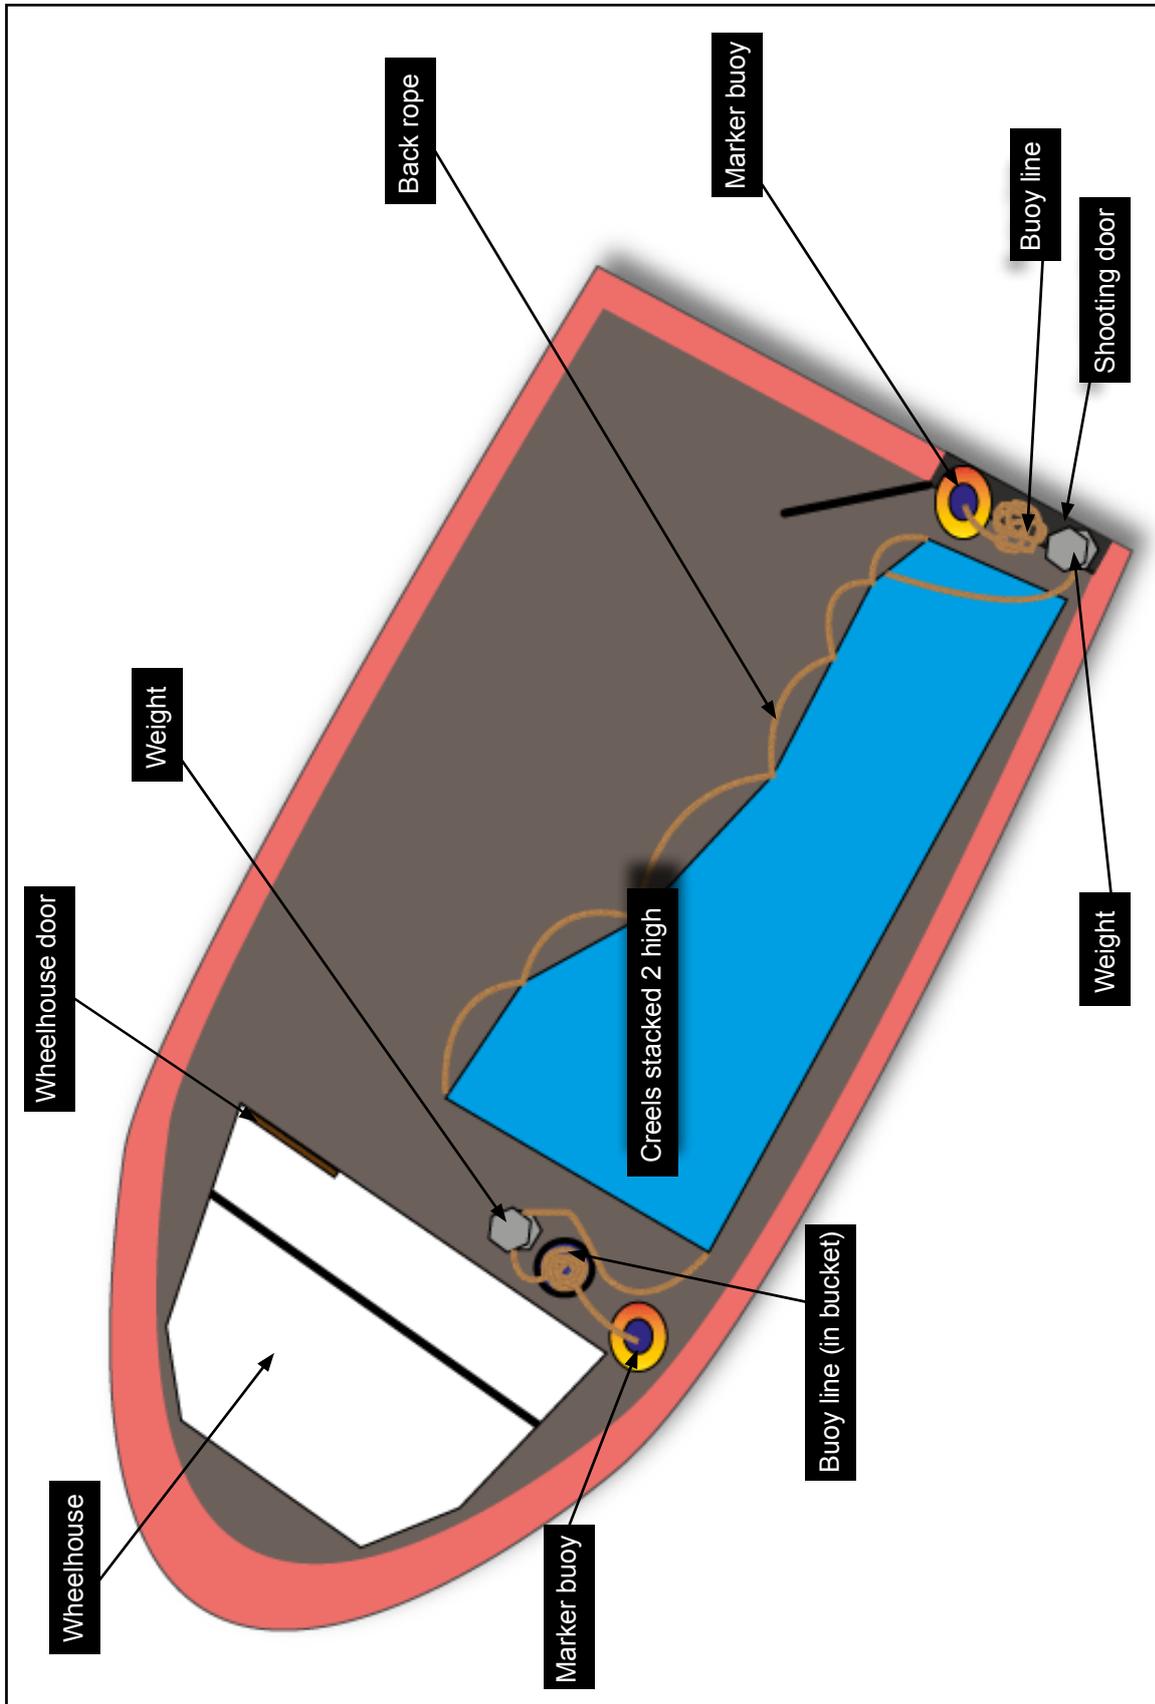
Figure 4: Illustration showing the storage of a single fleet of creels on deck of *Barnacle III*

When working one fleet of creels on deck, the creels were stacked in rows two-high, positioned so that sufficient space remained between the stack and wheelhouse to separate the crew member from the running gear when shooting.

To shoot the gear, the crew member threw the first marker buoy overboard and then released the first weight using a remote release wire operated from a position aft of the wheelhouse. As *Barnacle III* steamed slowly ahead, the tension on the back rope pulled successive creels through the shooting door

while the crew member remained forward of the stack. Once all the creels had been shot, the crew member walked the second weight to the vessel's stern so as to prevent damage to the bulwark frames. The crew member then released the second marker buoy, which was stowed on the port side, aft of the wheelhouse. The buoy was connected to the weight by means of a line of about 80 metres in length that payed out from a bucket stowed forward on deck.

The main safety benefit of a self-shooting arrangement is that it keeps the crew clear of the back rope and therefore reduces the risk of them becoming caught in the running gear and being dragged overboard. With only one fleet of creels stowed on deck, the creels deployed without the need for manual intervention so it was possible for Gary to stand in a position where he did not have to step across the back rope, or buoy line, at any stage of the shooting operation. Despite this system not strictly following the recommended practice of providing a physical barrier between a crew member and the back rope, it nevertheless enabled Gary to remain separated from the running gear.

However, to prevent damage to the bulwark frames, Gary walked the end weight towards the vessel's stern after the creels had been shot. This placed him in a potentially hazardous area due to the close proximity of the buoy line. When working with one fleet, this hazard was partially mitigated by stowing the buoy line in a bucket, which reduced the risk of Gary inadvertently standing in a bight of loose line or having to cross over it.

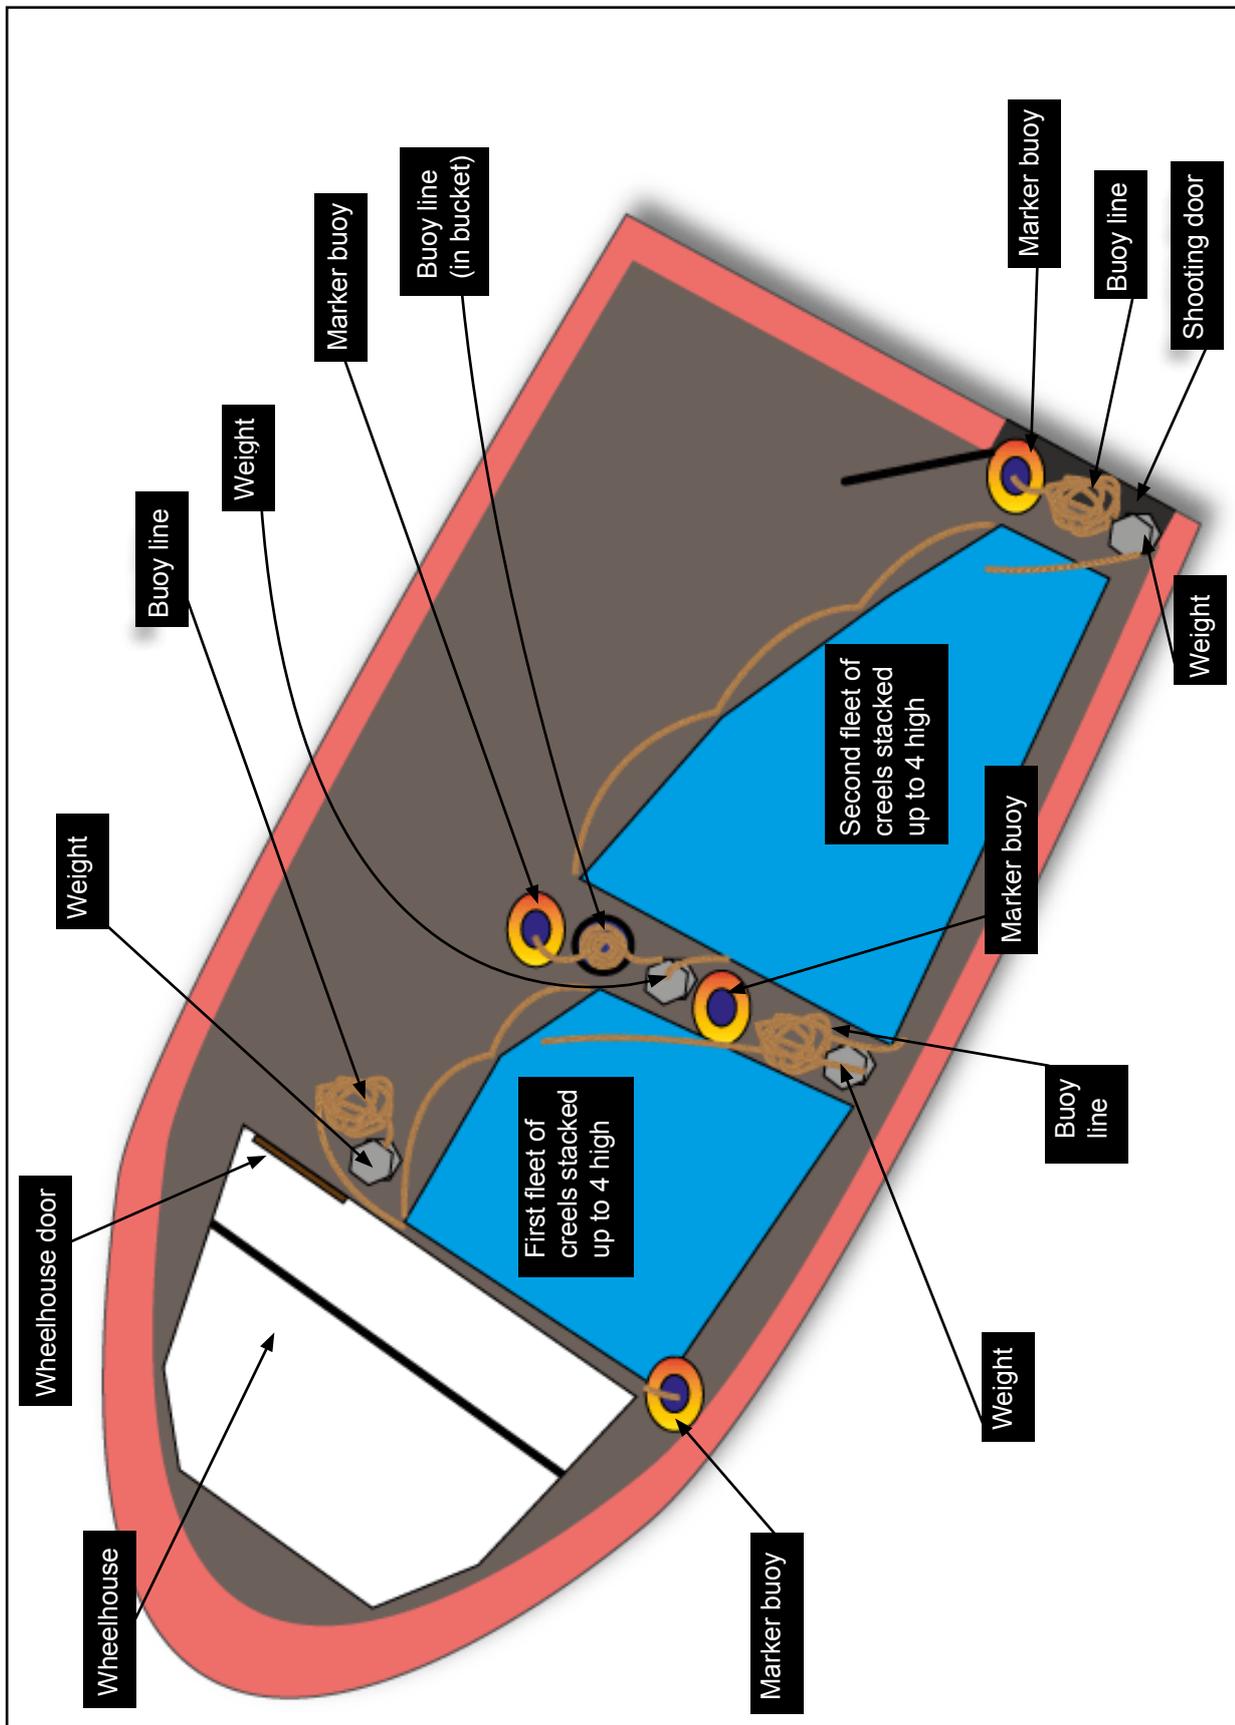
Figure 5: Illustration showing the storage of two fleets of creels on deck of *Barnacle III* (as on the day of the accident)

When working two fleets of creels on deck, the first fleet was stacked in three rows, two of which were four-high, immediately aft of the wheelhouse. The second fleet was then stacked in rows of up to four-high aft of the first fleet, with the stack tapered towards the shooting door.

The second fleet was shot first. The crew member threw the first marker buoy overboard and then released the first weight using the remote release. To prevent the creels becoming tangled together and deploying in a clump, the crew member had to lift down the creels stacked more than two-high, requiring him to step across the back rope. Once the creels had been shot, the crew member then walked the second weight to the vessel's stern and threw the second marker buoy overboard.

The first fleet on deck was shot in much the same way as the second, except that the second buoy line and weight were respectively coiled and stowed close to the wheelhouse door, with the second marker buoy released from its stowage position on the port side, aft of the wheelhouse.

To enable stowage and working of two fleets on deck, creels had to be stacked higher and immediately aft of the wheelhouse. This reduced the amount of free deck space and removed the separation between Gary and the running gear. Importantly, it also required him to repeatedly step across the back rope to lift down the upper tiers of creels to prevent the stack collapsing and becoming entangled, and to step across the buoy line to release the second marker buoy.

Given the length of the buoy line, the distance at which Gary surfaced from *Barnacle III* and the absence of Gary's right wellington boot, it is concluded that Gary's right leg probably became caught in the buoy line either while he was walking the weight to the vessel's stern, or shortly afterwards.

While changes had been made to the system of work to enable the stowage of a second fleet of creels on deck, insufficient changes had been made to the shooting operation to adequately control the consequent additional risks of a crew member becoming entangled in the running gear.

The system of work when shooting two fleets of creels on board *Barnacle III* did not sufficiently separate the crew member from the running gear, in contrast to the above published advice. An option existed to remove the upper tiers of creels prior to shooting each fleet so as to remove the need for a crew member to step across the running gear. Additionally, a running board, or similar, could have been fitted inboard of the bulwark to prevent damage to the frames when the second weight was pulled across the deck.

- Acquired an extra bucket to stow the additional buoy line when a second fleet of creels is worked on deck.
- Introduced a policy requiring all *Barnacle III*'s crew to wear PFDs while working on deck.
