Report on the investigation of the fatality
of a rescue boat crewman on board

Tombarra

at Berth 3, Royal Portbury Docks,

Part A - The failure of the fall wire

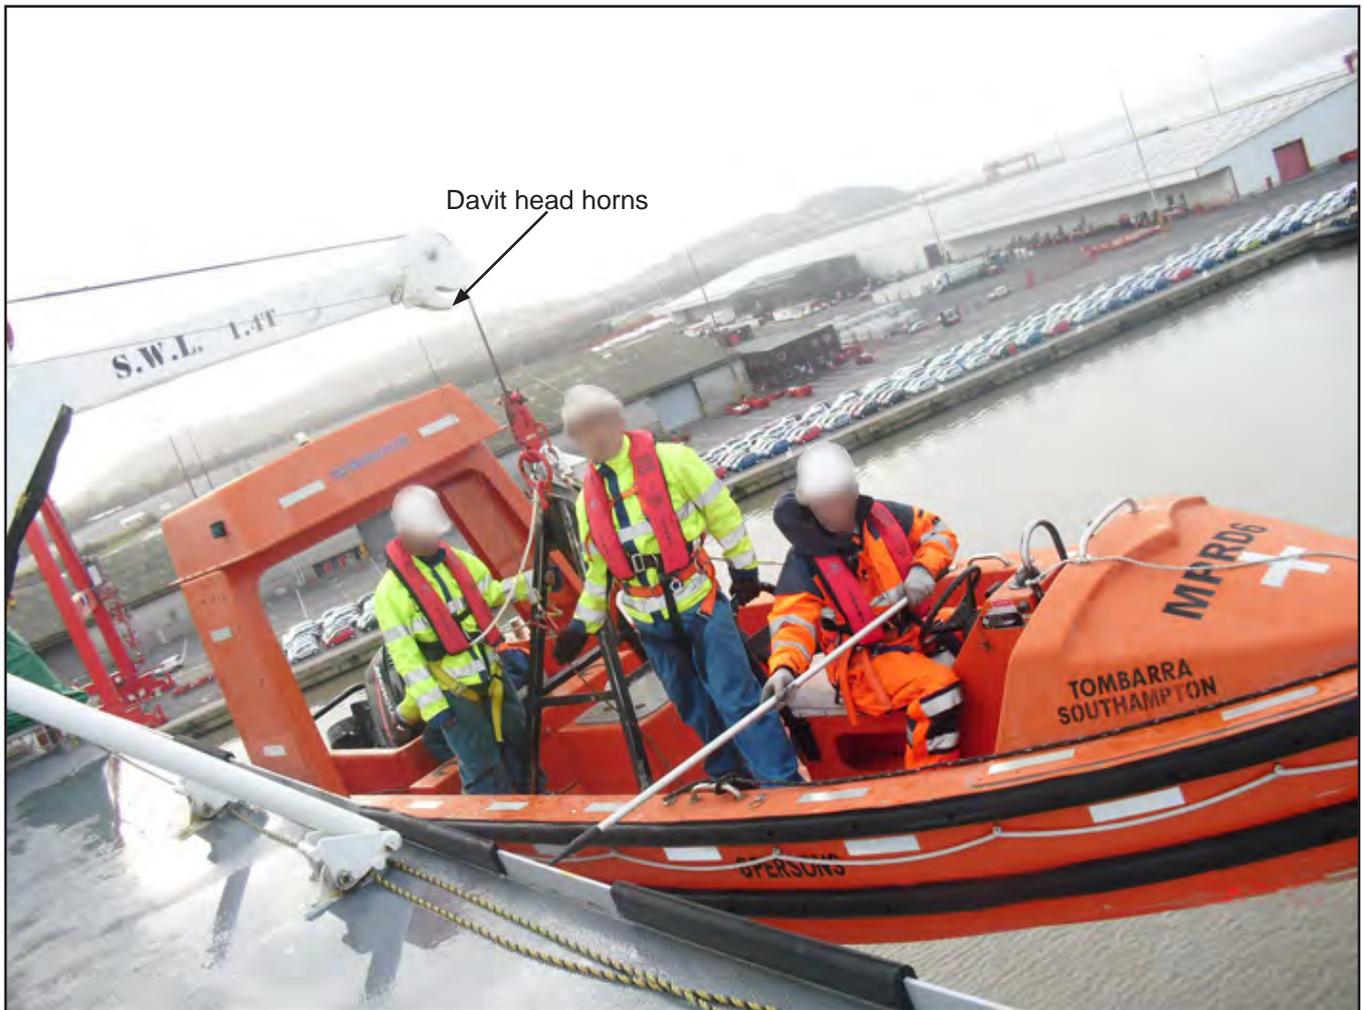
Figure 5: Rescue boat recovery

The hoisting of the rescue boat was recommenced, this time with the bosun keeping the low speed button depressed to bring the davit arm and rescue boat towards their fully stowed positions. The chief officer and the deck AB steadied the boat and the chief officer also checked that the guide pins on the fall wire hook were correctly housed in the davit head horns.

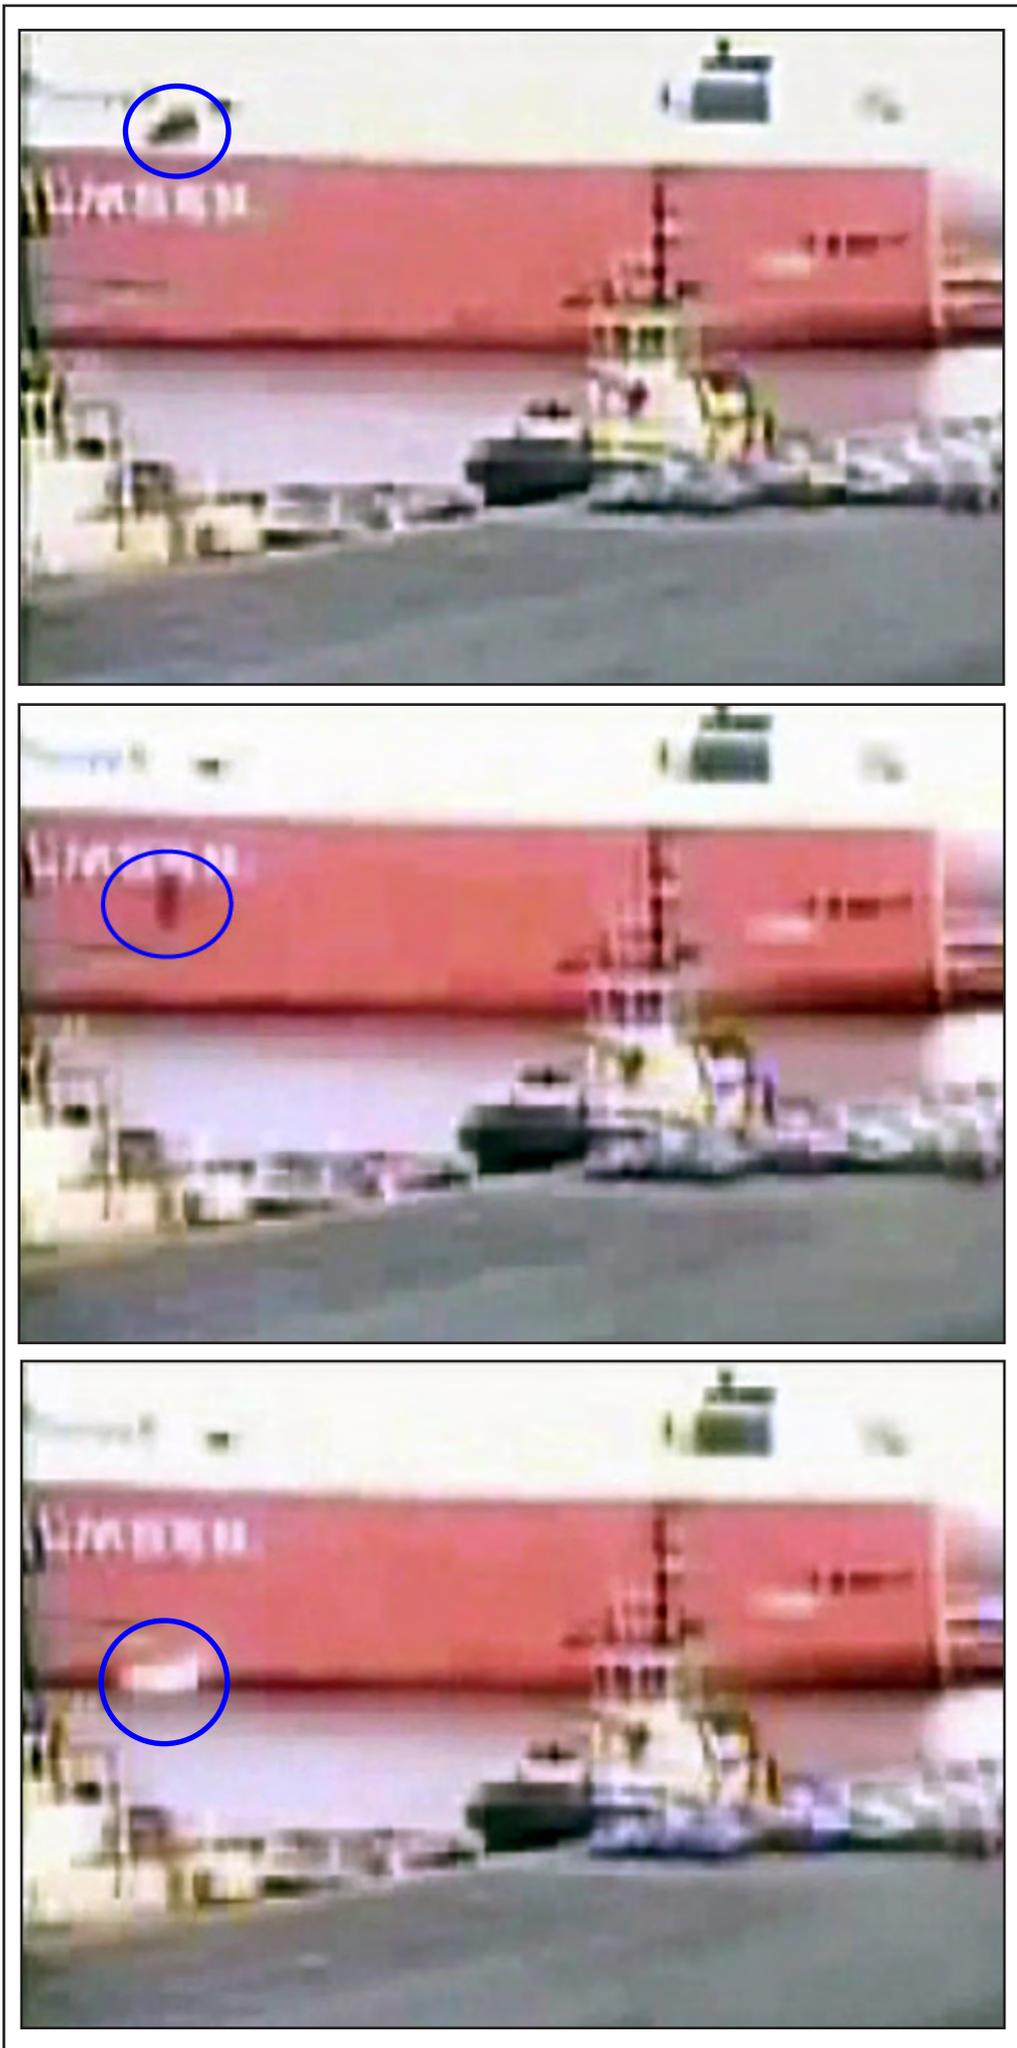
Figure 6: CCTV footage of fall

At about 1549, the rescue boat came hard against the davit fenders. Almost immediately, a bang was heard, the fall wire parted and the rescue boat and its davit swung out. The boat then rolled to port before plummeting bow-first into the water (**Figure 6**).

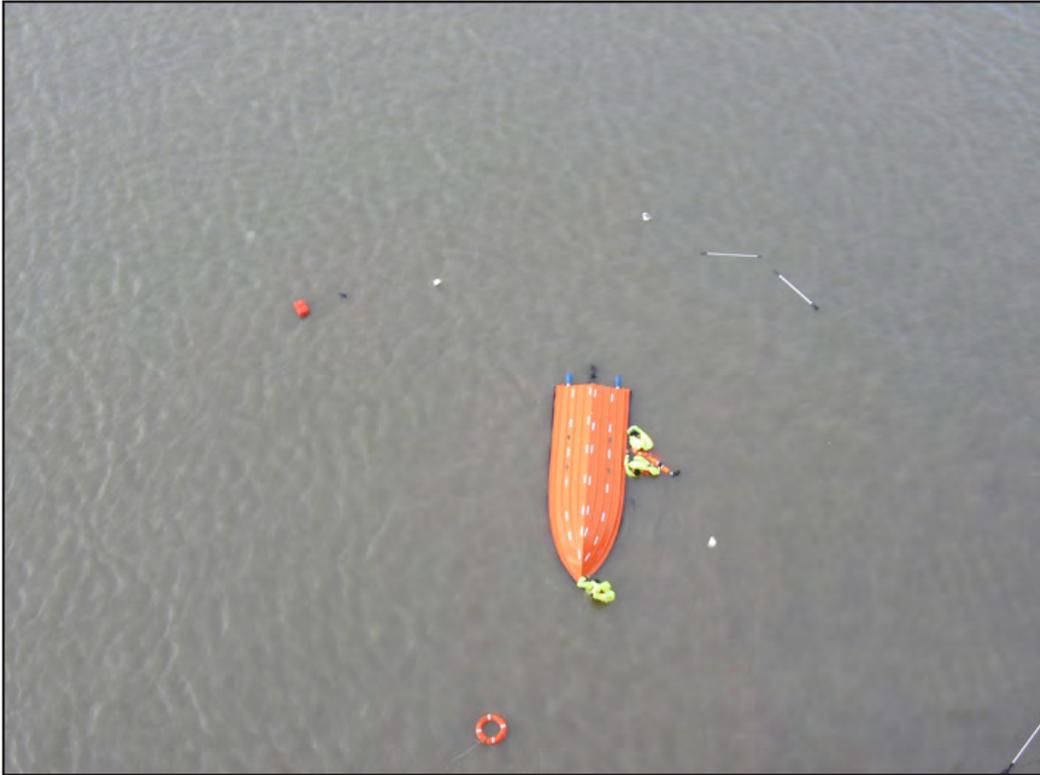
Figure 7: Rescue boat capsized

The rescue boat surfaced upside down. Three of its crew also surfaced alongside the upturned hull with their lifejackets inflated (**Figure 7**). The deck crew immediately threw life rings towards the men. At 1555, the chief officer informed the master and then the port authority of the accident, using his hand-held very high frequency (VHF) radio. The port authority immediately tasked its workboat *Gordano* and the port police to assist. *Gordano* was at berth 5 and quickly headed towards *Tombarra*, stopping between berths 3 and 4 en route to collect two port policemen. The port authority also made a request for an ambulance to attend.

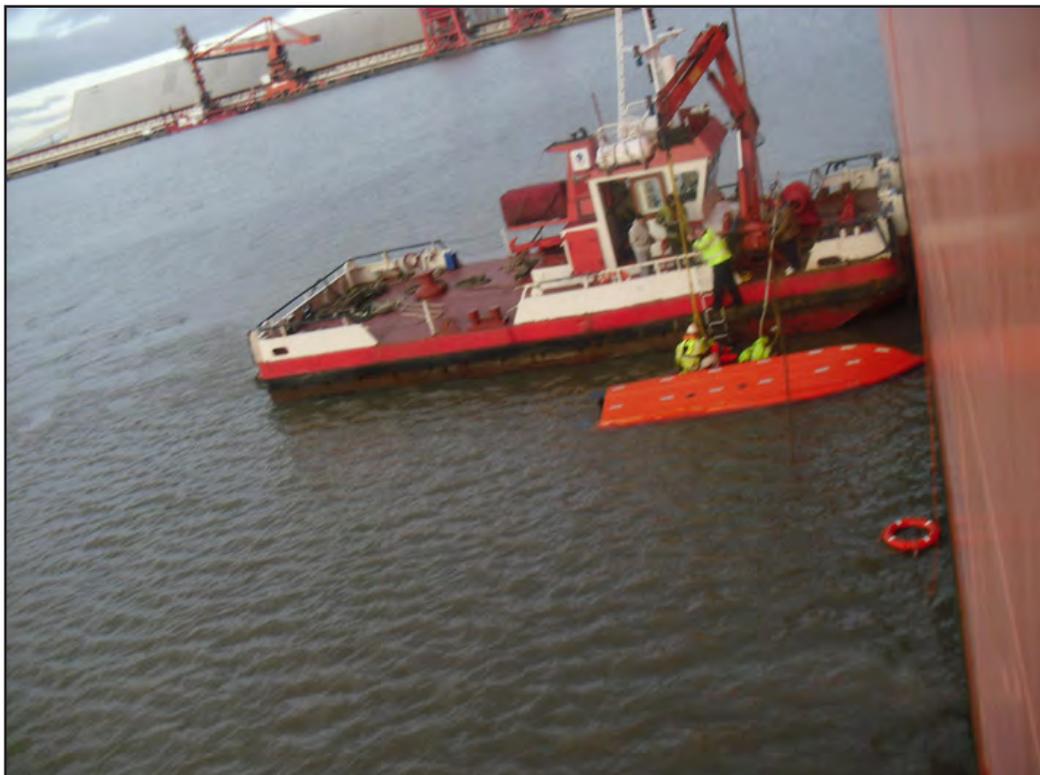
Figure 8: Recovery of fourth engineer

In the meantime, *Gordano* was alerted by *Tombarra*'s crew that one of the boat's crew was trapped under the upturned hull. The workboat's crane was connected to the rescue boat's bow cleat and the bow was raised clear of the water (**Figure 8**). *Tombarra*'s fourth engineer, Gerardo Tonogbanua was then seen by the rescuers. His 275N lifejacket was inflated, he was face-down in the water and his harness lanyard was still attached to the fall wire hook.

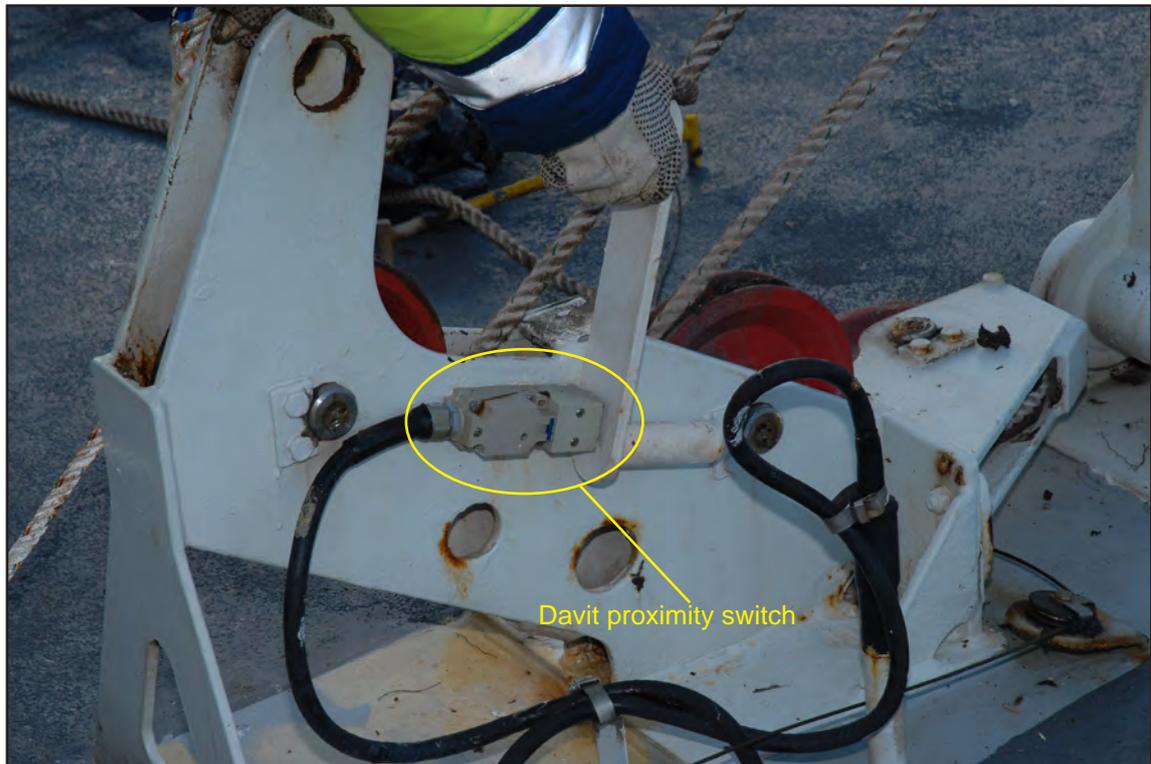
Figure 9: Proximity switch testing in situ

The davit proximity switch was mounted on the forward part of the fixed davit structure adjacent to the sheaves. It was orientated so that the sensing head faced outboard and angled downward at approximately 20° to the horizontal (**Figure 9**). The sensor head could be rotated in order to align it with the actuating object. The switch manufacturer's instructions stated that the switch should be mounted either horizontally or vertically.

It is likely that the davit proximity switch did not function as intended due to the gradual ingress of moisture into the unit (**Annexes E and F**) leading to the eventual absorption of the moisture by the epoxy resin potting compound which probably caused a short circuit on the printed circuit board. This failure mode is consistent with long-term exposure to moisture and extreme temperature fluctuations. Although the switch enclosure met the IP67 standard when new, the moisture resistance of the switch was possibly compromised by several factors. These factors included the physical deterioration of the cover seal and/or cable gland with age, the extreme changes in atmospheric conditions and temperatures experienced during the ship's voyages from the tropics to the Baltic, and the use of pressure washers or similar to clean the adjacent deck areas. The likelihood of moisture ingress was

certainly increased by the orientation of the switch on the davit (**Figure 9**), which was contrary to the switch manufacturer's guidance, and would have increased the possibility of moisture ingress due to capillary action through the cable gland.

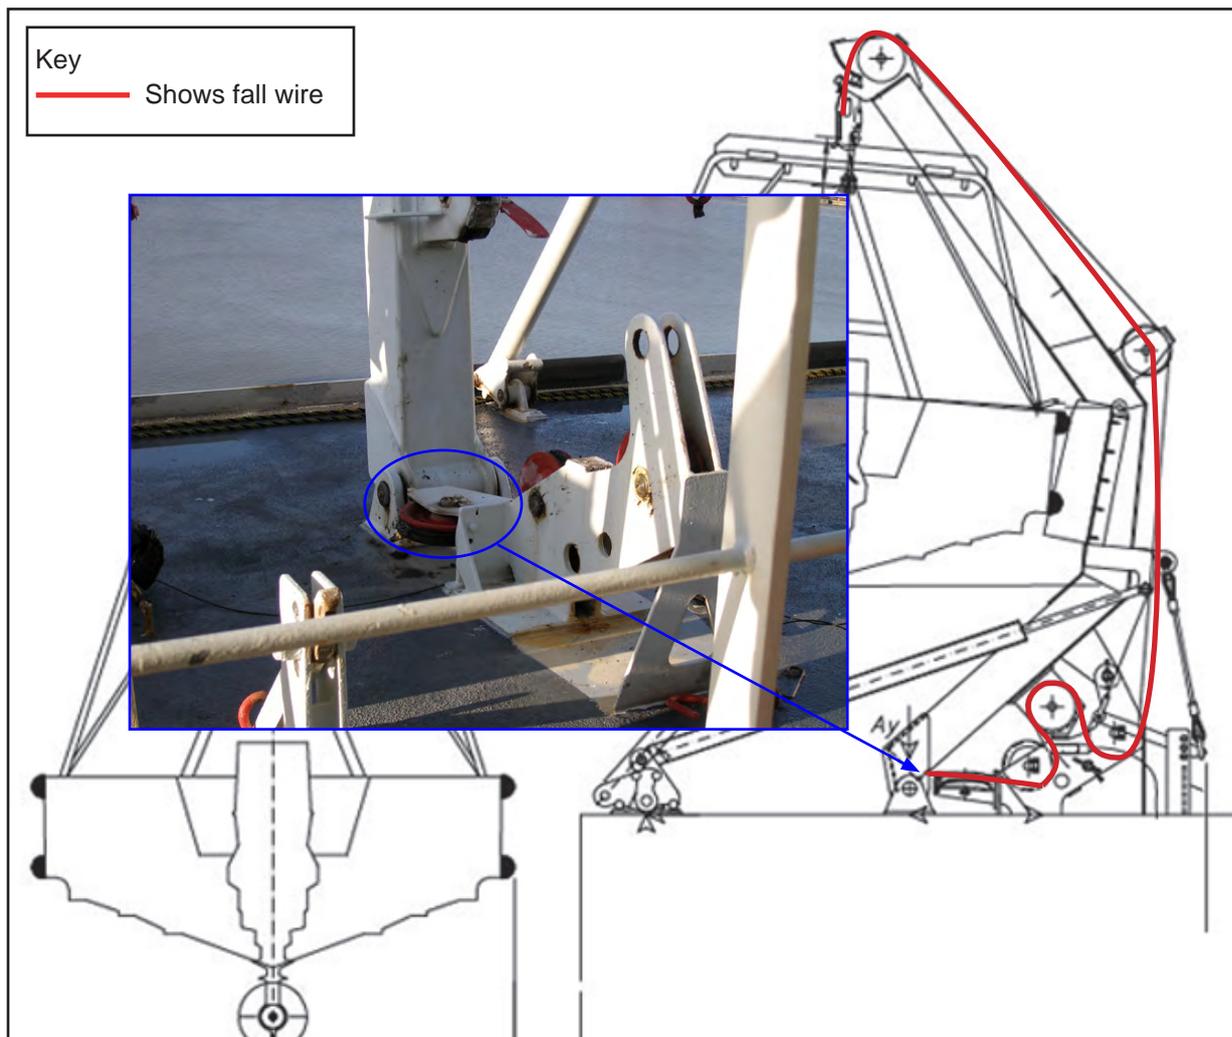
Figure 10: Position of fall wire failure

The fall wire was measured and found to have failed approximately 5.54m from the hook. With the boat and davit in the stowed position, the failure point coincided with the last sheave on the davit (**Figure 10**).

It is evident, from the test report at **Annex C**, that the fall wire was in good condition and was fit for purpose. The failure of the wire was caused by a rapid single tensile load in excess of 133kN. Although the weight of the rescue boat and its crew (approximately 1550kg (boat) plus 300kg (4 persons)), exceeded the davit's SWL of 1500kg, it was much less than the breaking load required to part the fall wire.

As the davit arm came hard up against the fixed davit structure, the winch motor would have drawn more electrical current and the winch's pull would have increased rapidly in order to overcome the resistance encountered. Given the maximum pull of the W50RS winch when fitted with a 15/20kW motor was between 210kN and 227.5kN (**Paragraph 1.7 and Annex I**), it was more than capable of exceeding the 133kN force needed to break the wire. The wire's failure in proximity to the final sheave on the davit (**Figure 10**) was not significant, as its strength would have been marginally reduced where it bent round the sheave.

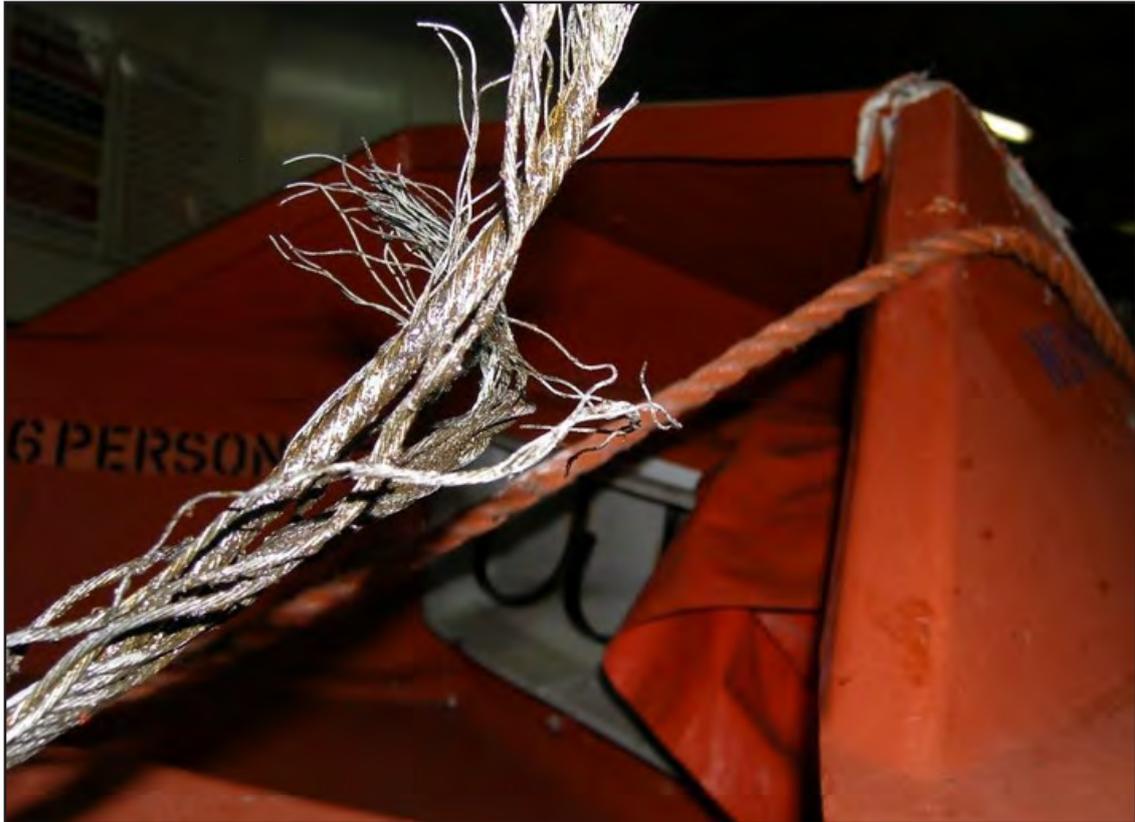
Figure 12: Failed fall wire

On 5 June 2011, a fast rescue boat fall wire parted (**Figure 12**) during a drill on board a ro-ro passenger ferry when alongside. The boat fell about 15m to the water below and was materially damaged. Fortunately, it was usual practice to first lower the boat to the water and recover it without crew on board.

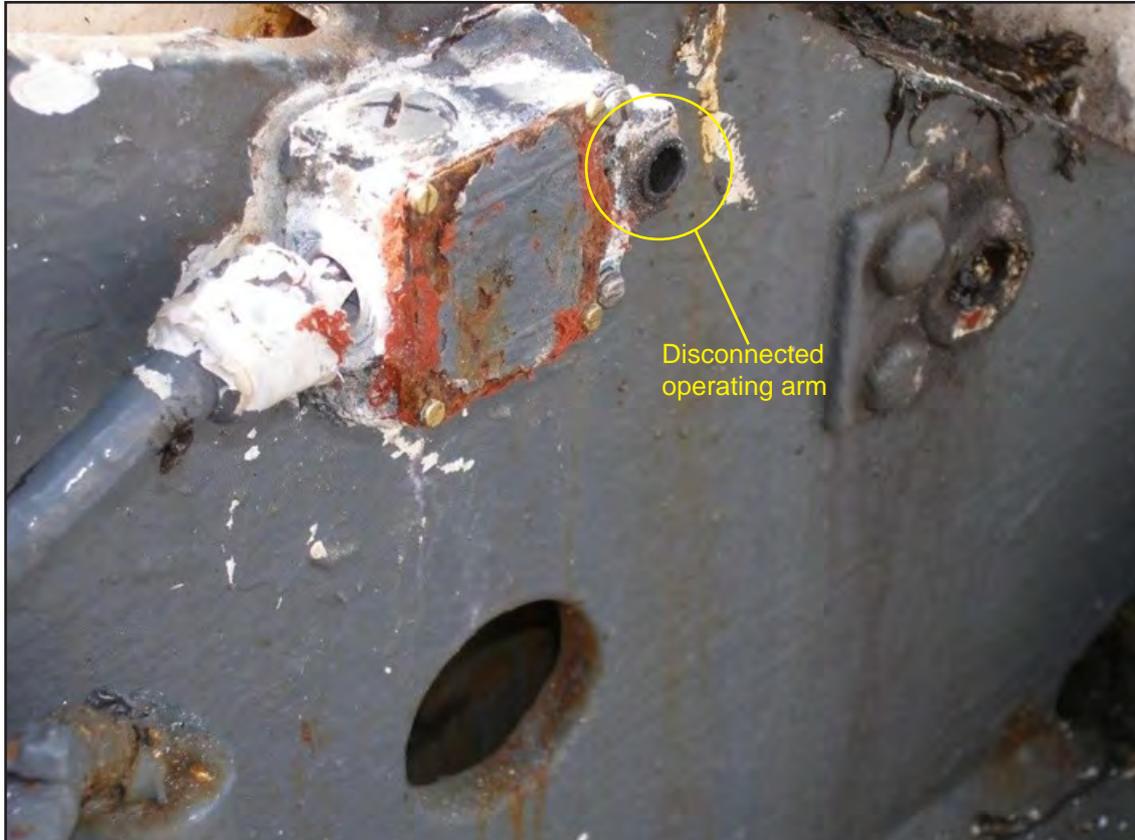
Figure 13: Broken limit switch

- The original electronic proximity switch had been replaced by a mechanical limit switch which was in poor condition, was not working properly, and did not comply with the davit manufacturer's specifications. Further inspection of the switch found significant signs of corrosion and, although originally IP67 rated, the general appearance indicated that it had not been maintained for some time, including the actuating arm not being firmly connected to the switch head (**Figure 13**).
- The fall wire, specified in the davit/winch manufacturer's drawings as 14mm with a MBL of 151kN (15400kgf), had been replaced in July 2009 with a 12mm wire with an actual breaking load of 107kN (10910kgf). Subsequent tensile load tests of the failed wire using a 6.5kW motor, produced failure loads of 82.38kN (8400kgf) and 83.06kN (8469kgf) respectively.
