Disappearance and rescue of the small fishing boat

Water-rail

in the North Sea

20 - 22 May 2014

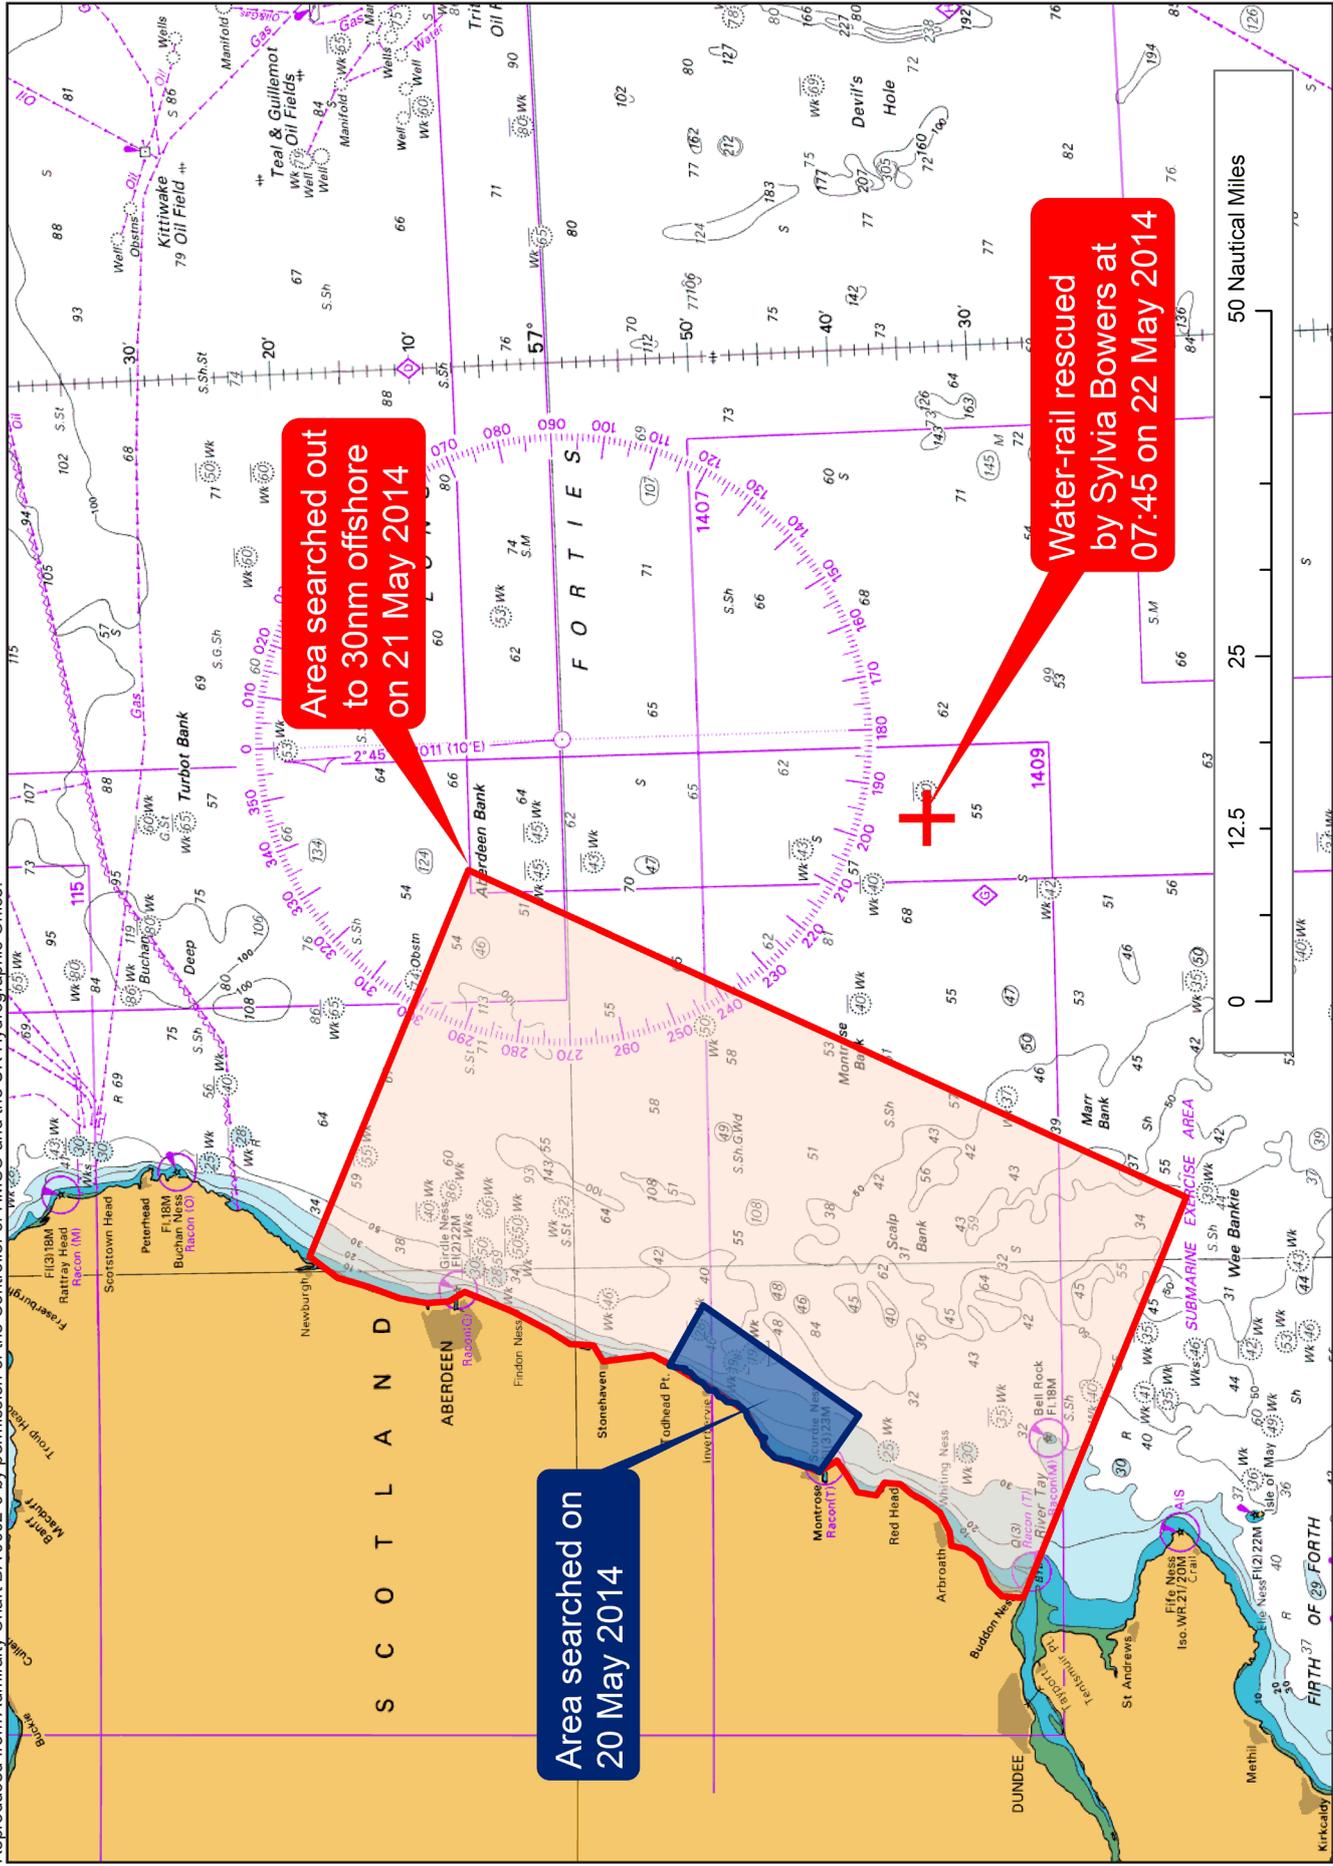
Figure 2: Area searched and rescue position

Water-rail's movements on the second day at sea are impossible to determine but it is likely that the boat was always outside the search area. This analysis is reinforced by the fact that *Water-rail* was not found during the initial inshore search effort, and it was anchored in deep water on the first evening.

- The search effort was well co-ordinated, employing multiple land, sea and air assets and covered an appropriate area based on reasonable planning assumptions. *Water-rail* was not located by coastguard search assets because it was almost certainly always outside the area being searched.

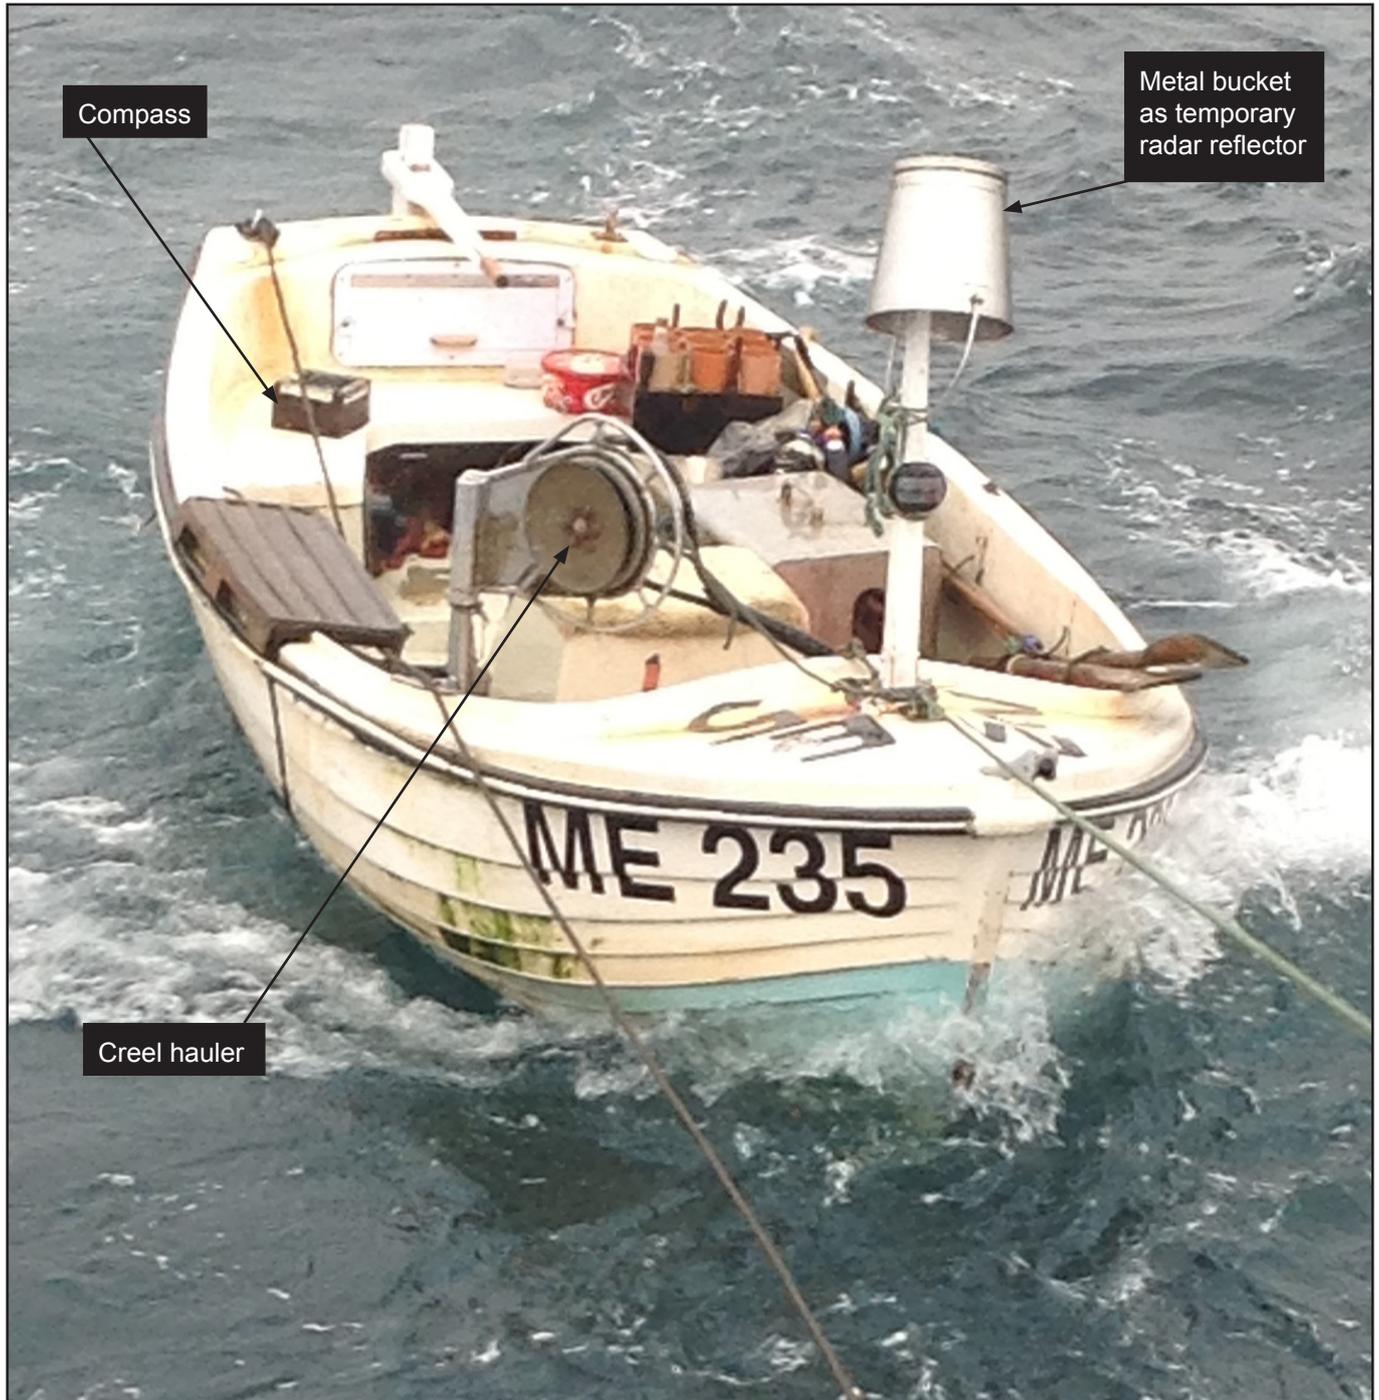
Figure 3: *Water-rail* under tow from *Sylvia Bowers*

Navigation lights were fitted and switched on when at sea. During daylight hours, the skipper placed a metal bucket over the boat's mast to act as a radar reflector (**Figure 3**). However, this meant that the single all round white light mounted on top of the mast was obscured, which should not have been the case in restricted visibility.

The skipper did not fix the compass box to *Water-rail*, instead, he placed it loosely on the seating at the stern of the boat (**Figure 3**). When reading the compass, he aligned the lubber line with the after end of the boat. The compass had never been checked for deviation errors and was kept in the lead-lined box because the skipper thought this would provide shielding from magnetic interference.

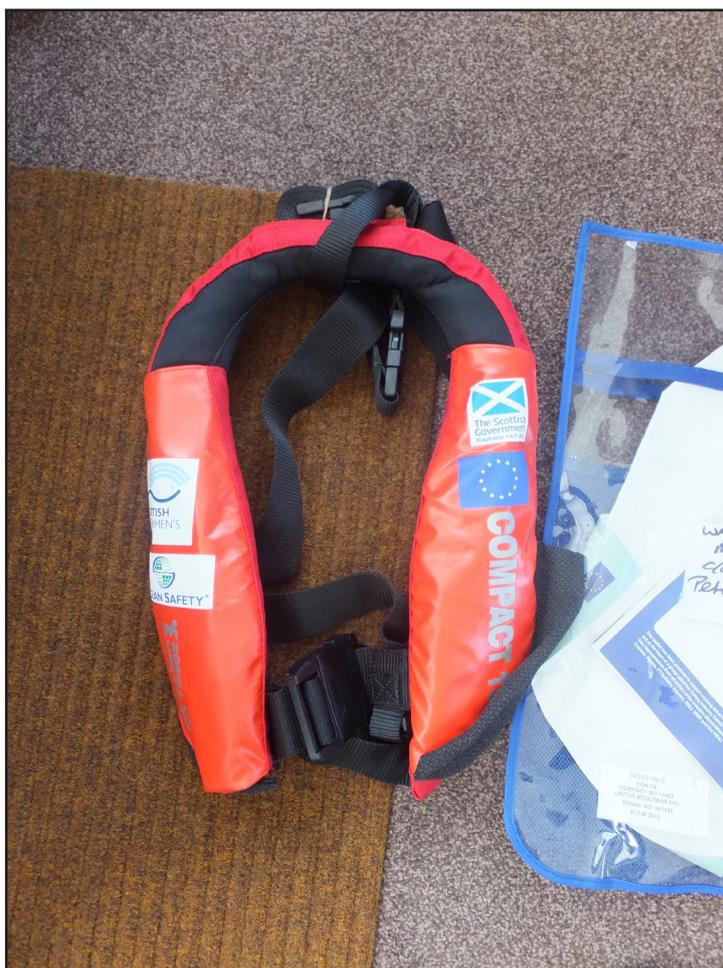
Figure 4: Ocean Safety personal flotation device (unused)

As *Water-rail* was lost during the rescue, the MAIB did not have the opportunity to inspect the vessel or the equipment on board. It was understood that, in addition to the two parachute flares used during the incident, two personal flotation devices (PFD) and a handheld gas-powered fog horn were carried on board. The skipper also had an unused Ocean Safety Compact PFD (**Figure 4**) at his home that had

been issued to him by the Scottish Fishermen's Federation. However, the skipper and his grandson never wore PFDs when they went sea and only donned them at the instruction of the trawler crew once they had been rescued.

- 2015/106** Improve the safe operation of any similar vessel he may own in the future by:
- Attending a navigation training course.
 - Ensuring that safety equipment is carried and crew are trained in accordance with MSN 1813(F), the MCA Code of Practice for the Safety of Small Fishing Vessels.
 - Applying additional safety measures recommended in MGN 502(F), the updated Code of Practice, specifically: carriage of an EPIRB/PLB and DSC VHF radio as well as wearing of PFDs on deck.

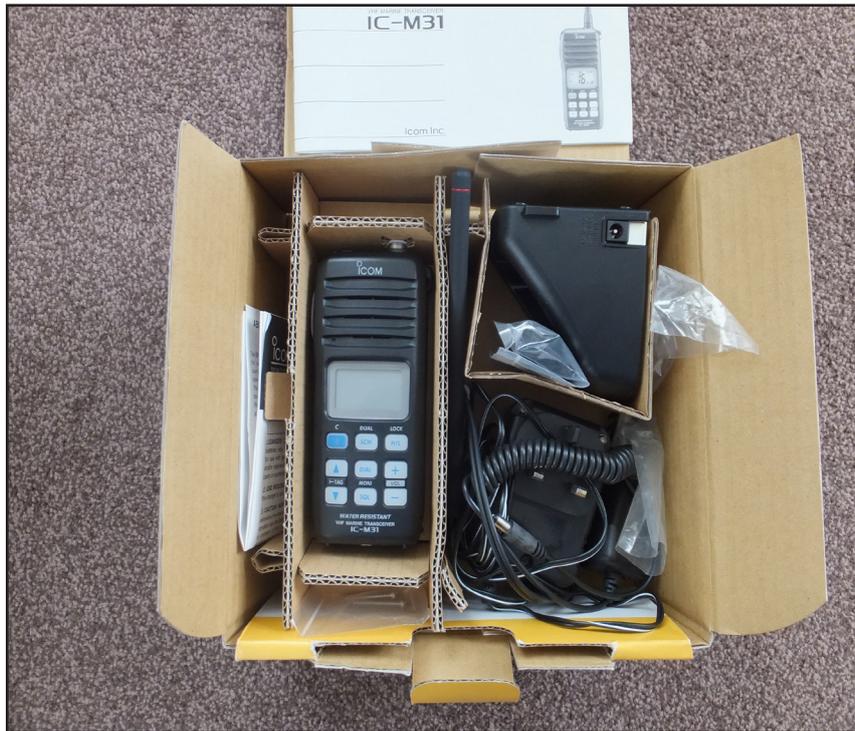
Figure 5: Marine VHF radio (unused)

The skipper of *Water-rail* owned a waterproof, handheld VHF radio (**Figure 5**). This radio was kept at his home in its original packaging and was never carried on board. When inspected by MAIB the day after the rescue, it was established that the radio's battery was fully discharged. Neither the skipper nor his grandson took their mobile phones to sea on this occasion.

Water-rail was not equipped with a VHF radio and, although no substitute for a marine radio, neither of the crew had brought their mobile phones on board. As a result, when things started to go wrong, they had no electronic method of alerting the coastguard or calling for help. The skipper did own a suitable VHF radio, however, it was never used, its battery was flat, and it had been purchased solely for the purpose of passing an inspection by an MCA surveyor. Had the skipper taken his VHF radio to sea with him, the alarm could have been raised soon after he became lost.

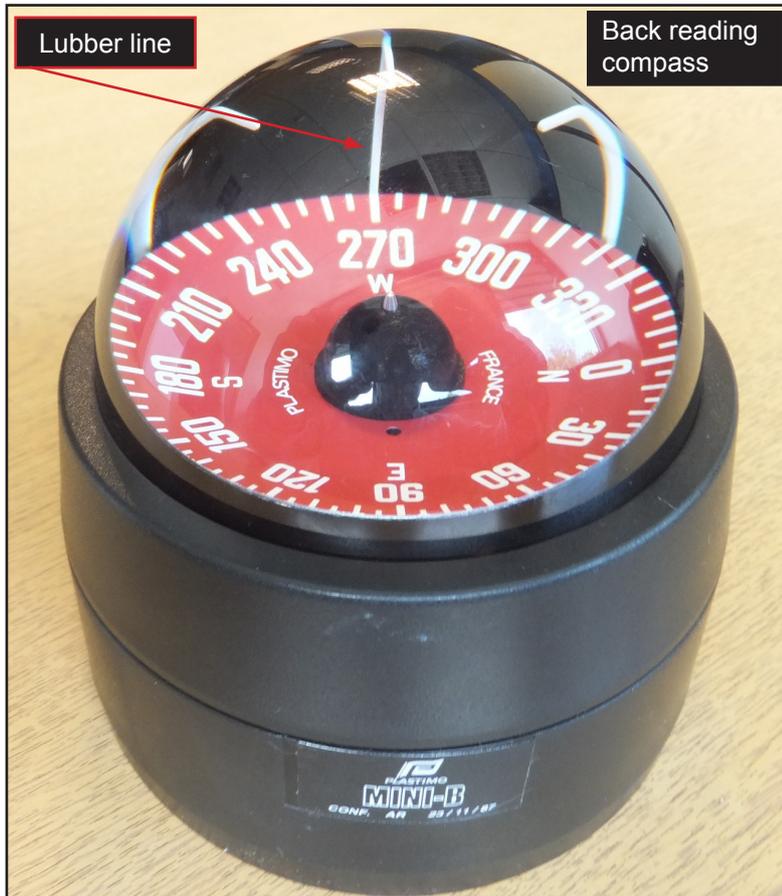
Figure 6: Plastimo Mini-B compass as seen by observer

The Plastimo Mini-B compass is a basic but nevertheless robust and precise navigation aid and it is considered highly unlikely that it failed. It was intended to be permanently fixed to the boat and, critically, it should have been aligned parallel to the boat's fore and aft centerline. Once fitted, it should be read by the observer looking ahead with the lubber line at the far side of the compass (toward the bow) (**Figure 6**).

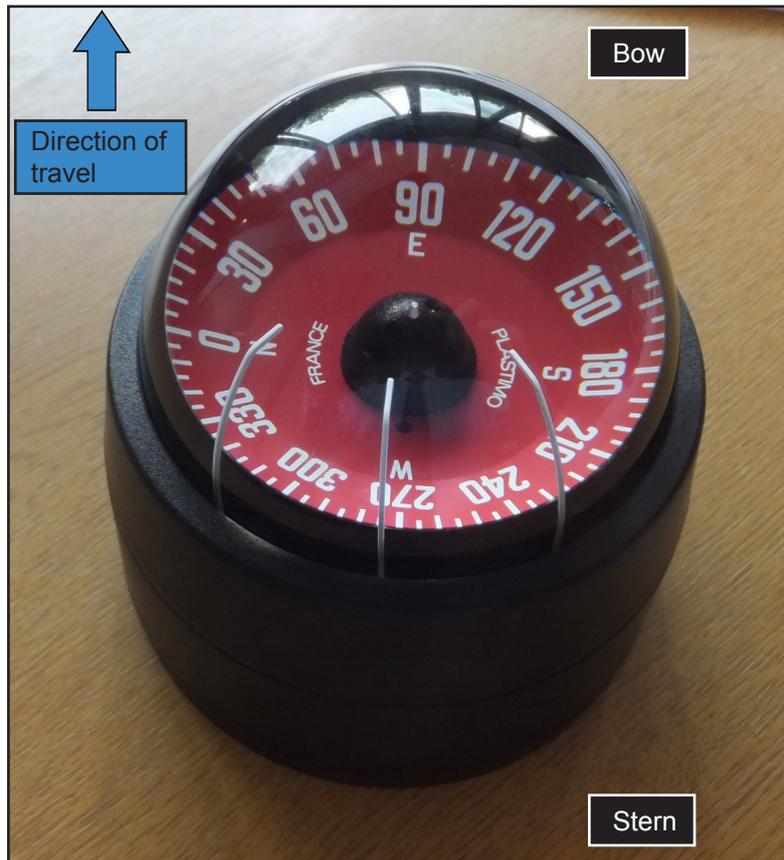
Figure 7: Assessment of skipper's view of compass when heading east with the lubber line aligned with west

When aligned towards the after end of the boat, as illustrated in **Figure 7**, the lubber line shows the reciprocal of the boat's actual heading. In a disorientating situation, particularly without visual references, this incorrect set up of the compass induced a significant risk of reading (and potentially steering) a reciprocal course.

Water-rail's compass was not permanently fixed to the boat; instead, it was loose in its home-made, lead-lined, wooden box. Lead is a non-ferrous metal: as such, it would not have provided any magnetic shielding and therefore the compass would have been subject to deviation errors. However, given the skipper's misconception over the shielding properties of lead lining, he would not have been concerned about the risk of deviation errors and, therefore, not taken these into account.

- The compass on board *Water-rail* was not installed, set up or operated correctly. While there is insufficient evidence to establish the route taken by *Water-rail*, it is most likely that the majority of the first day at sea was spent heading in the opposite directions to those intended by the skipper.
