**Report of the Inspector's Inquiry
into Three Fatalities and Injuries
to Six Crew Members on board
fv ATLANTIC PRINCESS
on 25 July 1996
off the Coast of Mauritania, West Africa**

I have the honour to submit the report of Mr J Stuart Withington, a Principal Inspector of Marine Accidents, on the circumstances which led to the loss of three lives and injuries to six people on board the UK registered trawler ATLANTIC PRINCESS while fishing off the Mauritanian coast on 25 July 1996.

fv ATLANTIC PRINCESS

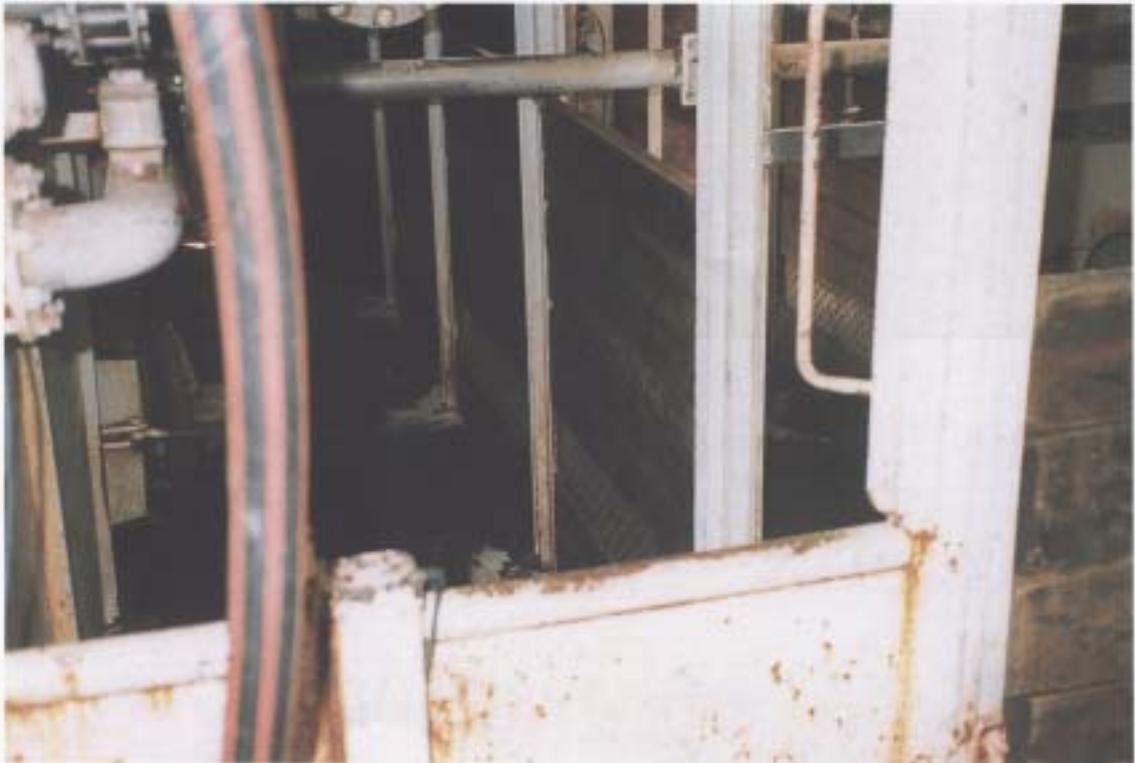
Figure 5

Starboard side of ramp deck in area of accident

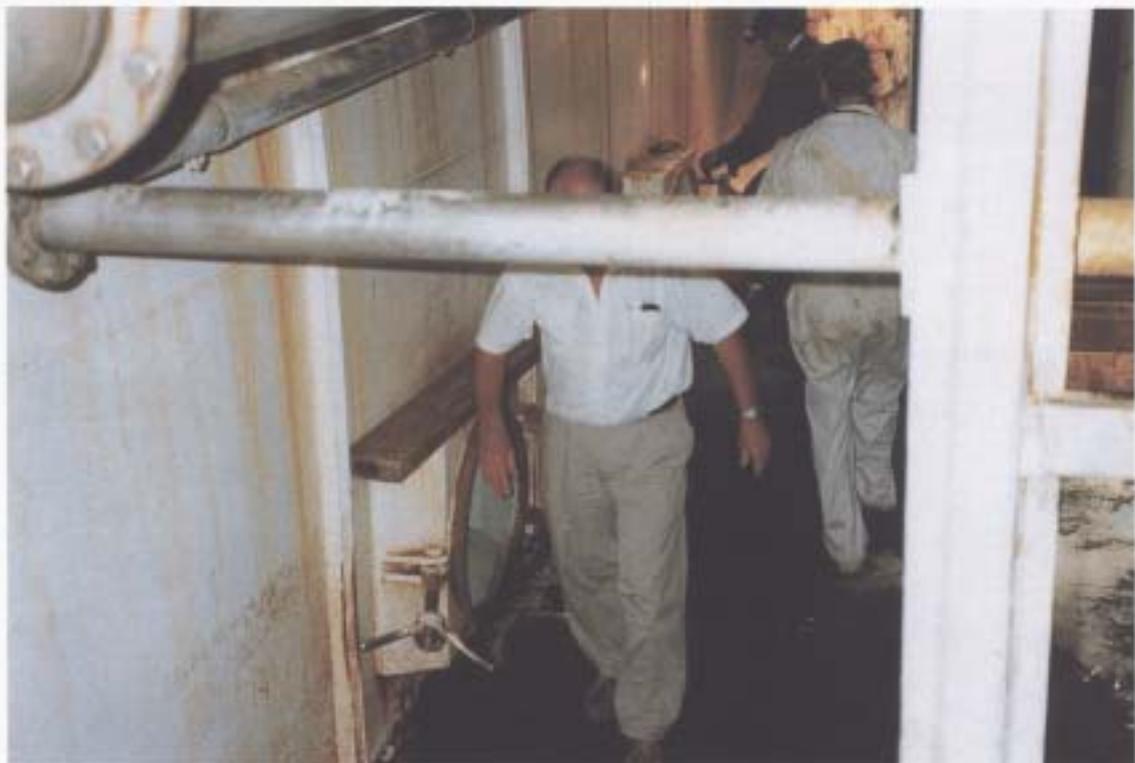
The Third Engineer on the 1800 to 2400 watch, Mr Bruin, took over the pumping operation which was expected to take about 20 to 25 minutes. He left the engine room and proceeded to the upper deck before going down to the ramp deck. He climbed over the low side of the pound boards and into the caged area (Figure 4) where he opened the door to No 3 starboard RSW tank (Figure 5) to release what was described later as grey/black water.

RSW tank side door: partly obscured door is that of No 3 starboard RSW tank

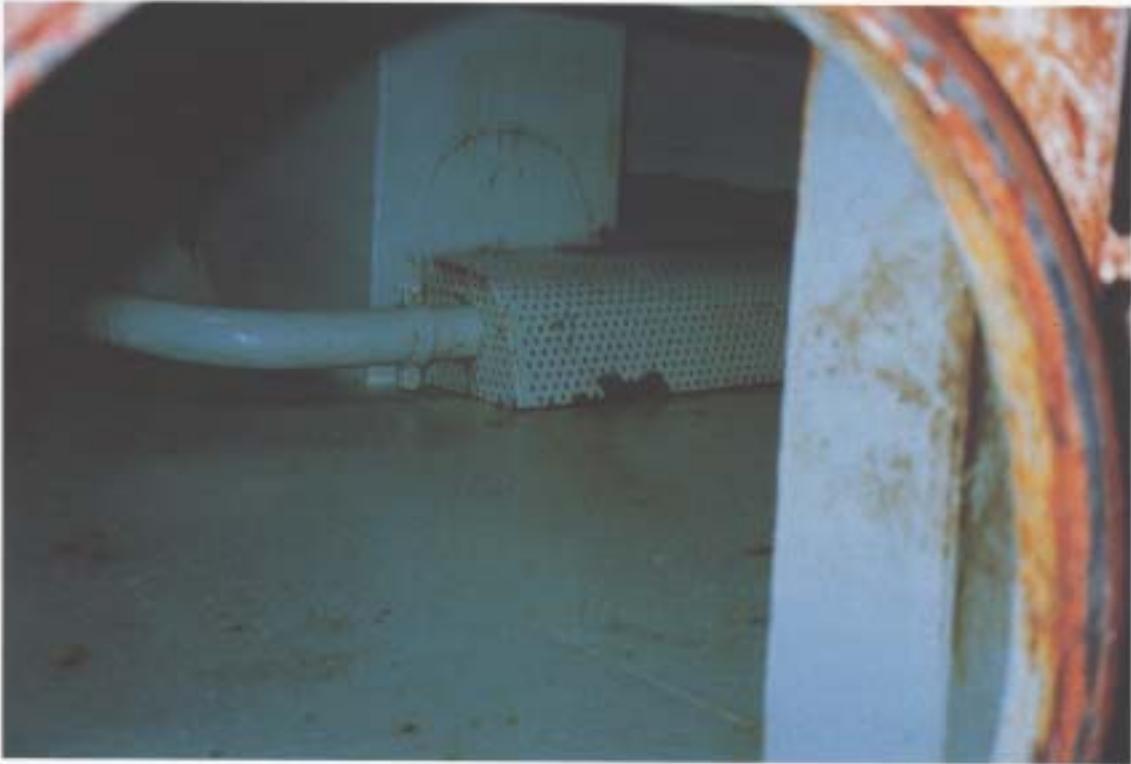
RSW circulating strainer in RSW tank

Manual which was supplied to the owners. The manual does not include information on how often the RSW system should be cleaned or maintained. The manufacturers advise that the system should be cleaned through with detergents every voyage, or at least once a month, not only to prevent accidents but to maintain the quality of the fish.

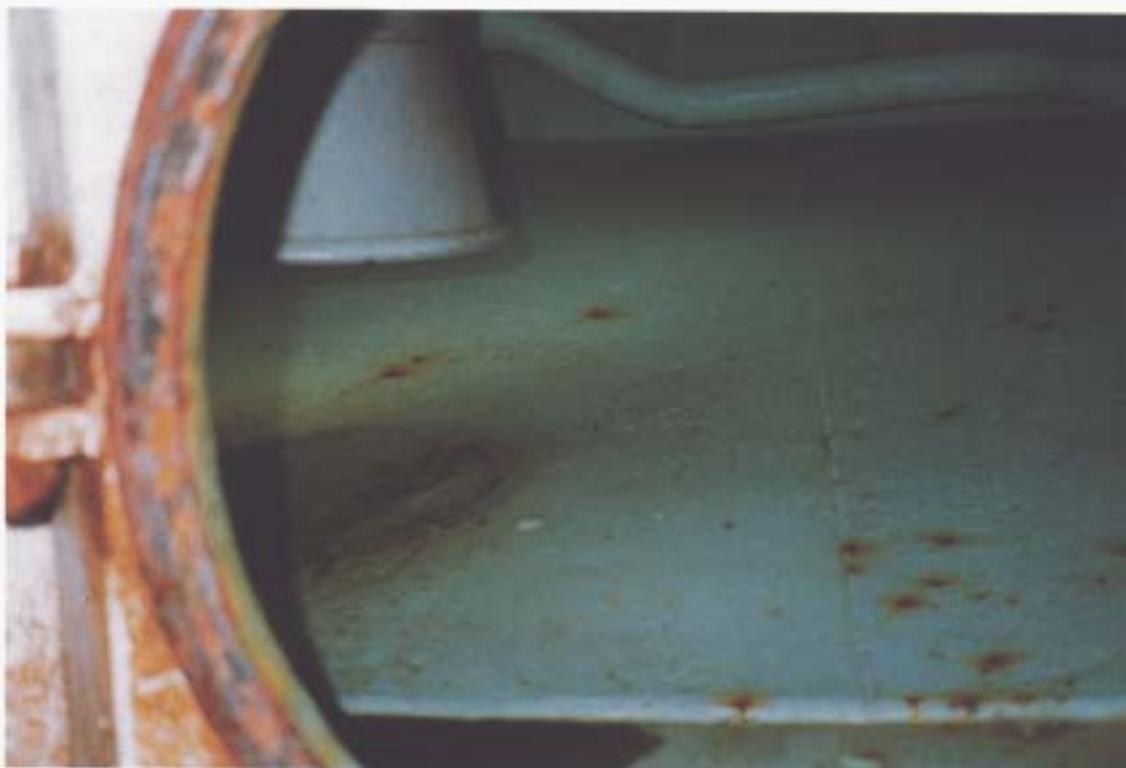
Although fish can be damaged in a number of ways, the most probable cause in this instance was the pumping action of the system pump and the crushing of fish in overfilled RSW tanks from earlier catches. Because the action of the cod end and RSW pumps damages fish over a certain size, the fish on 25 July 1996 were being bagged and transferred directly through the aft upper deck onto the ramp deck below.

End of fish suction pipe (elephant's foot) in RSW tank
