Report on the investigation of the
fire and subsequent foundering of
the passenger transfer catamaran

ECC Topaz

while conducting engine trials
off the east coast of England

14 January 2014

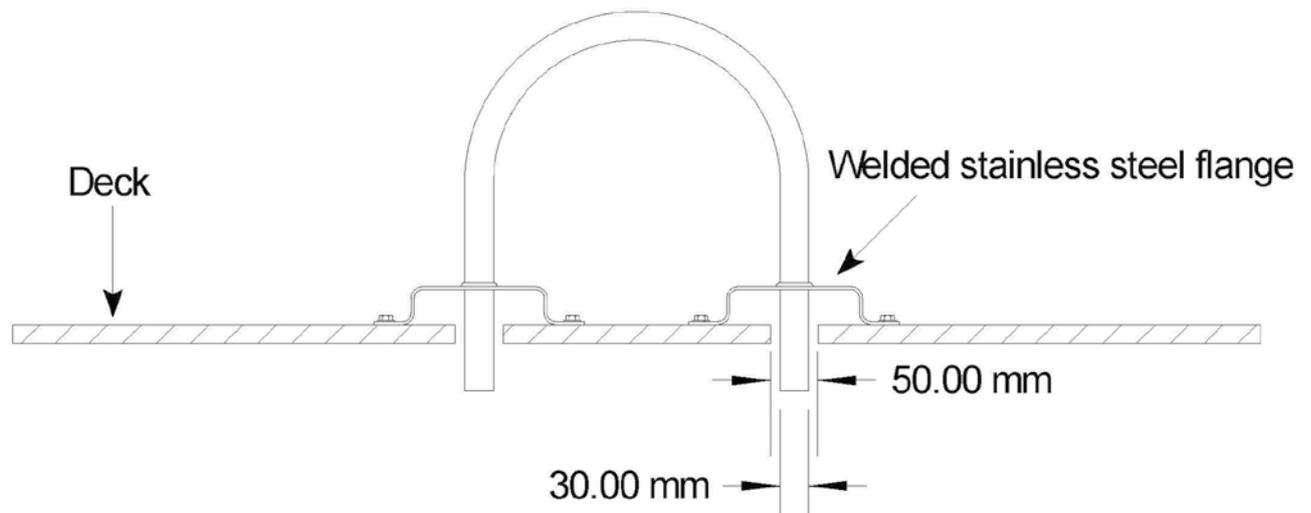
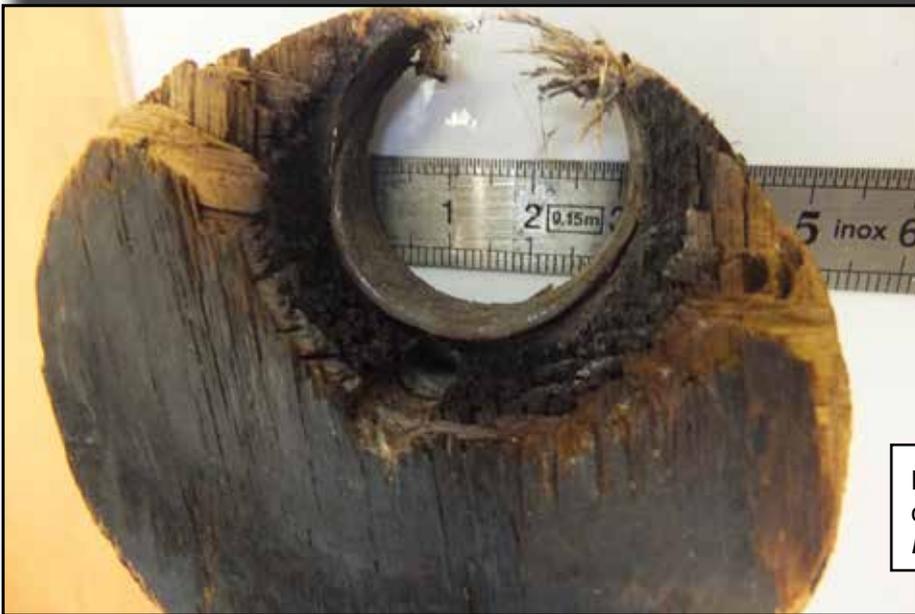
At the end of 2010, an owner of a workboat similar to *ECC Topaz* complained to Blyth Workcats Ltd about seawater flowing back into the heater of his vessel through the exhaust pipe outlet, which was located just above the waterline. Blyth Workcats Ltd consulted Krueger Ltd, who provided them with a design to overcome the problem. The new design introduced a single walled inverted U-pipe of steel into the exhaust piping system, elevating it approximately 30cm above the main deck, thus preventing the flow of water back from the sea. The exhaust pipe from the heater was connected to one end of the U-pipe and the other end was connected to the exhaust outlet overboard stub pipe (**Figure 5**). Although the section of the U-pipe exposed on deck was insulated, the length of pipe penetrating the deck was not.

30mm O.D. Stainless steel through deck exhaust fitting

Modified exhaust pipe penetration on a vessel of the same class as *ECC Topaz*

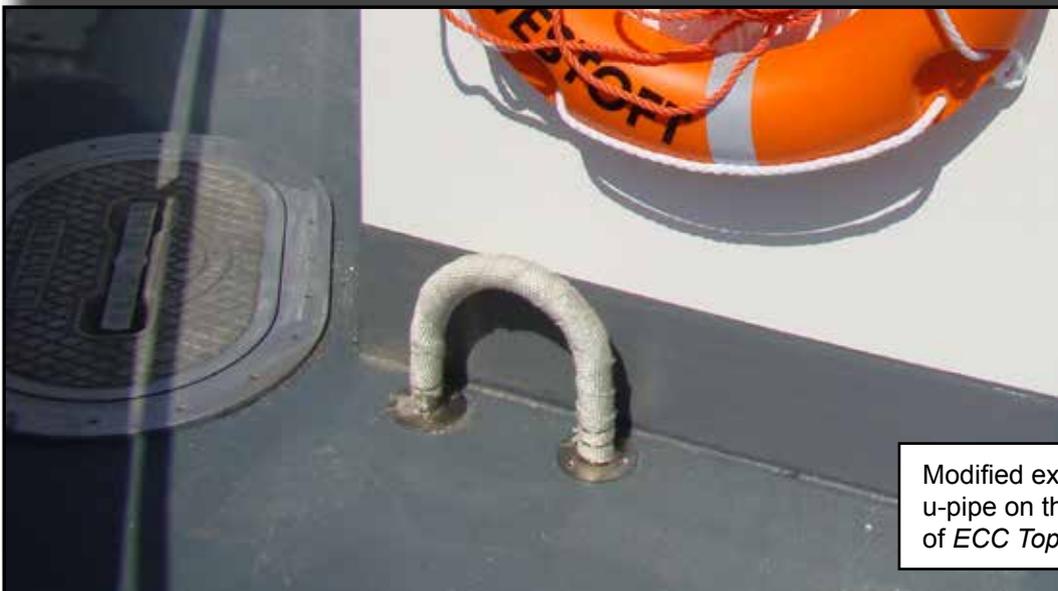
Modified exhaust u-pipe on the deck of *ECC Topaz*

Although the exhaust pipe modification solved the original water ingress problem, it was not authorised by the manufacturer and introduced a fire hazard by neglecting to assess the potential fire risk. Furthermore, the close contact between the uninsulated pipe and the deckhead caused by neglecting to adhere to the 50mm opening as required by the original design exacerbated this risk. Considering that the auto-ignition temperature of the plywood underdeck was well below 440°C, and that the compartment had very few openings through which to dissipate heat, the heat transferred from the uninsulated section of the exhaust pipe to the plywood in the 3 hours after the heater had been switched on that morning, would have been sufficient to start a fire.

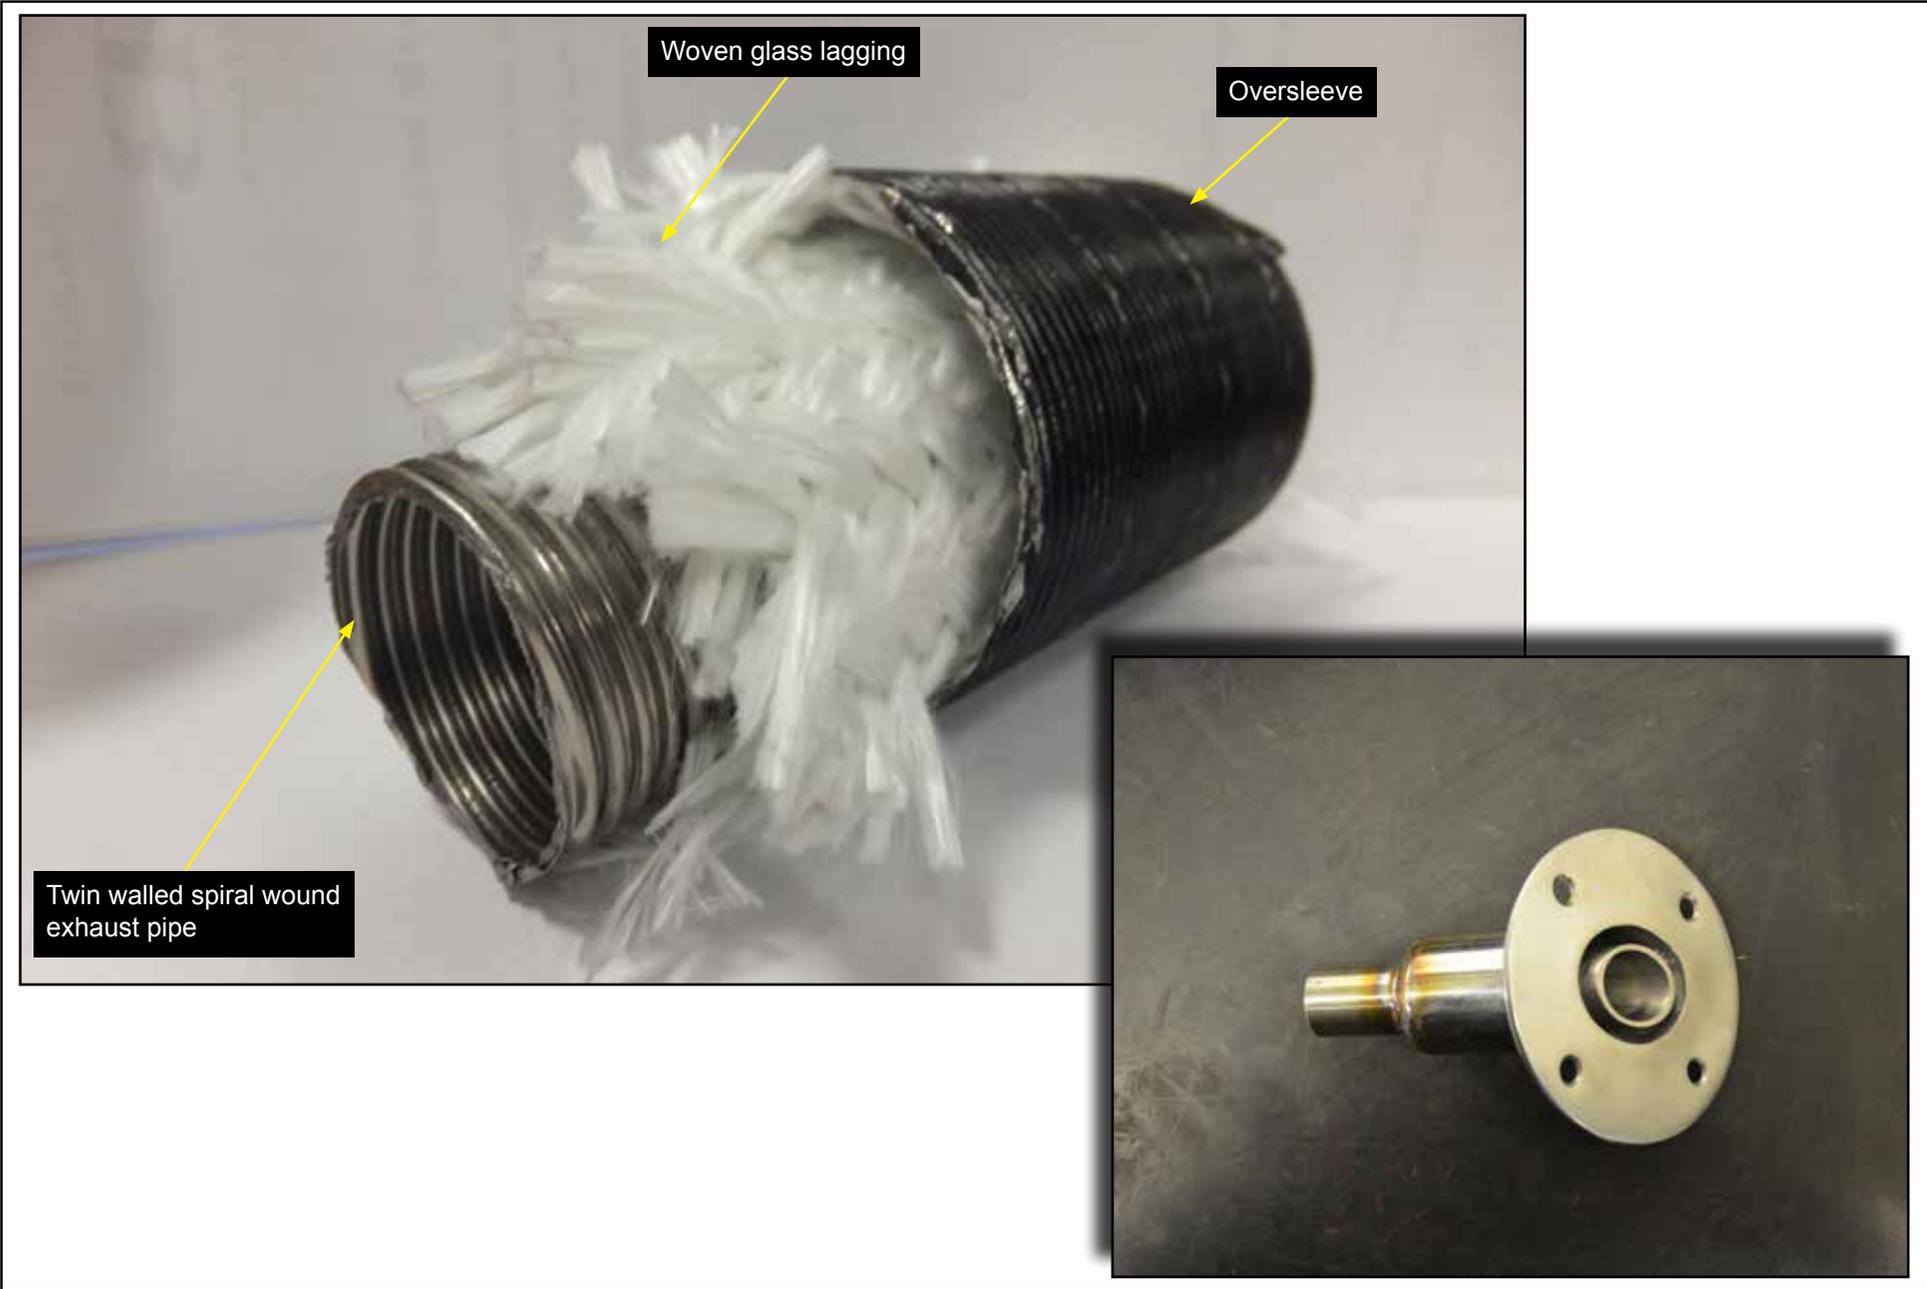
Figure 6: Exhaust pipe with insulation (inset: Double walled overboard discharge stub pipe)

The exhaust pipes of Eberspächer heaters fitted to land vehicles were uninsulated. Marine heaters were supplied by their dealers as complete kits, including the exhaust pipe, air trunking and fixtures. The exhaust pipe arrangement for marine systems consisted of an inner twin walled spiral-wound stainless steel pipe with a woven glass lagging and an aluminium over-sleeve, leading to the overboard stub pipe which was a double walled stainless steel pipe (**Figure 6**).

The inner exhaust pipe supplied by Eberspächer UK (Ltd) was made by Westaflex and was the INOXMD type. The specification sheet for this exhaust pipe stated that it had a continuous temperature resistance less than or equal to 350°C and a temporary temperature resistance of 600°C (**Annex A**).

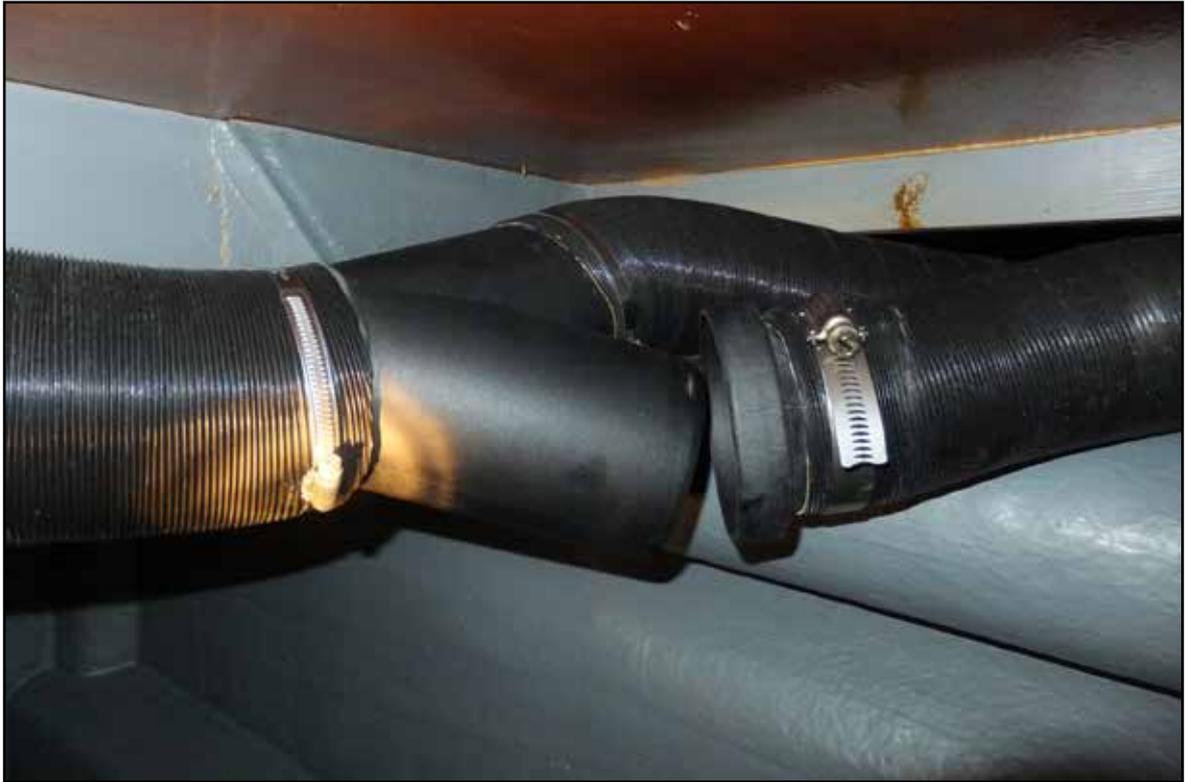
Figure 9: Air circulation delivery trunking on *ECC Opal*

The crew of *ECC Topaz* carried out no maintenance on the air heater. The only time they saw the heater was when they entered the heater compartment to access the items stored there. Immediately after the accident, MAIB inspectors went on board *ECC Opal*, another 14m catamaran built by Blyth Workcats Ltd for East Coast Charters Ltd. The supply air trunking was found to have come adrift (**Figure 9**).

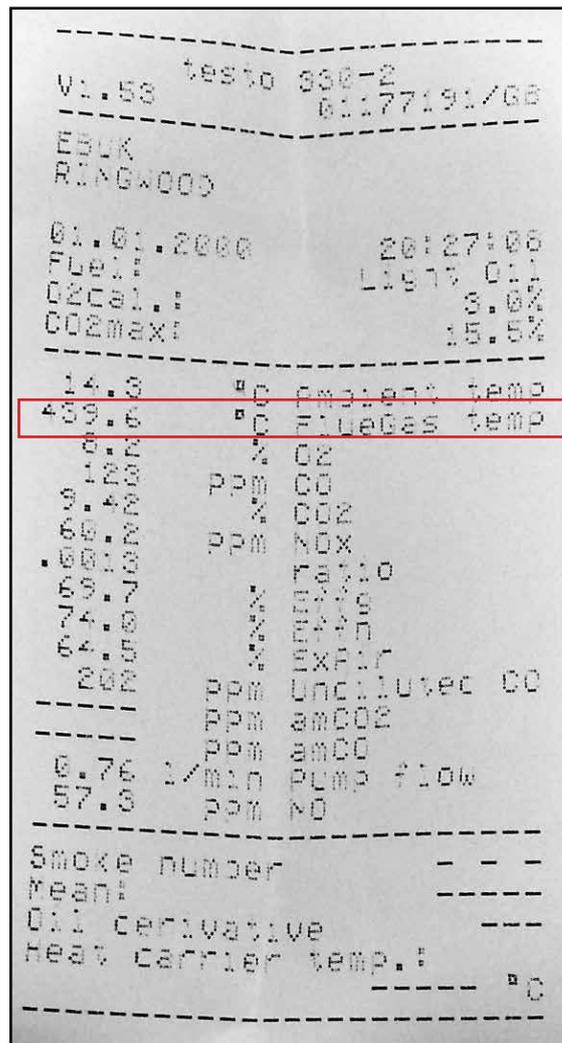
Figure 10a: Print out of heater parameters during tests carried out at Eberspächer (UK) facilities

Tests were conducted at Eberspächer (UK) Ltd's facilities at Ringwood in the UK to establish the maximum expected exhaust temperatures from a D4 Plus unit and also to understand the period of time that diesel would continue to be injected in the event of flame interruption. It was established that the exhaust temperature of a brand new heater could rise to around 440°C (**Figure 10a**). These results were

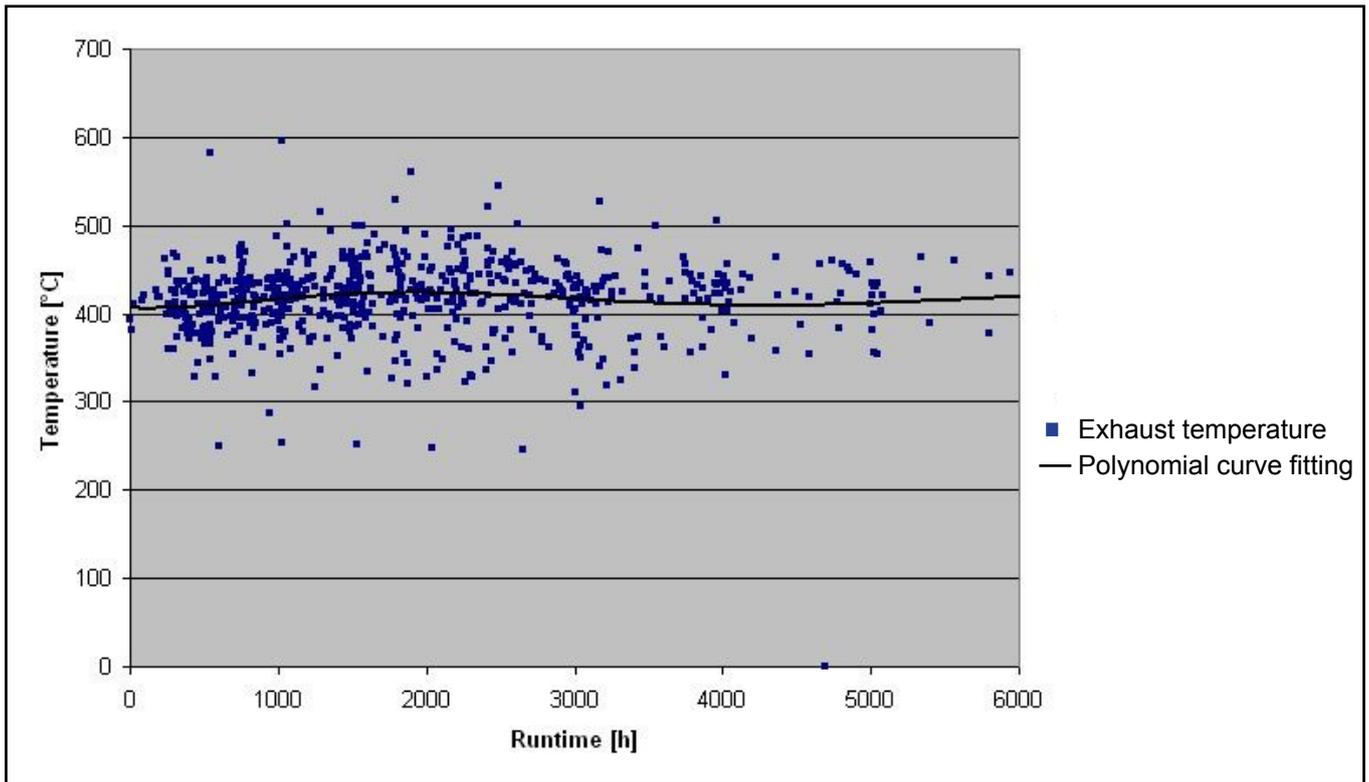
Figure 10b: Exhaust temperatures measured by Eberspächer at the outlet of several models of Airtronic D4 heaters

corroborated further with data supplied by Eberspächer Climate Control Systems GmbH & Co. KG, (**Figure 10b**), who also reported that the surface temperature of an uninsulated heater exhaust pipe, 5cm away from the heater, was measured at 292°C.

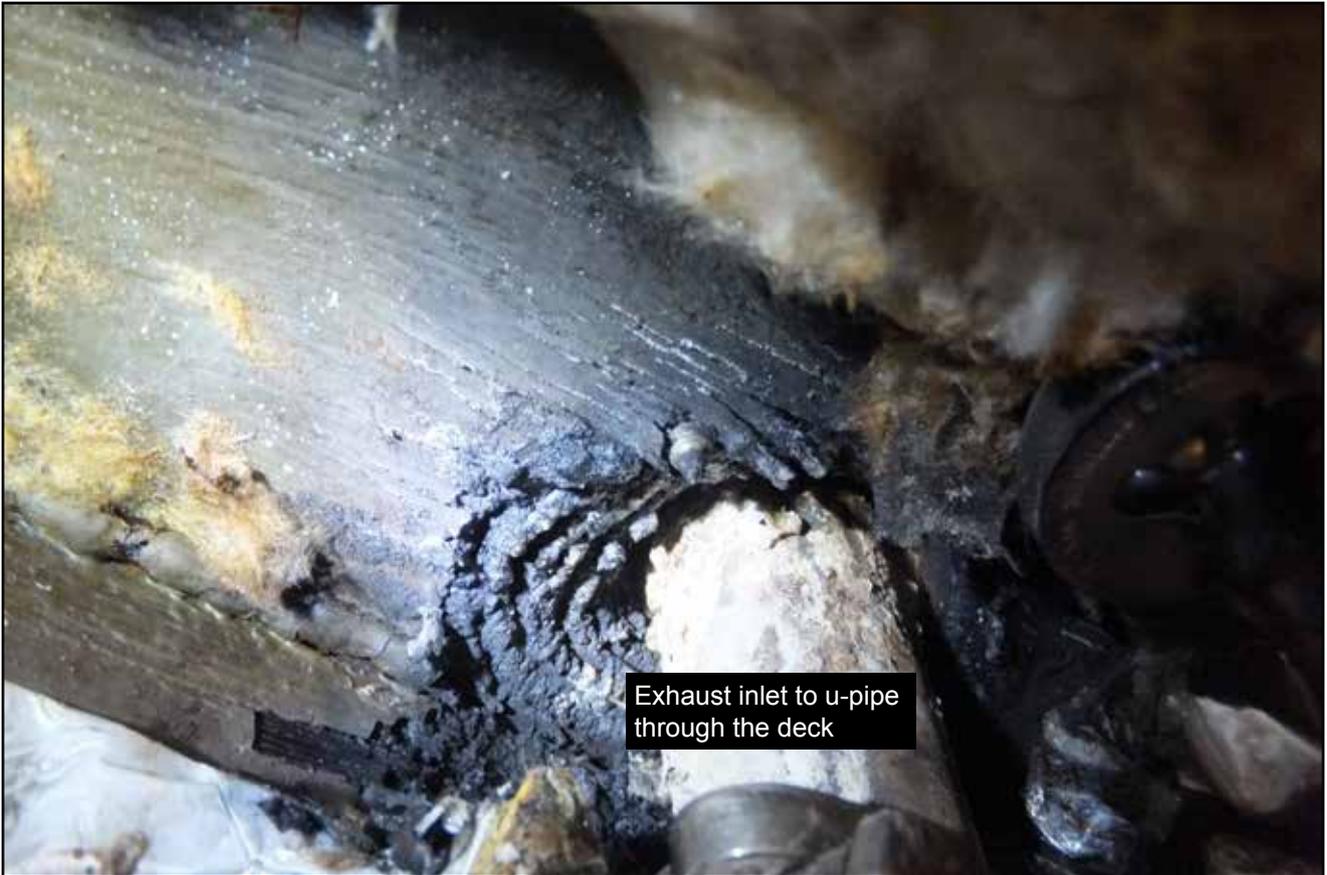
A few days after the accident, the MAIB received information that crews of other 14m Blyth Workcats Ltd vessels had observed signs of scorching and charring at the deck penetration of the modified section of the air heater exhaust pipe. **Figures 11a** and **11b** show the condition of the underside of the plywood deck in the diesel generator compartment of two vessels similar to *ECC Topaz*. The heater exhaust pipes in all these vessels were subsequently modified by Blyth Workcats Ltd, so that the insulated exhaust pipe was continuous from the heater outlet to the overboard discharge.

Exhaust inlet to u-pipe through the deck

Figure 11a: Scorched condition of deck underside on a 14m Blyth workboat with insulated deckhead

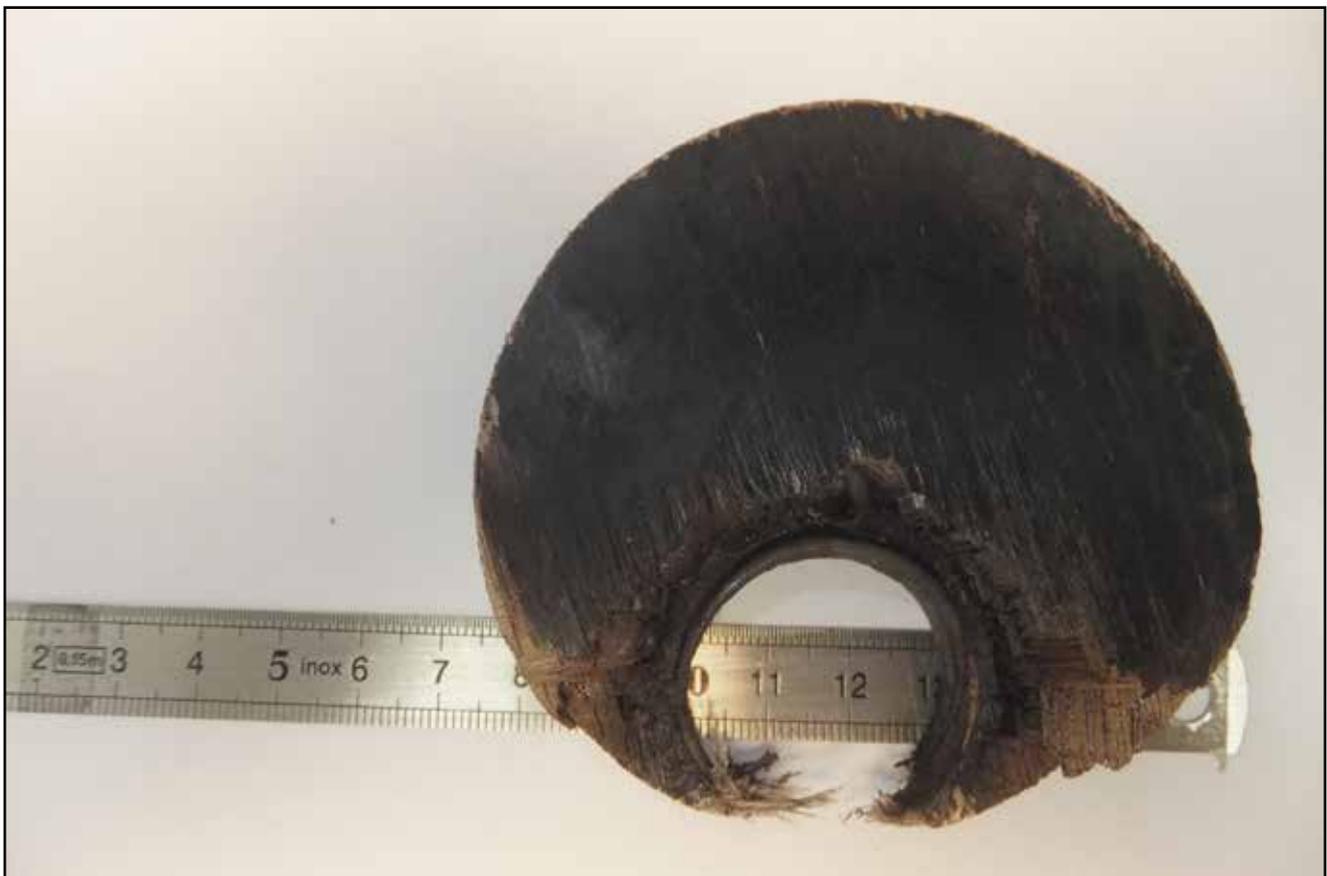
Figure 11b: Scorched condition of deck underside on a 14m Blyth workboat with - uninsulated deckhead

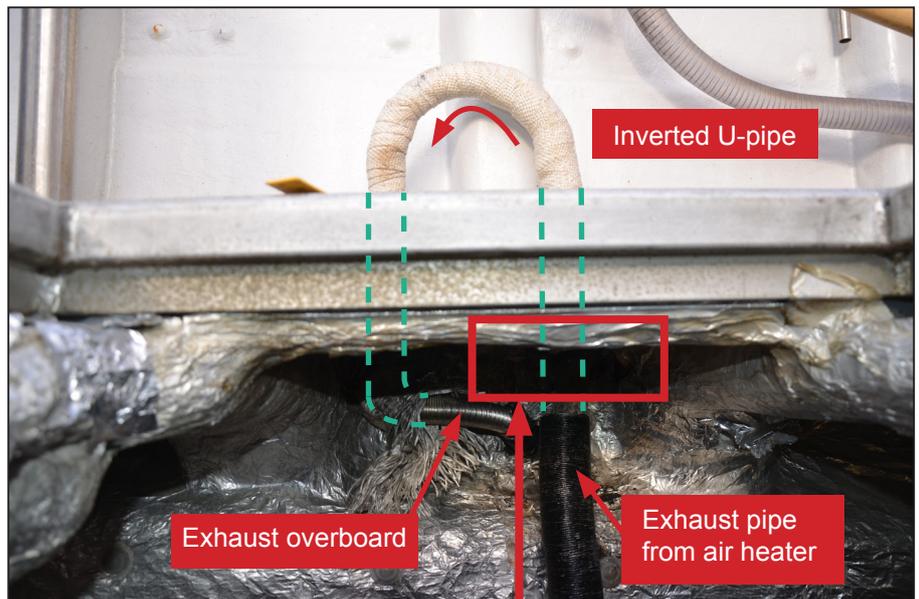
Detailed examination of one of these vessels revealed that the heater exhaust had been modified to route through a single walled, inverted U-pipe on the main deck (**Figure 2a**) to prevent sea water ingress from the exhaust overboard. As originally built, the exhaust pipe was insulated by woven glass lagging protected by an aluminium oversleeve (**Figure 3**) to prevent the hot exhaust gases (around 450°C) from heating the surrounding area. However, where the exhaust piping had been broken to route it through the main deck,

Figure 2a: Air heater exhaust pipe layout on similar vessel

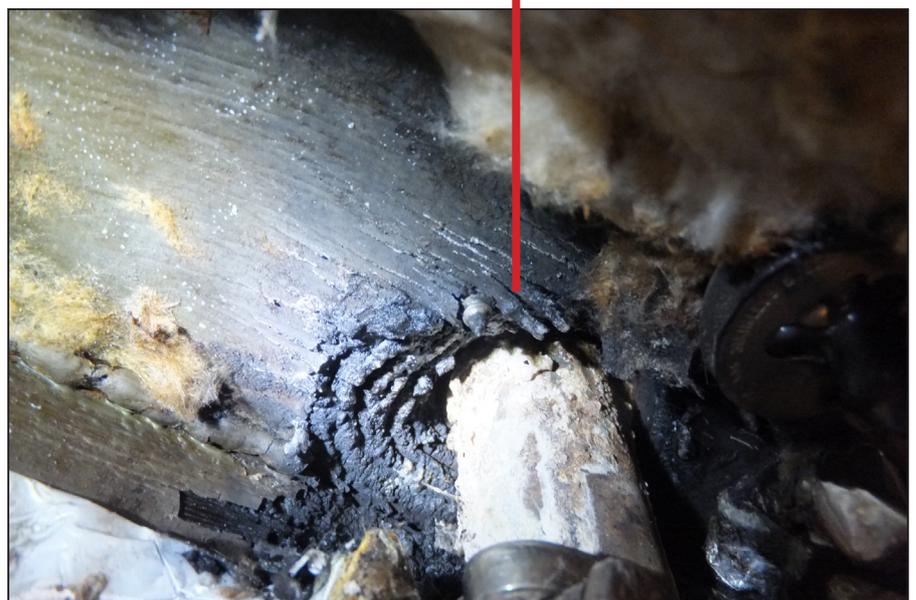
Figure 2b: Scorching under deck on similar vessel

the connection between the heater exhaust pipe and the inverted U-pipe was not insulated. Consequently, the uninsulated section of the hot exhaust pipe in close proximity to the plywood underside of the deck, caused the charring seen in **Figure 2b**.

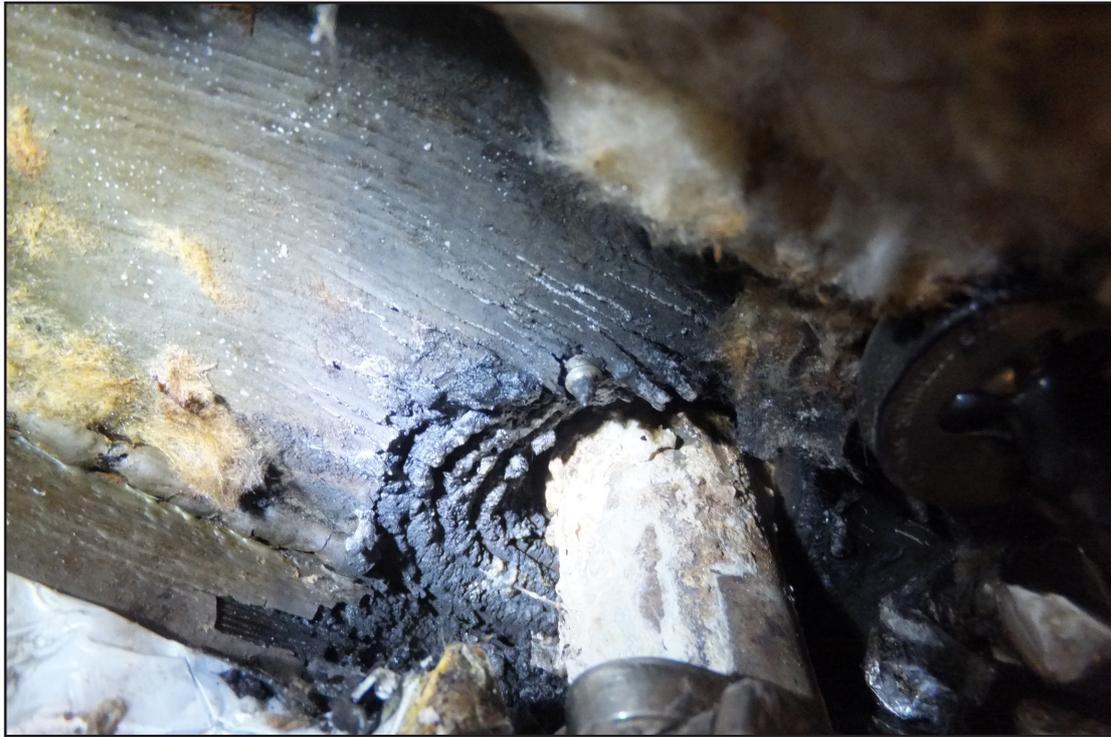
A few days after the accident, the MAIB received information from the owners of similar workboats stating that charring to the underside of the wooden deck through which an uninsulated section of a diesel fired air heater exhaust pipe was routed had been noted (**Figure 2**). Further investigation identified that it also was possible that *ECC Topaz's* exhaust pipe might have deteriorated, allowing hot exhaust gases to impinge directly onto the wooden deck above or flammable substances stored in the heater compartment. These included drums of diesel and lubricating oils, sacks of rags and paper rolls.

Figure 2: Scorching of the plywood underdeck on a similar vessel
