Report on the investigation of  
a serious injury to a crew member  
on board

***Wanderer II***

1 mile south-east of Wiay Island,  
Outer Hebrides

19 November 2013

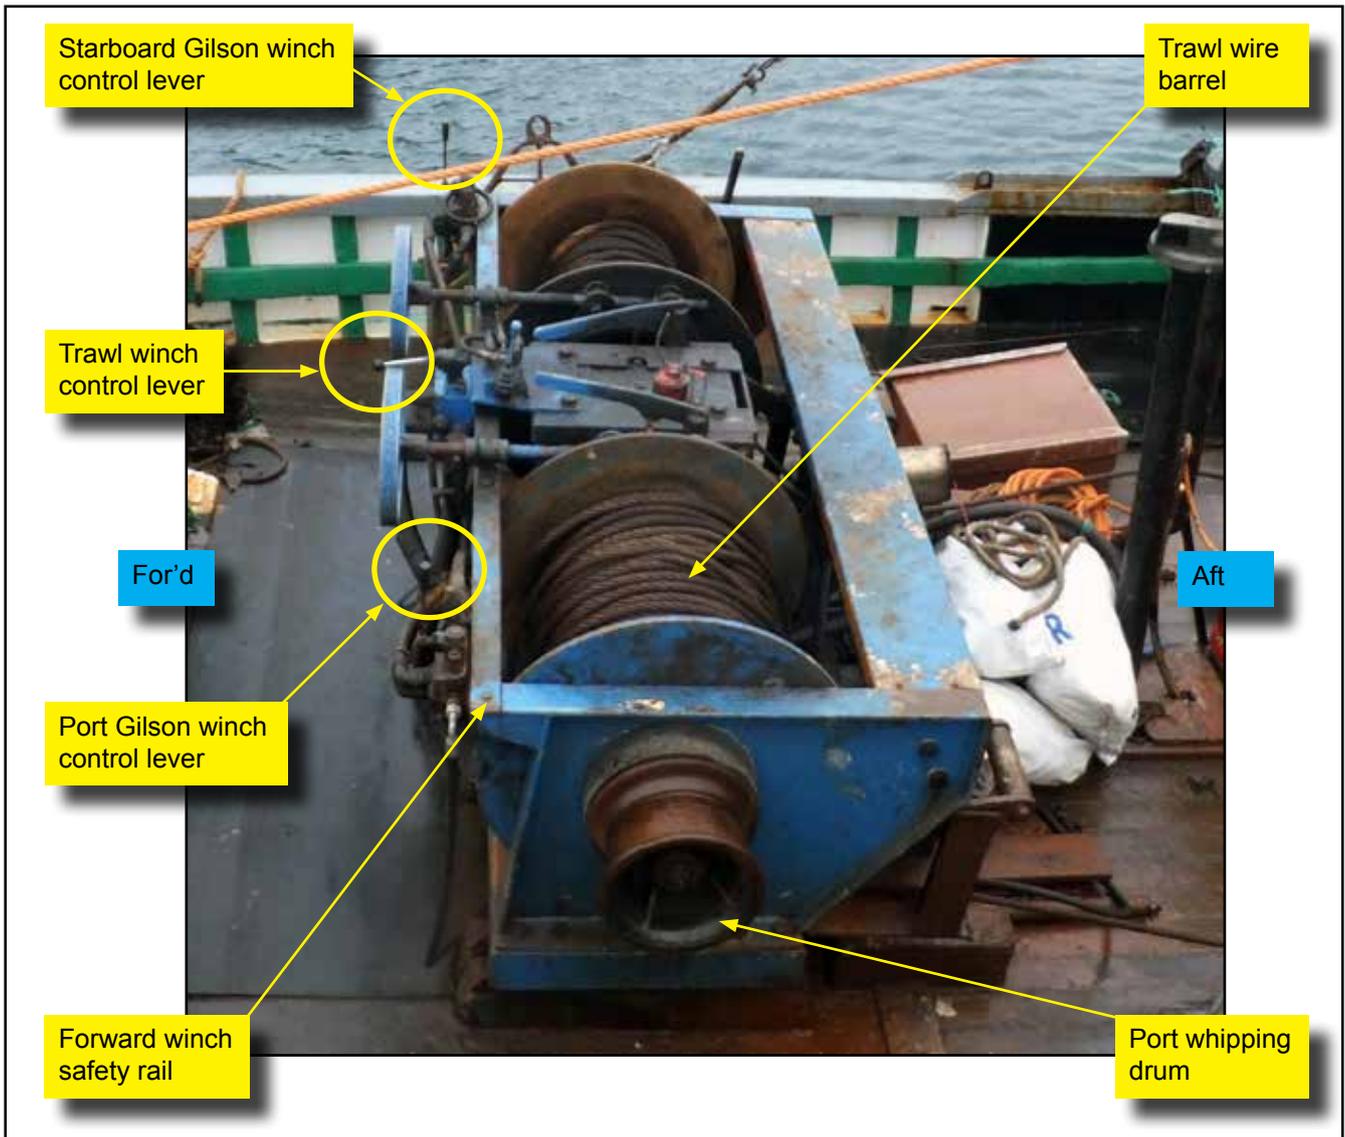
**Figure 2:** *Wanderer II's* trawl winch

The hydraulically operated main trawl winch (**Figure 2**) had a core pull of 3.5 tonnes on empty barrels. The 22mm trawl wires were stowed on two barrels, each with its own dog-clutch and hand tensioned band brake. On either side of the winch were whipping drums that were predominantly used for dredge tipping. The control lever

for the winch was centrally placed (**Figure 2**), around 1.2m from the whipping drums. The control lever was not spring-loaded and could be set to continuously haul or veer without being held in place.

The junior deckhand could not reach the winch control, positioned 1.2m from the whipping drum that he was drawn into. Had there been remote stops adjacent to the whipping drums it is possible that he could have stopped the winch and possibly saved his hand. MSN 1770 (F) mandates and MGN 415 (F) recommends fitting remote emergency stops to winches, although there is no obligation for them to be installed on vessels such as *Wanderer II*, that are under 18m in length and built before 23 November 1995. Neither is there a requirement for vessels structurally or mechanically modified since that date (as *Wanderer II* was) to comply; this is a shortcoming within the regulation. Nevertheless, where winches are set to rotate with the controls unattended, all vessel owners should give serious consideration to fitting emergency stops or, where this is not practicable, modify the operation to ensure that someone is always stationed at the winch control.

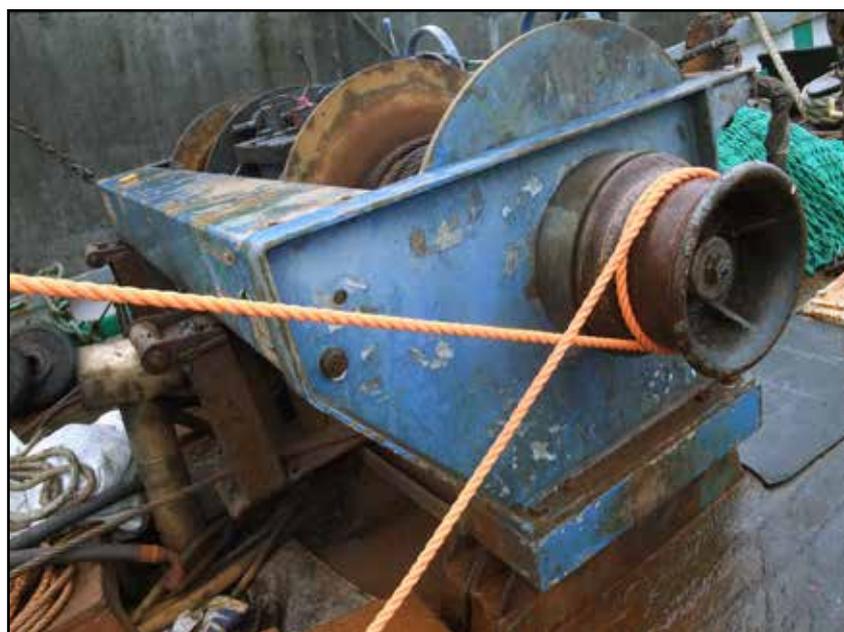
**Figure 3:** Starboard whipping drum with 1.5 turns of rope

turn around the whipping drum. Added to the 1.5 turns of rope already present on the drum this created a total of around 3.3 turns from the rope's point of entry to its point of exit. Number five dredge started lifting immediately, without the need to apply any tension to the tipping rope, and it became apparent to the junior deckhand that the dredge was jerking up and down and lifting higher than was necessary for emptying. In an attempt to stop this, he placed his gloved left hand against the rope on the underside of the rotating whipping drum, pushing against the direction of rotation. In doing so, the glove and his hand became trapped between the rope and the drum, causing them to be drawn in and around the whipping drum.

The skipper tipped the starboard side dredge bags on his own. The method adopted was to apply 1½ turns of rope to the constantly rotating whipping drum (**Figure 3**), and allow it to surge freely until he pulled on it to increase tension, causing the rope to grip on the drum. Using this method he was able to hook in the tipping rope to the dredge becket, pull on the rope to raise the dredge and, while surging the rope on the whipping drum with one hand, shake the raised dredge bag with the other. He would work his way aft, always leaving the 1½ turns of rope to surge on the whipping drum, tipping all six dredges in this manner. By the time he had reached dredge

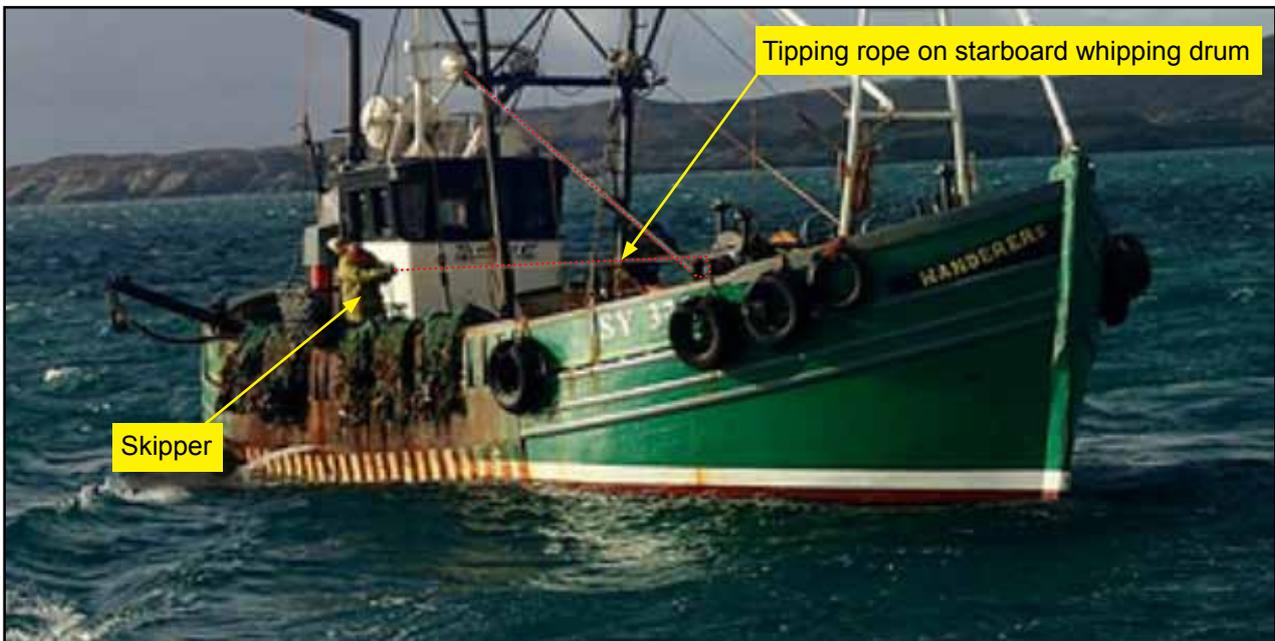
No.6 he was adjusting the tension of the rope turns around the whipping drum from a distance of about 7.5m (**Figure 9**). The system on board *Wanderer II* was identical to the one the relief skipper had operated on his own scallop dredger several years previously and is commonly adopted throughout the UK scallop dredging industry.

**Figure 9:** *Wanderer II* tipping dredges with the skipper operating the starboard whipping drum from a distance
