ACCIDENT

Aircraft Type and Registration:	Pietenpol Air Camper, G-ECVB	
No & Type of Engines:	1 Continental Motors Corp O-200-A piston engine	
Year of Manufacture:	2002 (Serial no: PFA 047-13014)	
Date & Time (UTC):	23 July 2014 at 1750 hrs	
Location:	RAF Cranwell, Lincolnshire	
Type of Flight:	Private	
Persons on Board:	Crew - 1	Passengers - 1
Injuries:	Crew - None	Passengers - None
Nature of Damage:	Right landing gear and right wingtip damaged	
Commander's Licence:	Private Pilot's Licence	
Commander's Age:	34 years	
Commander's Flying Experience:	133 hours (of which 58 were on type) Last 90 days - 4 hours Last 28 days - 1 hour	
Information Source:	Aircraft Accident Report Form submitted by the pilot

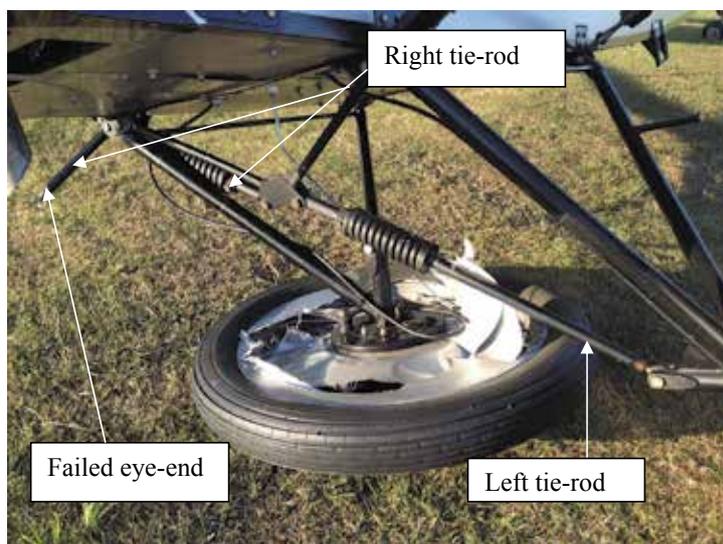
Initial examination of G-ECVB showed that the rod-end bearing connecting the right mainwheel struts to the right tie-rod had failed, allowing the landing gear to collapse, Figure 1. The failed rod-end did not incorporate a grease nipple.

Figure 1
Failed landing gear

A detailed examination was carried out by the LAA which determined that the rod-end was of a lower specification to that specified in the production drawings and that the failure appeared to have been as a result of progressive deterioration in-service. As a result of the investigation the LAA published details of the incident and findings in Light Aviation magazine.

Feedback received by the LAA as a result of the article indicated that a number of other aircraft showed evidence of rod-end deterioration. After examining a number of these rod-ends the LAA published Airworthiness Information Leaflet (AIL) LAA/MOD/047/009 Issue 1 in November 2014 which required inspections of Cub type landing gear rod-ends to confirm that the correct parts were fitted and that there was no evidence of deterioration. In addition the AIL introduced a 100 flying hour life for the rod-ends. Publication of the AIL was highlighted in LAA Airworthiness Alert LAA/AWA/14/13.
