ACCIDENT

| Aircraft Type and Registration: | Yak-52, G-YAKR | |
| Date & Time (UTC): | 29 March 2014 at 1453 hrs | |
| Location: | Near Highwood, Chelmsford, Essex | |

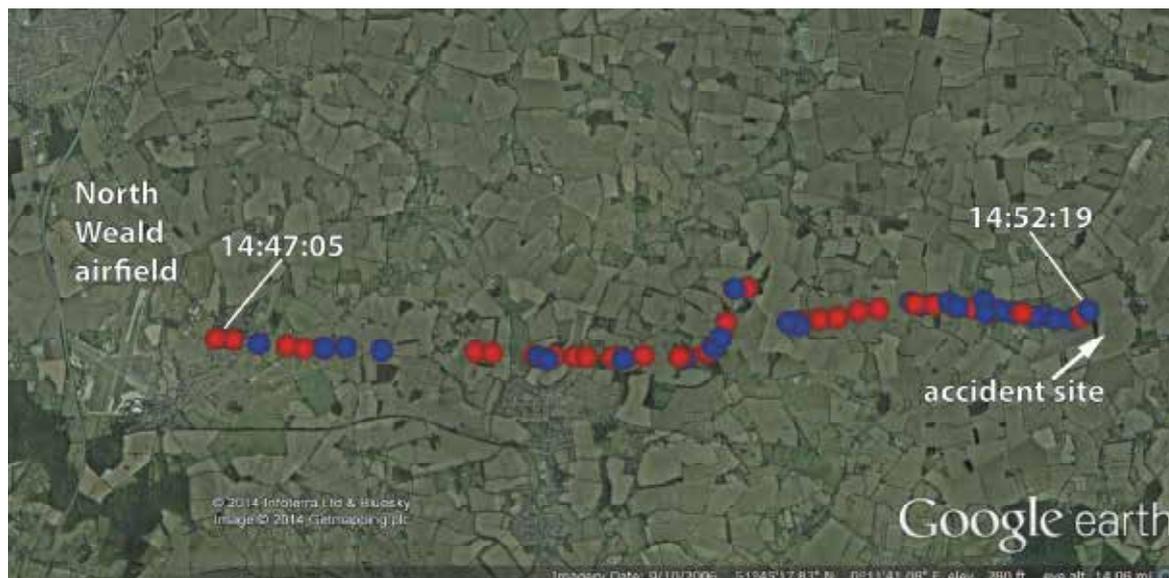
Figure 1

The radar returns were primary only, so no altitude information was available. However, both recorded radar tracks were intermittent, suggesting that the aircraft was flying at an altitude on or near the lower line-of-sight height limit of both radar heads. The lower limit for both radar heads, in the region of the aircraft’s track, was about 200 ft agl, and in places it was down to ground level. The average groundspeed for the accident flight was 86 kt.

Debden (red) and Stansted (blue) radar ground tracks for the accident flight
