**Report on the accident to
Shorts SD3-60 EI-BEM
3.5 km from East Midlands Airport
on 31 January 1986**

Aircraft Accident Report No. 6/87
(EW/C947)

<i>Operator:</i>	Aer Lingus Commuter
<i>Aircraft: Type:</i>	Shorts SD3-60
<i>Nationality:</i>	Irish
<i>Registration:</i>	EI-BEM
<i>Place of accident:</i>	3.5 km from East Midlands Airport Latitude 52° 49.3' N Longitude 001° 23.5' W
<i>Date and Time:</i>	31 January 1986 at 1851 hrs
	All times in this report are UTC

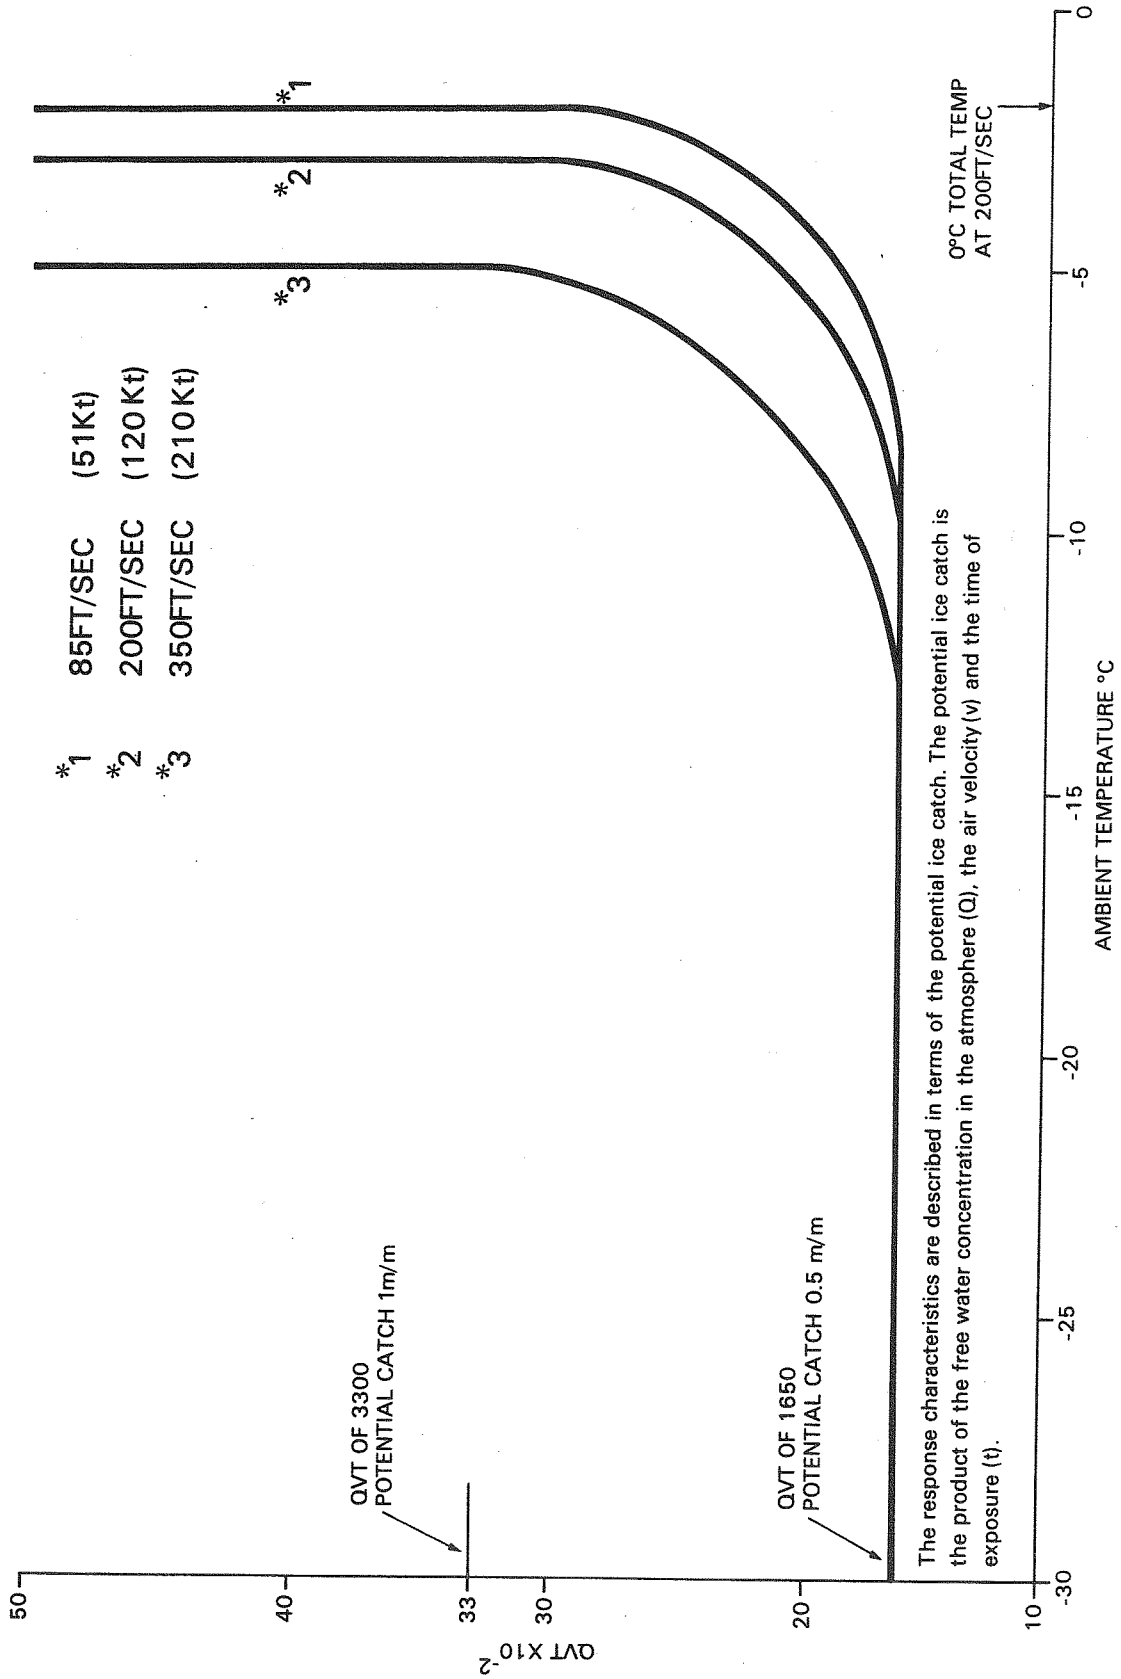
ROTATING CYLINDER ICE DETECTOR - GENERAL PERFORMANCE CHARACTERISTICS

Examination of the graph at Appendix IV shows that, in the prevailing conditions of temperature and airspeed, the detector was operating in a range of parameters defined by the manufacturers as close to the ice detection threshold.

The lack of warning by the ice detector is more difficult to explain as the system appeared to be working correctly. However, a study of the effectiveness of ice warnings, in different conditions of temperature and water content, showed that in the conditions encountered on the night of the accident it is possible that the detector would not provide a warning. (See Appendix IV).

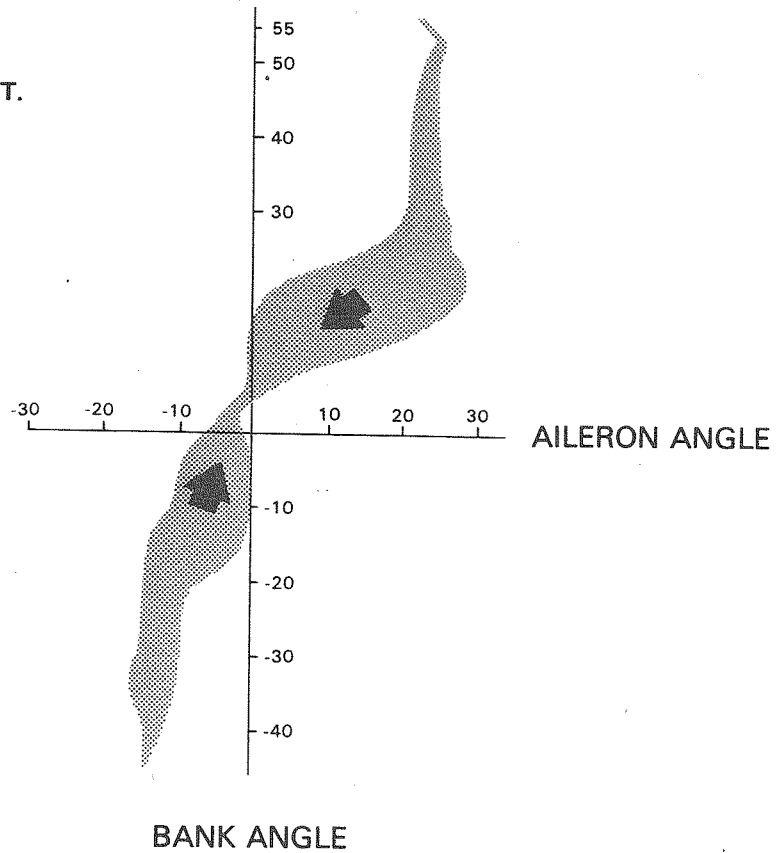
**FIGURE 2.
THE ACCIDENT FLIGHT.**

The right side of the two graphs represents aileron displacement which should provide left wing down aircraft motion, and the lower half of each displays the left wing down bank achieved.

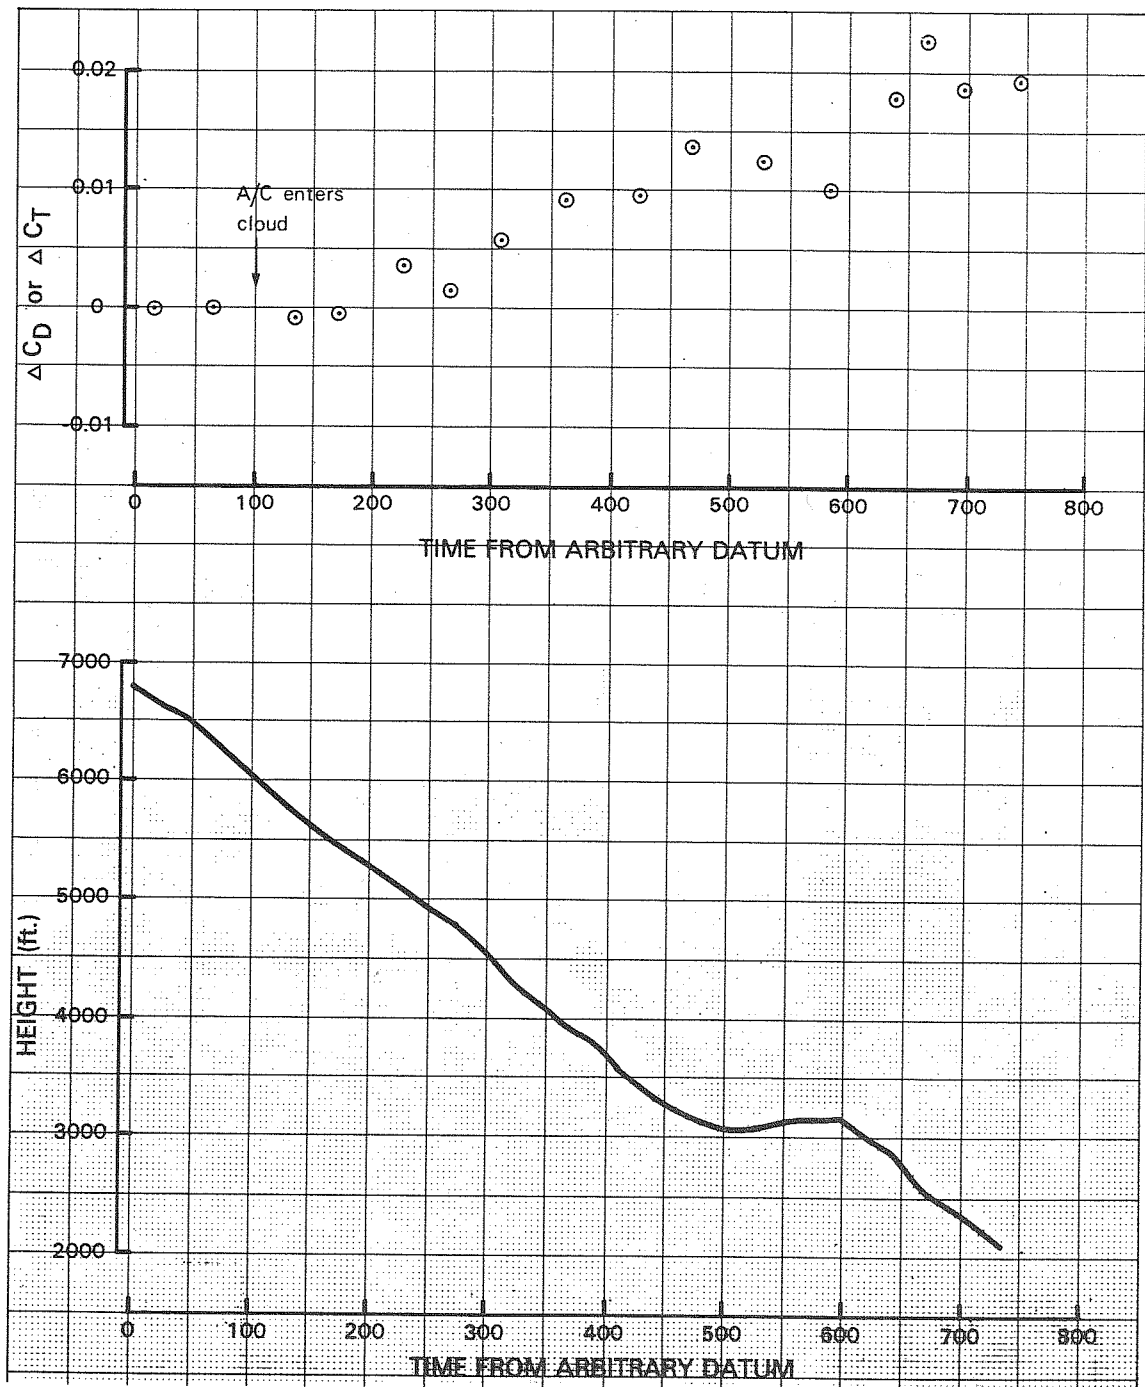
DIFFERENCE BETWEEN CALCULATED AND THEORETICAL DRAG/THRUST

The difference between achieved and theoretical rate of change was deduced and converted into an equivalent drag coefficient difference (ΔC_D). This is shown plotted, together with height, against elapsed time in Appendix X. It should be noted that it is not possible to determine whether this is in fact a drag difference, an engine thrust difference, or a combination of the two.
