ACCIDENT

Aircraft Type and Registration:	Cessna F150I, G-YIII
No & Type of Engines:	1 Continental Motors Corp O-200-A piston engine
Year of Manufacture:	1972 (Serial no: 827)
Date & Time (UTC):	14 June 2014 at approx 1225 hrs
Location:	Near Hucknall Airfield, Nottinghamshire
Type of Flight:	Private
Persons on Board:	Crew - 1 Passengers - 1
Injuries:	Crew - 1 (Fatal) Passengers – 1 (Fatal)
Nature of Damage:	Aircraft Destroyed
Commander's Licence:	Private Pilot's Licence
Commander's Age:	70 years
Commander's Flying Experience:	293 hours (of which 240 were on type) Last 90 days - 4 hours 30 minutes Last 28 days - 2 hours
Information Source:	AAIB Field Investigation

Synopsis

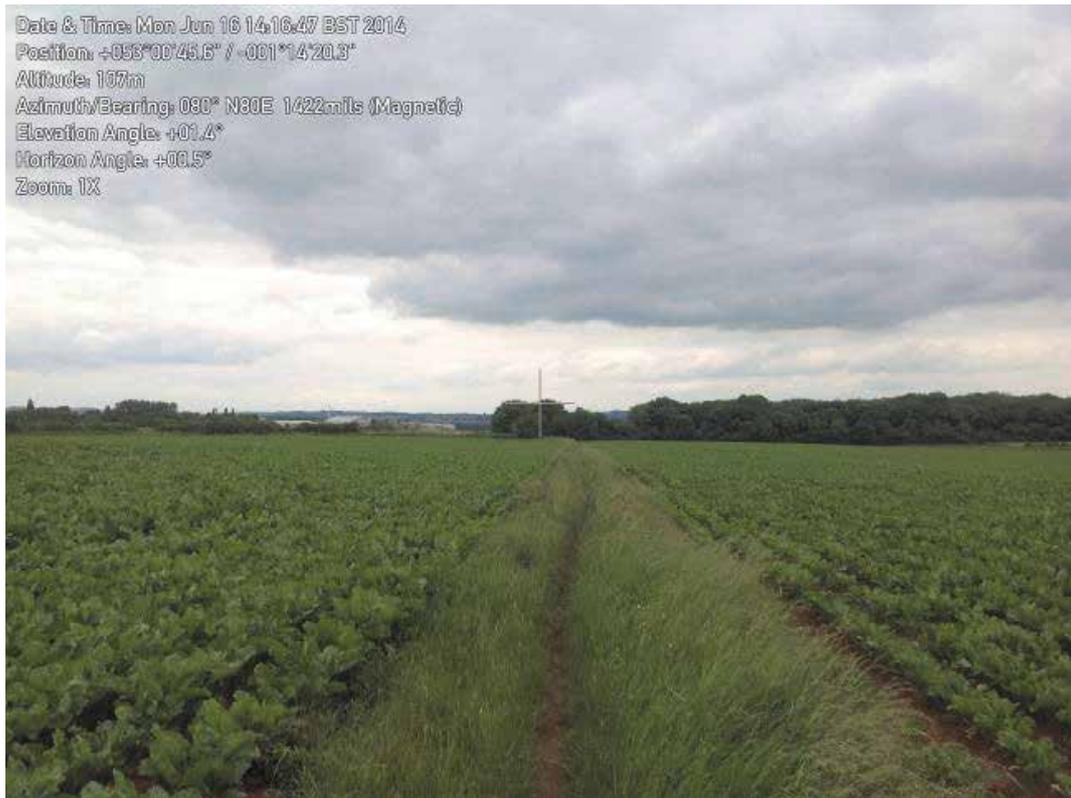
Figure 2

In an attempt to refine the height estimates, Eyewitness A and B were interviewed in the locations from which they had seen the aircraft. They were provided with an electronic tablet device with a camera, screen and geo-referenced aiming mark, and asked to place the crosshairs where they recalled seeing the aircraft at various points during its flight. (Figure 2 is an example of the presentation). Estimates of the aircraft height were then made using trigonometry. The aircraft height of the aircraft as first seen by these witnesses was calculated to be about 100 ft.

Exemplar of witness height estimation imagery.
The aircraft track was reported as from left to right in this image

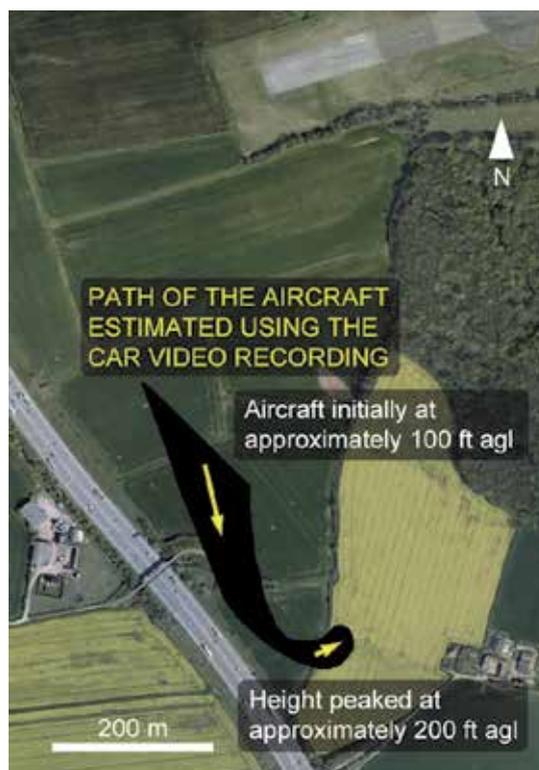
Figure 3

Analysis of the video indicated that the aircraft was approximately 100 ft above the ground when it first appeared on the video recording and peaked in the climb at a height of approximately 200 ft. The video recording was of insufficient quality for a more accurate analysis. The estimated flight path of the aircraft indicated by the video is given in Figure 3.

Path of the aircraft estimated from analysis of the car video recording
