**SERIOUS INCIDENT**

<b>Aircraft Type and Registration:</b>	DHC-8-402 Dash 8, G-JEDM	
<b>No &amp; Type of Engines:</b>	2 Pratt & Whitney Canada PW150A turboprop engines	
<b>Year of Manufacture:</b>	2003 (Serial no: 4077)	
<b>Date &amp; Time (UTC):</b>	19 January 2015 at 1014 hrs	
<b>Location:</b>	Inverness Airport	
<b>Type of Flight:</b>	Commercial Air Transport (Passenger)	
<b>Persons on Board:</b>	Crew - 4	Passengers - 47
<b>Injuries:</b>	Crew - None	Passengers - None
<b>Nature of Damage:</b>	None	
<b>Commander's Licence:</b>	Airline Transport Pilot's Licence	
<b>Commander's Age:</b>	58 years	
<b>Commander's Flying Experience:</b>	13,800 hours (of which 3,300 were on type) Last 90 days - 180 hours Last 28 days - 50 hours	
<b>Information Source:</b>	Aircraft Accident Report Form submitted by the pilot

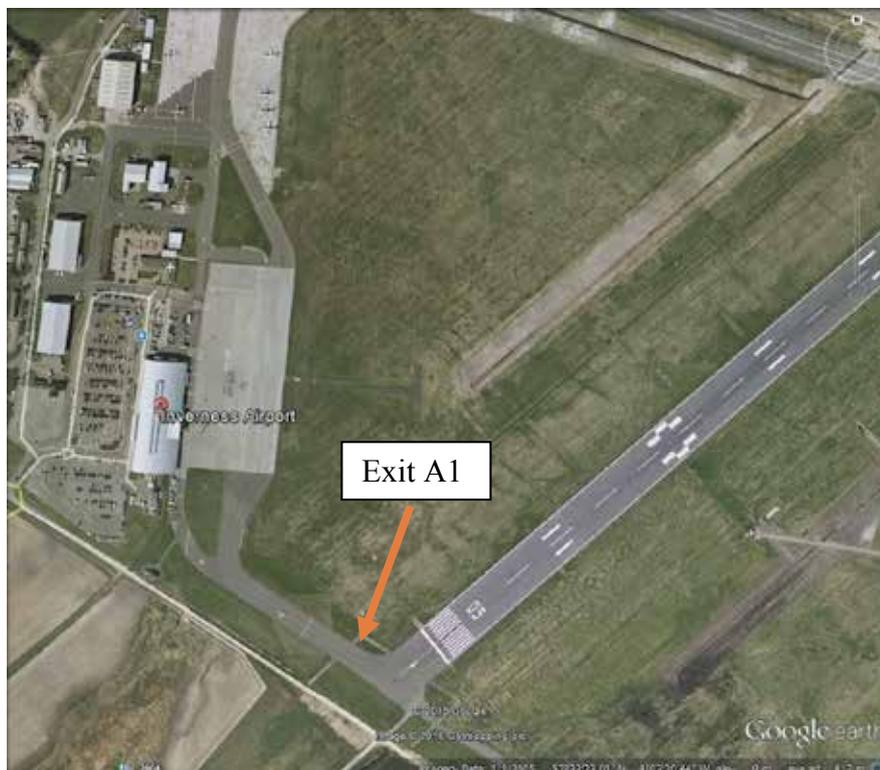
**Figure 1**

Aerial view of Inverness Airport showing location of exit A1
