Report on the examination of *Olivia Jean* on 18 October 2009

Report of examination of the UK Beam Trawler

***Olivia Jean* TN 35**

18 October 2009

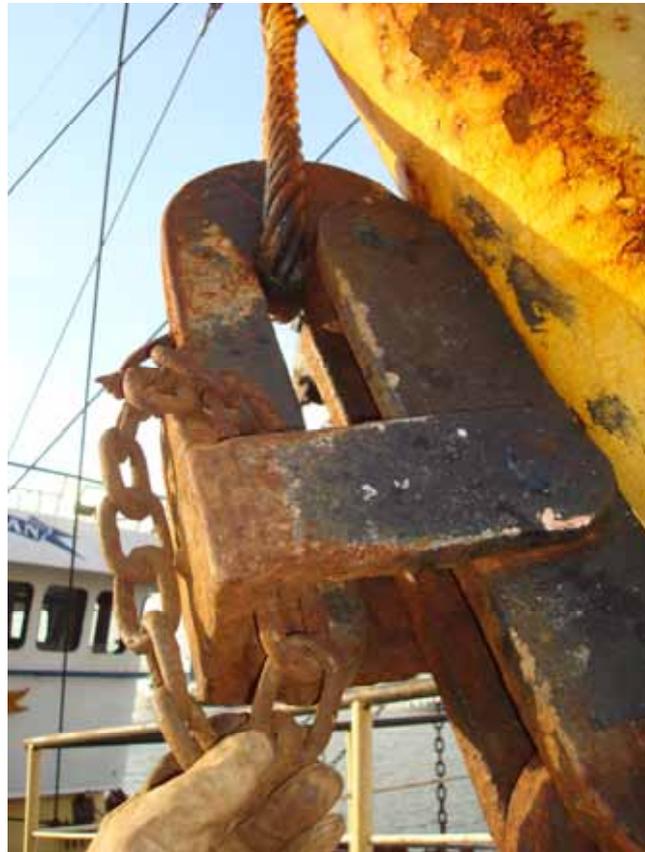
- Quick release hooks chained up, possibly with the intention of preventing inadvertent release? (**Figure A.2**).
- Worn and cracked derrick heel assemblies, and their attachments to the gantry legs (**Figures A.21, A.22, A.23, A.24**).
- Unsecure shackle at derrick forestay attachment (**Figure A.25**).

Figure A.2: Detail - quick release pelican hook (starboard)

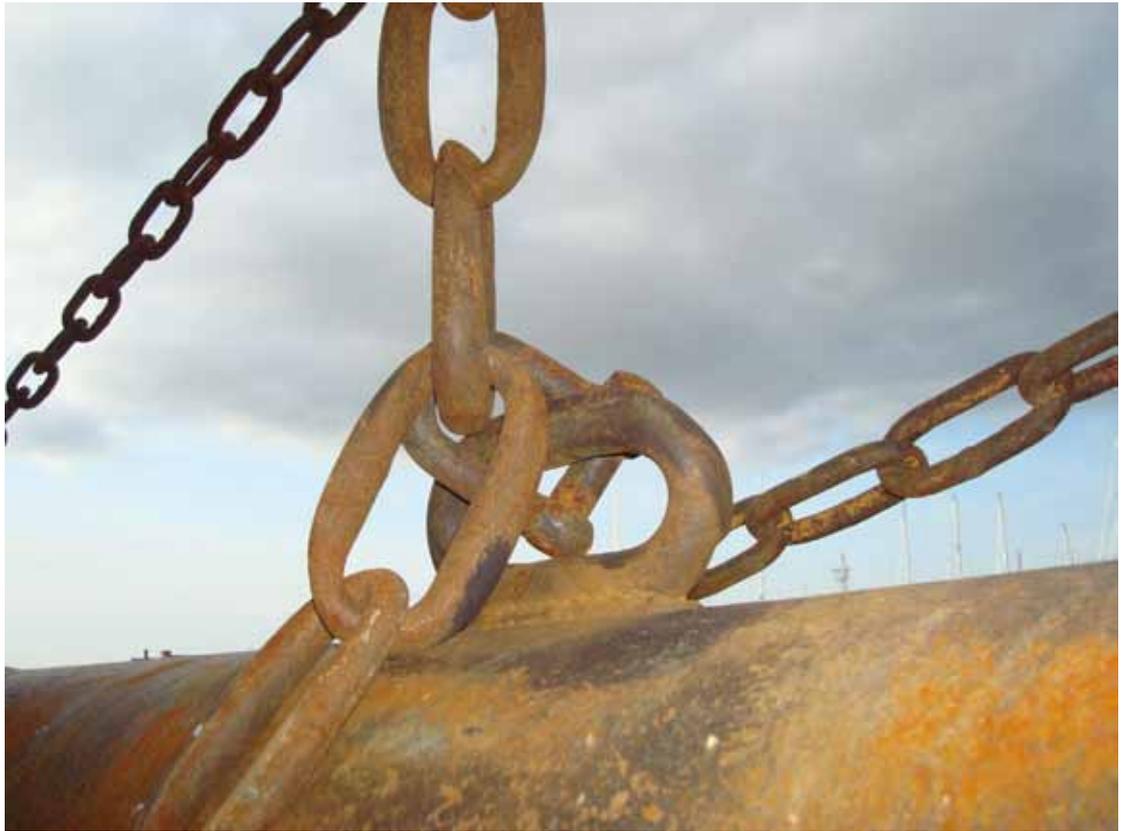
- Main trawl beam attachments to lifting chains poorly designed and manufactured. Fabricated using “fishing gear” type shackles and cut links of trawl chain. Many shackles and chain links also badly worn (**Figures A.7, A.8**).

Figure A.7: Detail of port towing bridle chains – note: worn chain, unsecure shackle

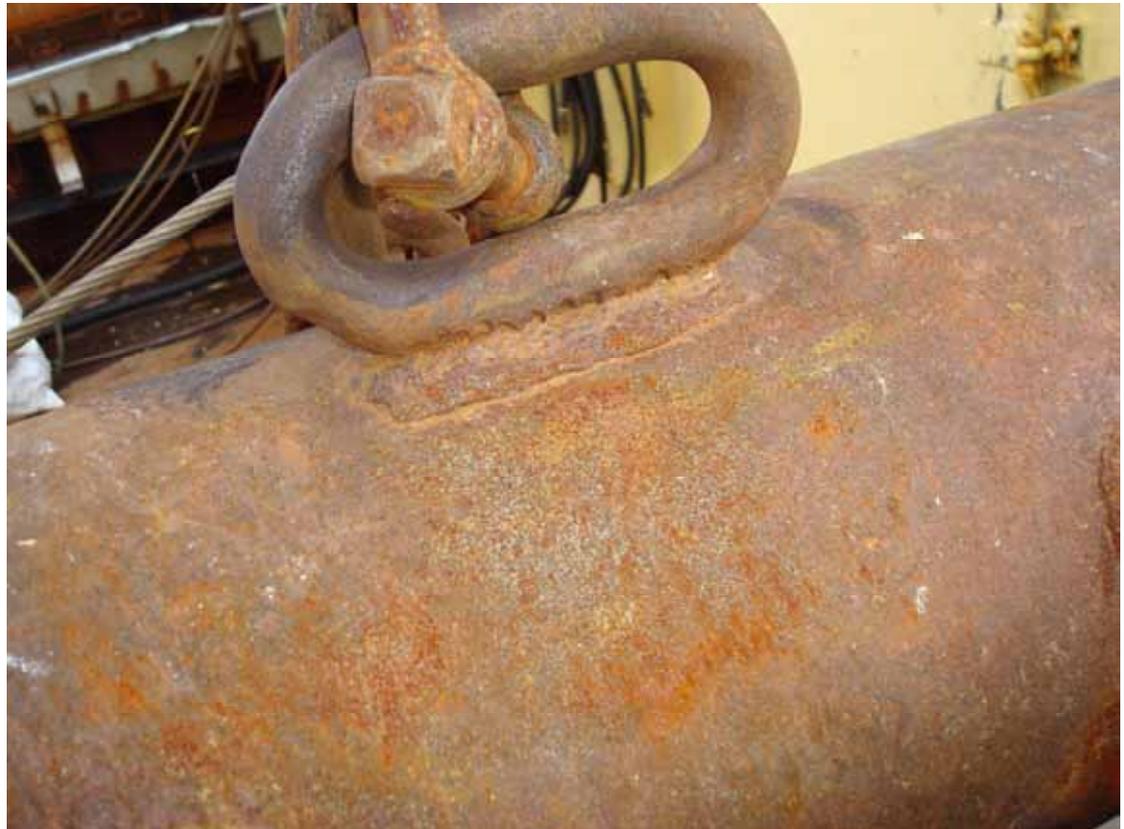
Figure A.8: Detail of trawl beam - poor welding

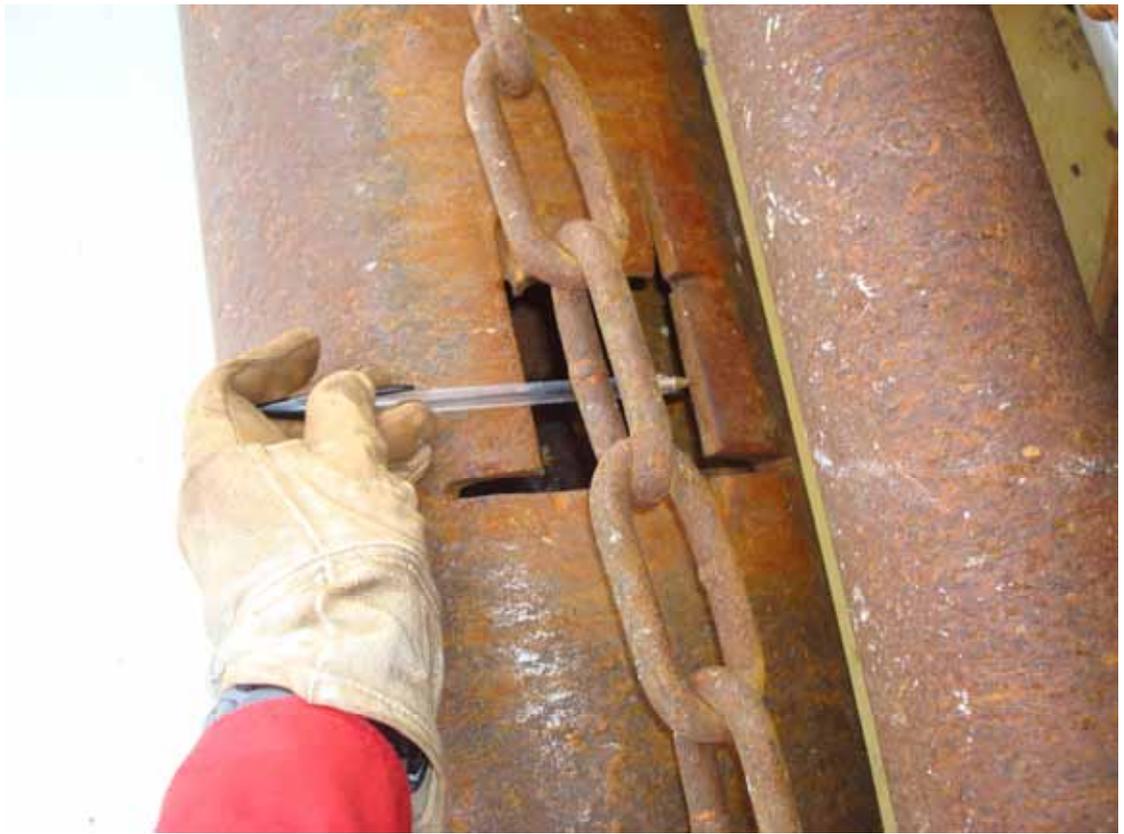
- Damages and modifications to trawl beam/tipping bar repaired poorly (**Figures A.9, A.10**).
- Most lifting shackle attachments for trawl beam and tipping bar loose, damaged, and not properly secured or moused. However, a small number of shackles had been welded secure (**Figures A.11, A.12, A.13**).

Figure A.9: Repairs/modifications to port trawl beam - hole cut through trawl beam

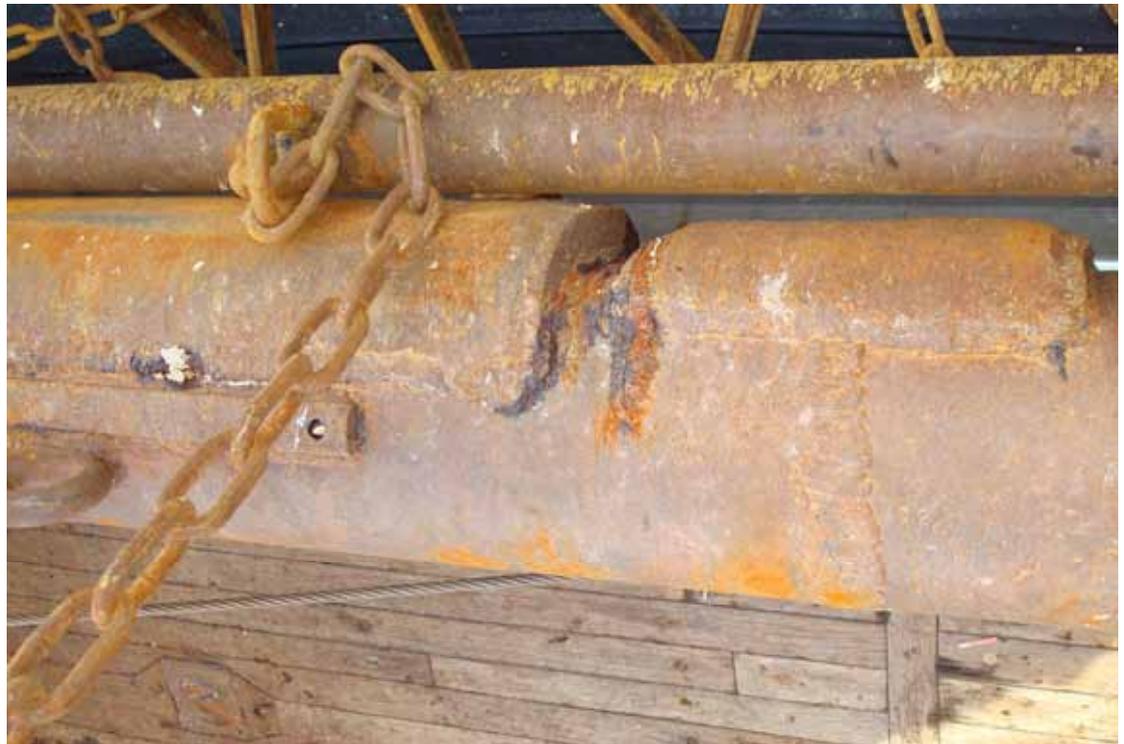
Figure A.10: Crack extending over 1/3 circumference of port trawl beam, in way of hard facing/sleeving. Evidence of earlier repair(s) also visible

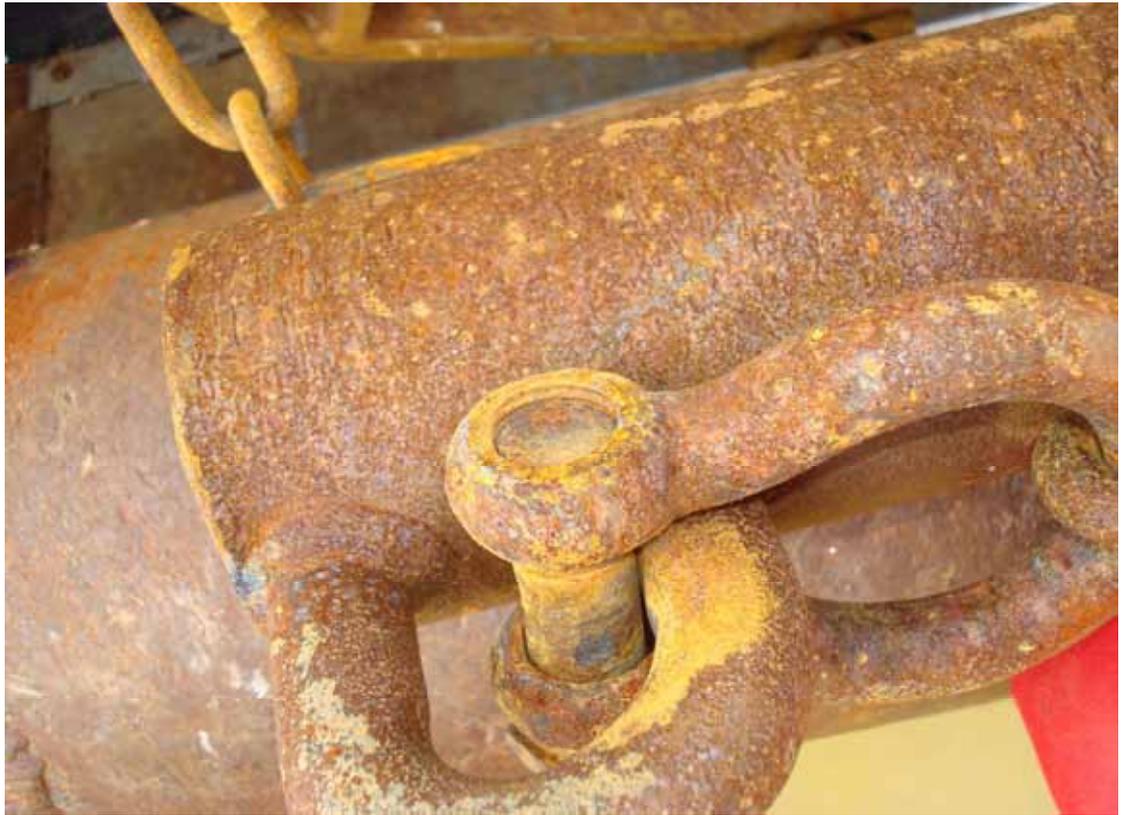
Figure A.11: Unsecure shackle at lifting chain to tipping bar - found hand tight

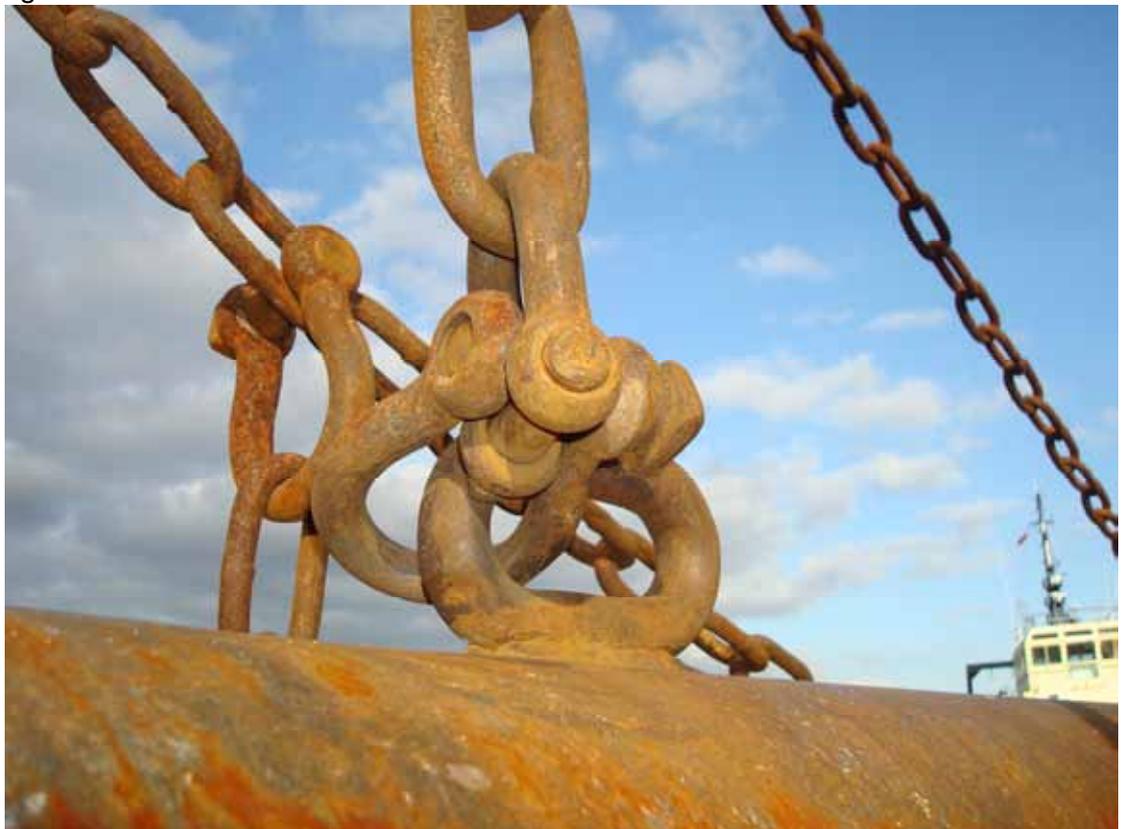
Figure A.12: Unsecure attachment of towing chains to beam - shackles found hand tight

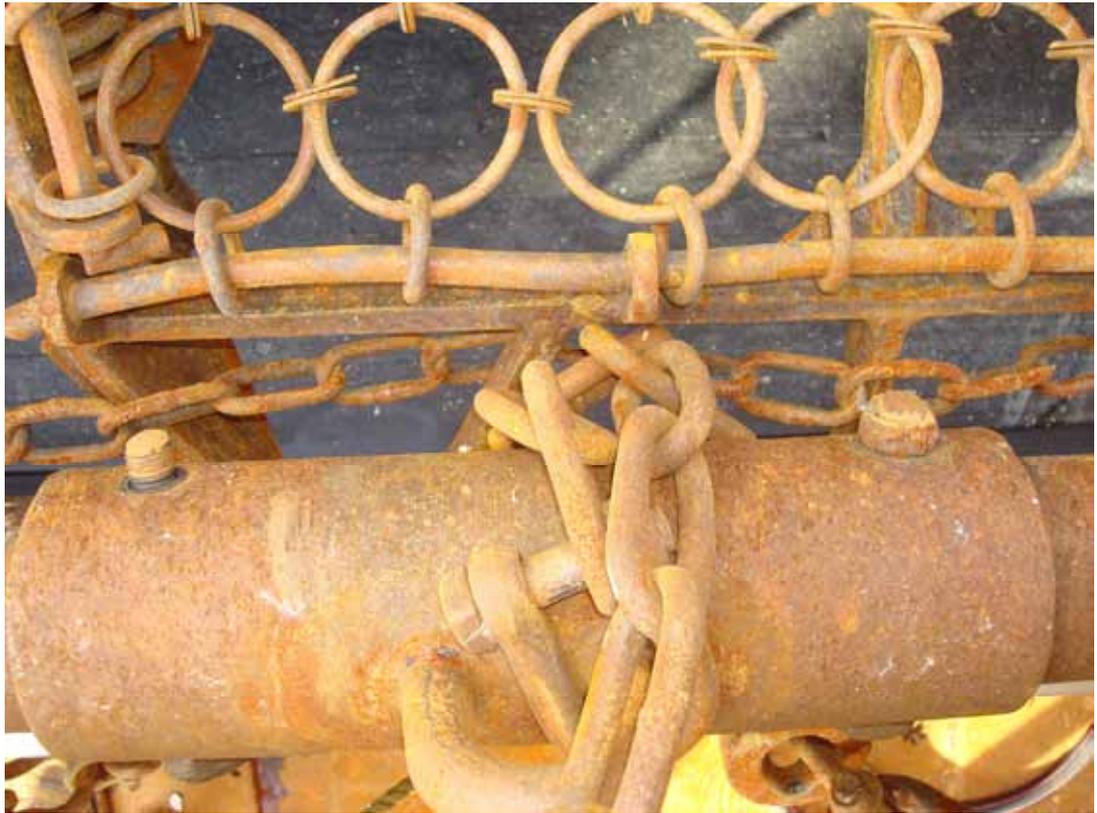
Figure A.13: Damage/missing parts at port tipping bar at connector sleeve

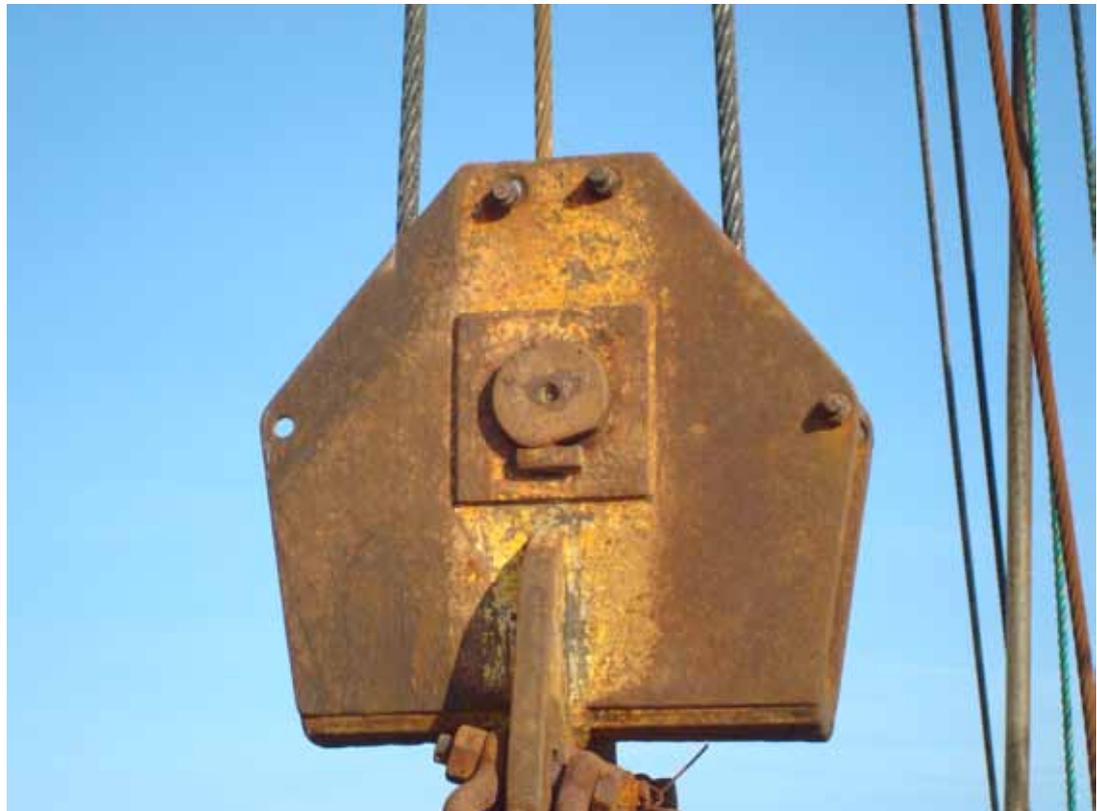
- Main double purchase trawl blocks worn, damaged and with parts missing (**Figures A.14, A.15**).
- Trawl warps - that visible was generally in an acceptable condition, and appeared to be relatively new. It is understood that the wires seen on board are not those in use at the time of the accident; they have since been renewed, and the original wires (including the broken part) have been dumped.

Figure A.14: Port trawl block. Missing parts, damage, wear, unsecure shackle attachments, sheave pin rotating

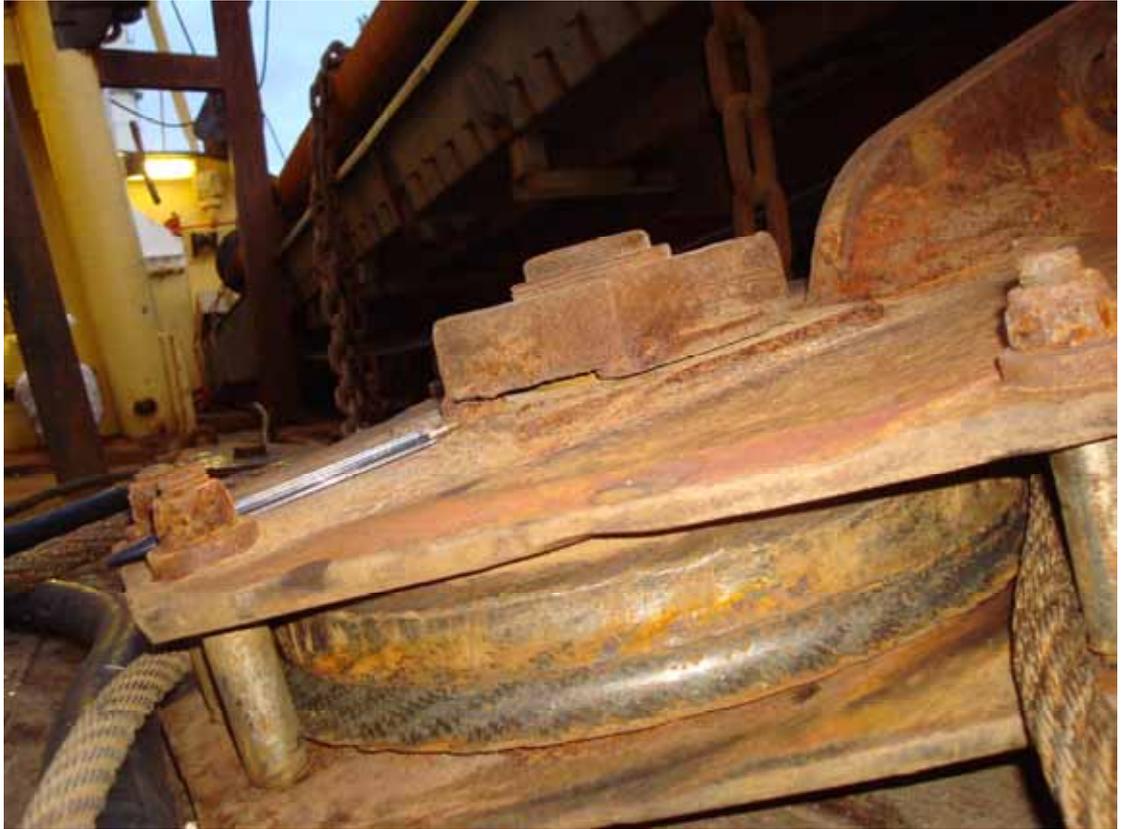
Figure A.15: Starboard trawl block. Damage, wear, unsecure sheave pin

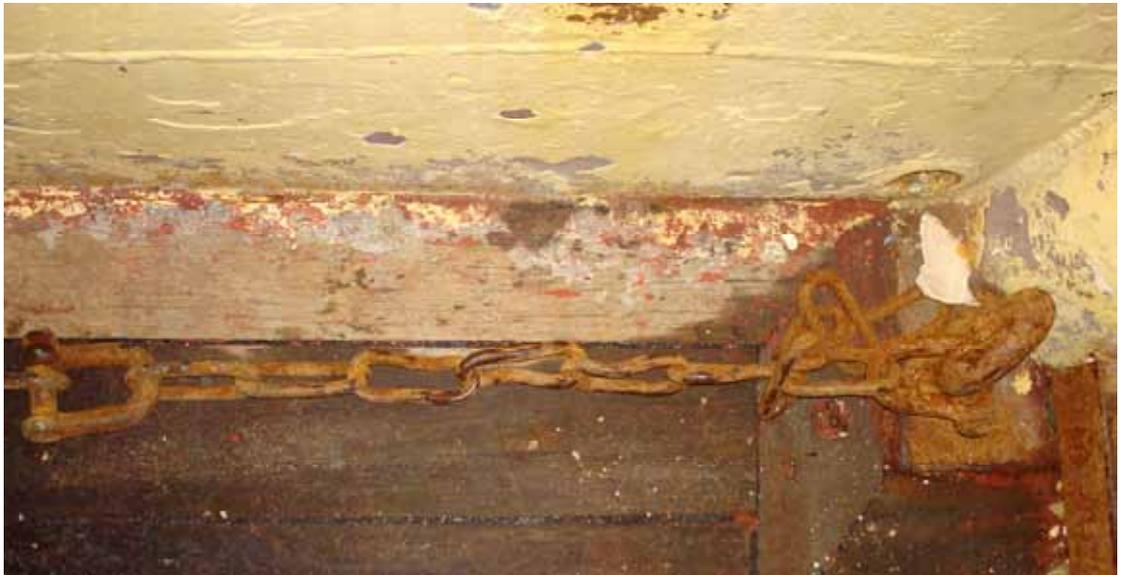
- Gilson wires - that visible was damaged, deformed and distorted; not lubricated. In poor condition.
- “Safety chains” - various parts of these chains were worn and/or distorted by overload; the assembly being made up from a mixture of ill matched components. The hooks in use consisted of either a proprietary item, or something similar fashioned from a section of shackle; however, spare new hooks were seen in the deck store (**Figures A.16, A.17, A.18**).

Figure A.16: "Safety chains" - worn, distorted, mis-matched

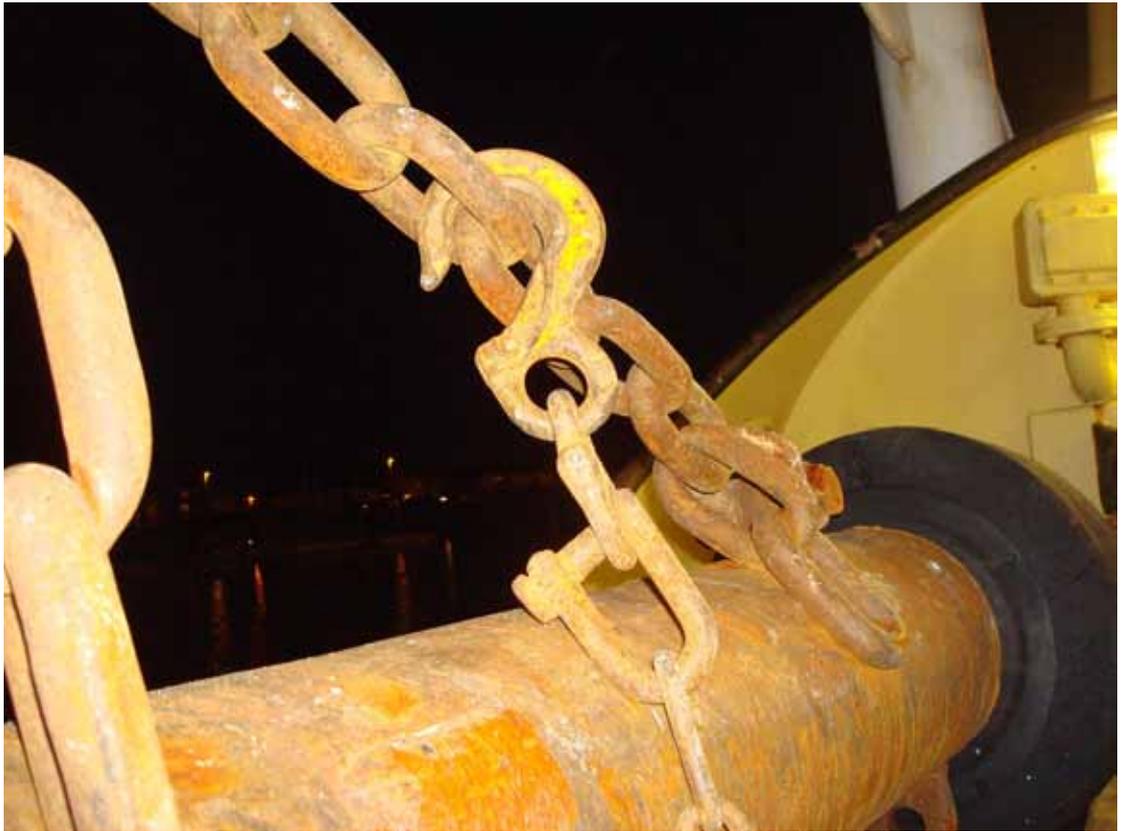
Figure A.17: "Safety chains" - hook, link, and D-shackle

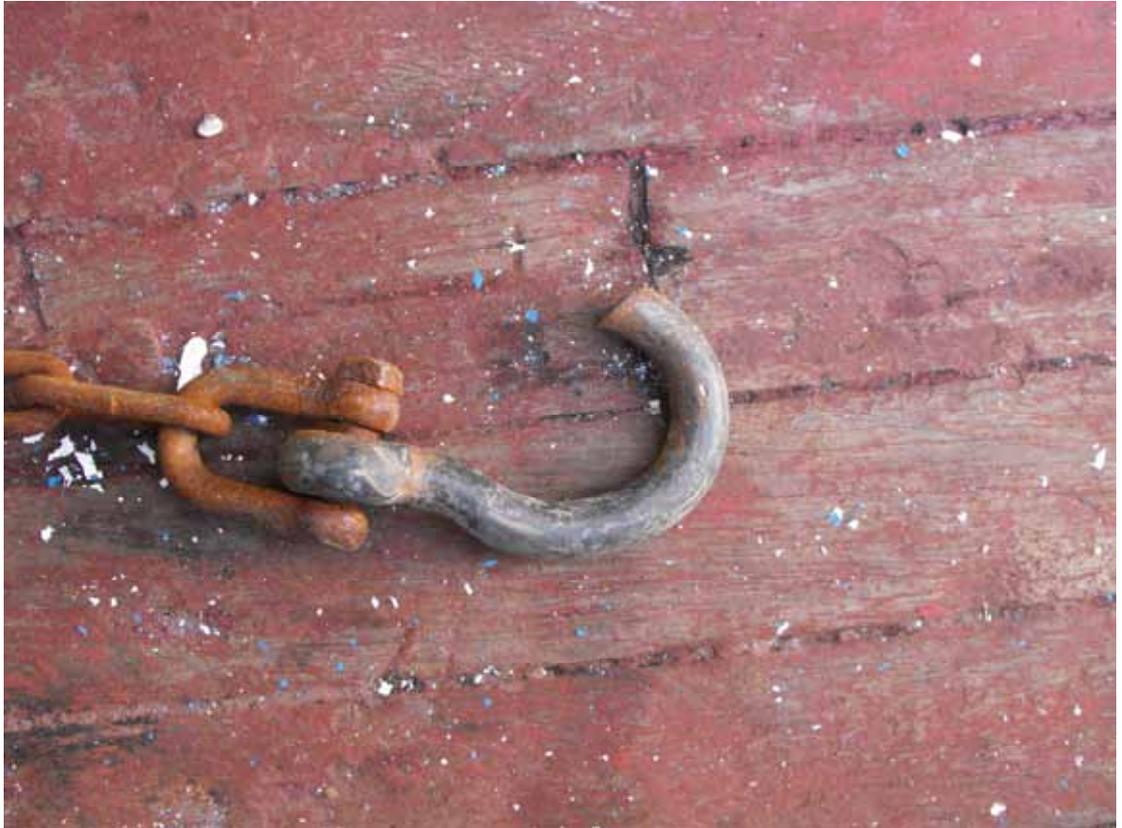
Figure A.18: "Safety chains" - hook made up from cut shackle

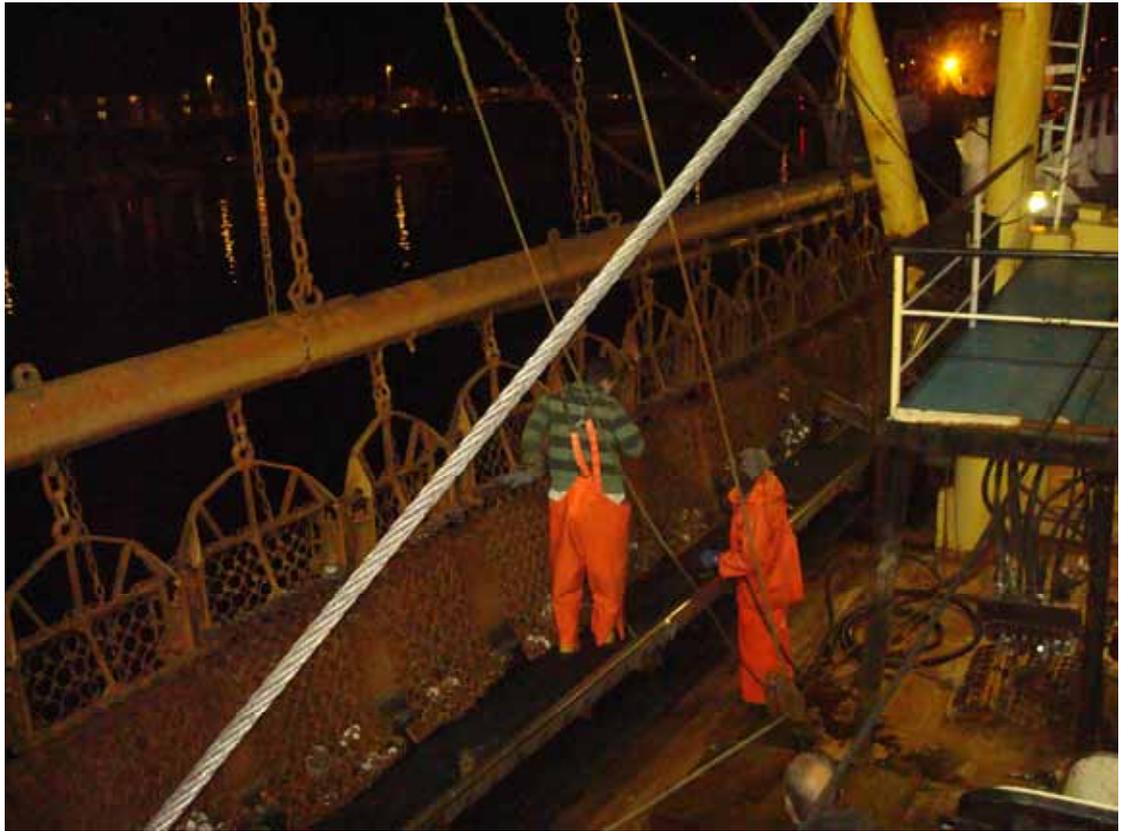
- With the gear cleared away over the side, the conveyor formed a ready access platform. However it then presented additional hazards, including a bulwark height reduced below minimum rule requirements, and a bouncy, trampoline-like working surface when standing on top of the conveyor (**Figure A.20**).
- Although not seen moving, the system appeared to have potential for entrapment/shearing hazards due to exposed moving parts. No emergency stops were seen.

Figure A.20: Working standing on the conveyor, beneath a hanging load

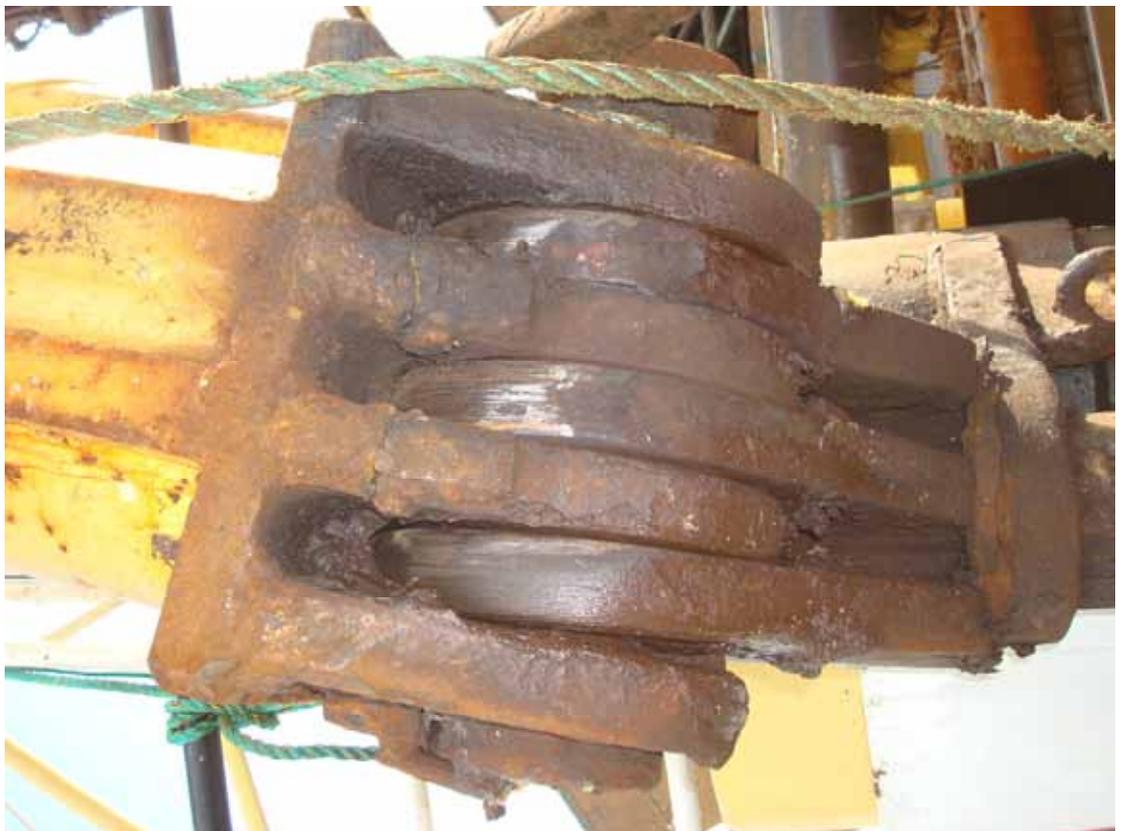
Figure A.21: Port derrick heel pin

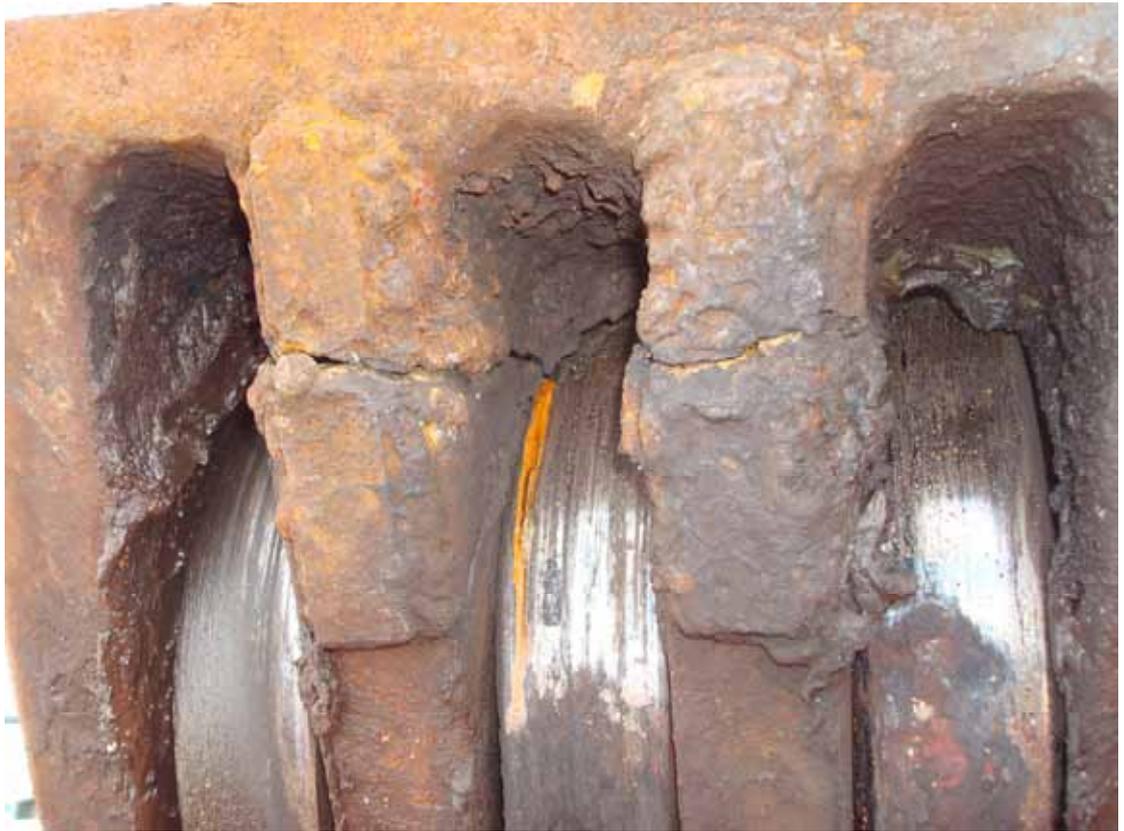
Figure A.22: Port derrick heel pin - close up

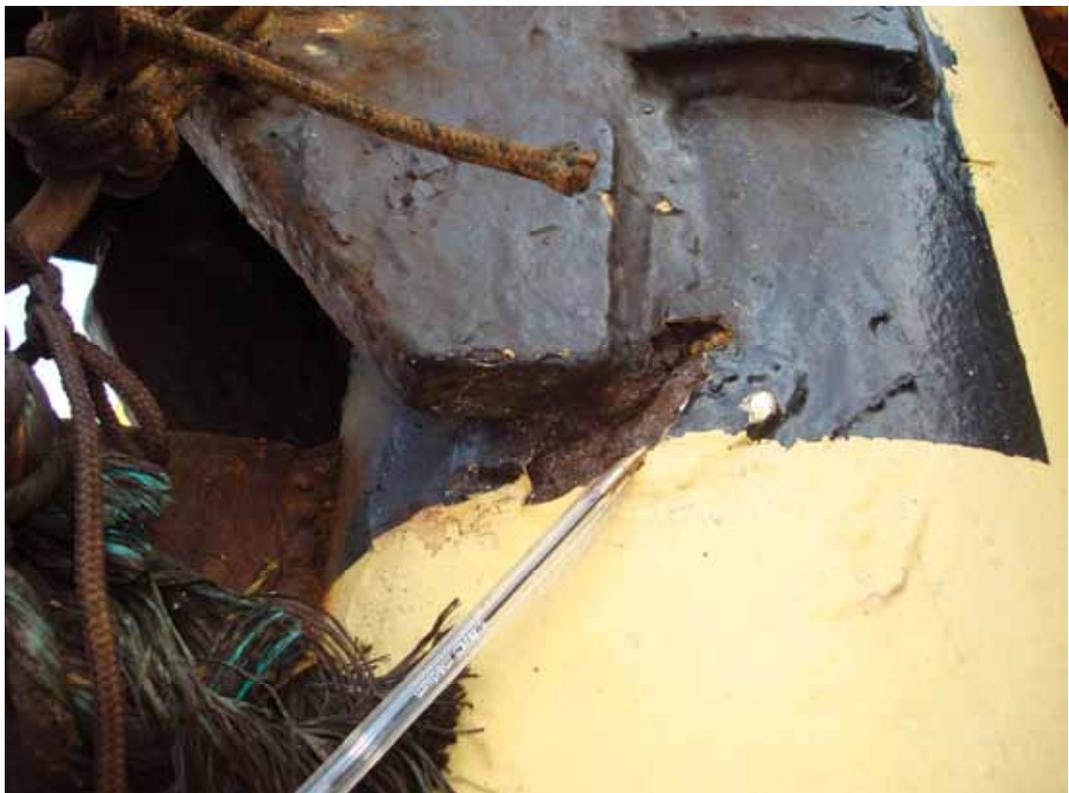
Figure A.23: Port derrick heel assembly - crack at attachment to gantry post

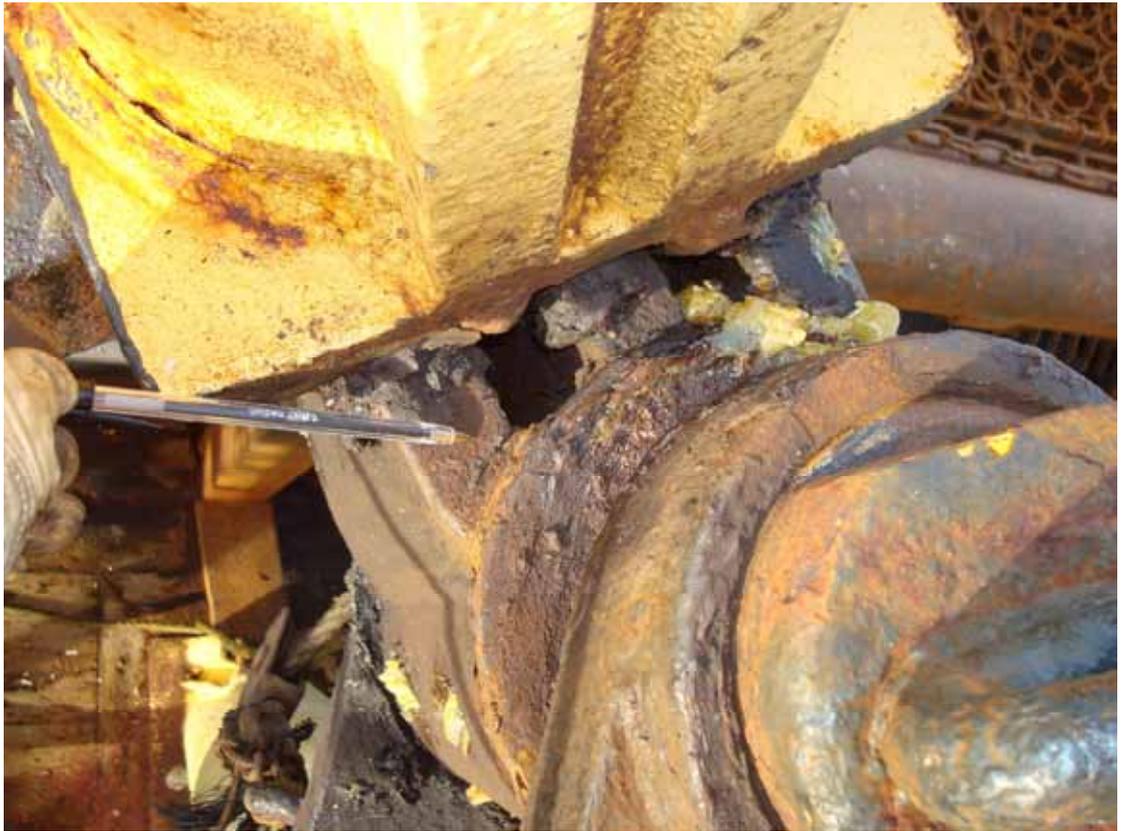
Figure A.24: Crack in base of port derrick heel assembly

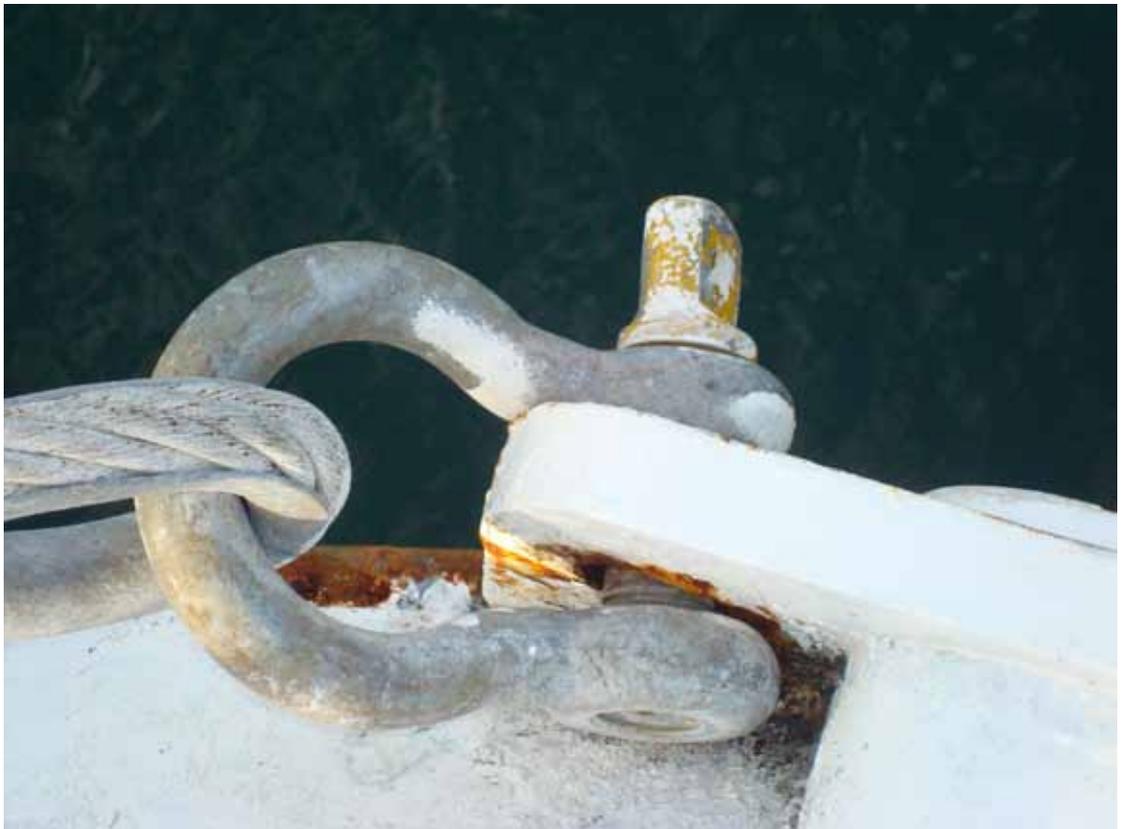
Figure A.25: Unsecure shackle at derrick forestay attachment, port

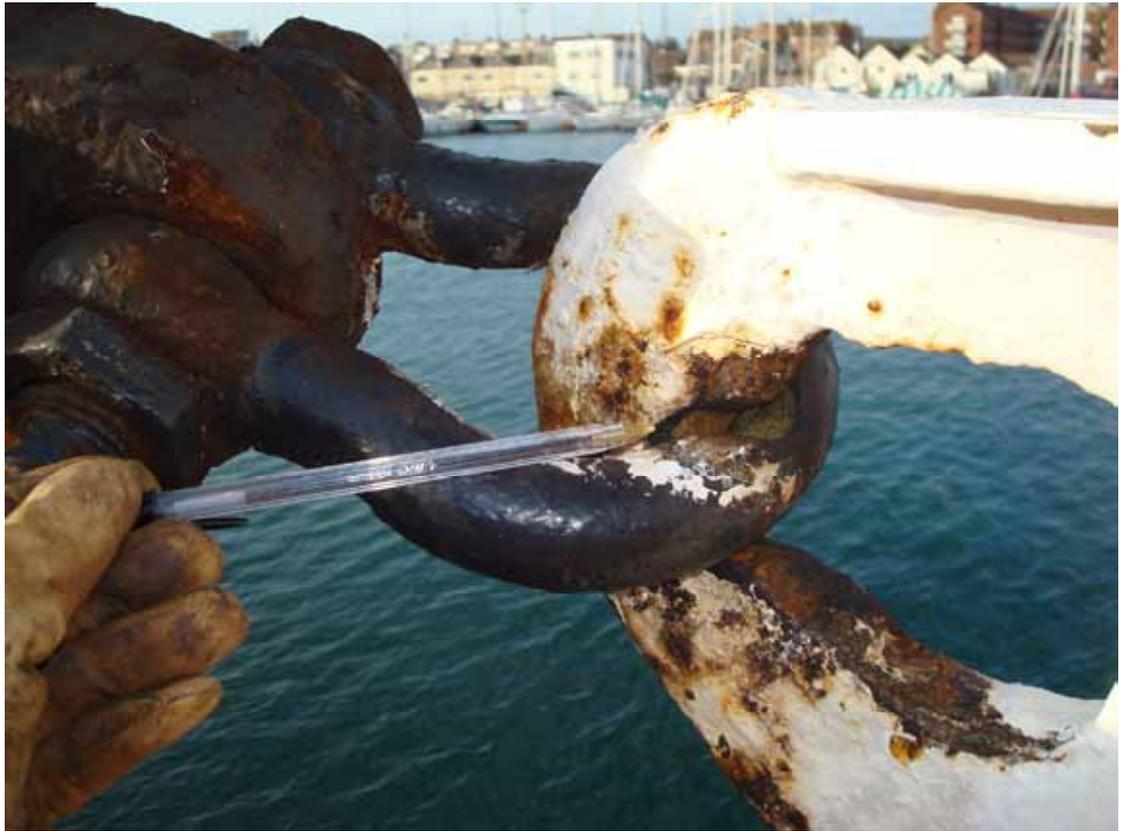
- Wear in shackles and associated attachment eyes. Unsecured shackles (**Figure A.26**).
- Cracks in gantry and associated attachment to ship's structure (**Figures A.27, A.28**).
- Heavy wear on sheaves and pins of main towing blocks (**Figure A.29**).

Figure A.26: Wear at attachment of port trawl block to towing post

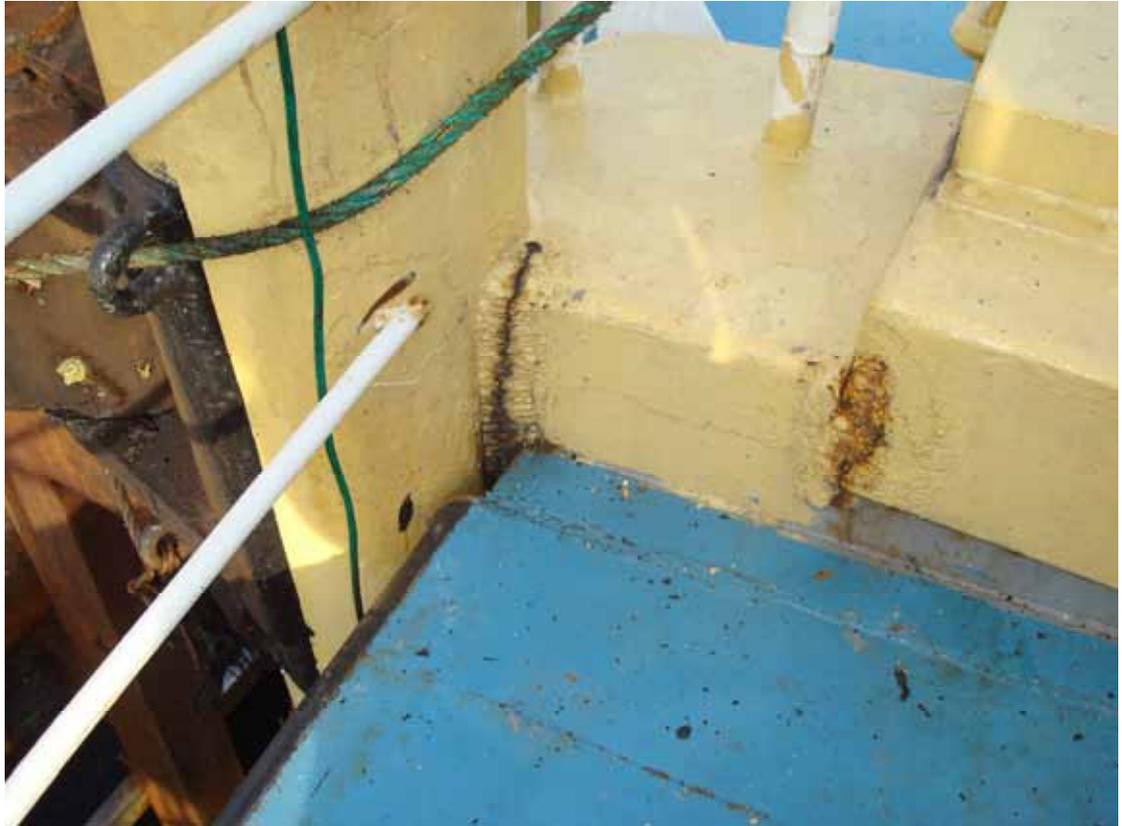
Figure A.27: Crack in attachment of gantry post to ship structure

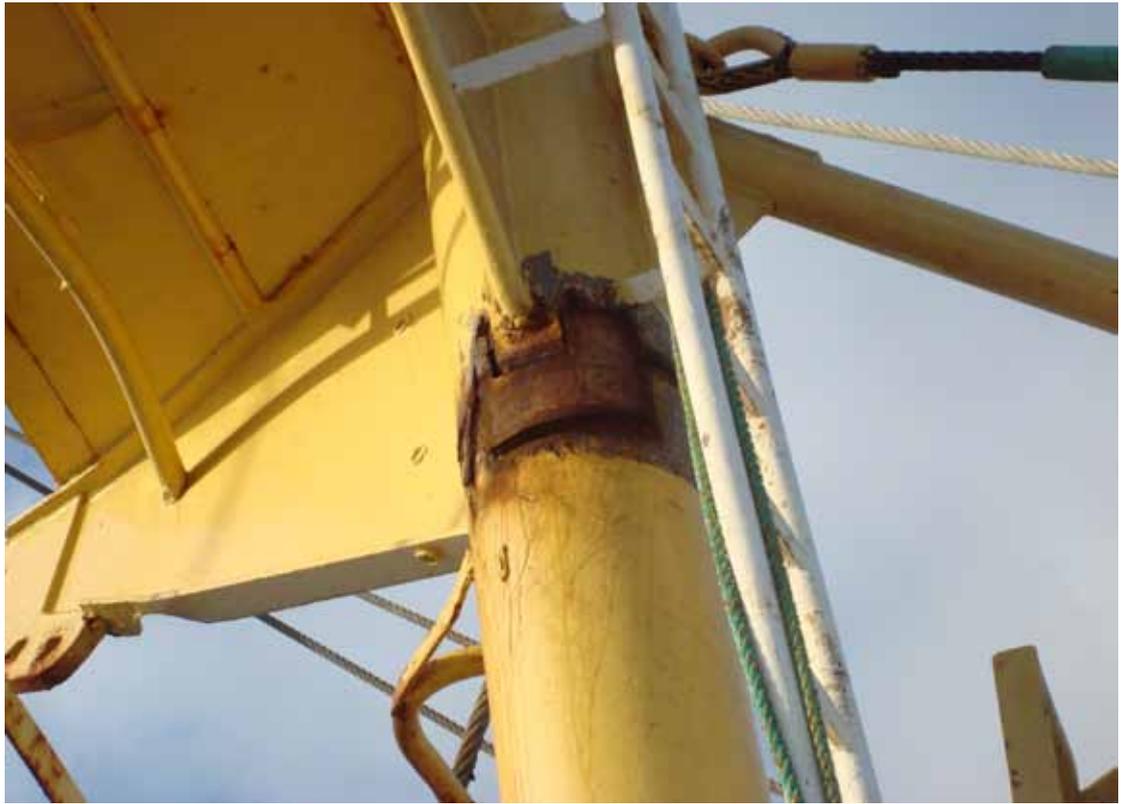
Figure A.28: Evidence of “temporary” repairs to cracks in gantry structure

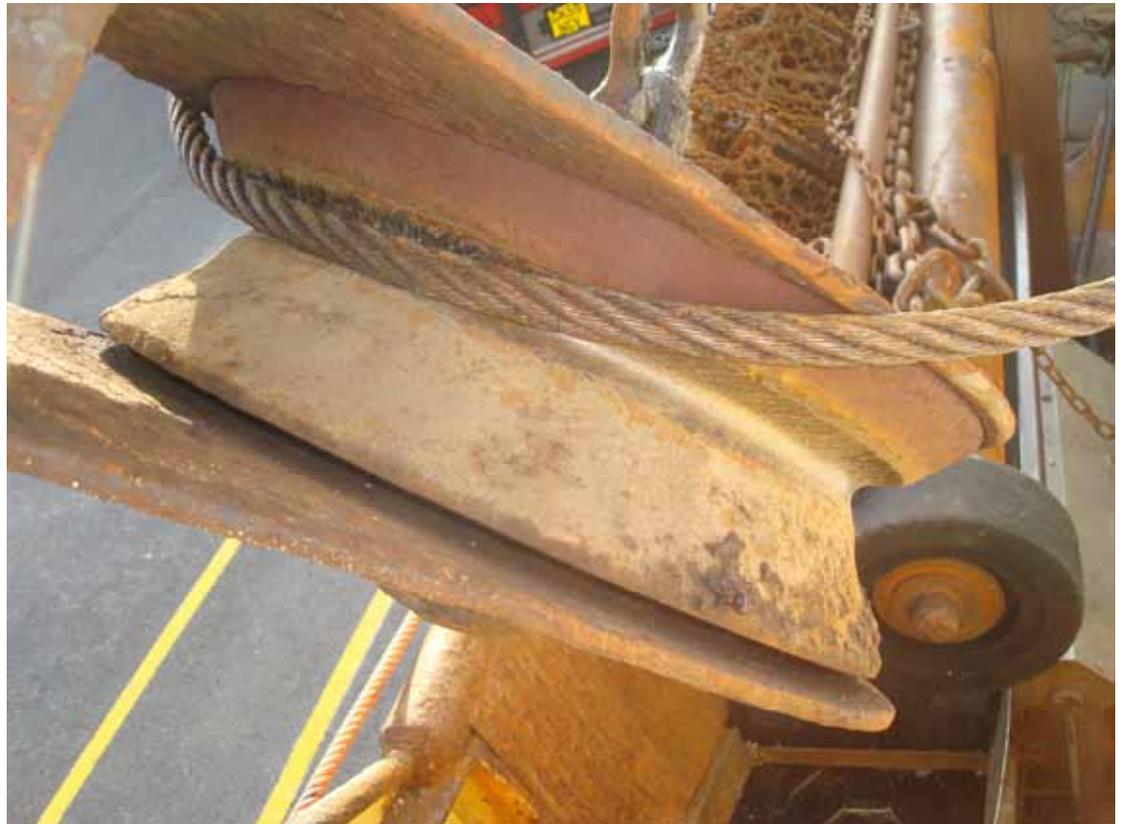
Figure A.29: Heavy wear on sheaves and pins of main towing blocks

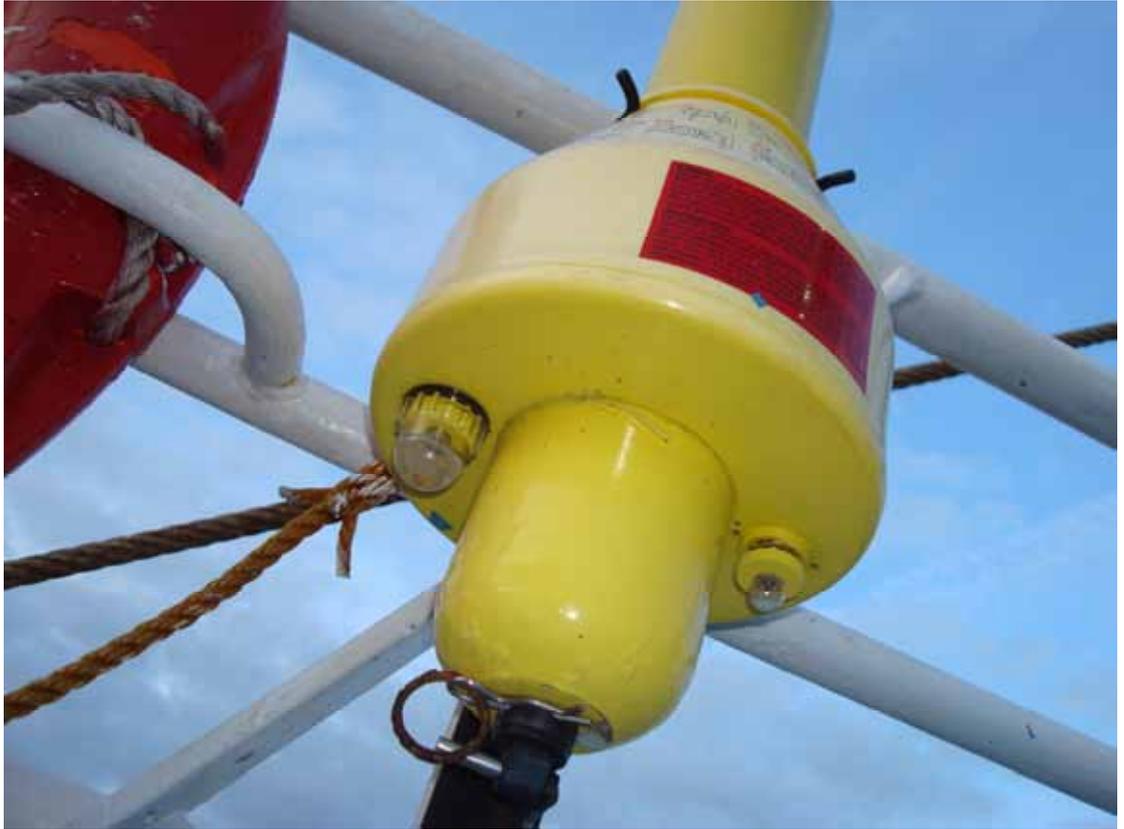
- Port - In date, but found damaged; defective when light tested. Requires replacement (**Figure A.30**).
- Stbd - Date illegible, defective when light tested. Requires replacement.

Figure A.30: Damaged MOB unit, port side
