# RAIB Bulletin 02/2015

## Derailment at Ashburys, Manchester, 13 November 2014

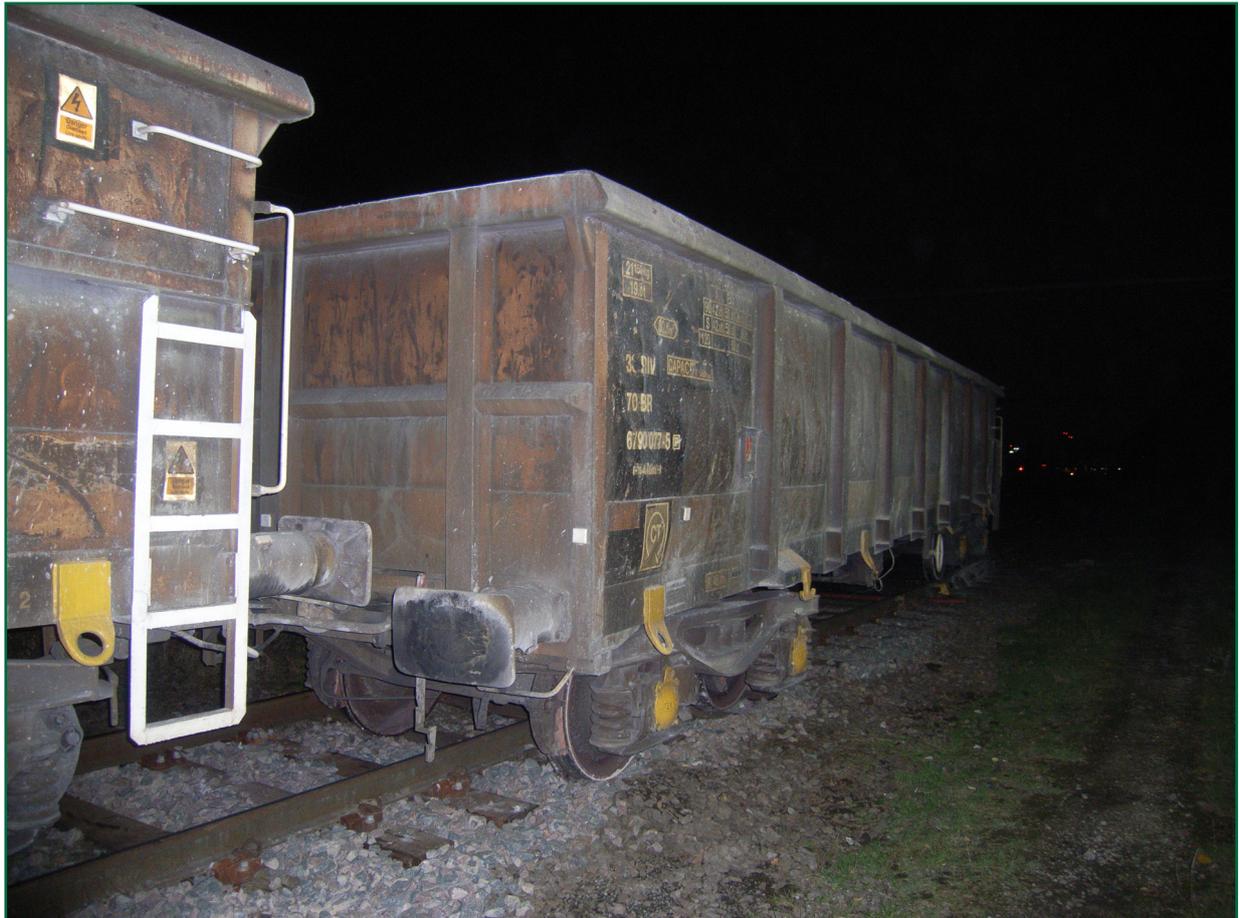
- 4 The derailment was caused by the fracturing, through to the axle, of the right-hand leading wheel of the trailing bogie (figure 3). This resulted in the loss of the *interference fit*<sup>4</sup> between the wheel and the axle and permitted the wheel to move inwards on the axle. The derailment of this wheel then pulled all the wheels of the trailing bogie off the rails (figure 1).

Figure 1: The derailed wagon

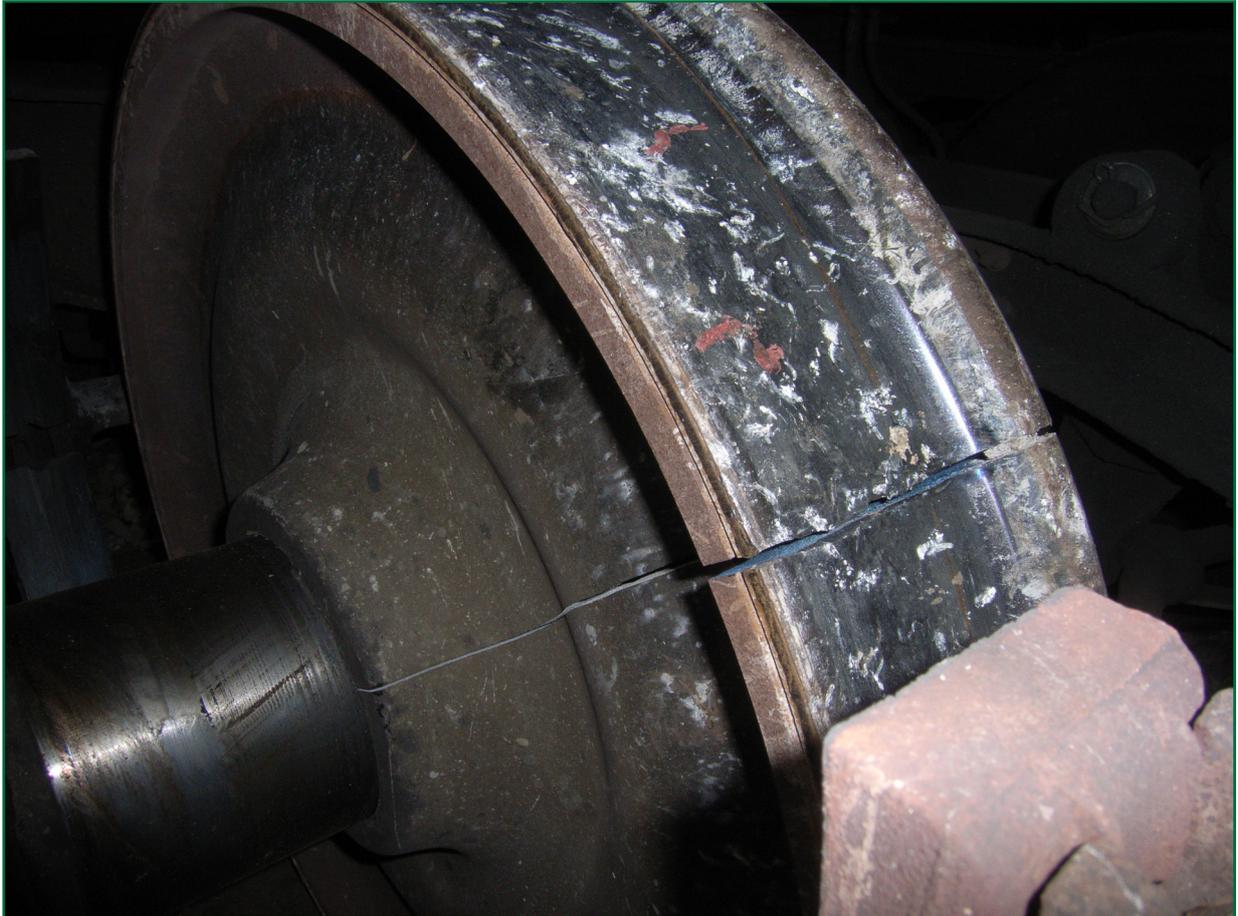
Figure 3: Right-hand leading wheel of the trailing bogie following the derailment

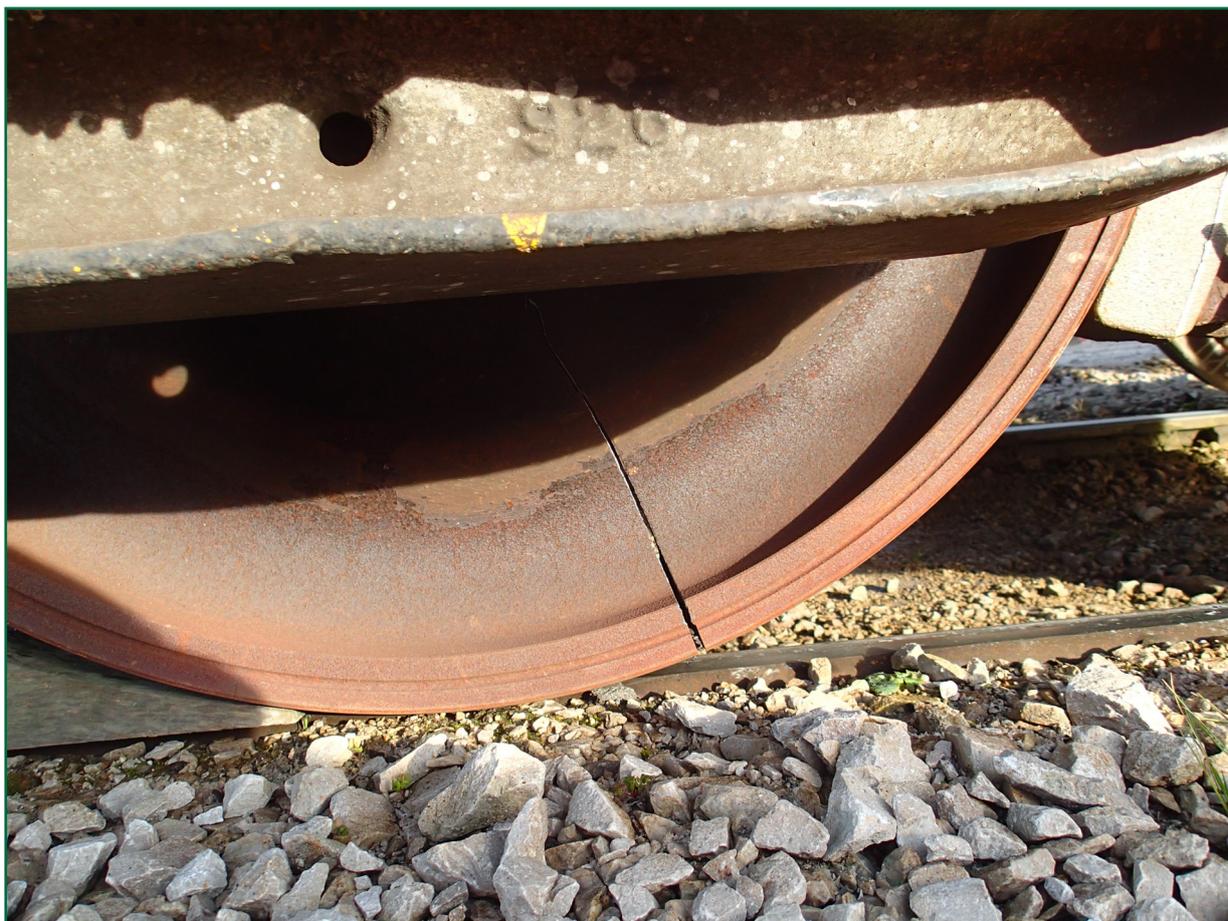
Figure 4: The left-hand leading wheel of the leading bogie found to be cracked through following the rereiling of the vehicle. It also shows evidence of overheating

Figure 6: The parts of a monobloc railway wheel

- 40 All the wheels on the wagon that derailed exhibited similar signs of overheating and those signs (flaking paint and rust – figure 4) had apparently not been observed during train examination<sup>10</sup> and therefore the wagon was not withdrawn from service. Given that the signs of overheating had probably been present for some time prior to the accident (paragraph 21), it is likely that these signs had been overlooked on multiple occasions.

- 45 The RAIB observes that proper examination of the wheels is made difficult by bogie, suspension and axlebox components obstructing the view of each wheel (figure 4). This probably explains why no other railway personnel observed the hot wheels. Also, by the time the examination was carried out, the wheels would have cooled had they been subject to overheating on the inward journey from Ashburys the previous day, so any radiation of heat would not have been felt.

- 46 The RAIB has identified the following Learning point<sup>11</sup>:
  - Staff who undertake the examination of freight trains should check for signs of overheated wheels, such as rust and flaking paint, and take appropriate action, such as arranging for a more detailed inspection or withdrawing the vehicle from traffic. It also confirms the need for yard management arrangements to include regular checks on the efficacy of train preparation and inspection procedures.
- 47 DB Schenker Rail has issued a safety alert notice to its staff reminding them of the need to check for overheated wheels as indicated by signs of excessive heat or burnt paint.

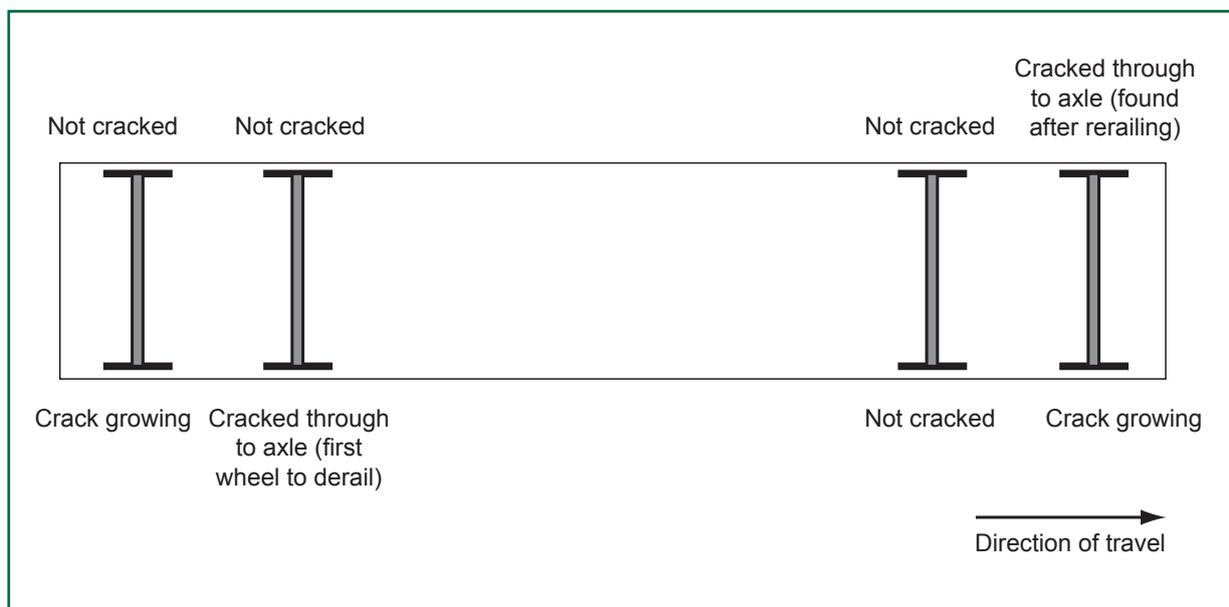
- 5 Subsequent to the derailment, further cracked wheels were identified:
- The left-hand leading wheel of the leading bogie and, though fractured through to the axle, the wheel had not moved on its axle.
  - The other wheel of the wheelset described above, but the crack had not broken through to the axle. This wheelset is shown in figure 4.
  - The right-hand wheel of the trailing wheelset of the trailing bogie, though not cracked through to its axle.

The layout of damaged wheels is summarised in figure 5.

Figure 5: The layout of damaged wheels fitted to the derailed wagon

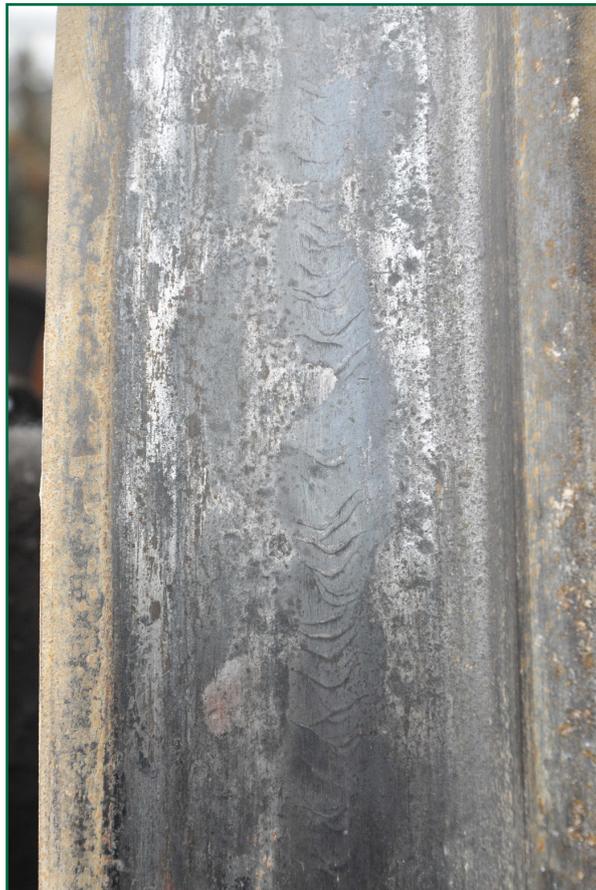
- 19 The specialist concluded that the wheel rims had either not been effectively quenched at manufacture, or overheating of the rims due to dragging brakes had reversed the residual stress. Of these, it considered that the latter was the more likely as there was significant evidence of overheating in the vicinity of the rims in the form of paint flaking and rusting (figure 4). The tread surface of the wheels was also found to be mottled (figure 7), which the specialist believed was thermal damage caused by the wheels slipping and/or sliding. Furthermore, wheels had been made by different manufacturers (table 1) and it is unlikely that the rim quenching process would have been deficient at each.

*Figure 7: Example of thermal damage to the tread surface (by courtesy of Serco Rail Technical Services)*

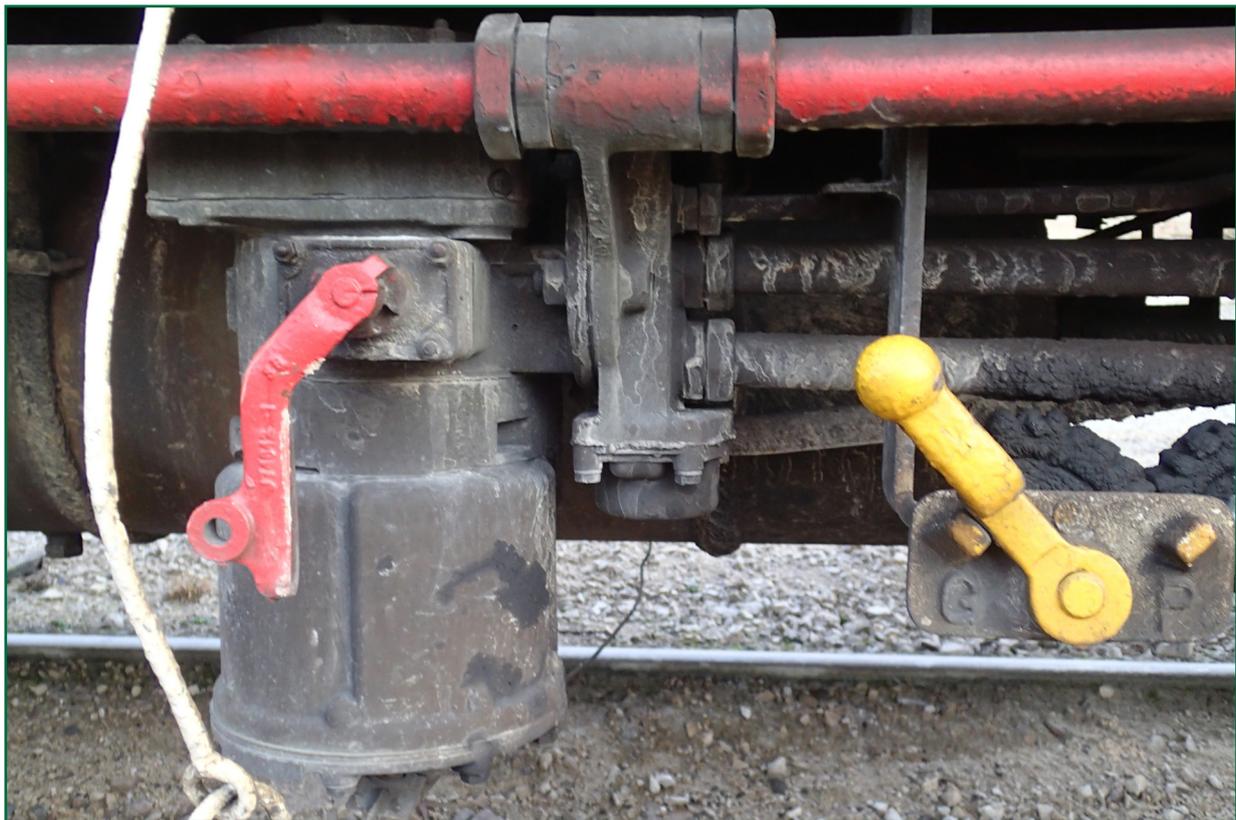
29 After the wagon had been rerailed, its brakes were tested at Ashburys to GE Capital Rail's standard procedure used for a VIBT. This found that the distributor<sup>9</sup> (figure 8) did not function as it should have done resulting in a residual brake cylinder pressure of 1-2 lbs/in<sup>2</sup> (0.07-0.14 bar) when the brakes should have been fully released. These pressures caused the brake blocks to only rub lightly against the wheel rims.

*Figure 8: The wagon's distributor (the red handle can be operated to isolate the distributor)*

- 38 The RAIB concludes that the dragging brakes, which caused the wheels to severely overheat, were probably caused by a defective distributor. The nature of the defect probably caused the distributor to act in an inconsistent way over a period of several weeks/months. The RAIB has not been able to discover why the distributor was defective, but it is possible that a contaminant affected its operation intermittently, and this was disturbed when the distributor was initially dismantled.
