Rail Accident Report

Derailment of an empty passenger train at Paddington station 25 May 2014

Report 03/2015
April 2015

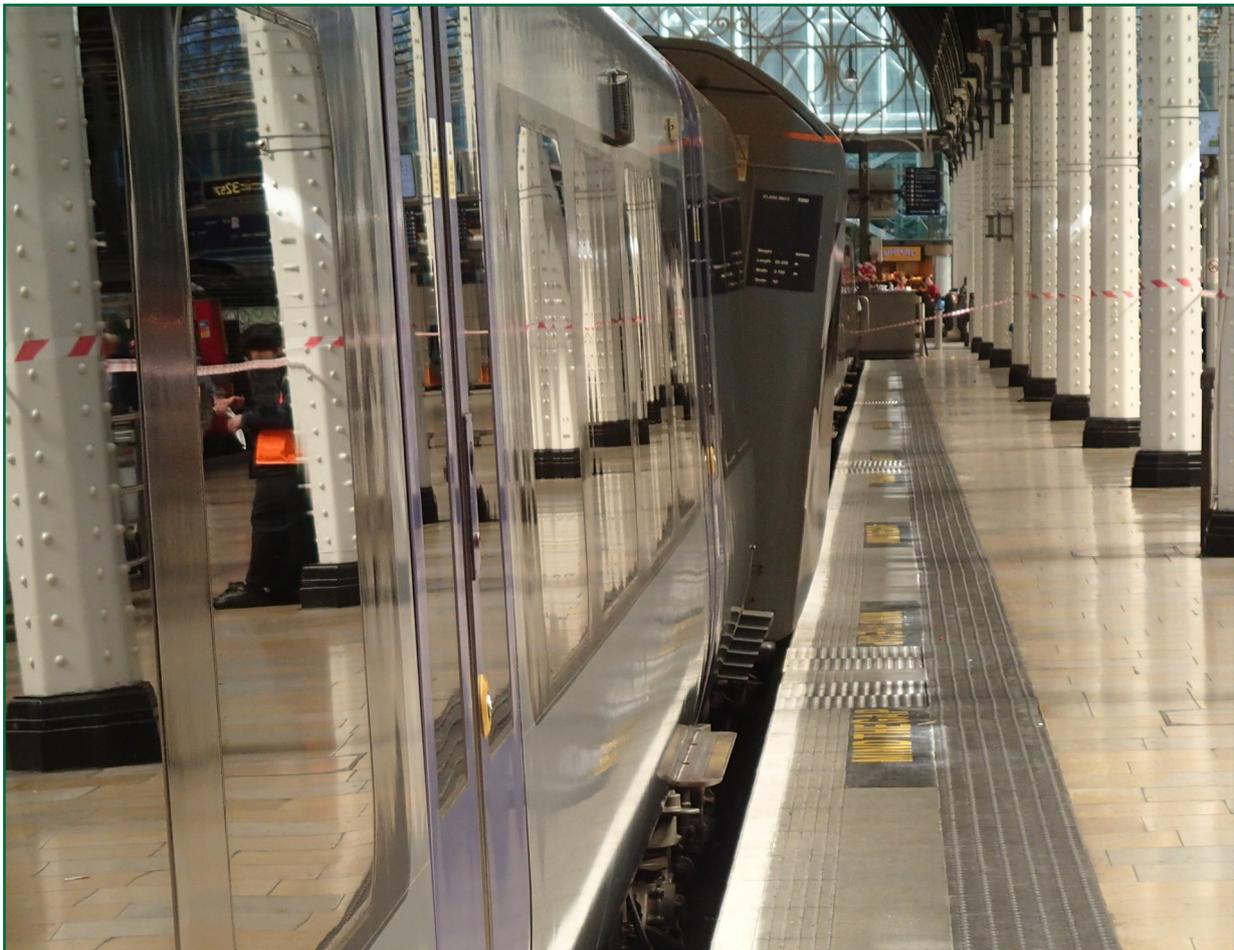
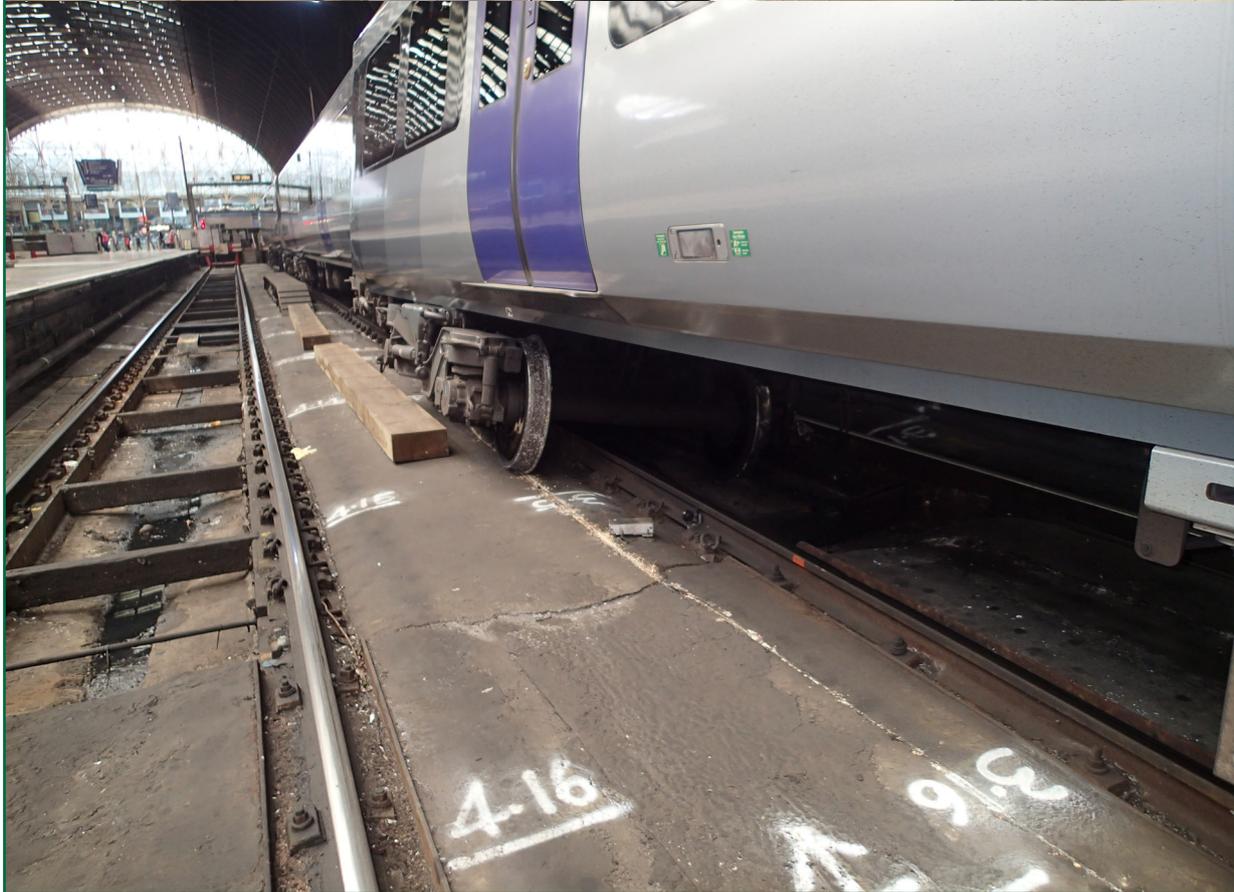
Figure 2: Final resting position of derailed vehicle at Paddington station platform 3

- 7 Train 5T08 was a five-car *electric multiple unit*. Both *wheelsets* on the leading *bogie* of the third vehicle derailed to the left, in the *six-foot*, on a right-hand curve (figure 2). The vehicle ran derailed for approximately 100 metres and damaged some track components in the process. There was only minimal damage to the vehicle itself.

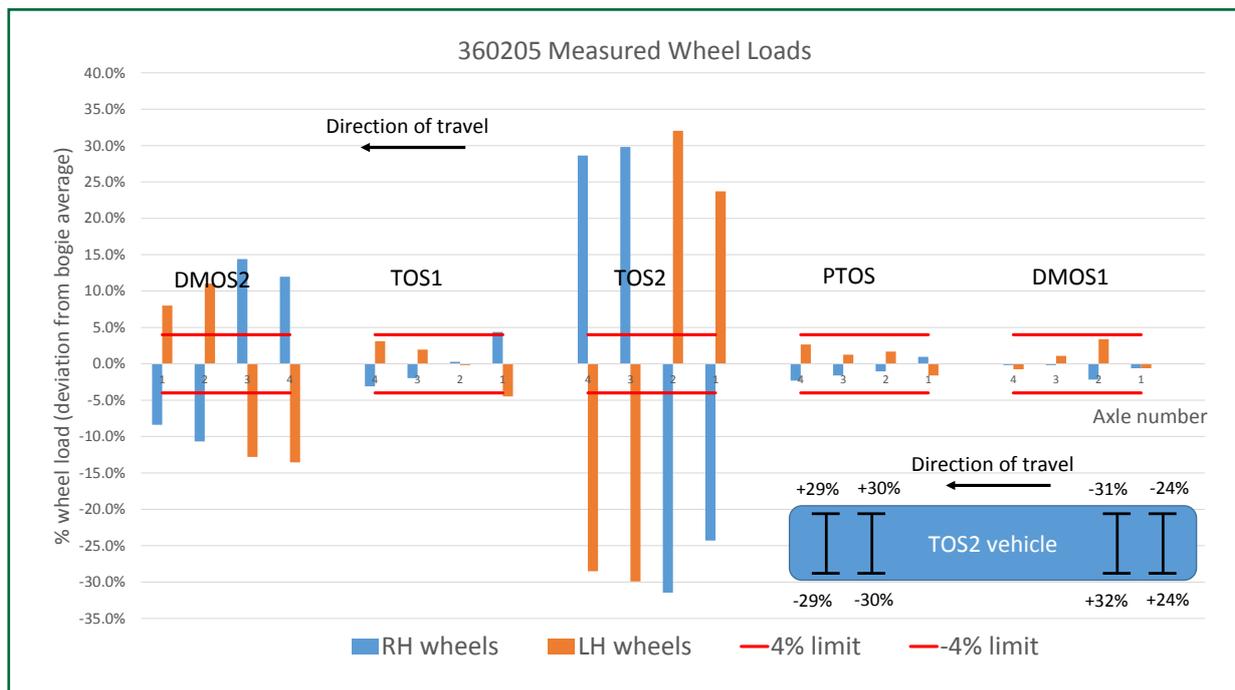
Figure 10: Wheel load distribution measured on unit 360205 after the derailment

49 **The wheels on the left-hand side of the leading bogie of the TOS2 vehicle were permanently unloaded beyond Siemens' manufacturing limits.**

50 Following the derailment, the RAIB commissioned a specialist company to measure the wheel load distribution on unit 360205 at Old Oak Common depot. The results of the measurements are shown in figure 10 as the percentage of wheel load variation compared to the average wheel load for each bogie. For reference, the acceptance criteria used by Siemens Germany when vehicles are first manufactured is also presented in figure 10 (maximum wheel load variation less than 4% of the average wheel load for the bogie – see paragraph 91).

Siemens' procedure for setting the vehicle ride heights after tyre turning or bogie replacement should be revised to reflect the original design intent, including the function of the anti-roll bars and the risks associated with incorrectly setting the anti-roll bar links. The revised procedure should also include checks of the bogie setup post-intervention to ensure that the wheel load distribution is maintained within Siemens' acceptable limit. These checks could be direct wheel load measurements, measurements of other indicators such as the Z1 dimensions or any other checks which positively confirm that the wheel load distribution has been maintained within Siemens' acceptable limit (paragraphs 129a, 130i, 130iii and 130iv).

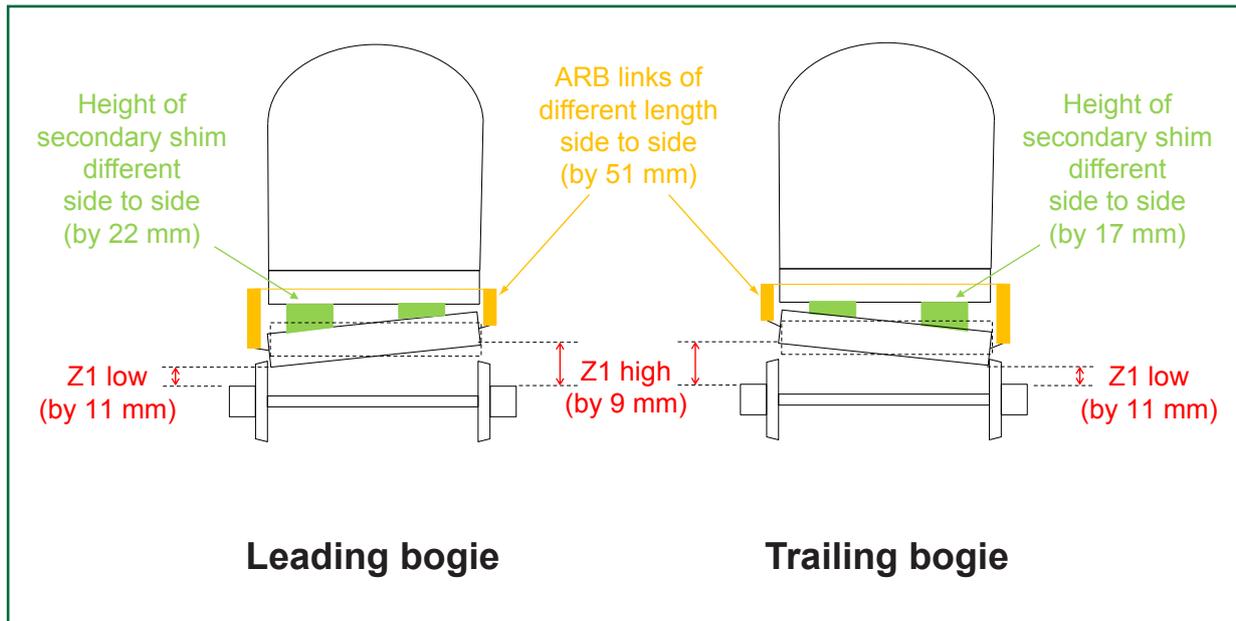
Figure 11: bogie setup as viewed from the front of the vehicle

- 57 The model showed a good level of correlation with the real life situation as it predicted that the left-hand wheels of the leading bogie would be permanently unloaded by 1,200 kg (in comparison with the measured 1,250 kg). This confirmed that the setup of anti-roll bar links and shims had led to the leading left-hand wheel of the leading bogie being permanently unloaded. The analysis indicated that the dominant factor was the difference in anti-roll bar link length but the difference in shim height also contributed.

- 60 The bogie setup was adjusted (in terms of anti-roll bar link length and shim height) after tyre turning or bogie replacement when the Siemens' technicians implemented the PTT procedure (paragraphs 17 and 40). The bogies under the TOS2 vehicle had been fitted to this vehicle in February 2012. Between February 2012 and May 2014, the TOS2 vehicle had been subjected to four PTT interventions (February 2012, June 2013, 12 April 2014 and 19 April 2014 – paragraphs 30 and 31) as part of routine maintenance interventions in response to wheel wear.

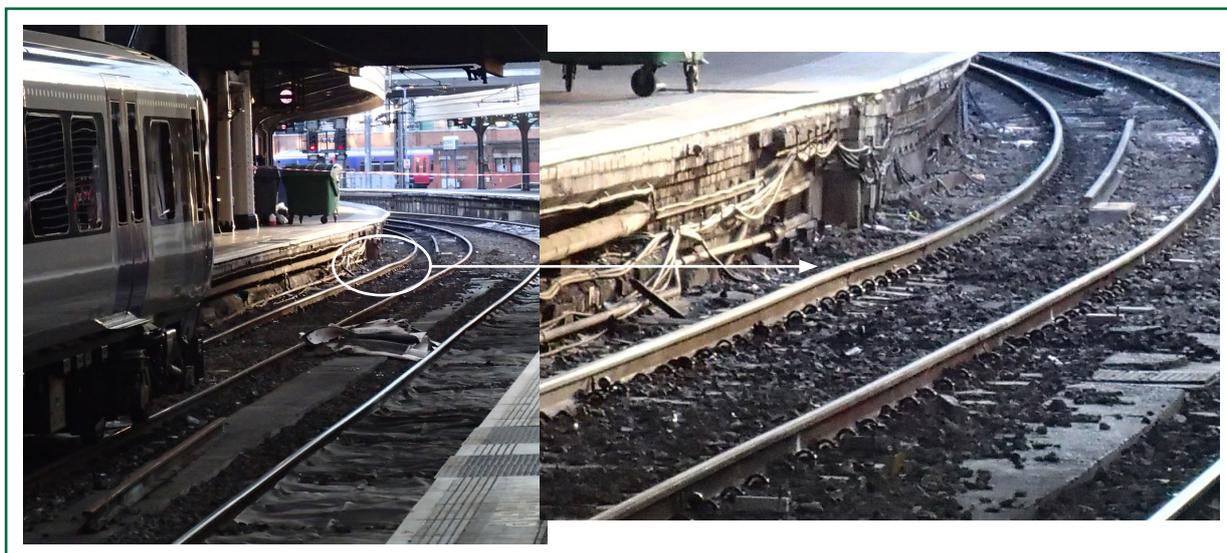
Figure 12: Track twist along platform 3

104 Following the derailment, the RAIB measured the track geometry on the approach to and along platform 3 using an *Amber trolley*. This identified a track twist in the immediate vicinity of the point of derailment (figure 12). The RAIB measured this track twist to be 22 mm over 3 metres. The RAIB also measured the *voids* at the derailment site to determine the dynamic track twist. Accounting for voids, the track twist became 24 mm over 3 metres.

105 The track twist (with or without voids) measured on site in the vicinity of the point of derailment was significantly in excess of the *intervention limit* (15 mm over 3 metres) set in Network Rail's standard NR/L2/TRK/001²⁵. According to the standard, this level of track twist should have been attended to by Network Rail's maintenance team within 36 hours²⁶.

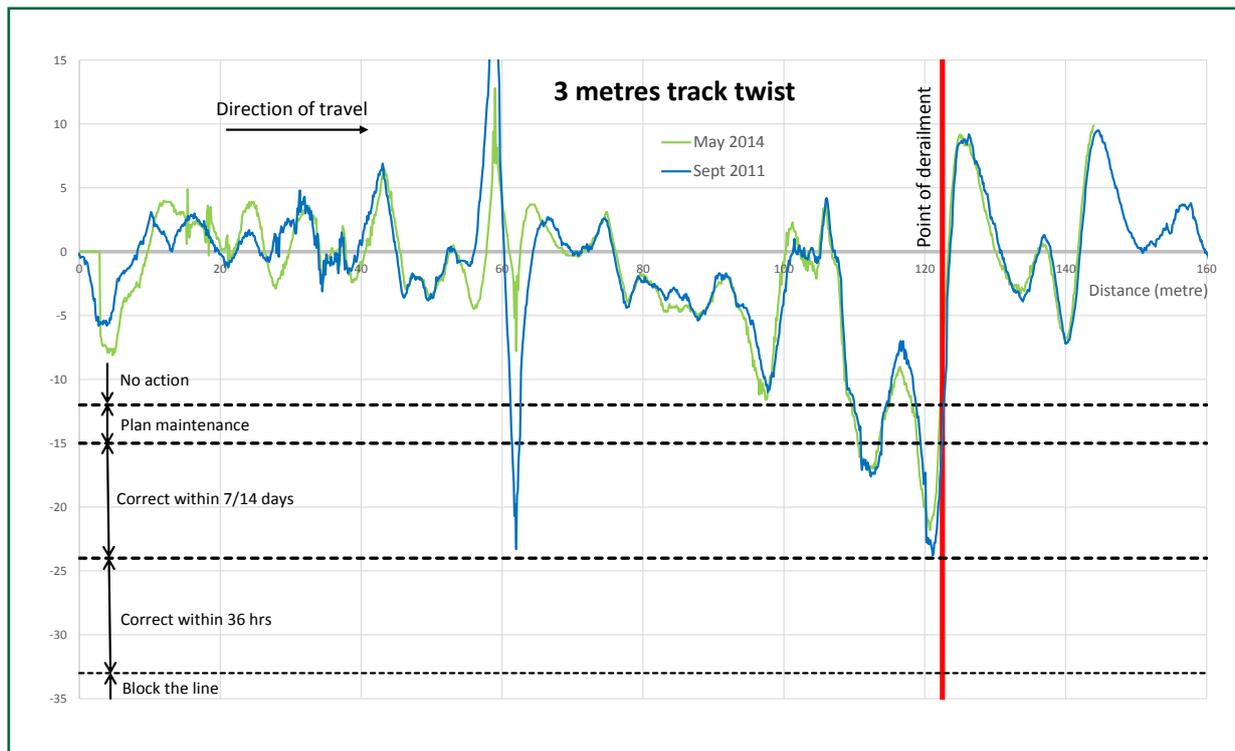
Figure 13: Comparison of 3 metres track twist in September 2011 and May 2014

108 Between September 2011 and the time of the derailment, the track at this location had been measured four times by the technical team (14 September 2011, 30 August 2012, 29 May 2013 and 26 November 2013 which was the last time the track was measured before the derailment). Since 2011, the frequency of these measurements had gradually increased to once every six months, which means that a measurement was due shortly after the date of the derailment²⁹.
