ACCIDENT

Aircraft Type and Registration:	Schleicher ASW 20 L, G-LYSA	
No & Type of Engines:	None	
Year of Manufacture:	1978 (Serial no: 20054)	
Date & Time (UTC):	18 June 2014 at 1618 hrs	
Location:	North Hill Airfield, Sheldon, Devon	
Type of Flight:	Private	
Persons on Board:	Crew - 1	Passengers - None
Injuries:	Crew - 1 (Fatal)	Passengers - N/A
Nature of Damage:	Aircraft destroyed	
Commander's Licence:	BGA Gliding Certificate	
Commander's Age:	73 years	
Commander's Flying Experience:	Approximately 12,000 hours (of which 11 were on type) Last 90 days - 24 hours Last 28 days - 12 hours	
Information Source:	AAIB Field Investigation

Synopsis

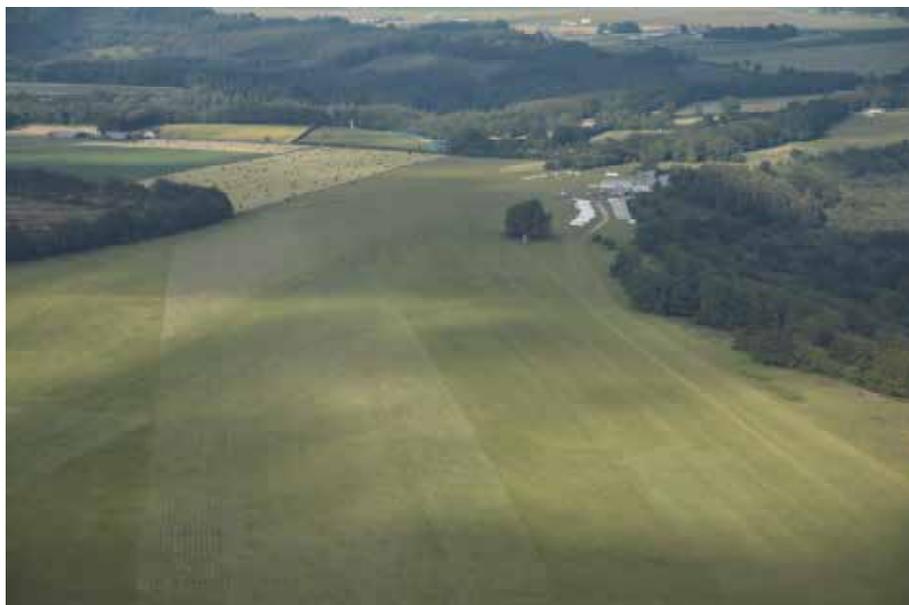
Figure 2

A view of the airfield from the direction of the final approach
(The accident site is at the far end of the field, beyond the isolated tree.)

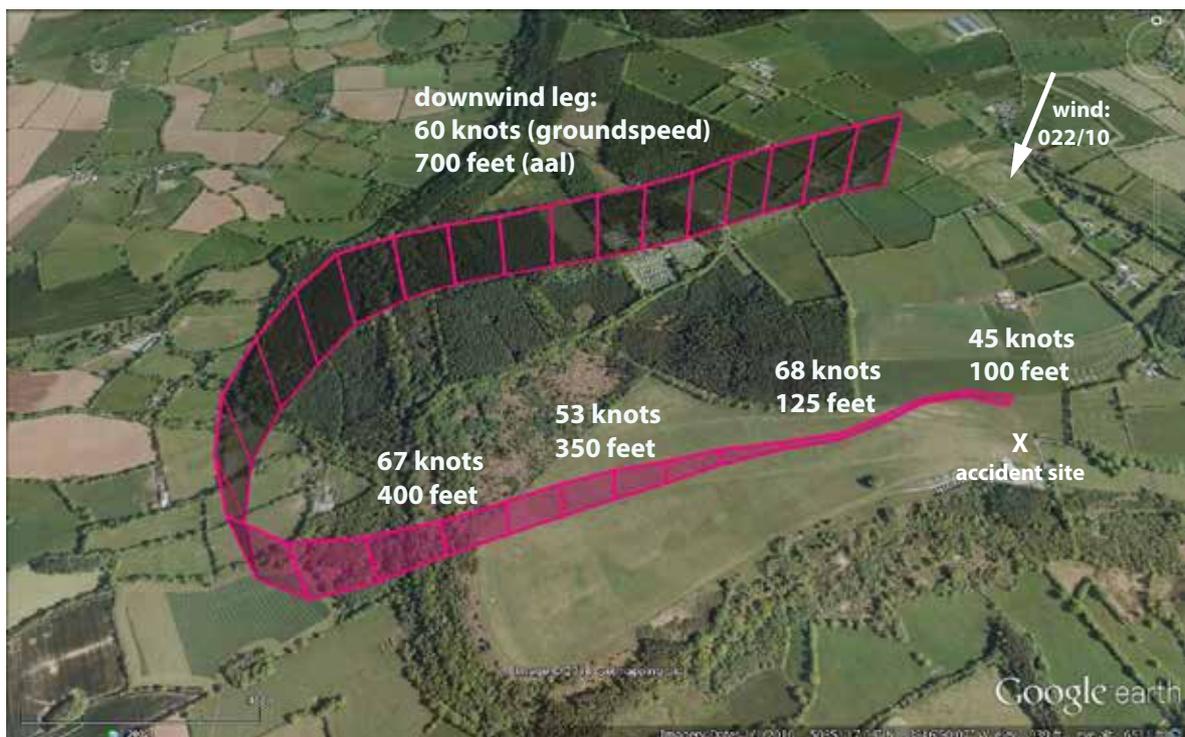
Figure 3
G-LYSA approach to North Hill

Figure 3 shows the final part of the track, in profile, with spot heights and groundspeeds (averaged between successive points). Figure 4 shows the ground track as a time history. These Figures indicate that the glider was downwind abeam the airfield at 700 ft aal, with a groundspeed of 60 kt, and descended to 400 ft aal above the airfield perimeter when established on final approach. Over the next 12 secs, there were minor variations in the glider's height, before it descended at about 1,250 ft/min to 125 ft aal, above a point just east of the airfield's two launch strips. Over the last 20 secs (to the last recorded point), the glider descended to 70 ft aal and then climbed back to 100 ft aal as it commenced a turn to the right. The groundspeed for this last point had reduced to 45 kt. Using the surface wind measured at the site two minutes before the accident, the airspeed at this point was estimated to have been between 52 and 55 kt. The data indicates that the drag of the glider increased during the approach; this is evident from the reversal in the increasing speed trend, while the descent continued.
