ACCIDENT

Aircraft Type and Registration:	Jodel DR1050 Ambassadeur, G-AYLL	
No & Type of Engines:	1 Continental Motors Corp O-200-A piston engine	
Year of Manufacture:	1960 (Serial no: 11)	
Date & Time (UTC):	4 November 2014 at 1043 hrs	
Location:	Lee-on-the-Solent Airfield, Hampshire	
Type of Flight:	Private	
Persons on Board:	Crew - 1	Passengers - None
Injuries:	Crew - None	Passengers - N/A
Nature of Damage:	Fracture of rear fuselage	
Commander's Licence:	Private Pilot's Licence	
Commander's Age:	67 years	
Commander's Flying Experience:	870 hours (of which 295 were on type) Last 90 days - 2 hours Last 28 days - 0 hours	
Information Source:	Aircraft Accident Report Form submitted by the pilot and additional inquiries by the AAIB

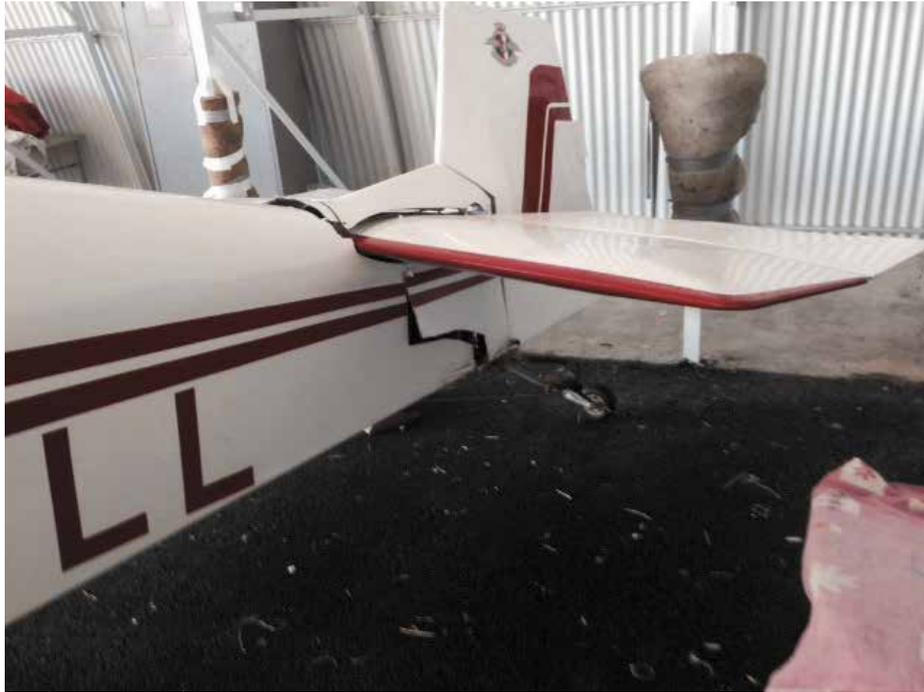
Figure 1

As the pilot shut down and vacated the aircraft, he saw that the rear fuselage had been badly damaged (Figure 1). He had not been aware of the severity of the damage until then.

G-AYLL showing damage to rear fuselage discovered after a ground loop landing incident.
(Photograph via pilot)

The pilot was of the opinion that the tailwheel shimmy may have been precipitated by the runway surface condition and major damage caused by striking the exposed concrete debris at the side of the runway, but it could not be ruled out that the fuselage may have failed on touchdown, leading to shimmy and the loss of directional control. Several witnesses who supplied photographs of the rear fuselage to the AAIB commented that the wooden structure appeared wet with possible indications of a 'tidemark', suggesting that liquid water had been present over an extended period. The photographs also appeared to show that deterioration of some of the bonded joints had been present for some time prior to the accident.

The extent to which this deterioration may have contributed to a possible structural failure during an otherwise normal touchdown could not be determined. However, the Light Aircraft Association (LAA) advised that they intended to highlight the particular importance of close inspection of elderly wooden structures in a forthcoming edition of their journal *Light Aviation*.
