Report on the investigation of
the collision between the dredger

Shoreway

and the yacht

Orca

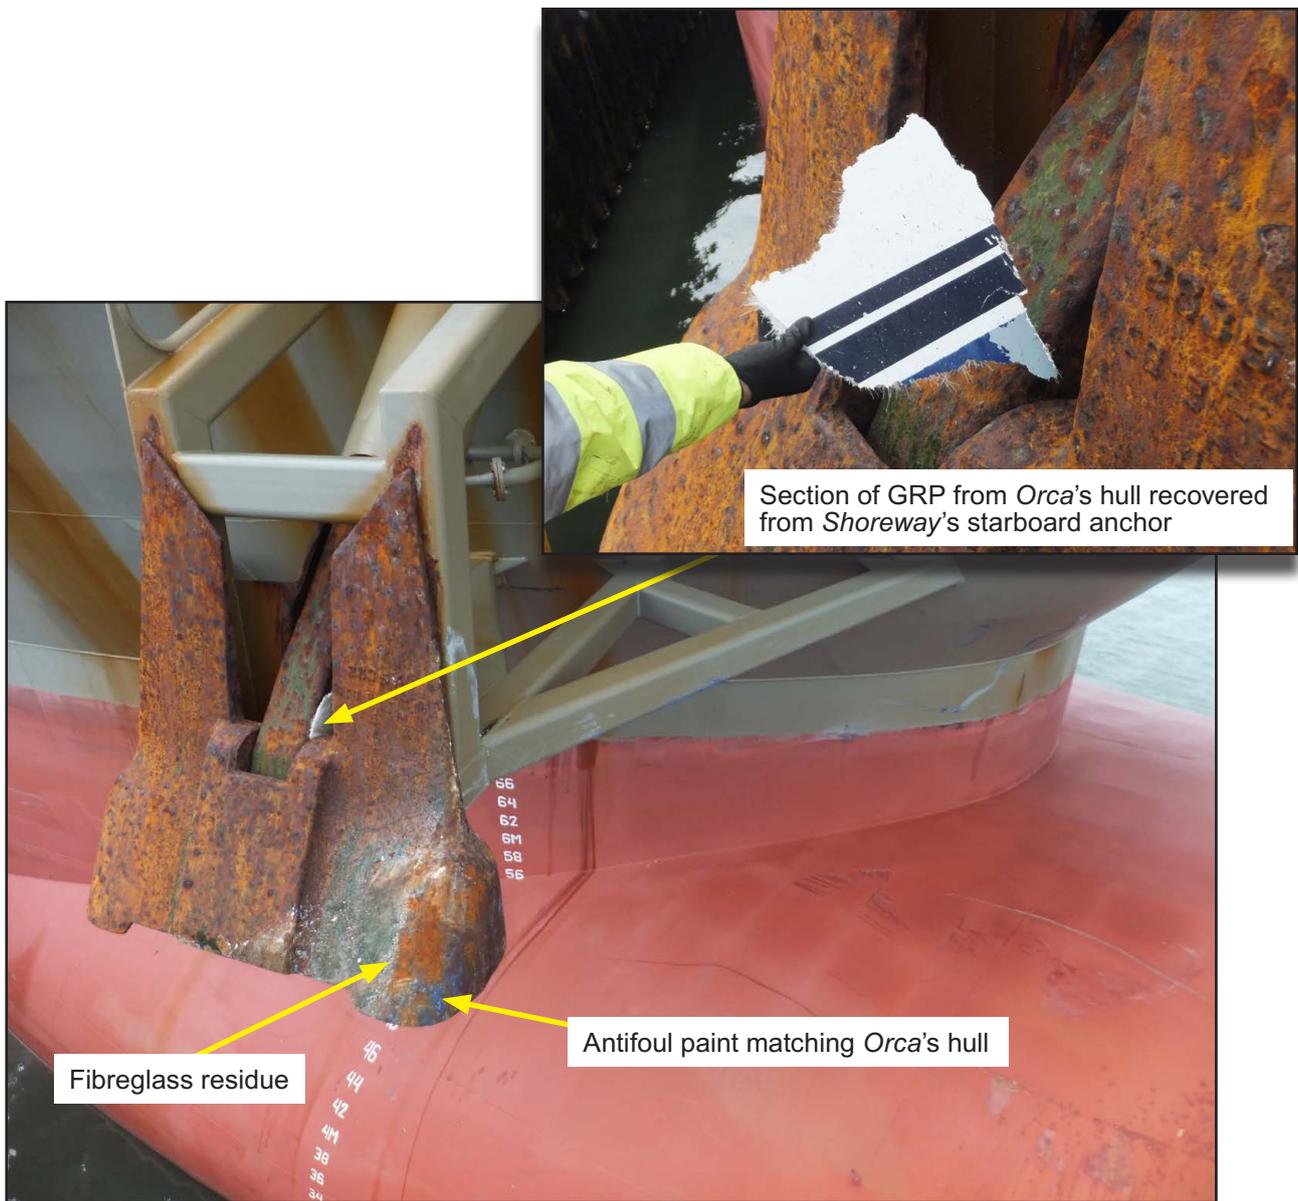
During the impact, *Orca* was dismasted, the cockpit flooded as a result of the yacht being pushed astern by *Shoreway*'s bow and the starboard side was punctured by *Shoreway*'s starboard anchor (**Figure 4**). The impact rotated the yacht through 180° and it then passed down *Shoreway*'s starboard side sustaining damage to its port side before moving astern of the dredger.

Figure 4: *Shoreway* starboard anchor, collision evidence

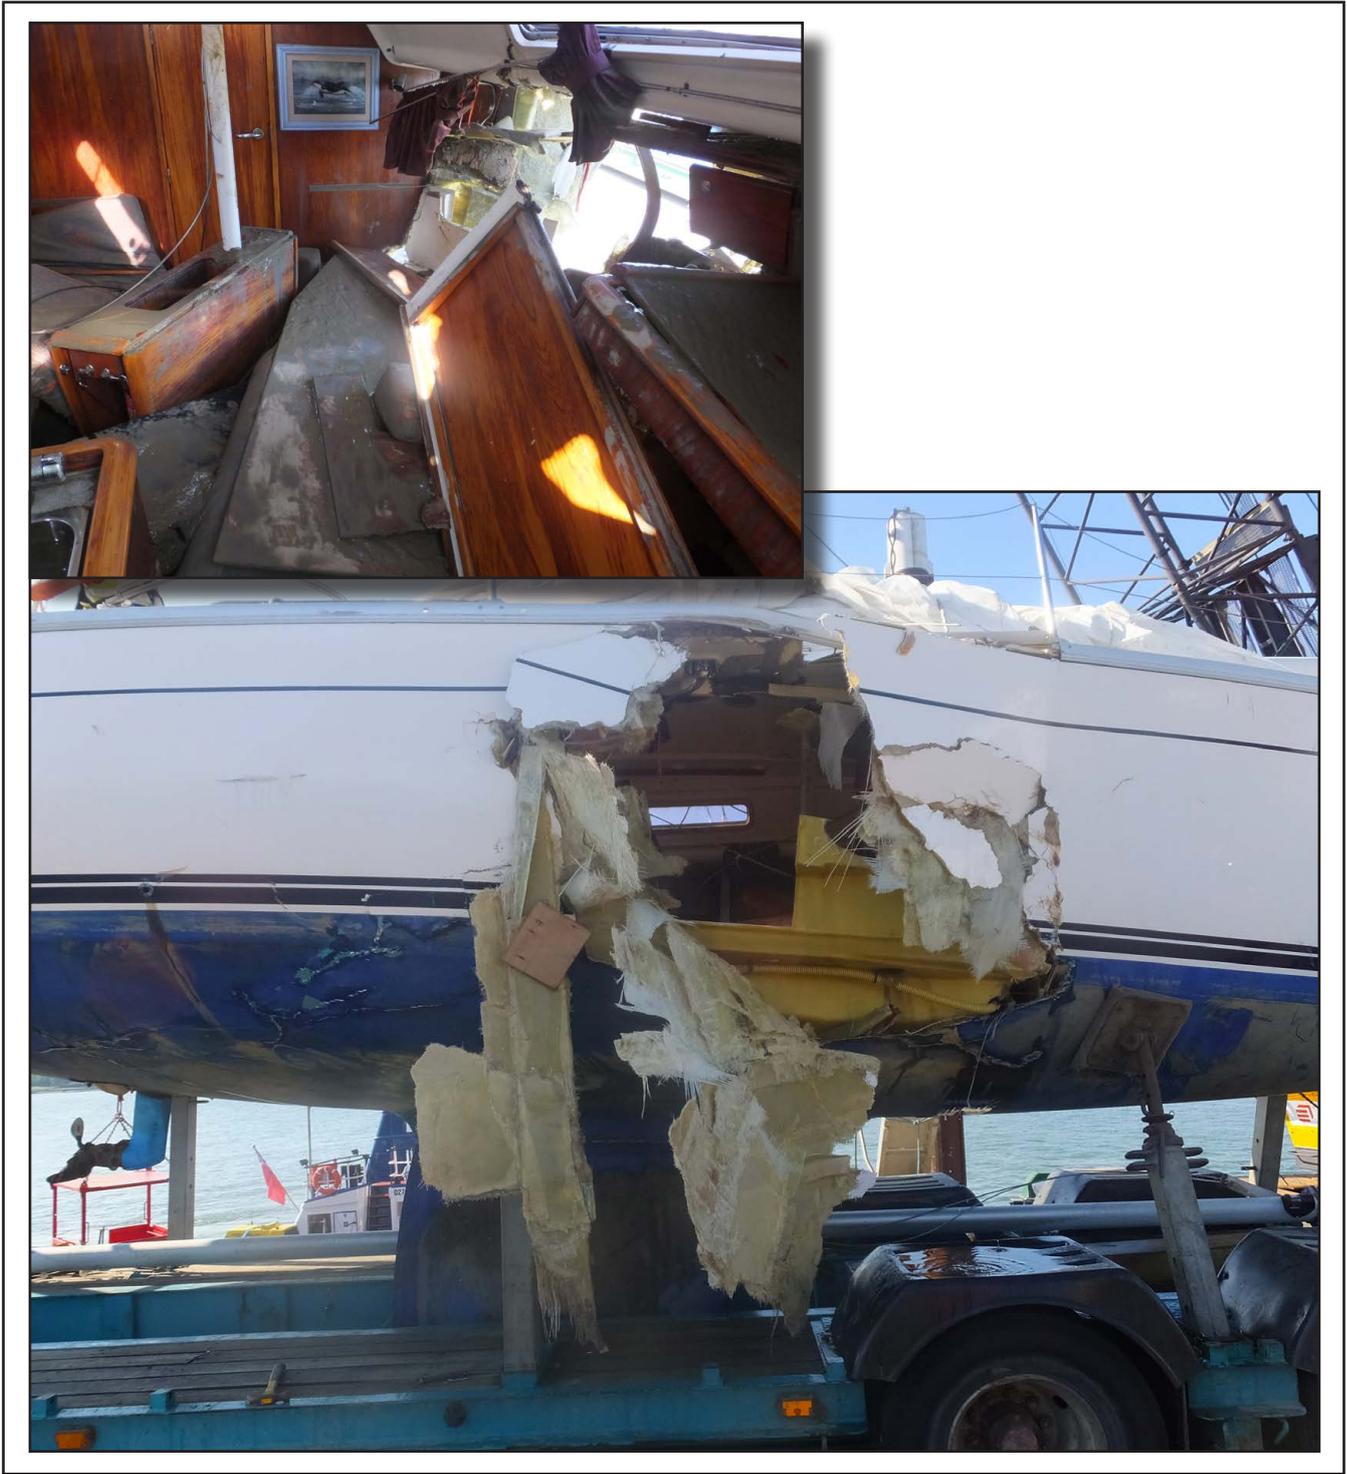
- Catastrophic structural damage to its starboard side mid-ships (**Figure 7**).
- Extensive damage to the internal mouldings, supporting steel work, frames and deck.
- Scuffs and paint witness marks on the port side of the hull (**Figure 8**).
- The mast was broken but remained held to the hull by its standing rigging.
- The pushpit rail mountings were damaged and the stanchions bent.
- The rudder was deformed, and bent to port of the centreline.

Figure 7: Damage to *Orca's* starboard side

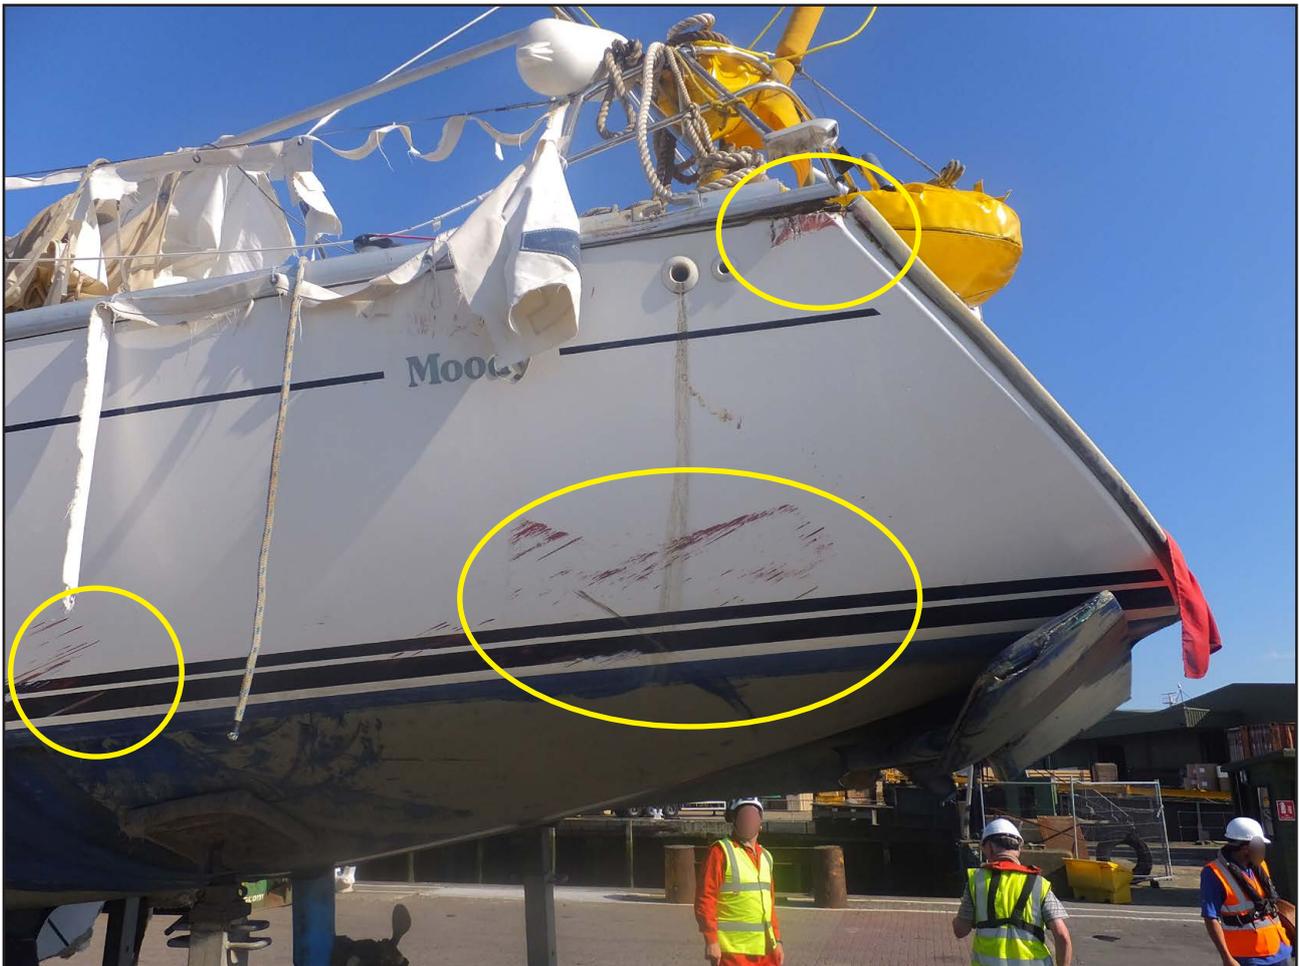
Figure 8: Marks and damage to Orca's port side

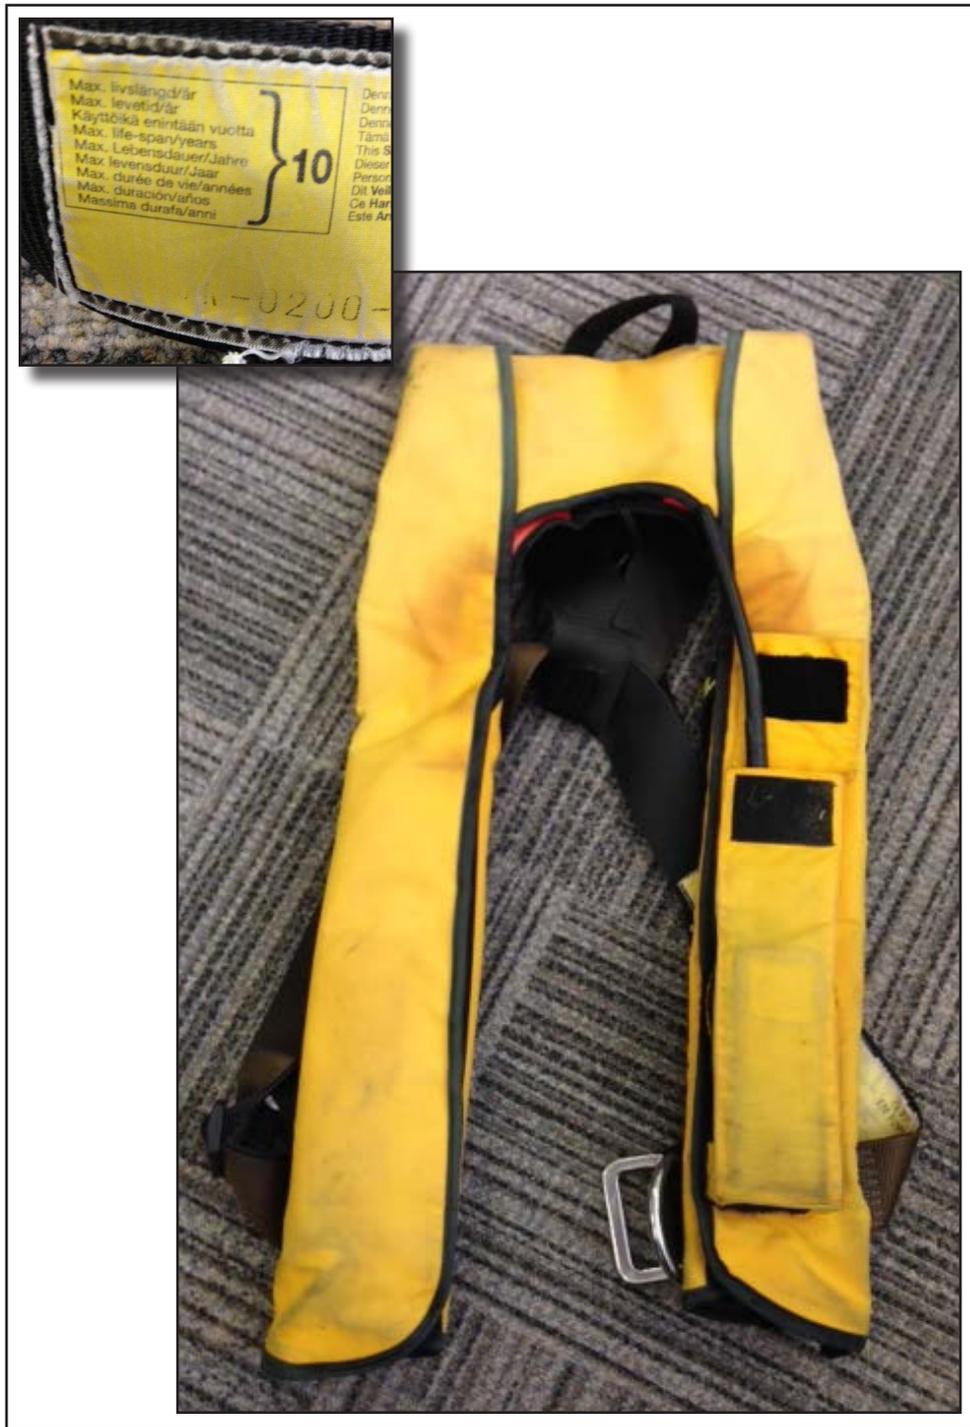
Both lifejackets were purchased by the skipper in 1997 and had a label indicating a maximum lifespan of 10 years. A label also recommended that the lifejackets be serviced once a year. The lifejackets had never been serviced but had been inspected by Orca's skipper annually at the start of each season.

During the accident, the lifejacket worn by Orca's skipper failed to inflate. The lifejacket worn by Mrs Ingram inflated as designed.

Figure 9: Lifejacket (inset: lifejacket label indicating 10 year lifespan)

MAIB commissioned Fleetwood Testing Laboratory to determine why the lifejacket worn by the skipper did not inflate. The laboratory's report (included at **Annex C**) concluded that the lifejacket had failed to activate because the carbon dioxide cylinder was not correctly fitted to the inflation mechanism.

Corrosion on the cylinder's threads indicated that the cylinder had been loose for some time. Additionally, residue within the automatic inflator components indicated that the system had been automatically activated well before the immersion on 8 June 2014, although this activation must have happened after the carbon dioxide cylinder became loose as the cylinder's cap had not been pierced.

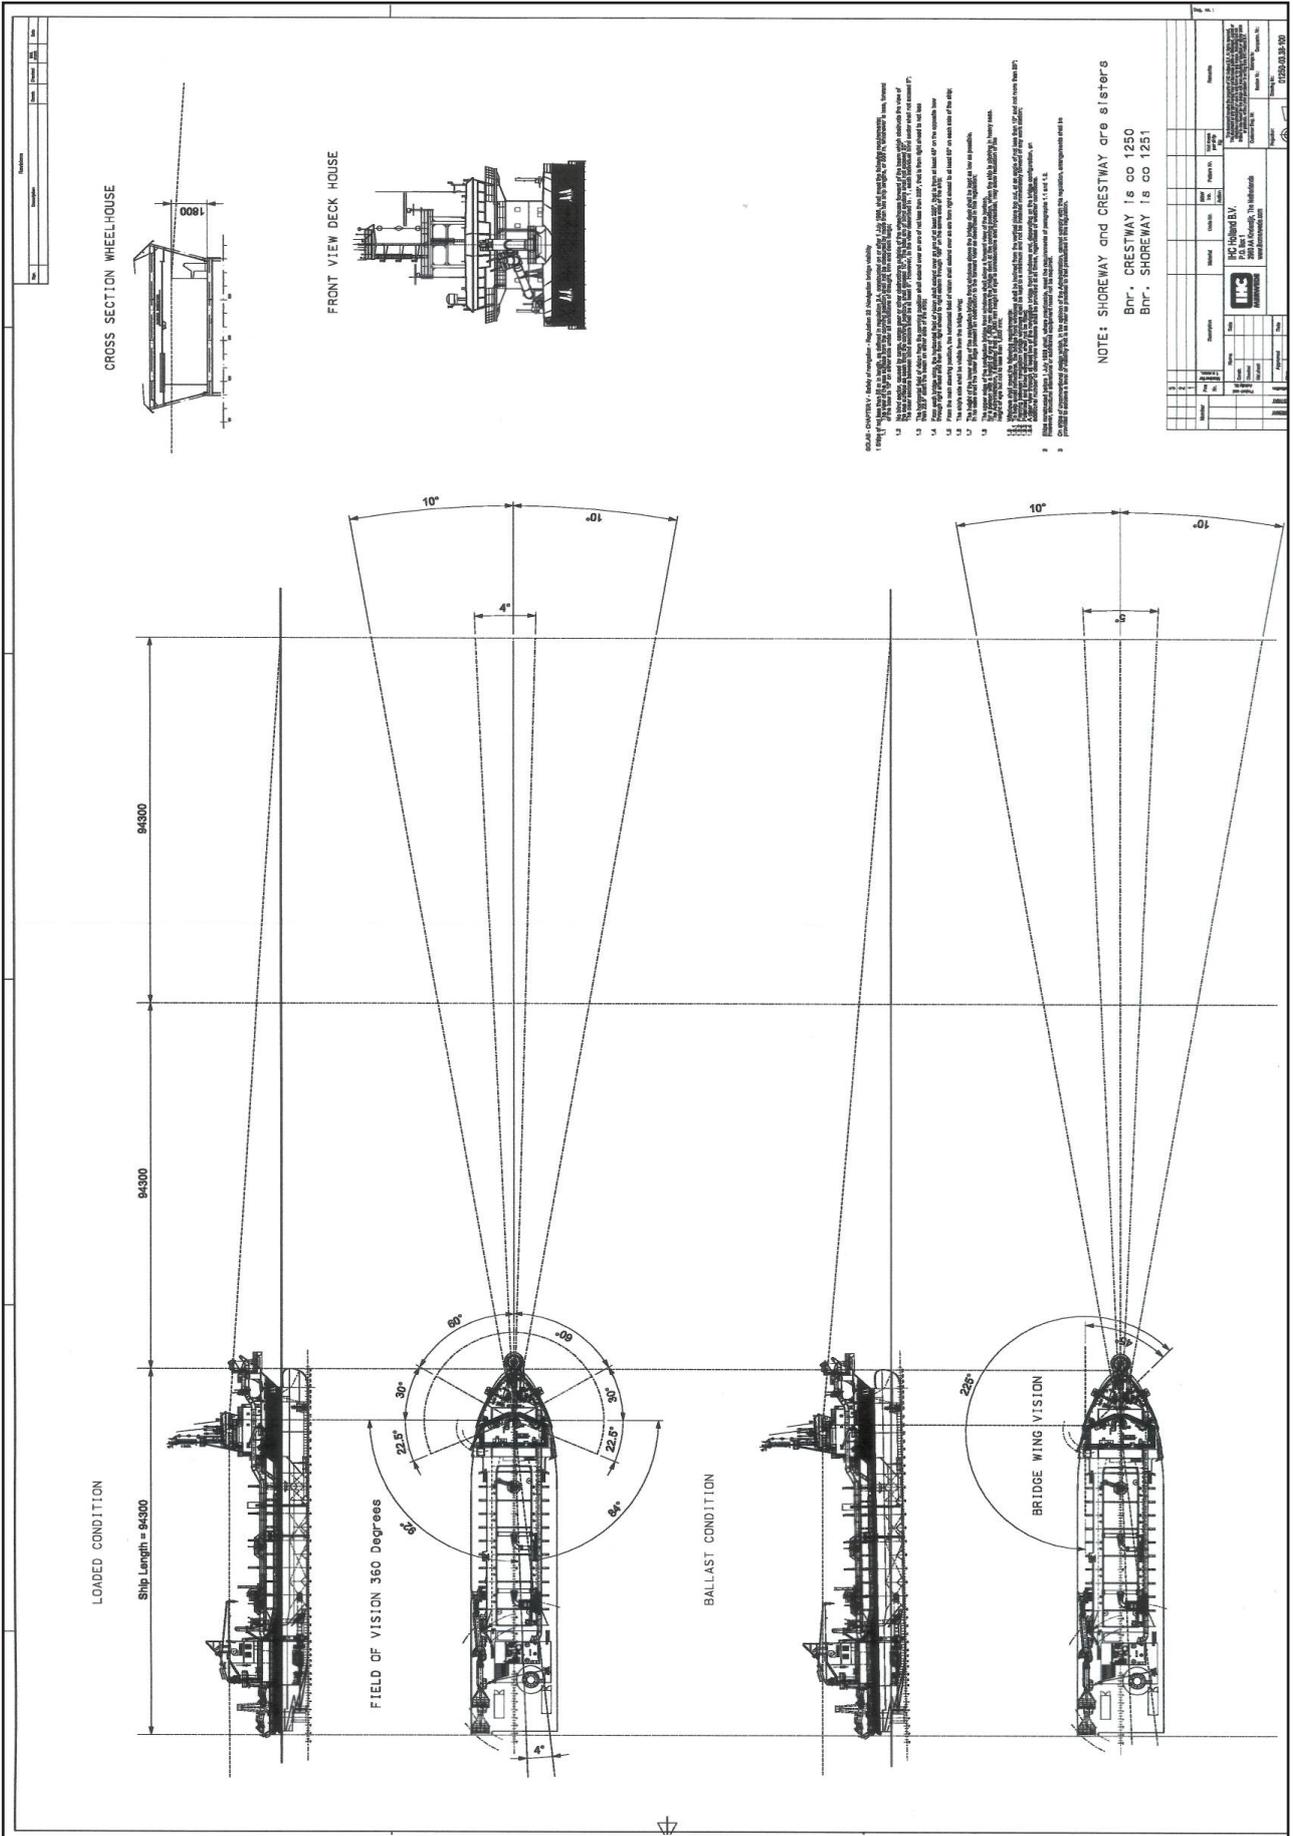
Shoreway was subsequently detained following the inspection, with one of the deficiencies cited as being Navigation Bridge Visibility – '*visibility from the conning position does not allow un-obstructed view ahead*'. Drawings were produced several days later to indicate that *Shoreway* did meet the international requirements as stipulated by SOLAS Chapter V, Regulation 22 (**Annex A**) and the detention notice was lifted. There were several other deficiencies recorded, not contributory to this accident, including:

The rainbow discharge equipment on *Shoreway's* bow obstructed the view directly ahead of the operator's seat at the horseshoe workstation by 4° of arc in the loaded condition and 5° of arc in the ballast condition. The field of vision, although obstructed, was within the requirements specified in SOLAS Chapter 5, Regulation 22 (**Annex A**) for navigation bridge visibility. *Shoreway* also met the requirements of IMO Resolution A.708(17) Navigation Bridge Visibility and Functions (**Annex E**). The blind sector caused by the obstruction (**Figure 14**) was not mentioned in any of the procedures, checklists or standing orders held on board.

Figure 14: Bridge visibility, SOLAS drawing

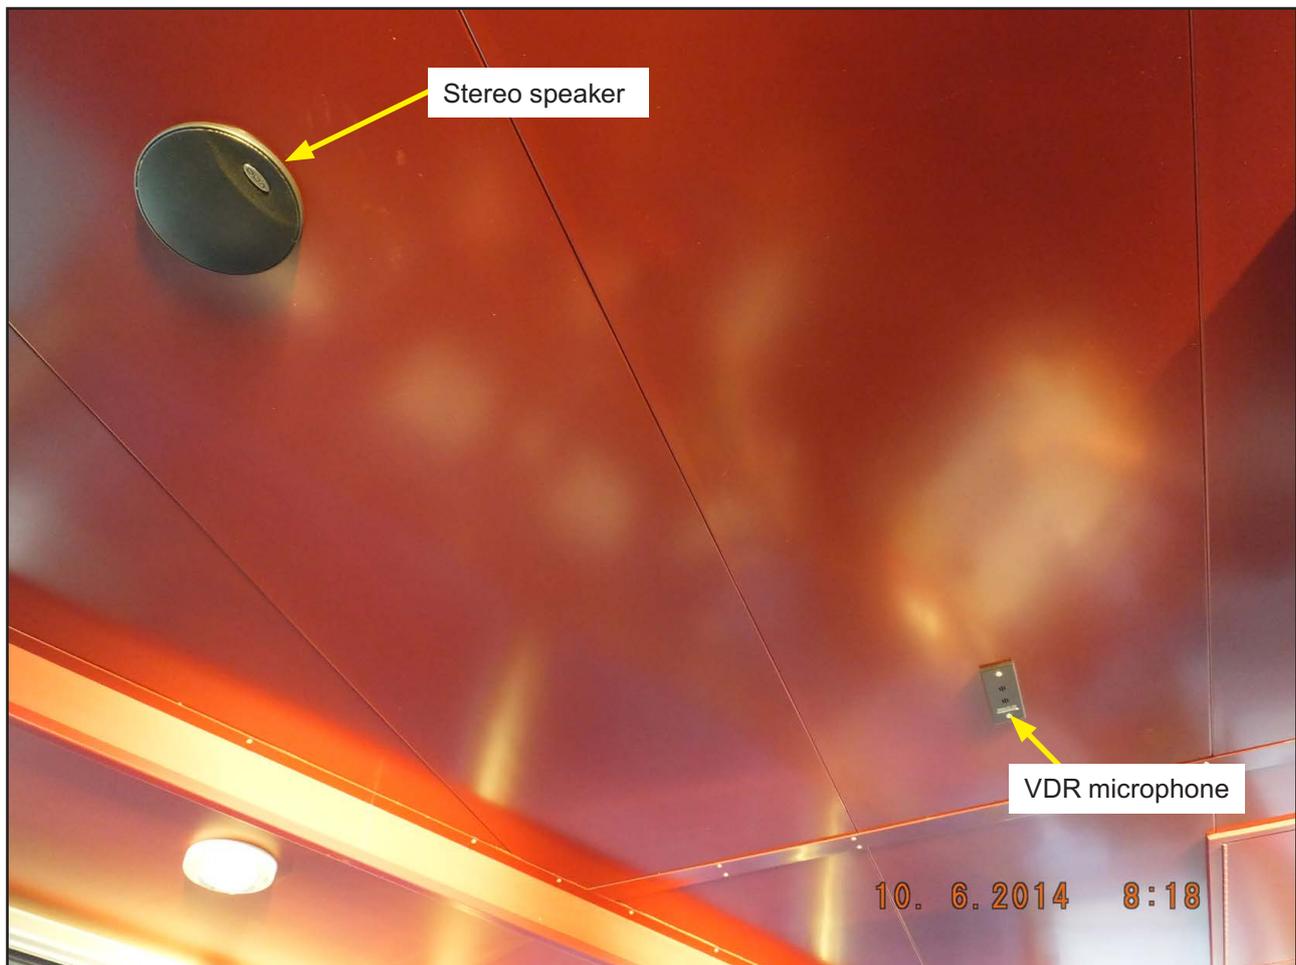
Boskalis's SMS did not specifically prevent the playing of recorded music on the bridge. *Shoreway's* master permitted officers to listen to music on the bridge as long as the volume was maintained at a level where VHF and operational conversations between bridge team members were not affected (**Figure 15**).

Neither the master's standing orders nor the vessel's SMS contained any reference to the VDR or guidance on when and how its data should be secured.

Figure 15: Bridge, proximity of stereo speaker to VDR microphone

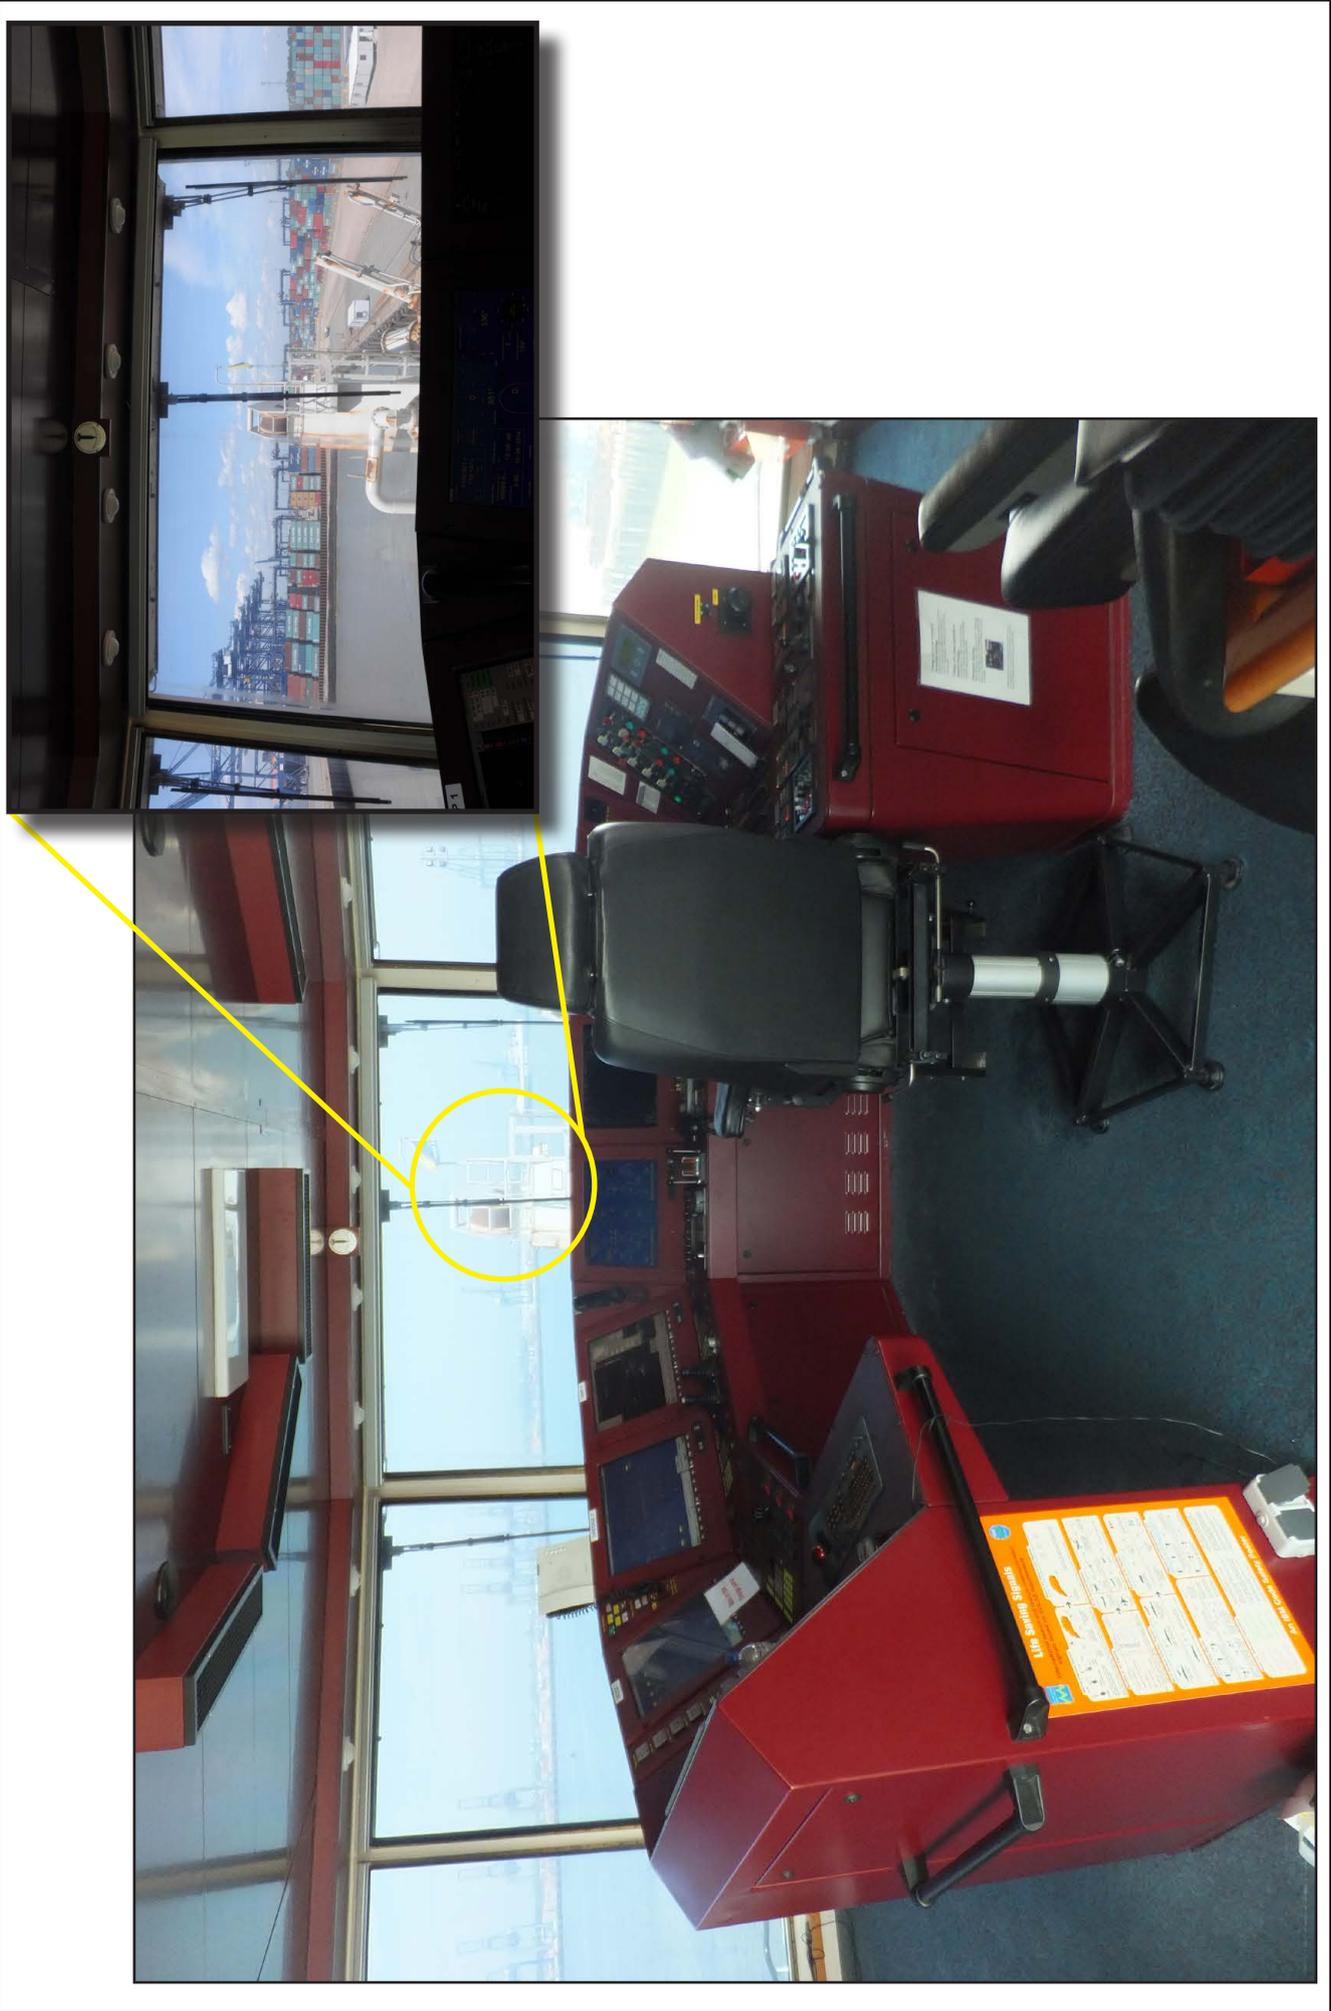
The design and position of the bridge horseshoe workstation, on the centreline immediately aft of the rainbow discharge equipment, caused the primary conning position to be in the location with the largest blind sector on the bridge. Having completed the course alteration, *Orca* remained directly ahead of *Shoreway*, hidden from the chief officer's position within the horseshoe until seconds before the collision (**Figure 16**).

Figure 16: Bridge horseshoe workstation (inset: obstruction)

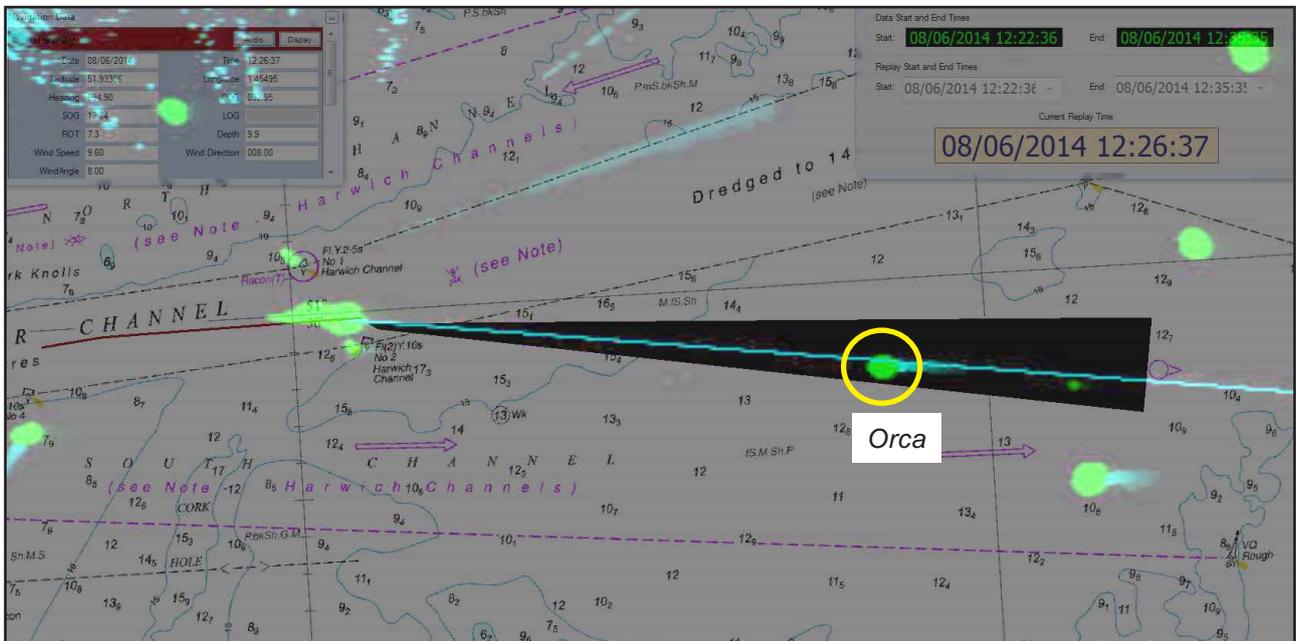
Figure 17: Projected blind sector

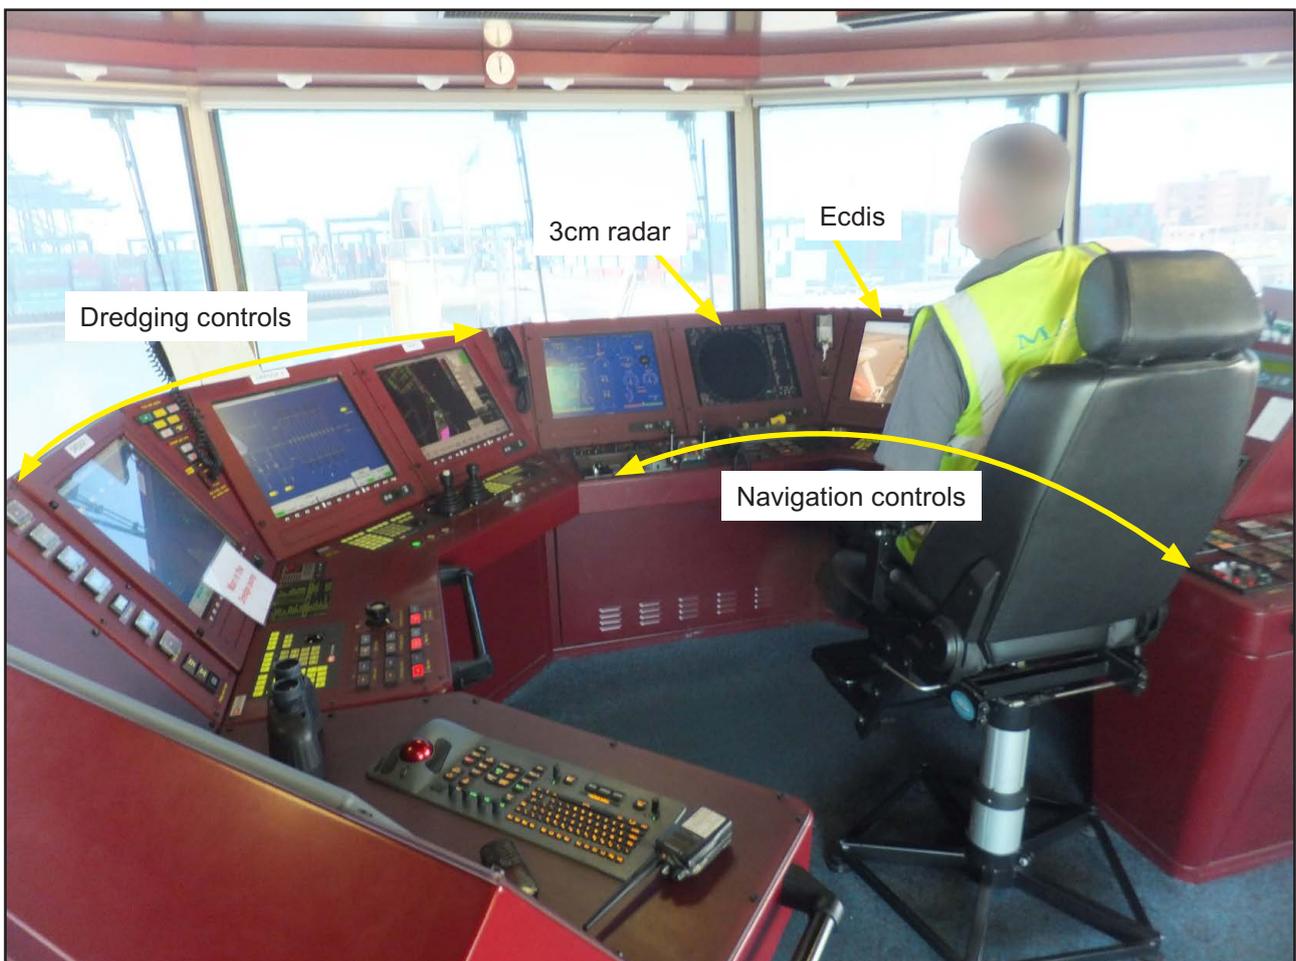
Shoreway's 3cm radar was set on a 3-mile range. It was not affected by the visual blind sector caused by the rainbow discharge equipment and was the main conning radar. Its display was positioned on the starboard side of the horseshoe workstation facing the chief officer (**Figure 18**). *Orca* had generated a clear radar target that had been visible on the display for 11 minutes prior to the collision (**Figure 19**). Two AIS targets had been automatically acquired earlier in the watch, and had passed clear with target data still displayed on the radar display. However, the weather conditions were good and the chief officer had not recognised the need to look at the radar or make use of its ARPA function. Therefore *Orca*'s target had not been seen, acquired or plotted.

Figure 18: 3cm radar location, bridge *Shoreway*

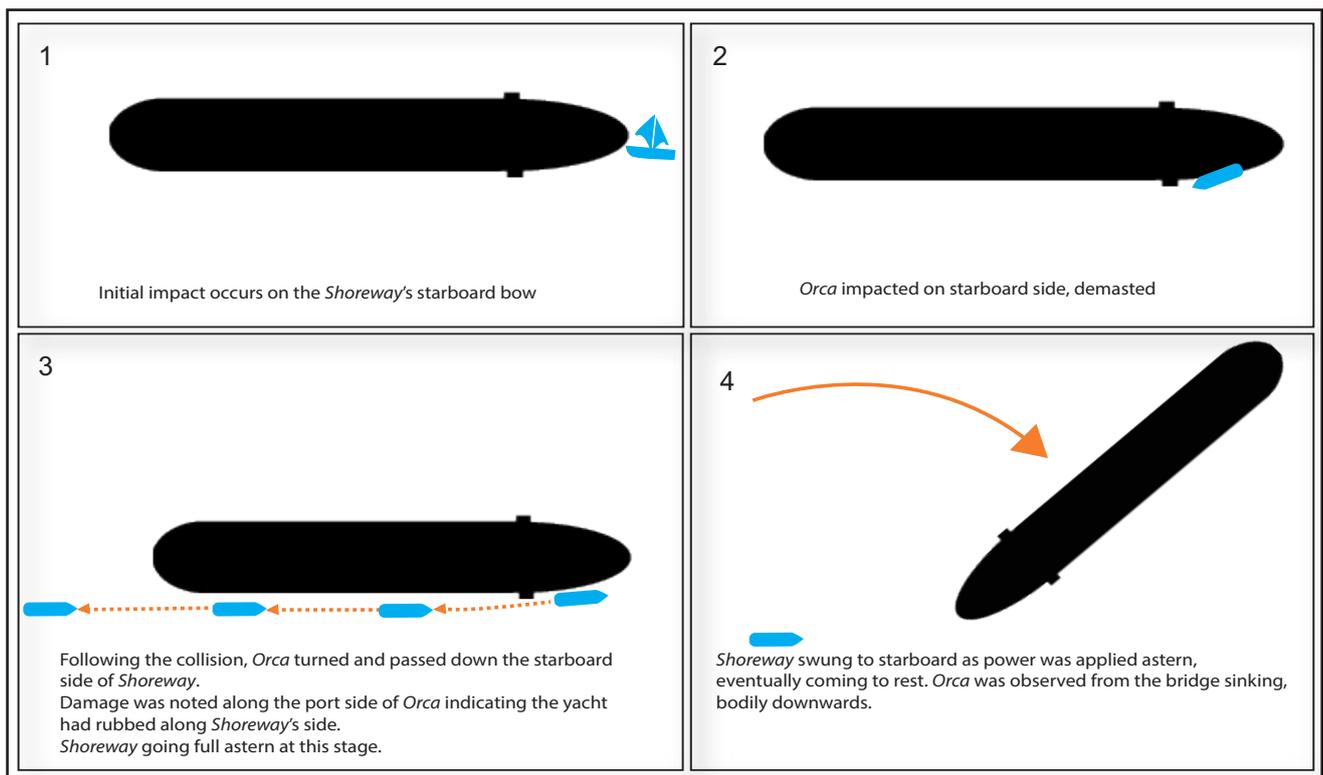
As *Shoreway* pushed *Orca* astern at over 12kts, the yacht flooded rapidly from the stern, before being spun around and passing down *Shoreway's* side. This caused a huge inrush of water, which swept both Mrs Ingram and one of the family's pet dogs down the companionway and into the main cabin with considerable force (**Figure 21**). Mrs Ingram sustained several injuries consistent with this accelerated fall and it is possible that these would have rendered her unconscious prior to her lifejacket inflating.

Figure 21: Damage sequence
